# Geological Engineering Reconnaissance of Damage Caused by the October 15, 2006 Hawaii Earthquakes

**Edmund W. Medley**, Senior Consultant, Geosyntec Consultants Inc., Oakland, CA, USA, Email: [emedley@geosyntec.com](mailto:emedley@geosyntec.com)

**ABSTRACT:** Two strong earthquakes shook the Island of Hawaii, Hawaii on the morning of October 15, 2006. Peak Ground Accelerations reached 1.2g, and earthquake felt intensity of MMI VIII. Earthquake damage of public and private property totaled about \$200 million, with no fatalities. Geological engineering reconnaissance of earthquake damage resulting from the earthquakes focused on the apparent relationships between the observed geology and the damage. Some roadway embankments failed causing temporary closure of Island highways. Landslides were common at steep coastal cliffs. Liquefaction and lateral spreading occurred in coralline fill at Kawaihae Harbor. There were extensive road cut failures, in which the performance of road cuts in soil slopes was generally better than that of rock slopes. Where a'a clinker underlay massive a'a basalt blocks in road cut slopes, the loose clinker dislodged thereby undermining the blocks, and cau

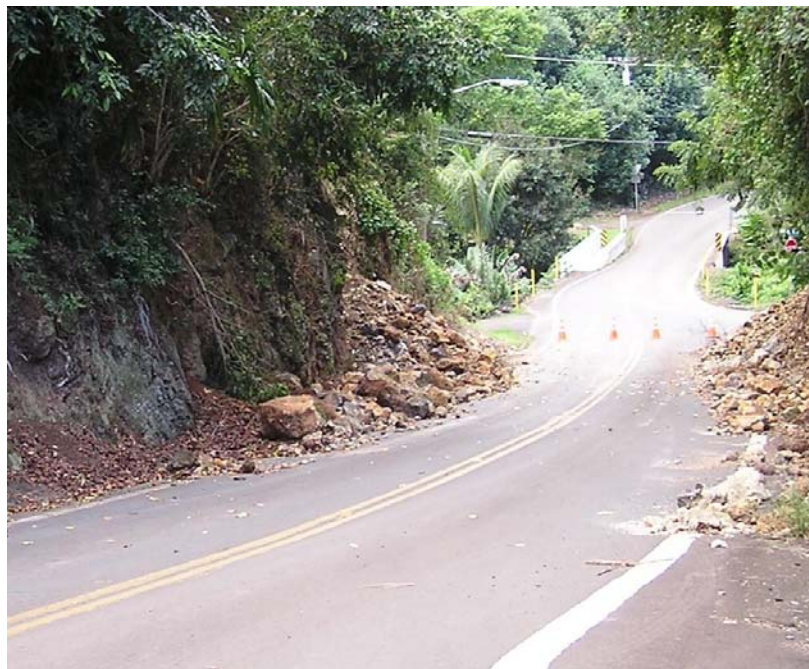
| Sta. | Location | Lat.<br>(N degs) | Long.<br>(W degs) | Feature | Comments |
|---|---|---|---|---|---|
| 18 | Hwy 270 Makapala<br>area | 20.2089 | -155.7388 | Rock cut failures,<br>embankment failure | Road cut failure of<br>fractured/well broken<br>angular basalt underlain by<br>residual soil/ Soil has<br>prominent baked zone at<br>contact with overlying rock;<br>and abundant core stones.<br>Failures occurred in upper<br>rock. On opposite side road,<br>significant slope cracking<br>and slope failure scarps at<br>top of high, steep<br>embankment. |

*Figure 7. Hwy 270, Station 18, near Kēōkea Bay Beach Park access road.  
Highway was blocked by rock falls after the earthquakes.*

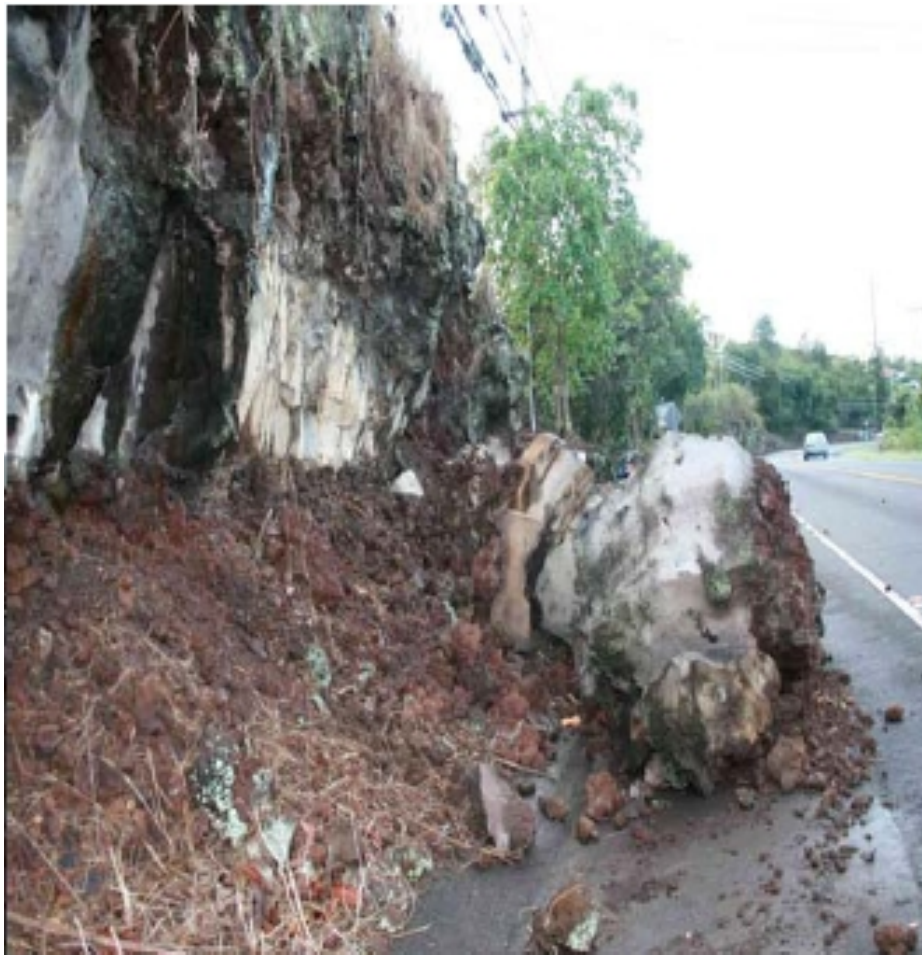
There is a considerable difference in the mechanical properties of the a'a clinker and massive basalt. During the earthquakes, loose a'a clinker raveled, removing support from the overlying massive blocks, some of which failed during the earthquakes as shown by Figures 9 through Figure 17 (includes 3-D stereo versions). It was the large and heavy blocks, rather than the soil-like clinker, that represented the greater hazard to traffic, and required greater effort to move. Consequently, where heavy equipment was not immediately available, fallen large rock blocks obstructed roads for longer periods than the finer debris.

*Figure 8. Failed rock cut: massive a'ā block undermined by raveled a'ā clinker (Chock, 2006; after Robertson et al, 2006).*

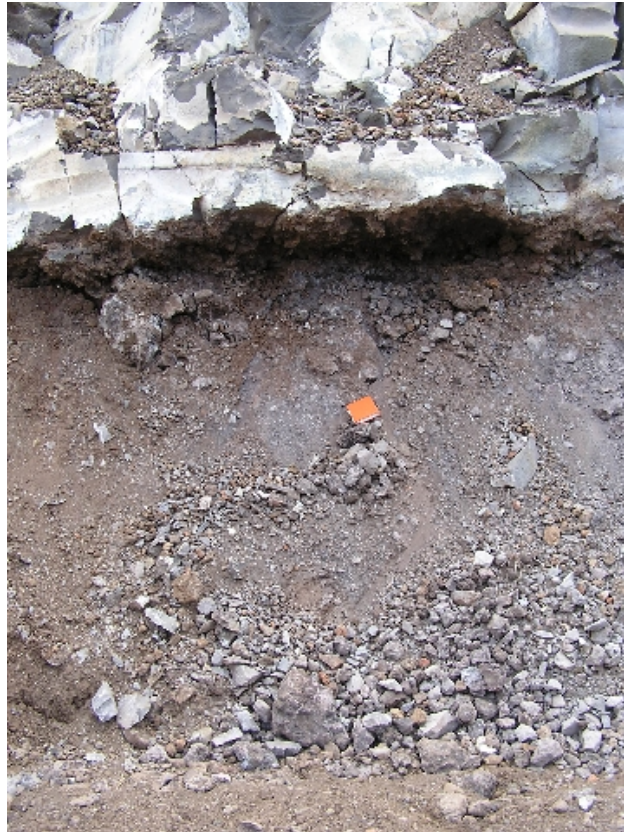
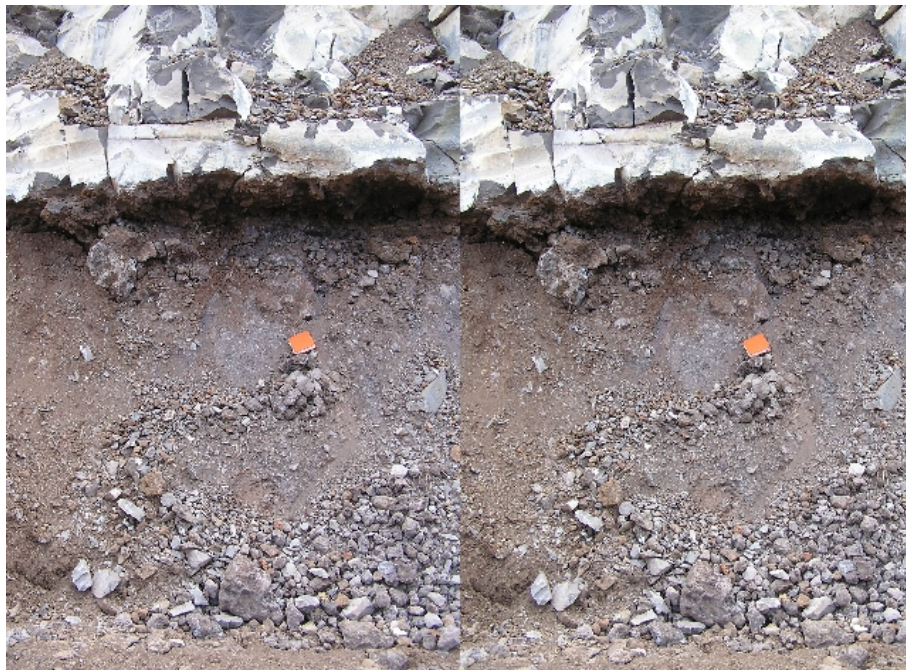
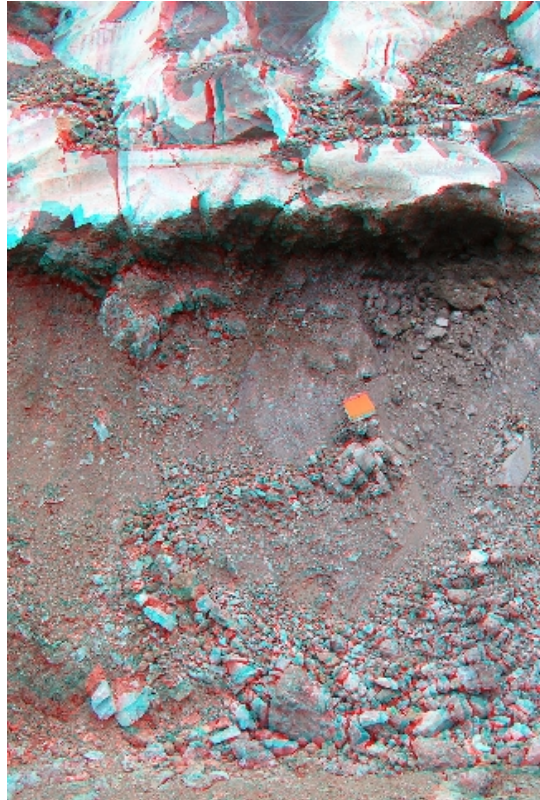
| Sta. | Location | Lat.<br>(N degs) | Long.<br>(W degs) | Feature | Comments |
|---|---|---|---|---|---|
| 25 | Hwy 270 north of Kawaihae, near entrance Kohala Estates | 20.0653 | -155.8482 | Rock cut failures | Extensive road cut failures, some retreat of road cut crest toward structure?? |

*Figure 15. Location 25, Hwy 270 north of Kawaihae. Cantilevered block of massive a'a basalt, undermined by clinker that raveled during the earthquakes. See 3-D stereo images of Figure 16 and Figure 17.*

*Figure 16. Location 25, Hwy 270 north of Kawaihae. 3-D stereo pair version of Figure 15. Cantilevered block of massive a'a basalt, undermined by clinker that raveled during the earthquakes.*

*Figure 17. Location 25, Hwy 270 north of Kawaihae. 3-D anaglyph stereo version of Figure 12. Cantilevered block of massive a'ā basalt, undermined by clinker that raveled during the earthquakes.*

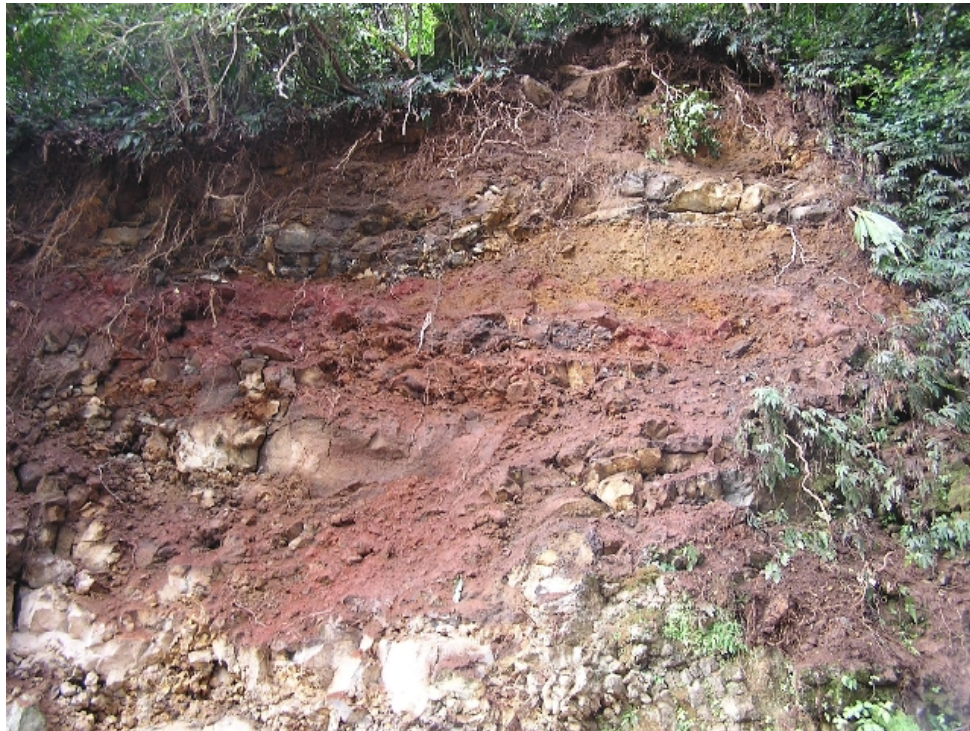
Figure 26. Location 4: old Hwy 11 near Ōōkala. Failure of soil above rock. Note inclusions of corestone rocks within soil.

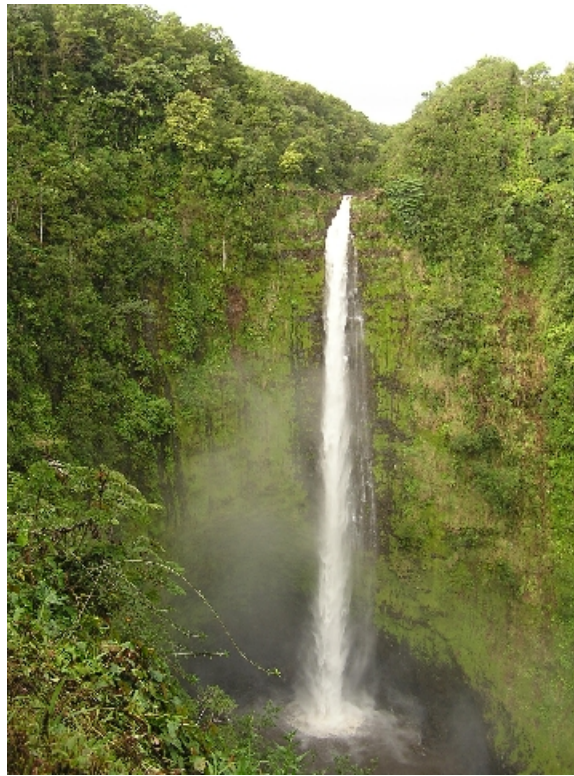
| Sta. | Location | Lat.<br>(N degs) | Long.<br>(W degs) | Feature | Comments |
|---|---|---|---|---|---|
| 2 | Akaka Falls State Park | 19.9540 | -155.1549 | Fresh scars at Falls | Scars due to landslides caused by EQ? EQ caused trees to topple, which damaged railings at Park. |

*Figure 30. Location 2, Akaka Falls, Hamakua Coast. Scars in the cliff face may not be attributable to the earthquakes.*

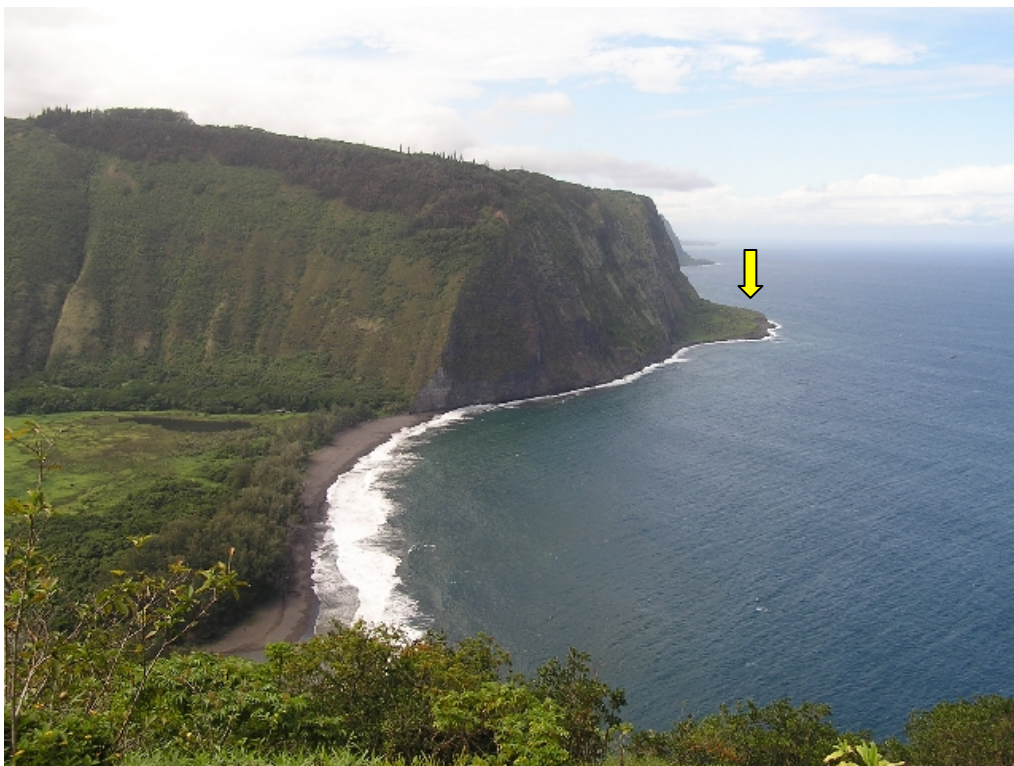
*Figure 31. Location 8, Waipi'o Valley cliffs. Debris from an older slide (arrow) intrudes into the sea in the background. Scars in the closer, truncated spur are apparently not a result of the earthquakes since the water is not muddy.*

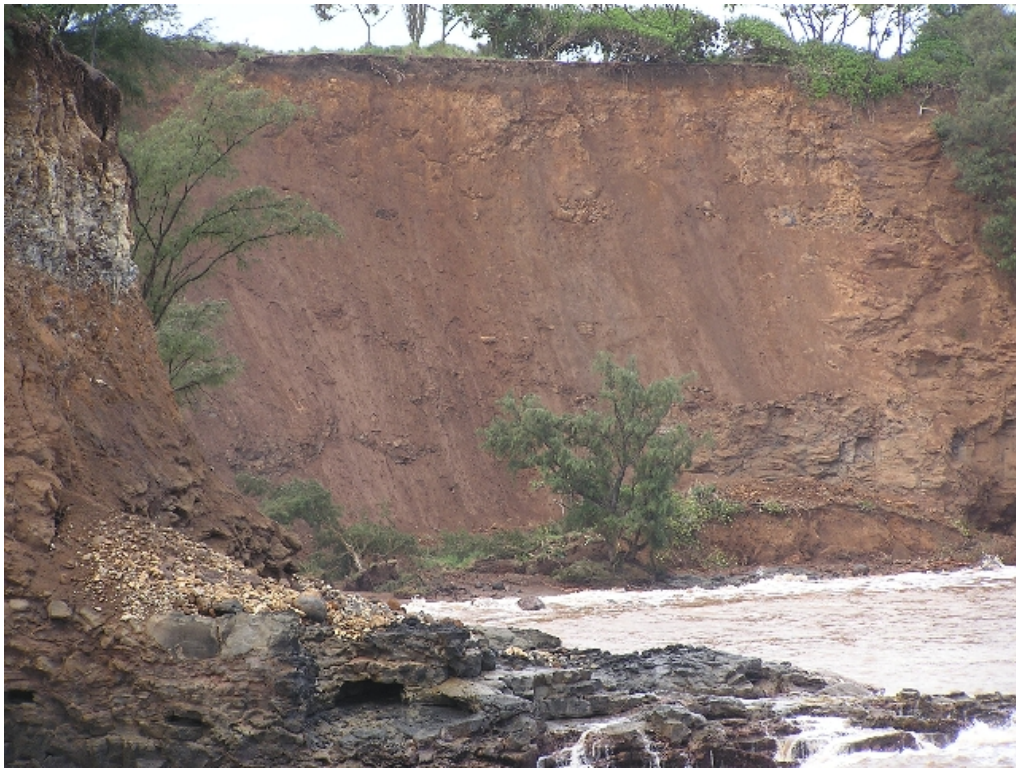
| Sta. | Location | Lat.<br>(N degs) | Long.<br>(W degs) | Feature | Comments |
|---|---|---|---|---|---|
| 19 | Kēōkea Beach Park | 20.2276 | -155.7453 | Sea Cliff failures | Large blocks of cliff top slid<br>down cliff faces, includes<br>block to west at headland of<br>Kēōkea Bay. |

*Figure 32. Location 19, Kēōkea Bay. Cliffs failed during the earthquake with displaced trees at base of slope and slide scars.*

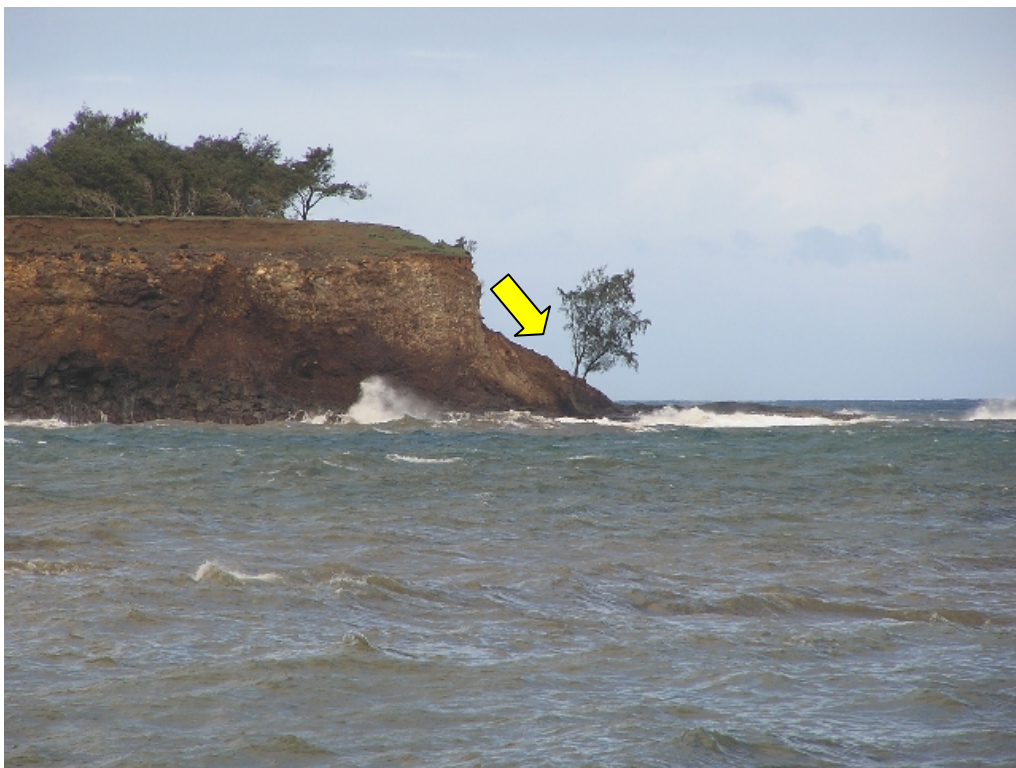
*Figure 33. Headland to the northwest of Location 19, Kēōkea Bay. Cliff top slid into the ocean, indicated by the displaced tree and the mostly submerged toe debris.*

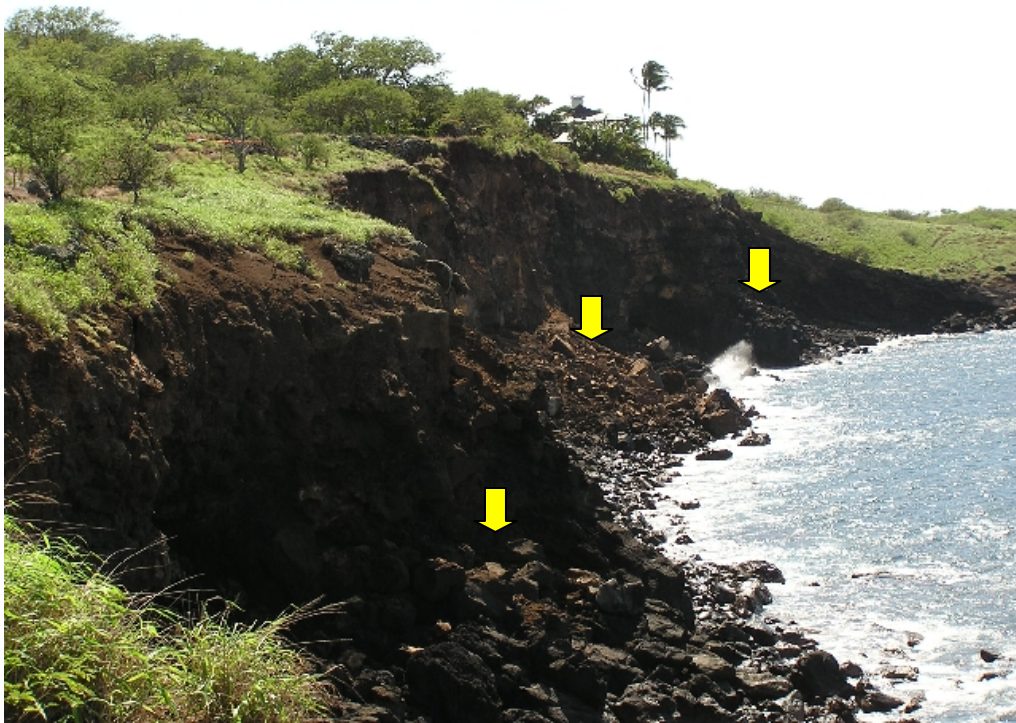
| Sta. | Location | Lat.<br>(N degs) | Long.<br>(W degs) | Feature | Comments |
|---|---|---|---|---|---|
| 23 | Ala Kahaki trail between Honoipu Landing and Parking area at Puakea Point | 20.2437 | -155.889 | Sea cliff failures | Cracks in cliff top; failures in weathered clinker; failures of rock structure below asphalt parking lot at rock walls. |

*Figure 34. Location 23, failed cliffs (arrowed) south of Honoipu Landing (Ala Kuakini Trail).*

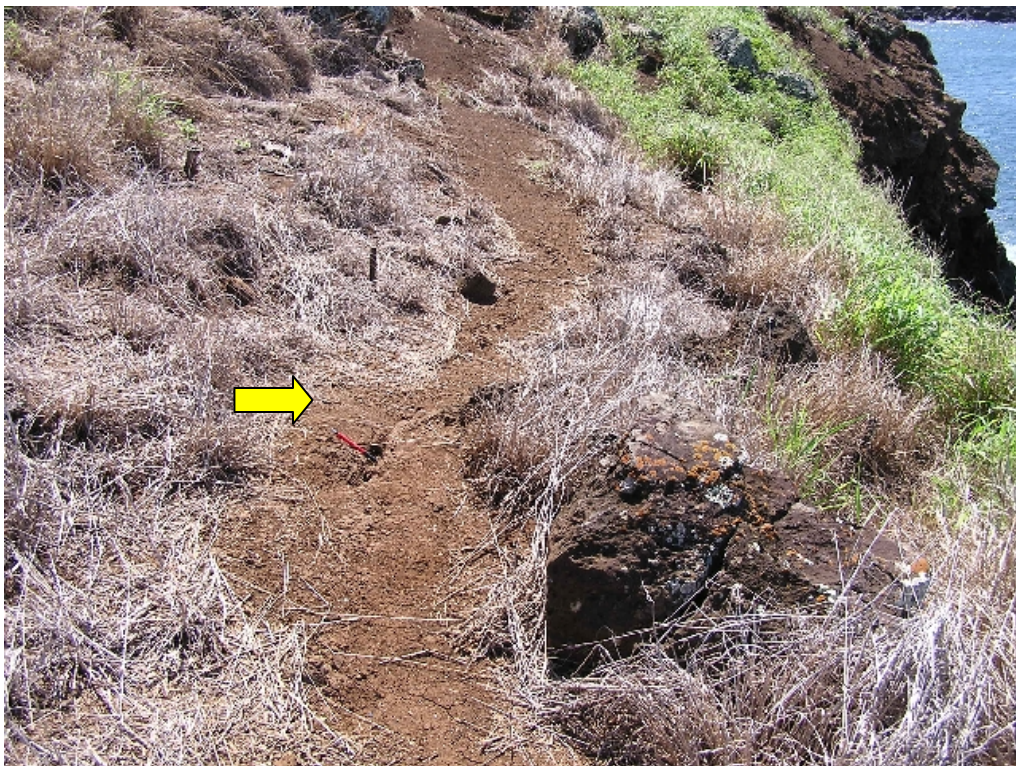
*Figure 35. Location 23, Ala Kuakini Trail. Tension cracks behind cliff top (arrowed) in foreground.*

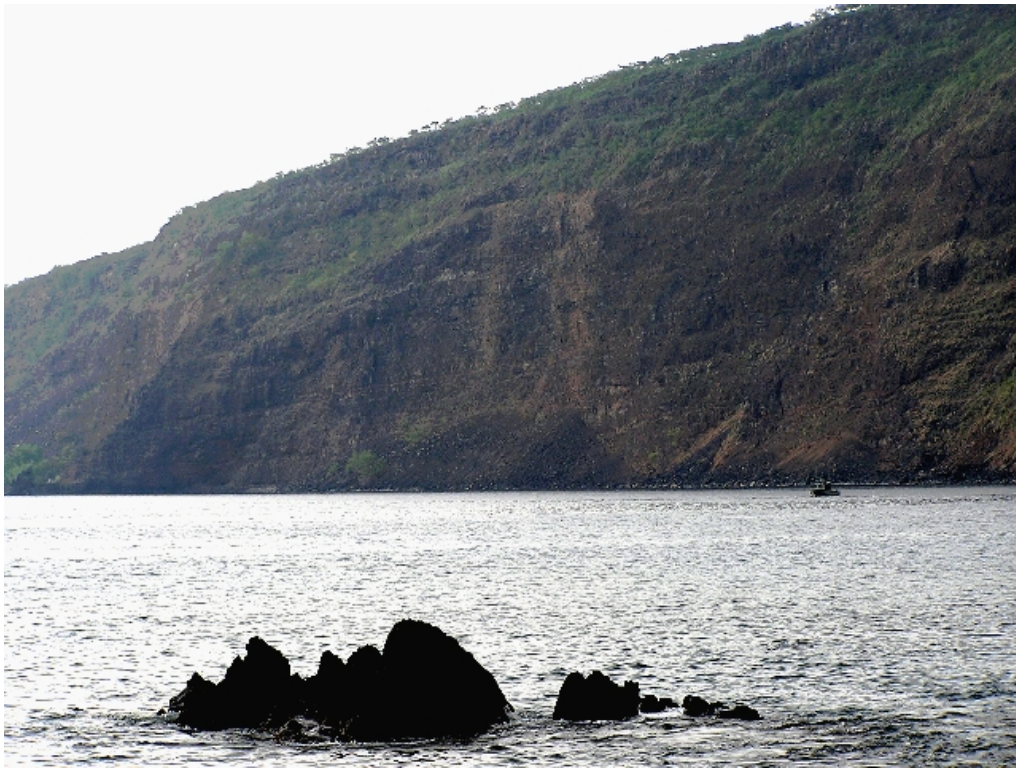
| Sta. | Location | Lat. (N degs) | Long. (W degs) | Feature | Comments |
|---|---|---|---|---|---|
| 36 | Napo'opo'o Beach Park | 19.4753 | -155.9196 | Sea cliff failure | Views of failures (in poor light) spawned from old landslide scarp (Pali Kapu o Keōua, head of Alike landslide; 100k to 105k yBP). See view of landslide occurring: <a href="http://www.flickr.com/photo/s/konaboy/270510964/">http://www.flickr.com/photo/s/konaboy/270510964/</a> |

*Figure 36. Location 36, Napo'opo'o, facing the Pali Kapu o Keōua, a fault/mega-landslide scarp.*

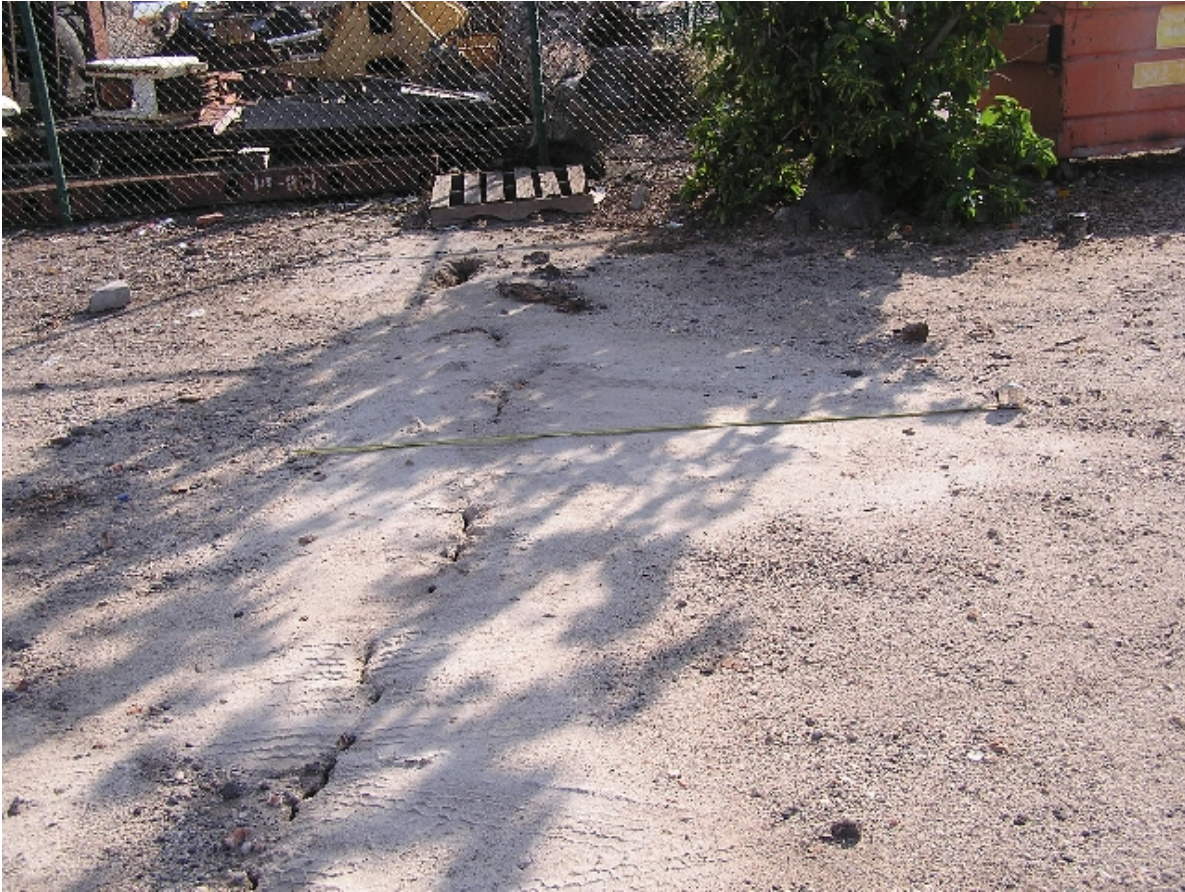
Figure 39. Location 27, Kawaihae Small Boat Harbor parking lot, adjacent boat yard at south side. Liquefied (white) sand was ejected from wide ground crack during the earthquake shaking.

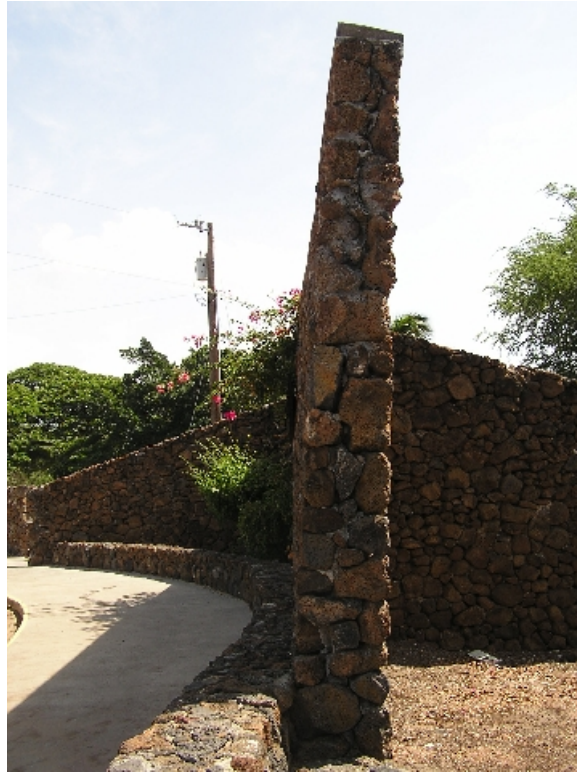
| Sta. | Location | Lat.<br>(N degs) | Long.<br>(W degs) | Feature | Comments |
|---|---|---|---|---|---|
| 30 | Spencer Beach Park, south of Kawaihae | 20.0245 | -155.8226 | Deformed cemented stacked rock block wall | Bent free-standing rock wall; formed from two panels of grouted rock blocks. Bending and block missing near base: evidence of recent EQ damage? No other deformed walls seen, but no other wall are free standing. |

*Figure 43. Location 30, Spencer Beach Park, south of Kawaihae. Apparent earthquake damage of partially mortared rock wall: wall is bent.*

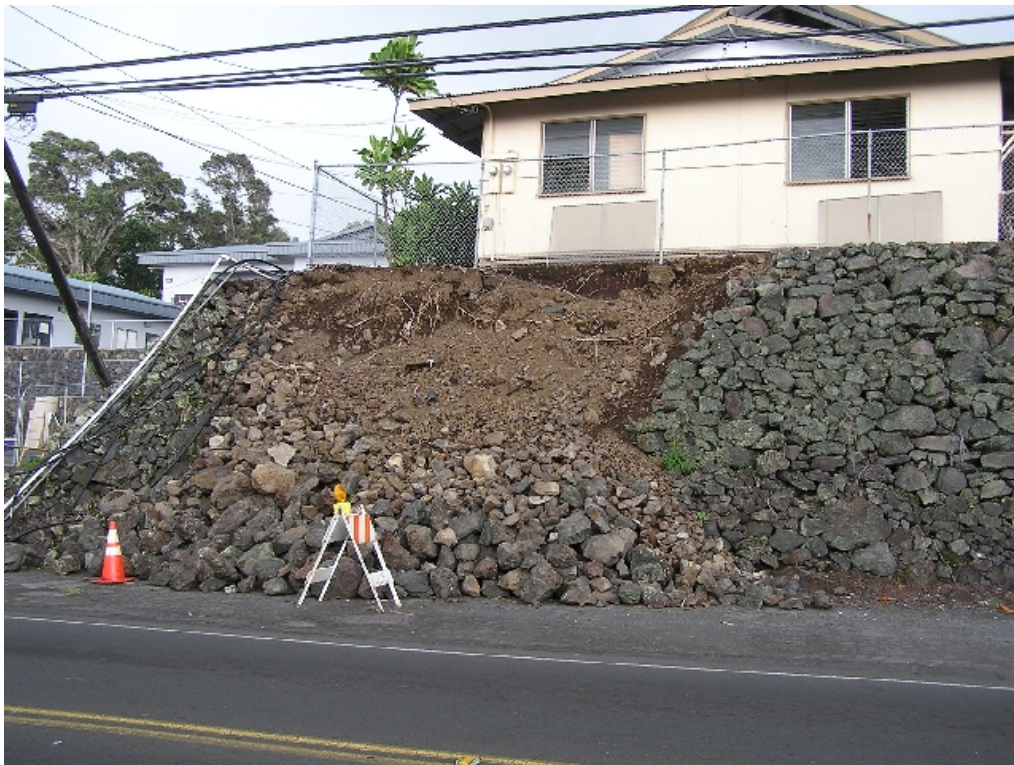
| Sta. | Location | Lat. (N degs) | Long. (W degs) | Feature | Comments |
|---|---|---|---|---|---|
| 35 | Captain Cook, Hwy 11 | 19.5006 | -155.9200 | Rock wall failures | Failed walls adjacent private property: typical of the few seen. |

*Figure 44. Location 35, Captain Cook. Failed stacked rock retaining wall. 3*

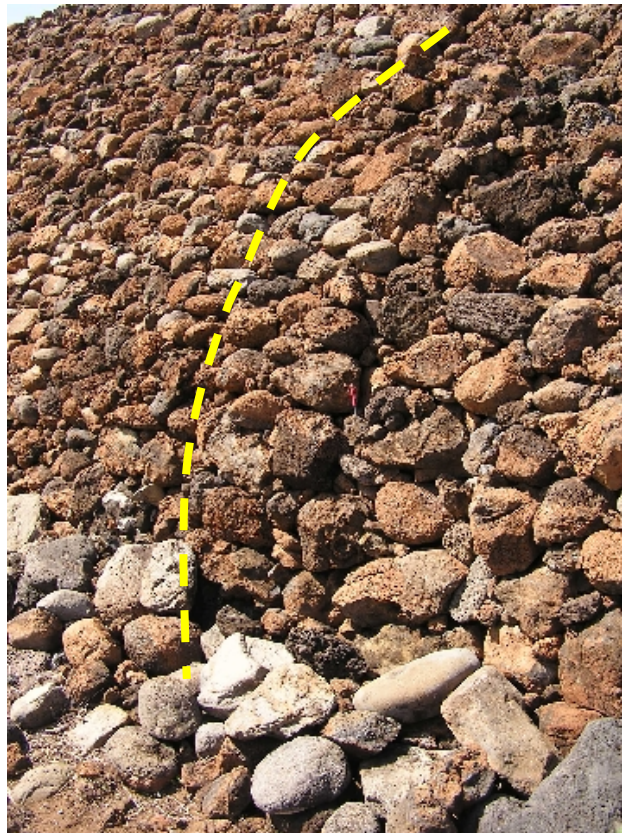
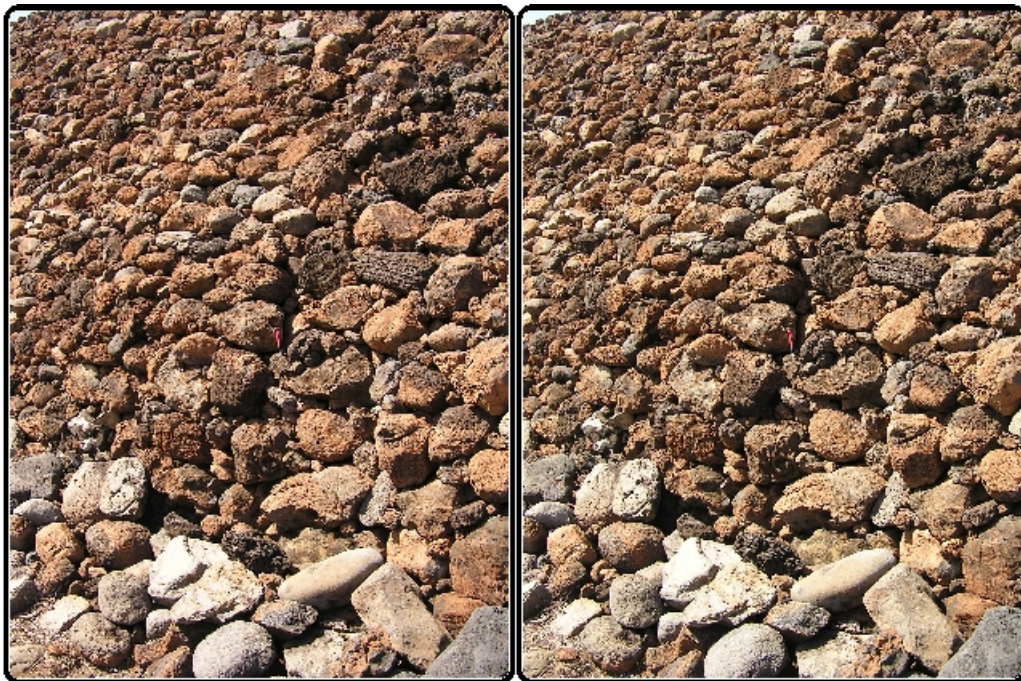
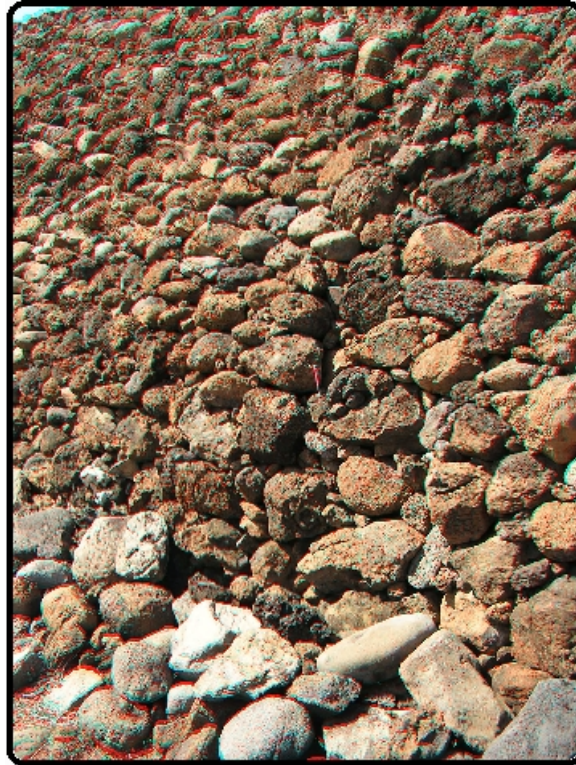
| Sta. | Location | Lat.<br>(N degs) | Long.<br>(W degs) | Feature | Comments |
|---|---|---|---|---|---|
| 29-2 | Pu'ukoholā heiau: east side, NE corner | 20.0279 | -155.8213 | Failures of stacked rock block slopes | East side and NE corner, major bulging, slumping and raveling failures |

*Figure 53. Location 29, NE corner Pu'ukoholā Heiau. Bulging of rock face approaches 90 degree inclination as indicated by yellow line. Bulge is clearly seen in 3-D stereo versions of Figure 54 and Figure 55.*

*Figure 54. Location 29, bulge at NE corner of Pu'ukoholā heiau. 3-D stereo pair version of Figure 53.*

*Figure 55. Location 29, bulge at NE corner of Pu'ukoholā heiau.  
3-D anaglyph stereo version of Figure 53.*

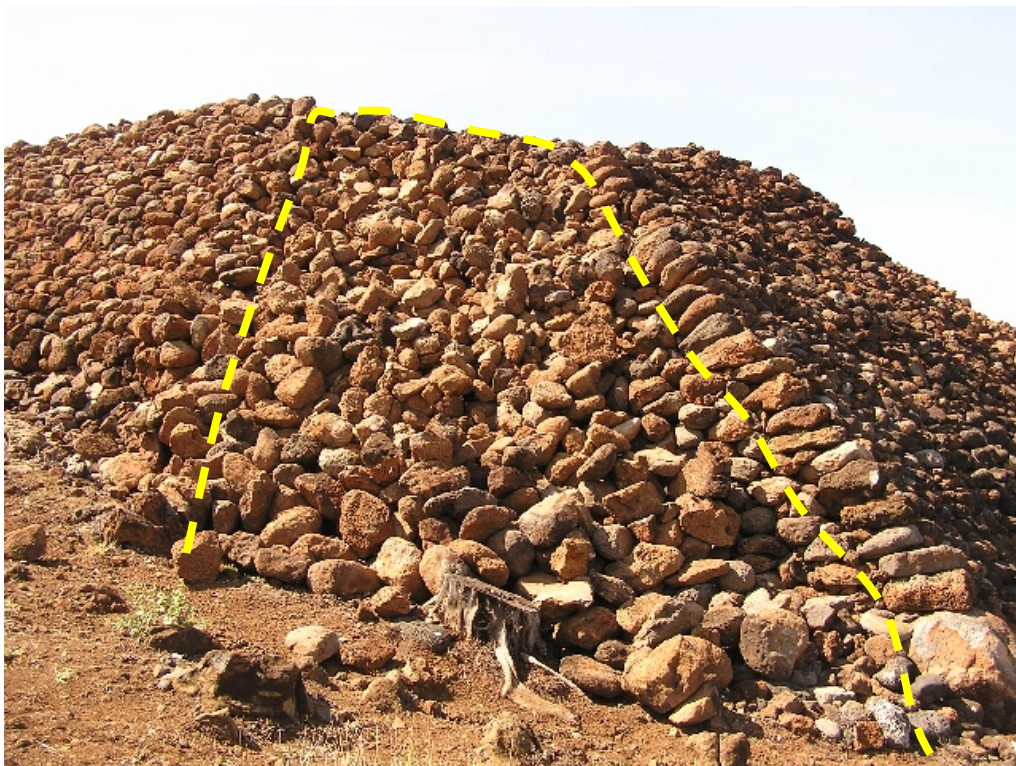
*Figure 56. Location 29, Pu'ukoholā heiau, northeast corner. Dashed lines indicate boundary of ravel zone.*

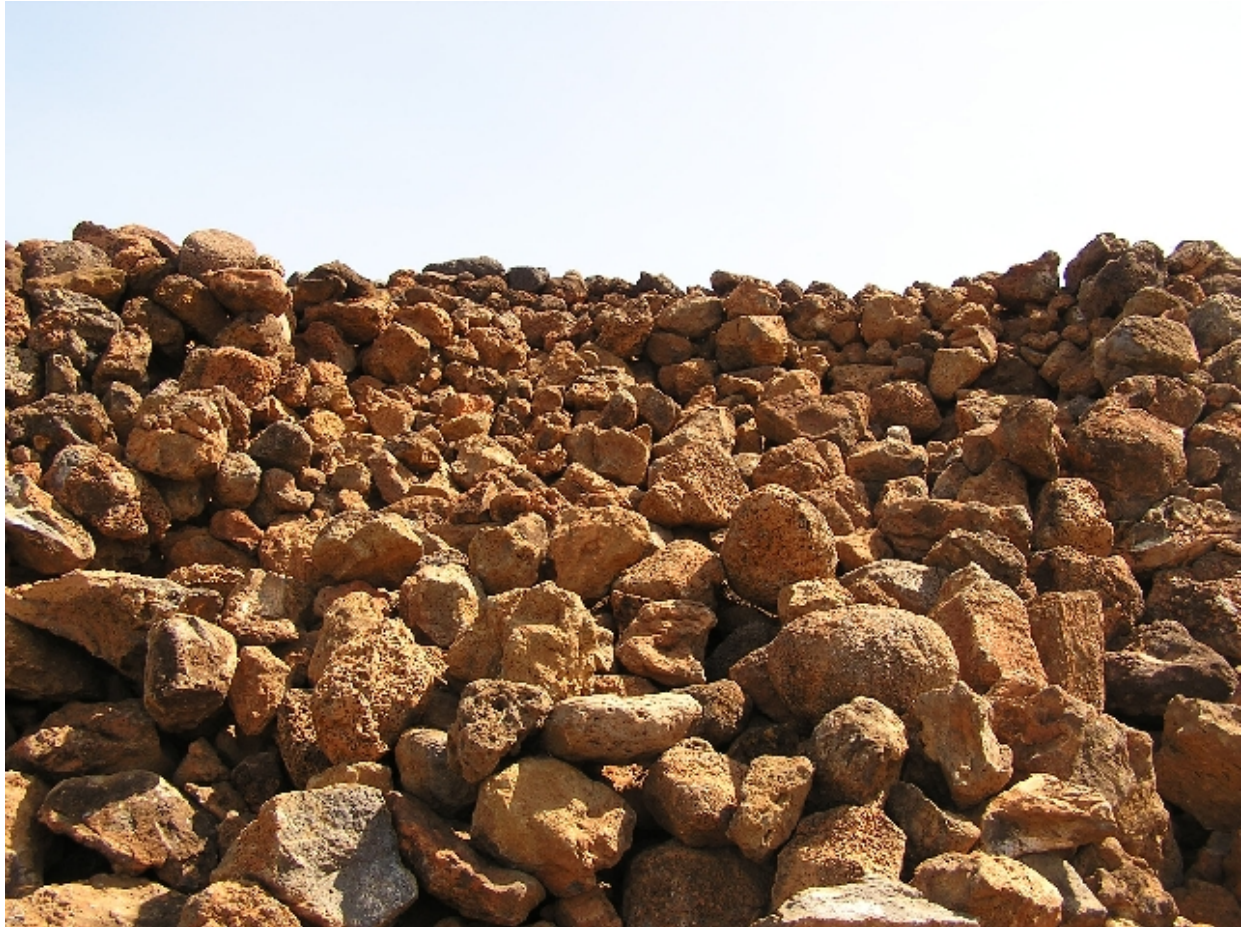
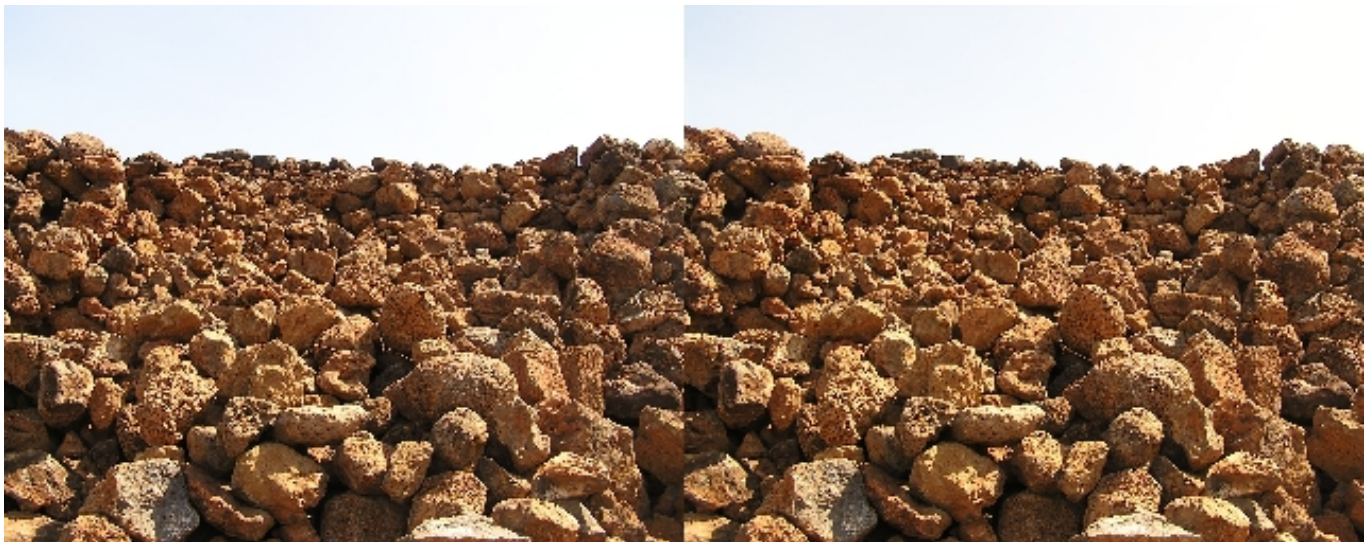
| Sta. | Location | Lat.<br>(N degs) | Long.<br>(W degs) | Feature | Comments |
|---|---|---|---|---|---|
| 29-4 | Pu'ukoholā heiau west side heiau, SW and NW corners | 20.0276 | -155.8217 | Failures of stacked rock block slopes | West side, SW and NW corners: slumping and bulging failures |

*Figure 57. Location 29, slump failure in high rock wall of Pu'ukoholā heiau, west side.  
See 3-D stereo images of Figure 58 and Figure 59.*

*Figure 58. Location 29, slump failure in high rock wall of Pu'ukoholā heiau, west side.  
Stereo pair 3-D version of Figure 57.*

Figure 59. Location 29, slump failure in high rock wall of Pu'ukoholā heiau, west side.  
3-D anaglyph stereo version of Figure 57.

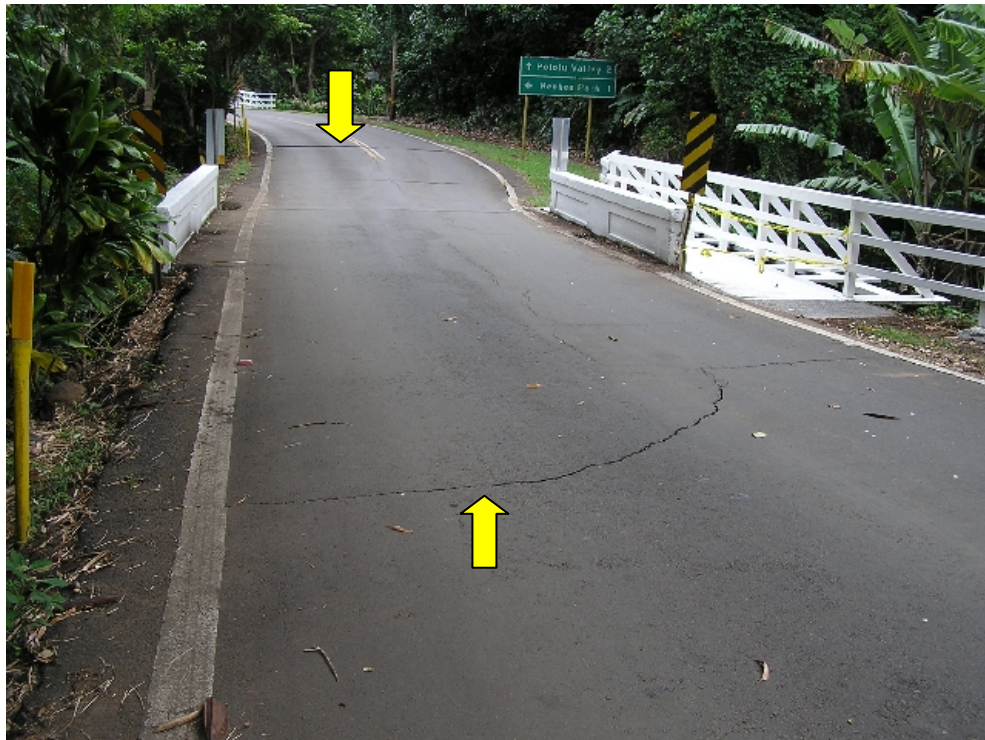
| Sta. | Location | Lat.<br>(N degs) | Long.<br>(W degs) | Feature | Comments |
|---|---|---|---|---|---|
| 20 | Hwy 270 Mile Post 27.3, Bridge 407 | 20.2204 | -155.7483 | Bridge failure | Thrust road pavement; abutment fill problems; bridge damage includes widening (?) of old cracks. |

*Figure 64. Location 20, bridge at approximately Mile Post 28, Hwy 270.  
Asphalt pavement cracked at approximately the cut/fill transitions of underlying subgrade.*

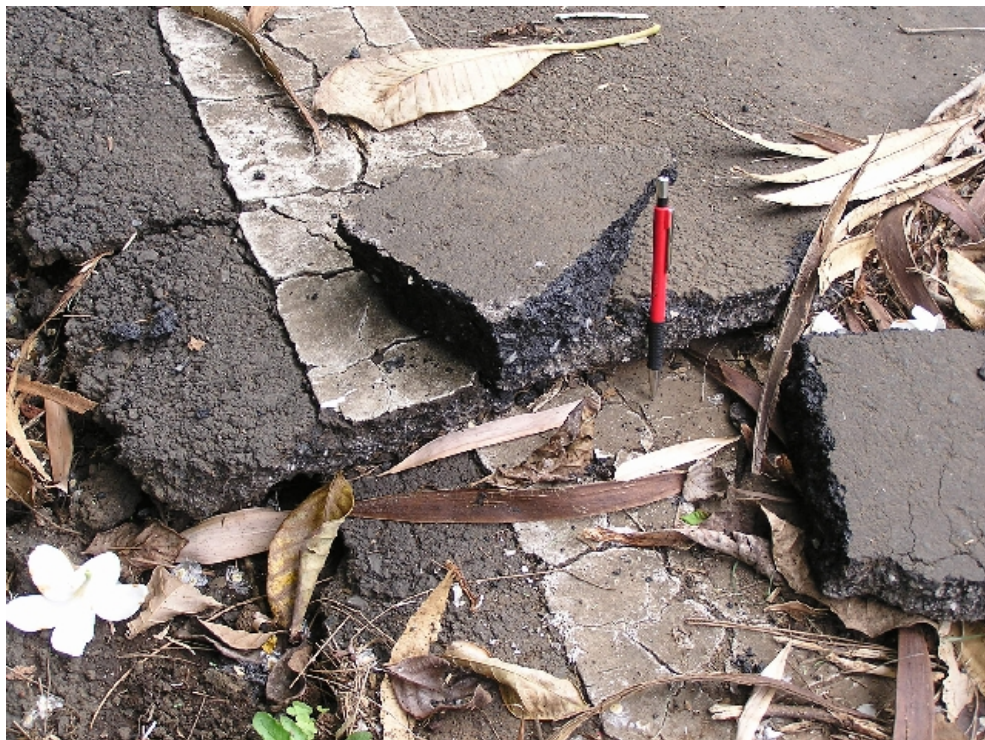
*Figure 65. Location 20, bridge at approximately Mile Post 28, Hwy 270.  
Thrusting of asphalt concrete pavement.*

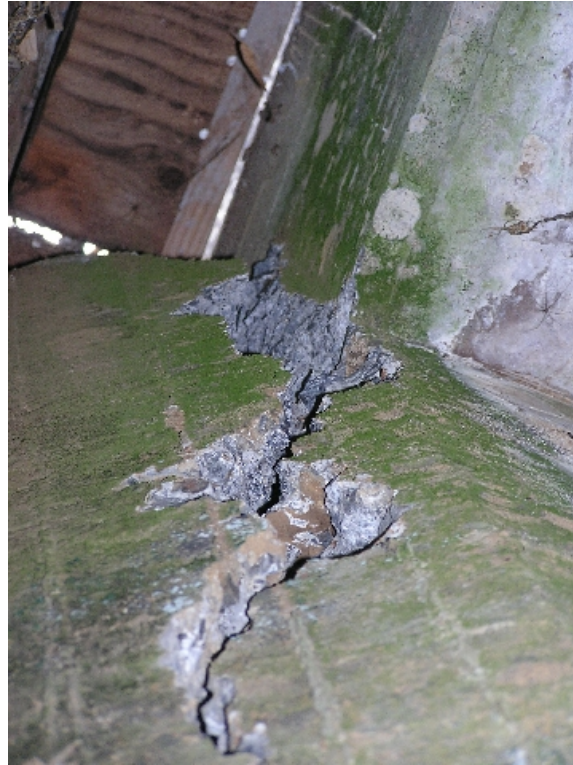
*Figure 66. Location 20, bridge at approximately Mile Post 28, Hwy 270. At SW corner of bridge, looking upward at wooden plank sidewalk above. Fresh spalling of bridge abutment headwall at old, pre-existing cracks.*

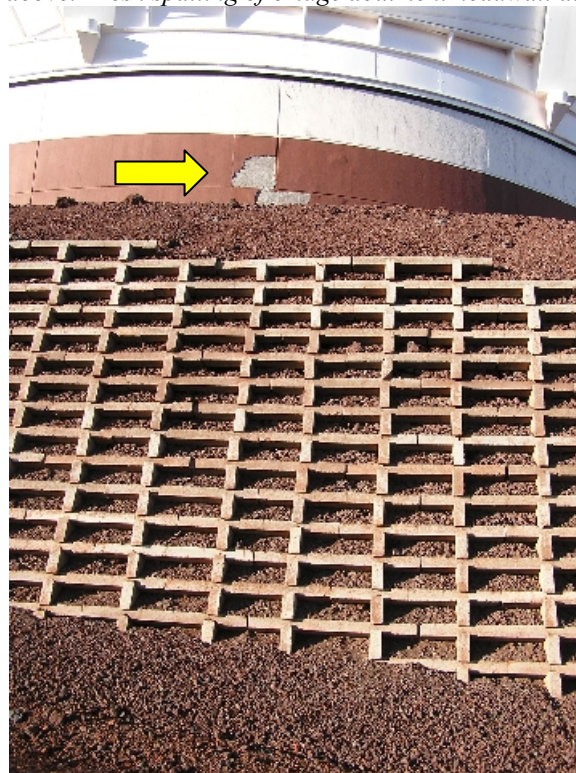
| Sta. | Location | Lat.<br>(N degs) | Long.<br>(W degs) | Feature | Comments |
|---|---|---|---|---|---|
| 28 | Mauna Kea Keck Observatory | 19.8260 | -155.4747 | Structure damage, | Some damage observed to stucco at Keck Observatory; none obvious at adjacent high crib retaining wall. |

*Figure 67. Location 28, Keck Observatory, Mauna Kea summit. No apparent distress to high embankment beside the observatory. Spalled stucco evident at two places on the exterior wall of the building (one arrowed).*
