# Lack of Maintenance Compromises Tunnel Structural Safety

**ABSTRACT:** *The Chekka tunnels represent a critical section of the Northern Lebanon Highway. The approximately 350-m long twin tunnels are the most important tunnels in the country. They are used by regular and freight traffic and are a vital link to the capital, Beirut. The tunnels were completed in the early 1970s on the eve of the Lebanon civil war. Given the state of affairs in the country for about two decades of strife, the tunnels were not maintained nor did they undergo any regular inspection. This unique condition of near-abandonment continued up until recently, when the first signs of distress were documented. These consisted of severe and extensive cracking, particularly in the portal approach of the southbound tunnel, along with significant deterioration of the tunnel lining and radial section joints. The danger to traffic and, potentially, to the structure itself was evident. In this paper, the results of an extensive site inspection and evaluation program are presented. The underlying causes of the observed damage are analyzed and discussed using a modeling approach of the progressive loading conditions. R

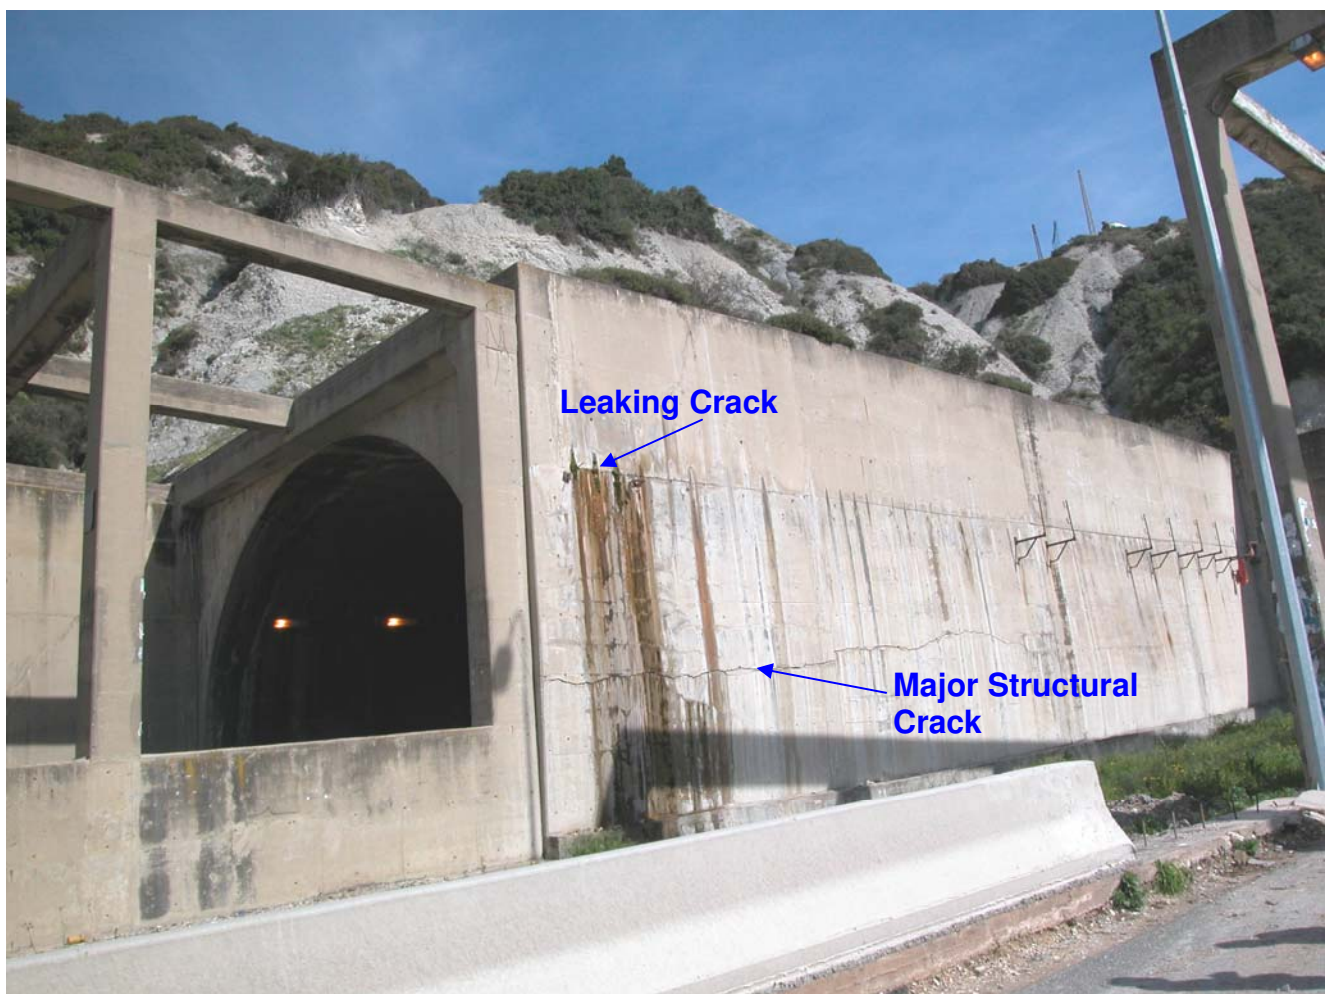
*Figure 1. Southbound Tunnel Portal - View of External Distress.*

The major crack along the 35-m long portal structure at the southbound tunnel exit (shown in Fig. 1 and Fig. 2) which initiated the engineering intervention, was attributed to increased differential loading. This possible cause for the structural damage was identified following the observation of a relatively large slumped mass of soil loading the western side of the portal structure of the southbound tunnel (Fig. 3). The slumped soil mass was due to weathering of the friable chalky limestone rock on the adjacent exposed slopes and subsequent instability and mass transport. The differential loading of one side of the portal frame structure by the slumped soil mass, along with other contributing factors, could have led to the observed cracking of the eastern wall of the portal along with the associated lateral deformations of up to 15 cm (Fig. 1 and Fig. 2). Additional pictures of this particular tunnel segment are provided in the online database that accompanies this paper.

1. A major longitudinal structural crack was clearly evident on the outside face of the eastern wall of the tunnel portal frame in the last 35 m span of the exit side of the southbound tunnel (Fig. 1). Signs of water leakage through a crack in the eastern wall were evident at the junction between the tunnel portal and the 4.72 m high retaining parapet. This pattern of damage was indicative of a number of problems with the tunnel portals, which are typically identified as potentially problematic areas in a number of situations (Rothfuss et al., 1995).

1. The major structural cracks on the outside face of the eastern wall of the portal frame were repaired by “crack-injection” using low viscosity, two-component epoxy resin. The injection was completed after thorough cleaning and preparation of the affected areas and the provision of injection ports to ensure thorough filling of the cracks. Similar treatments were applied to all cracks and damaged areas in the tunnel concrete lining (Fig. 15).

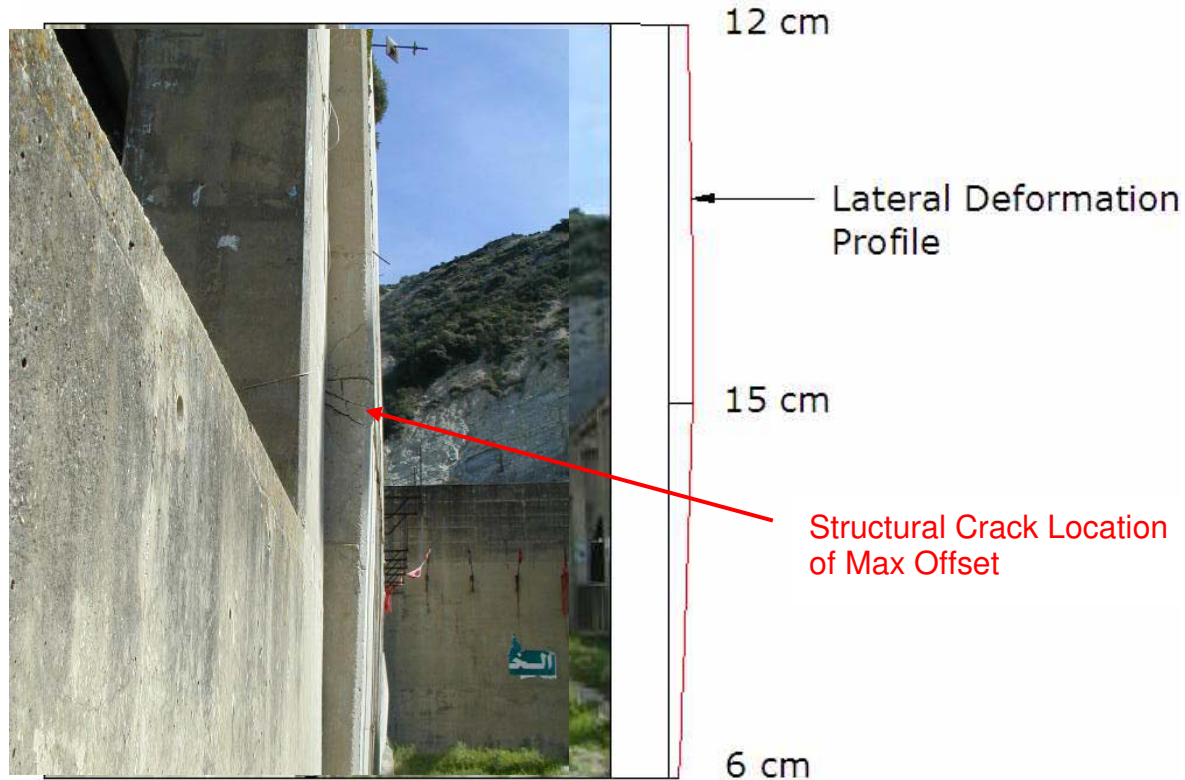
Figure 2. Close-up View of the Outward Movement/bulging of the Eastern Portal Wall.

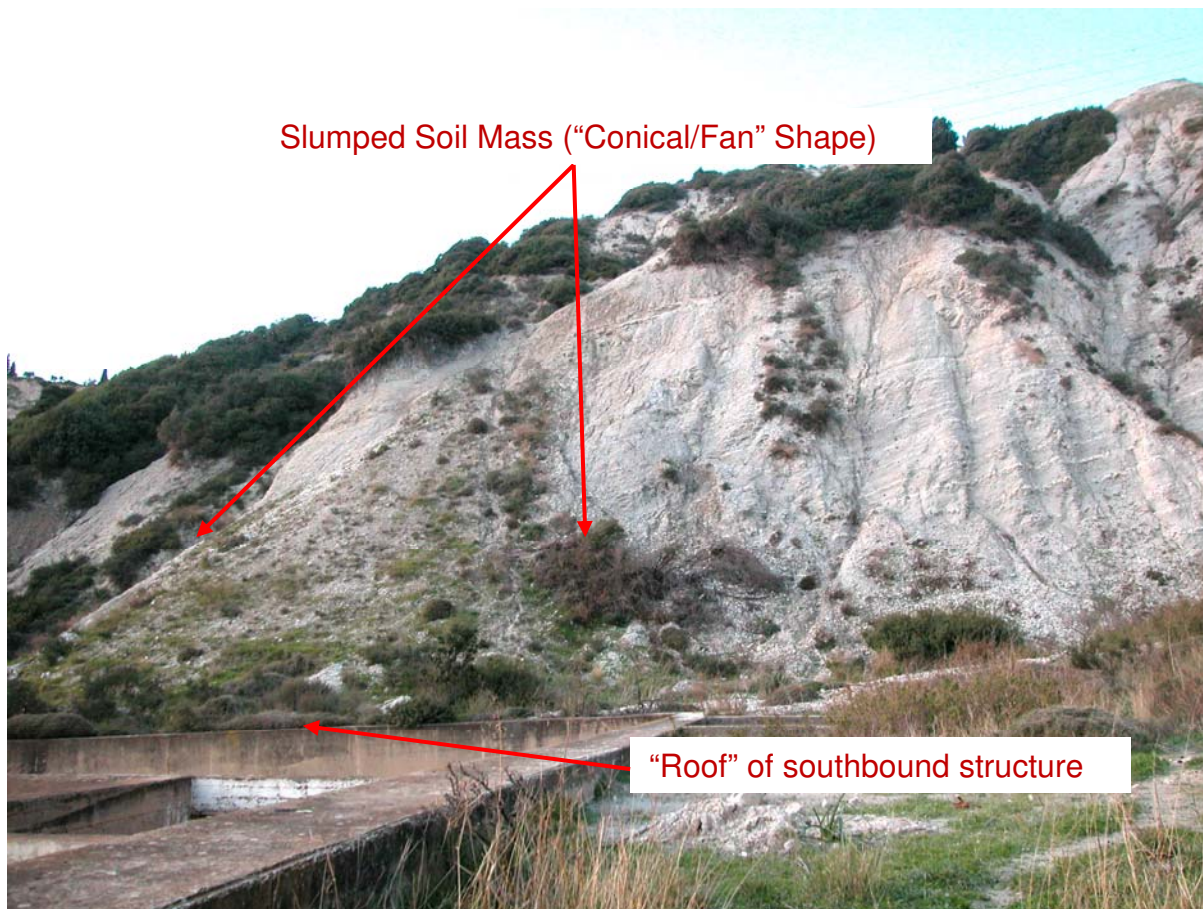
*Figure 3. Slumped Soil Mass Loading the Top of the Southbound Tunnel Exit Structure.*

1. “Soil 1”, is characteristic of the slumped mass above the southbound tunnel cross-section (Fig. 3). This soil type is characterized by relatively low values of the Menard modulus, dry density and unconfined compressive strength.
2. “Soil 2” is typical of the soft marlstone layers. This material is typical of materials in a band 4 to 6 m thick as evidenced in boreholes BH-1, BH-2, and BH-5.
3. Finally, the third type is the intact marly-limestone rock of the Chekka Formation.

1. Controlling surface water flow and improving drainage around structure area.
2. Removal of the slumped mass on top of the southbound tunnel exit structure and the provision of long-term stability and erosion control measures to eliminate the possibility of recurrence. These provisions included the installation of rock bolts/nails with a high strength steel wire mesh facing (Fig. 13 and Fig. 14). A program for regular inspection and maintenance of the structures was also developed.

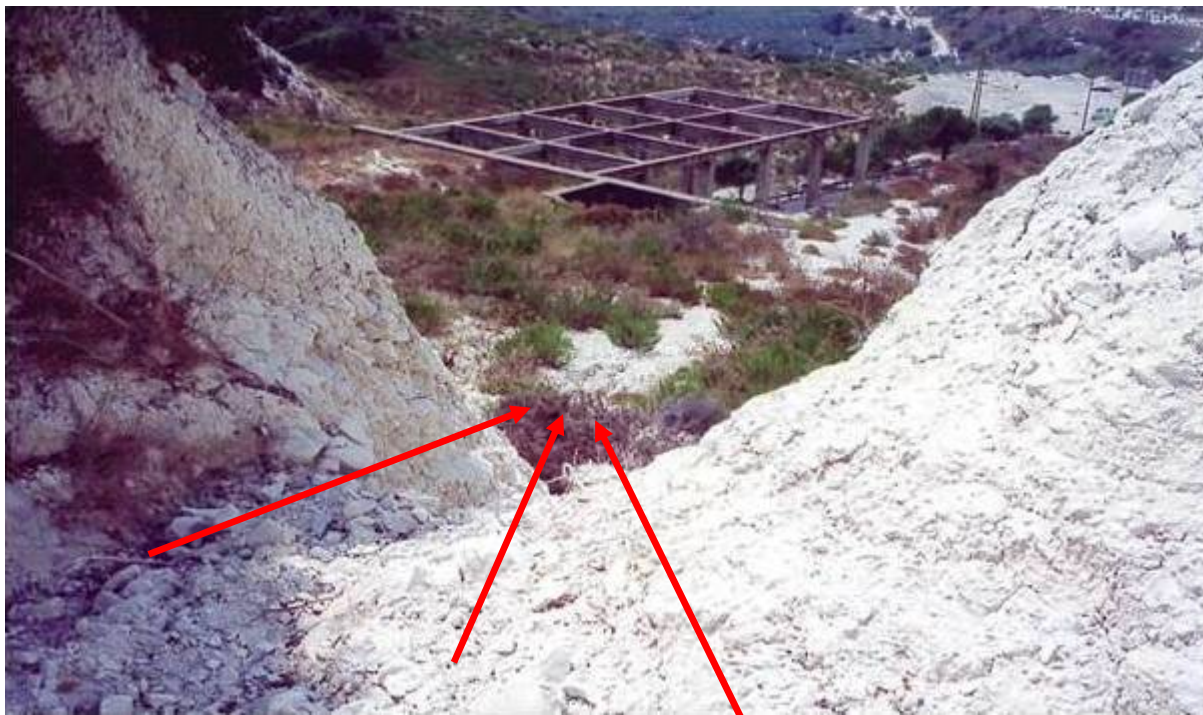
*Figure 4. Direct Surface Flow (arrows) Towards South Facing Tunnel Exit/entrance Structures -View From Top.*
