# Reconstruction of Konstantinovsky Palace in a Suburb of Saint Petersburg

**ABSTRACT:** *This article describes a complex approach to the condition survey and design executed as part of the remedial works on Konstantinovsky palace in the suburb of Strelna (Saint Petersburg)--one of the most beautiful historic monuments of 18th century Russia. The palace was almost completely destroyed in the 1940s. In 2000 the decision was made to reconstruct the palace, and the project for palace reconstruction was developed. The project was completed in 2003. The following important stages of the project are discussed in this paper: palace condition survey and site investigations, analyses of the palace retaining structures, design project of palace reconstruction, and phases of the remedial works.*

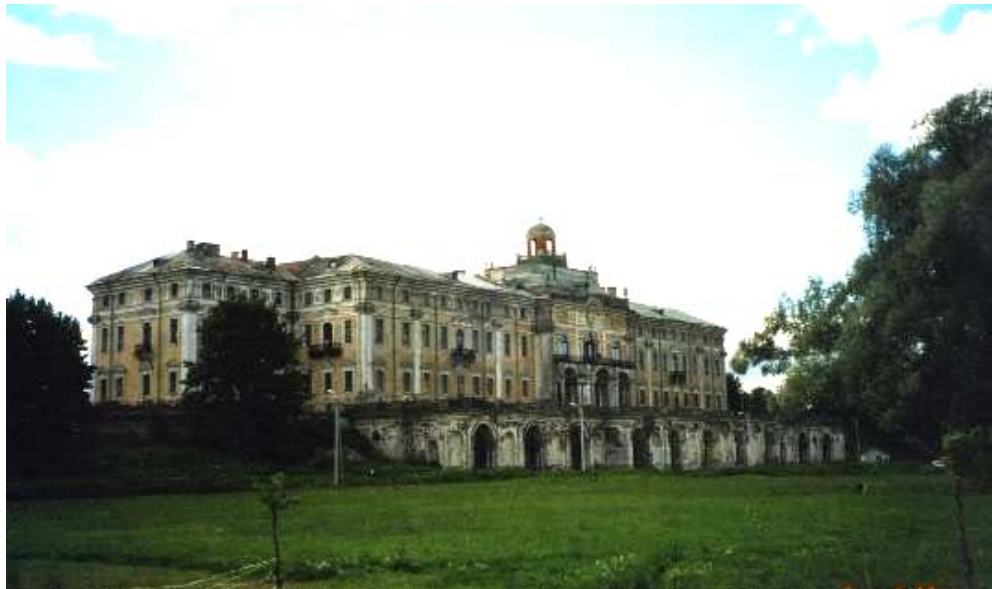
*Figure 6. A photograph of Konstantinovsky Palace taken in 2000 before reconstruction.*

1. Foundations of the dilapidated retaining walls were constructed of bricks. The foundations were no longer capable of being classified as a structure. There was imminent danger of crushed brickwork movement with formation of local bulges.

2. The entire brickwork structure was soaked in water, causing dilapidation through cycles of freezing and thawing.
3. There were no foundations of the transverse walls of the cellars. Footing was level with the cellar's floor. Decomposed timber pile heads supported the transverse walls.

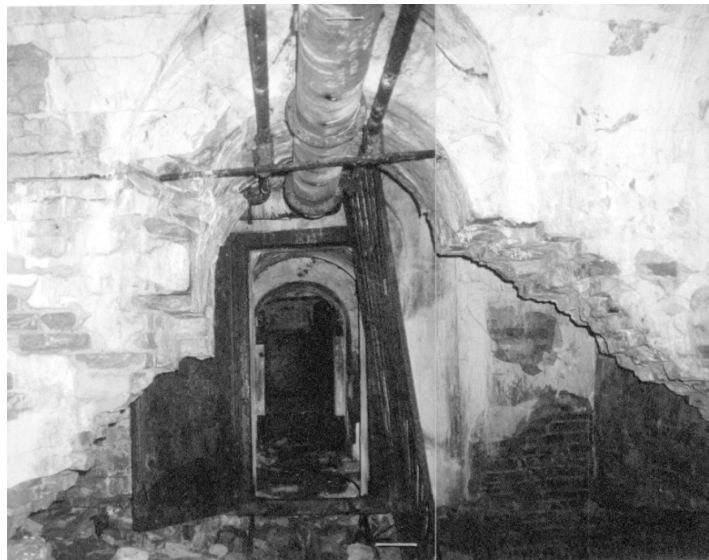
*Figure 7b. Dilapidated structures of the palace: transverse walls.*

5. Drilling of 42 mm vertical bores paced at approximately 1.0 m from the terrace in front of the palace along each transverse wall down to the brick-wall footing level (absolute level 8.9 m BD) in order to reinforce the transverse walls and rear longitudinal wall of the cellars. This was followed by interval grouting and subsequent redrilling of the bores by 151-mm augers, used in the bored piles construction, down to absolute level of 1.5 m BD. Those piles were likewise reinforced through their entire length.

6. Construction of pile heads in the dilapidated areas of the transverse walls at the level of the brickwork footing (absolute level 8.8 m BD), with subsequent construction of the pile caps and masonry courses within the original scope.

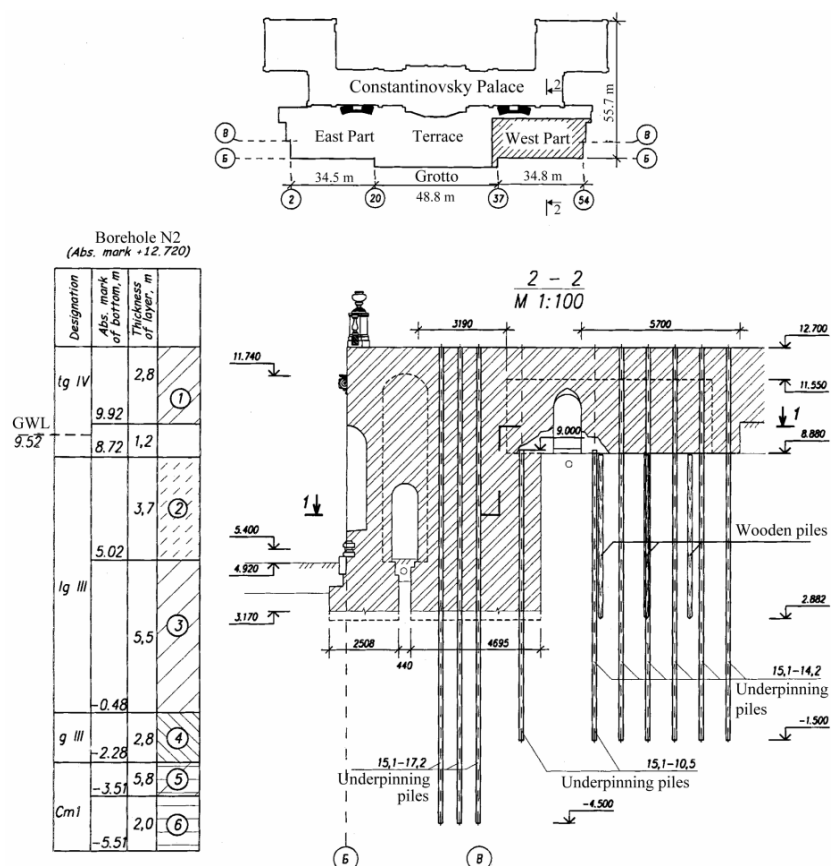
Figure 14. Palace layout in plan - Underpinning of the retaining structure. See Fig. 8 for soil stratification.

In light of the overall surface dilapidation and general weakening of the brickwork, the option of bandages, confining frames, or other structural reinforcement was considered impractical for providing safe retaining structures and would damage the appearance of the historical building. Therefore, the only option that would address all the issues listed previously appeared to be pressure grouting and strengthening of brickwork, with underpinning of all retaining structures with piles embedded into stiff stratum (Fig. 14, 15).

Based on the above, the foundations underpinning of the retaining structures was carried out in the following sequence (see Fig. 14, 15).

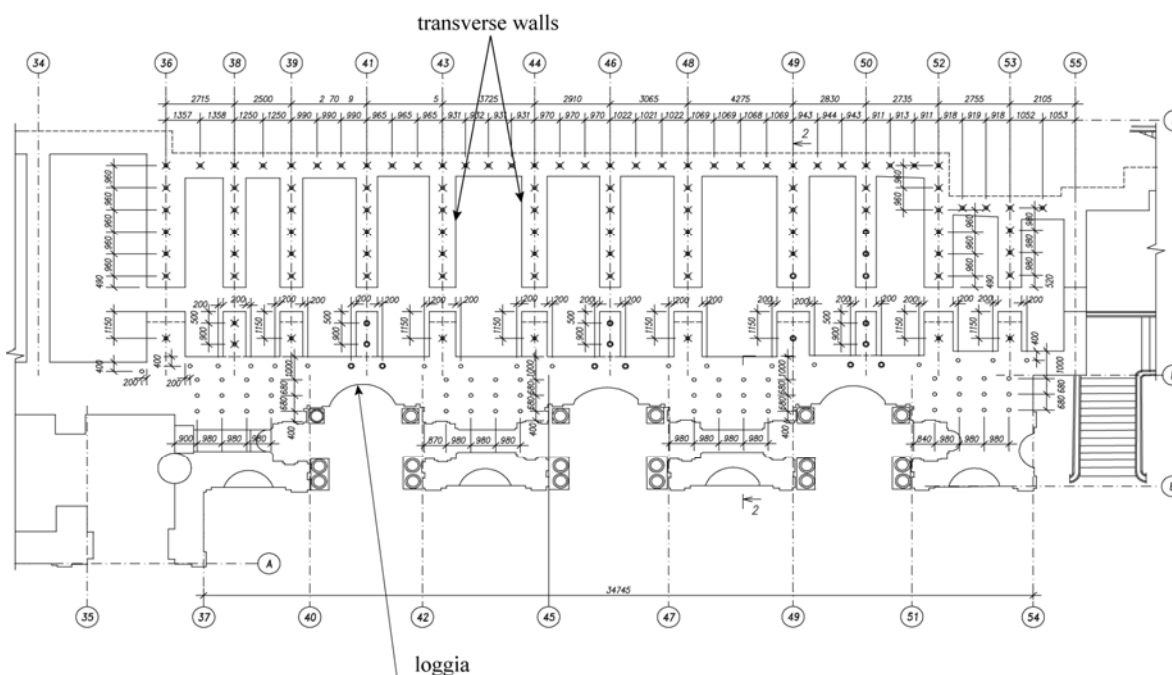
Figure 15. Location of underpinning piles in plan: o, x - underpinning piles.

3. Drilling of 42 mm vertical bores above the partitions of the retaining wall from the terrace in front of the palace down to the brick-wall footing level. Subsequently, the brickwork was grouted by intervals with packing lime mortar until completely permeated.

4. Redrilling of the bores by 151-mm core bores down to the top of the firm Cambrian stratum following 70% setting of the mortar. Drilling below foundation footing was either carried out using thixotropic grout or was casing protected. Cement grout with added plasticizing and shrink-proofing agents was pumped into the subsoil and brickwork at 0.2 and 0.1 MPa respectively, followed by a stain-proof reinforcement casing tube being oscillated into the grout mix. The resulting pile was thus constructed with its toe against the stiff Cambrian stratum reinforcing and underpinning the entire retaining brickwork section. The tube was required to ensure both longer pile life and subsequent possible of deepening of the cellars. Toe levels and bearing of the piles had been previously confirmed based on the static loading tests.

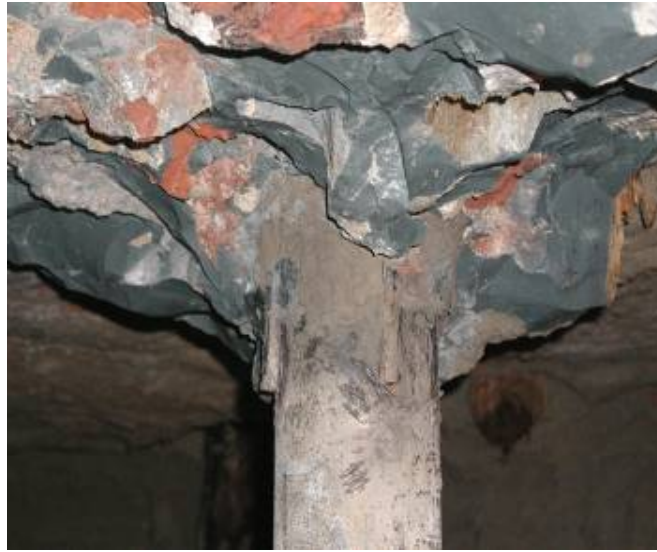
*Figure 18. Bored pile with tube reinforcement viewed from underneath foundation.*
