# Rockfall and Subsidence on Mumbai-Pune Expressway

**ABSTRACT:** *Mumbai-Pune, India's first expressway, which crosses the mountainous and rugged Deccan Trap Province, suffered from a large amount of rockfall and major landslides in 2003 and 2004. A significant number of accidents and fatalities have occurred on the expressway as a result of such events. On the basis of frequency and magnitude of the recorded incidences of rockfall, seventeen critical areas of the road have been deemed in need of investigations and mitigation. One of the problematic areas that suffered from rockfall and subsidence is at km 41 on the expressway, adjacent to a tunnel (Adoshi). This location has been chosen for detailed study. This area extends for 500 m along the expressway, and the embankment has subsided by 2 to 3 m along the entire length. Based on the geological, geomorphologic and geotechnical investigations, causative factors for rockfall and subsidence at this location have been established. This paper presents the field investigations, probable causes, stability analysis and remedial measures for controlling the subsidence and rock fall.*

investigations carried out to assess the probable c

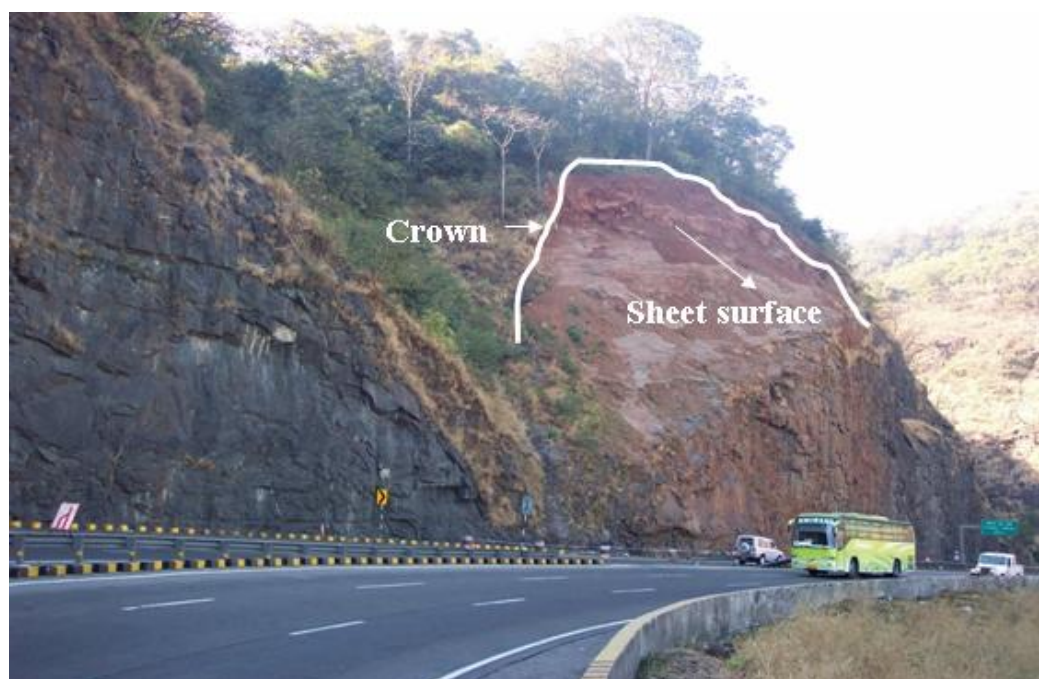
Figure 1 shows the location of the Adoshi site. Rockfall and debris flow are the predominant problems at this location. The first incident of rockfall and debris flow (Figure 2) reportedly occurred in 2003–2004, during the monsoon. Since then, rock blocks have been intermittently falling from the face and top of the slope, damaging the side drains as well as the middle of the expressway. The size of the rock blocks varies from a few centimeters to a meter—and sometimes even larger—in diameter (Figure 3). The hill slope geometry at this location is such that rock blocks fall directly onto the expressway. There is no space or slope bench on the side of the expressway and the hill; as a result, there is no reduction in the momentum of the detached rock when it plummets toward the expressway at this location. This direct fall makes the impact more dangerous and more potentially fatal when rock blocks impact a running vehicle. Such incidences are particularly frequent during the rainy season. Rockfall can be caused by a variety of reasons such as unfavorable jointing, freeze-thaw cycles, water effects, earthquake loading, etc. (Topal et al., 2007; Dorren, 2003). In the present case, on the basis of field observations and the records of failures, the jointing and the effect of water are expected to be major contributors to the failure. Rockfall can be studied using various techniques such as empirical, experimental and modeling procedures (Giani, 1992; Okura et al., 2000; Evans and Hungr, 1993).

Figure 2. General view of rockfall and debris.

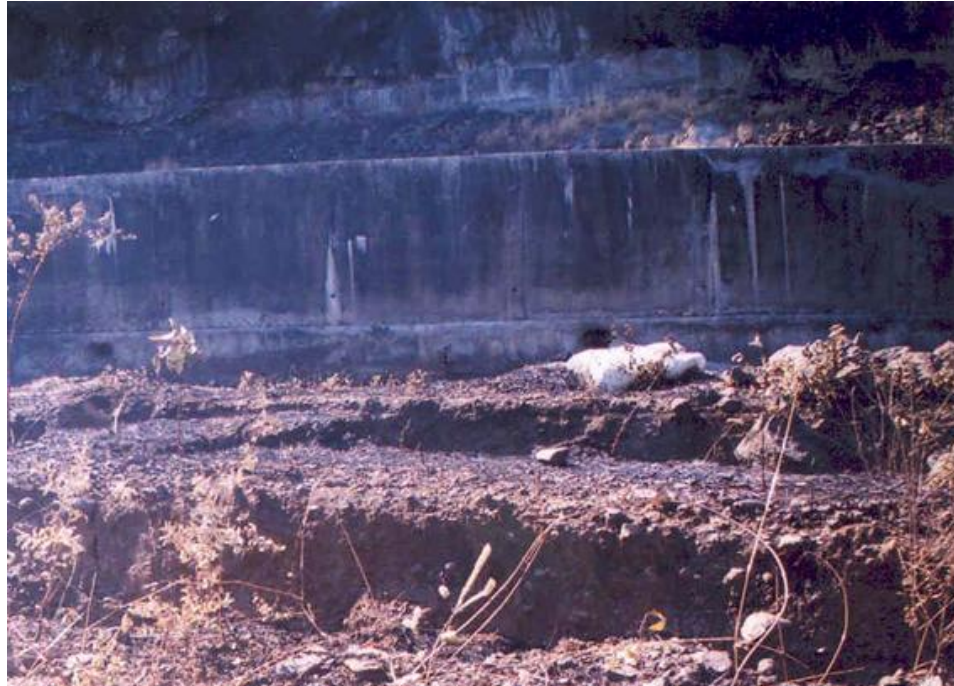
A crash barrier has been provided along the slope. Beyond the crash barrier, the average width of the embankment on the downhill extends downhill another 12 m. Drainage holes (Figure 15) are provided in the crash barrier at frequent intervals, but the holes are left open directly on the embankment surface. The considerable quantity of water passing through these drainage holes is causing saturation of the embankment fill beyond the parapet and is weakening the foundation of the crash barrier as well as the scouring below the crash barrier and pavement (Figure 16). A longitudinal drain is provided after a certain distance from the crash barrier on the embankment. From the crash barrier to the longitudinal drain, the surface is not lined and scouring was observed below the crash barrier. The crash barrier is also tilted, and below the crash barrier, the embankment slope has experienced scouring up to a depth of 1 m. The embankment has subsided by 2 to 3 m in steps, and each step has an average height of 1 m (Figure 17).

Figure 17. Subsidence of the embankment.

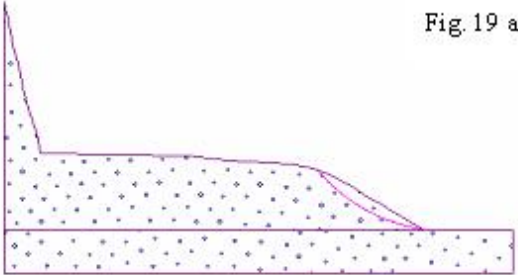
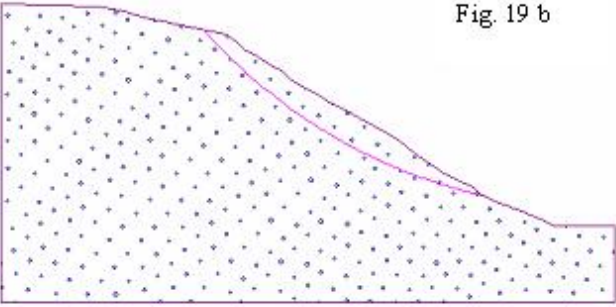
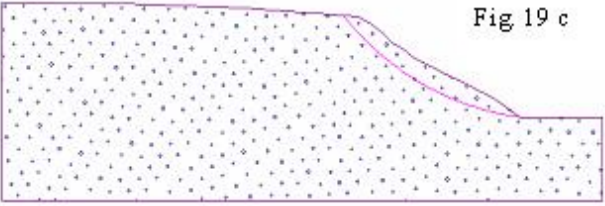
Figure19. Slope stability of subsidence portion.

| Cross section | Stability analysis | Factor of Safety | |
|---|---|---|---|
| A – A | <p>Fig. 19 a</p> | 1.17 | 1.14 |
| B – B | <p>Fig. 19 b</p> | 1.14 | 1.11 |
| C – C | <p>Fig. 19 c</p> | 1.38 | 1.34 |
| D – D | <p>Fig. 19 d</p> | 1.46 | 1.42 |
