## Mississippi River Levee Failures: June 2008 Flood

**ABSTRACT:** During the spring and summer of 2008, record rainfall in the Midwest United States led to severe flooding as water overtopped the levees bordering the Mississippi River and its tributaries. The erosion associated with the overtopping resulted in levee breaches in many places. After the flooding, a field reconnaissance team was sent to collect time-sensitive data and provide a comprehensive overview of the performance of the levees during the flooding.

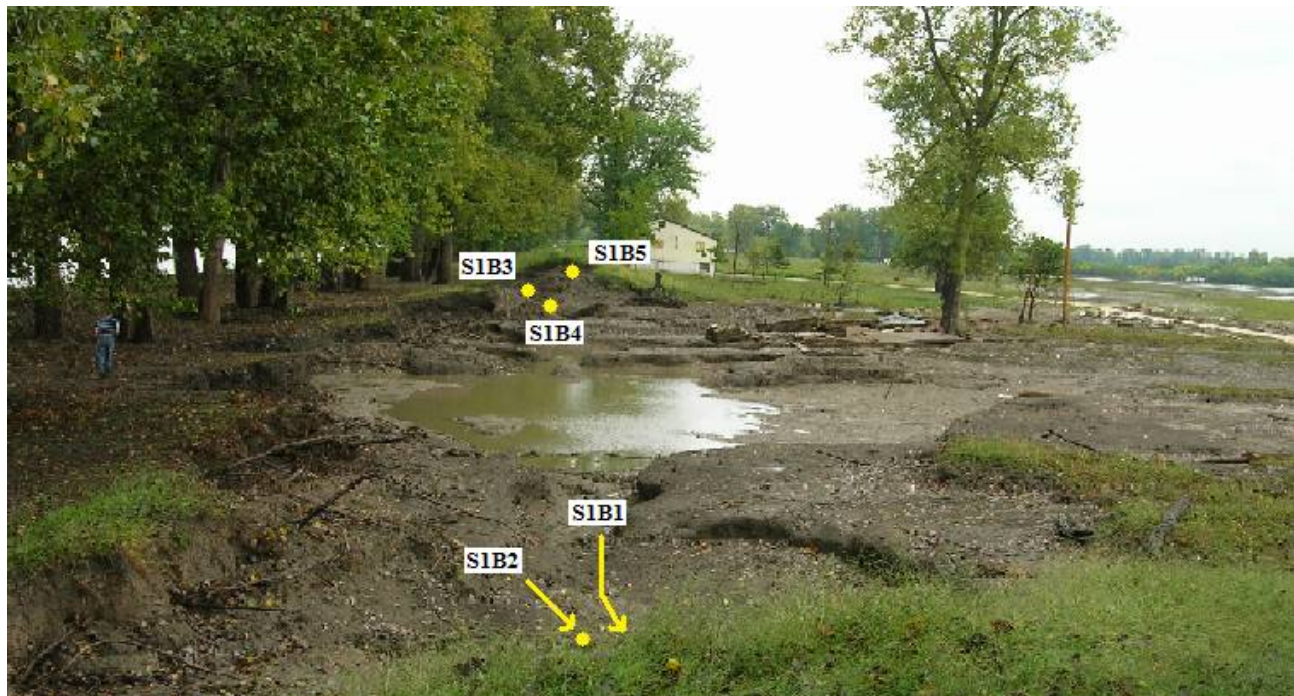
Five samples were taken from various locations within the breach (15). Table 3 provides a summary of the sample locations as well as Torvane and Pocket Penetrometer readings. Note that the Pocket Penetrometer gives an estimate of the unconfined compression strength while the Torvane estimate the undrained shear strength directly. Common practice is to take the undrained shear strength equal to 0.3 times the Pocket Penetrometer readings.

Figure 15. Boring locations Winfield – Pin Oak breach looking south.

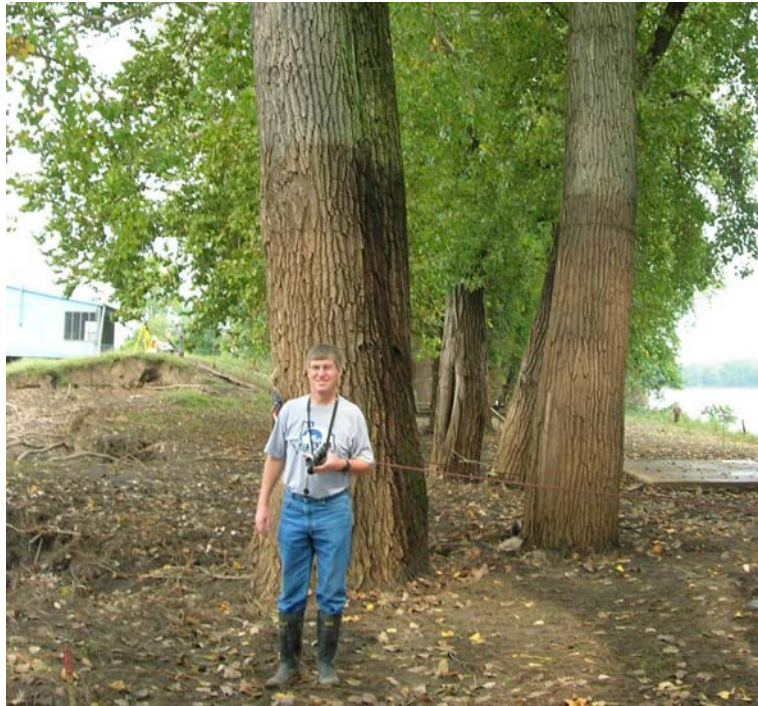
The Mississippi River runs North to South at this location. The levee borders the West river bank while the East bank is bordered by natural cliffs which provide a barrier for the flood waters and force the rising water into the levees. The water line on the trees that border the river side of the levee (Figure 16) was about 1 m higher than the existing levee crests indicating that during peak flow the water was overtopping the levee by almost 1 m. It also shows that the overtopping duration was long enough to leave a water mark or mud line on the trees.

*Figure 16. High water marks on trees bordering levees.*

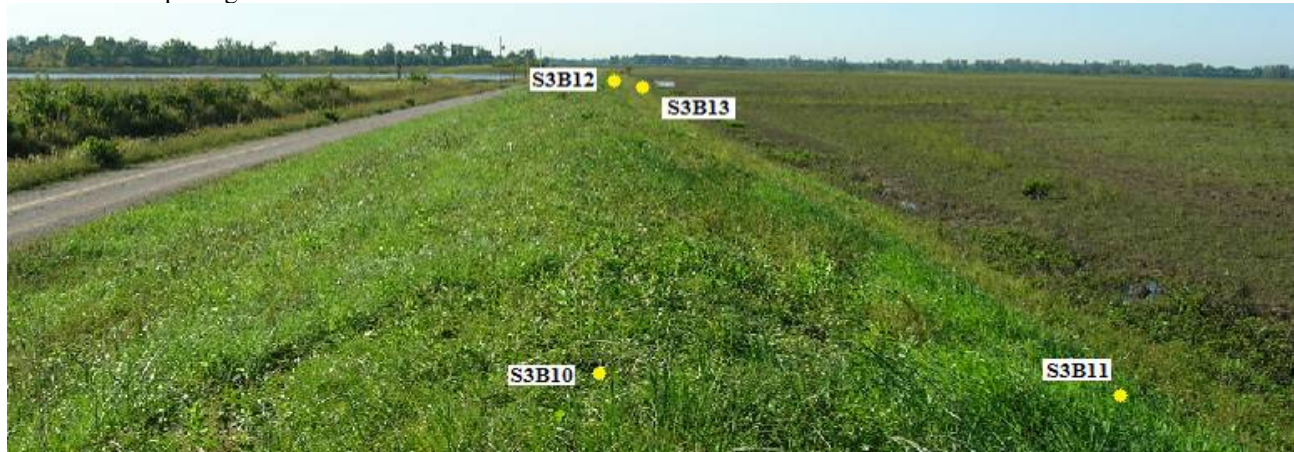
This site was unique in the fact that there was no breach in 2008. The only sign of erosion was at a box culvert that was cracked allowing water and soil to seep through. A local resident (Mr. James Pieper) informed the team that the levee was overtopped by nearly 1 m of water for three days and never failed. Four samples were collected from various locations along the levee. Because there was no actual breach, only surficial samples were taken. These samples were much harder to obtain and the soil seemed to be much stiffer than at the previous sites as can be seen by the higher Pocket Penetrometer values (Table 6) obtained at this site compared to the Winfield site. Figure 20 shows the boring locations and Table 6 presents the sample logs for this site.

Figure 20. Brevator boring locations.

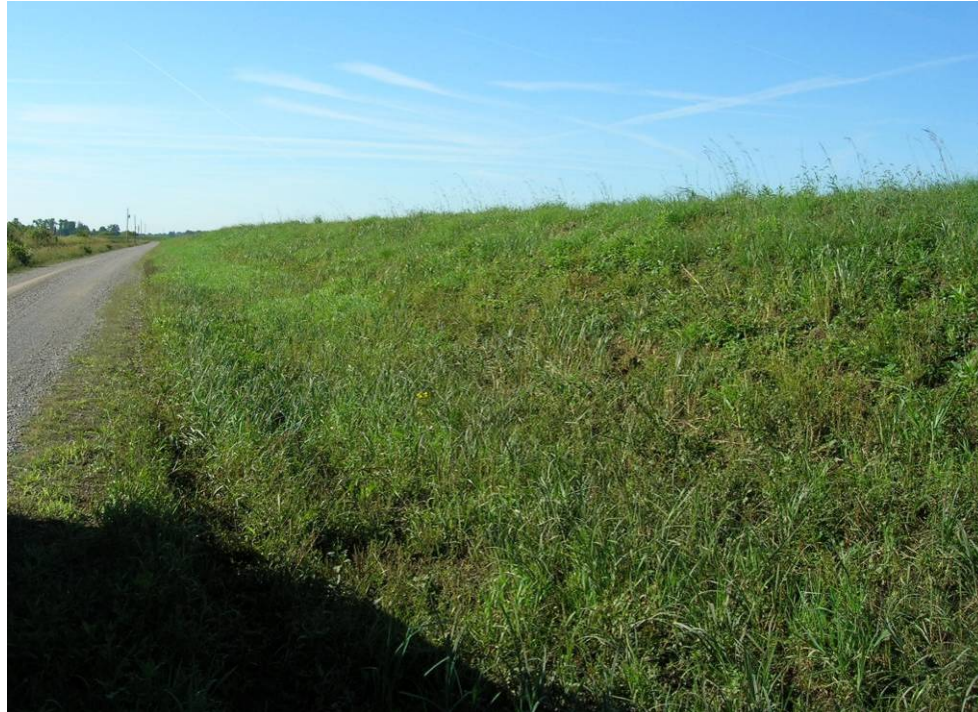
At the time of overtopping, there was substantial vegetative cover. Figure 22 shows the vegetative cover present on the levee 3 months after the flooding. It was noted that the grass was Reed Canary grass approximately 1 m tall at the time of flooding. This type of grass survived the continuous flow of water and had a positive impact on preventing erosion. The overtopping waters forced the grass to lay down essentially creating a protective cover or barrier on top of the soil surface and preventing erosion.

Further examination of the grass cover indicated that additional varieties of plants were present at the site including: Switchgrass, Smooth Brome, Reed Canarygrass, and Foxtail. The consistency of the coverage and the root density were much higher at this site than any of the other sites.

Figure 22. Brevator vegetative cover on September 30, 2008.

The grasses found at the Brevator site seemed to satisfy all of these criteria. The recommended grasses for the Midwest include: Switchgrass, Tall Fescue, Smooth Brome and Reed Canarygrass. A percent coverage of at least 90 percent is desirable. It is also recommended that the grasses on the levee be allowed to grow to taller heights during the flood season (0.5 to 1 m). While most of the erosion prevention depends on the root system, it is not always adequate for the magnitude and duration of flows experienced during overtopping flood events.
