# Quarry-Induced Slope Instability at a Broadcasting Transmission Plant near Valcava, Lombardia, Italy

**ABSTRACT:** *Since 2006, a broadcasting tower and ancillary buildings on the top of a hill adjacent to a large, active limestone quarry, in northern Italy near the village of Valcava, has been heavily damaged by ground deformation due to slope instability. In 2005, the quarry began to work the slope toward the broadcasting plant, releasing bedding planes that affected the tower site: a number of fractures occurred in the warehouse and in the ground around it, that grew particularly during significant rainfalls. In October 2006 a landslide occurred in the quarry area, close to the broadcasting site. In order to understand what induced the fracture process in the buildings and define a support system to stabilize the broadcasting site, a detailed geotechnical survey and a number of numerical slope stability analyses were carried out. One of the main goals of the paper is to underline the effectiveness of the numerical analyses to understand the instability phenomena when they are particularly complex. Furthermore, by using a reliable numerical model with a good understanding of s

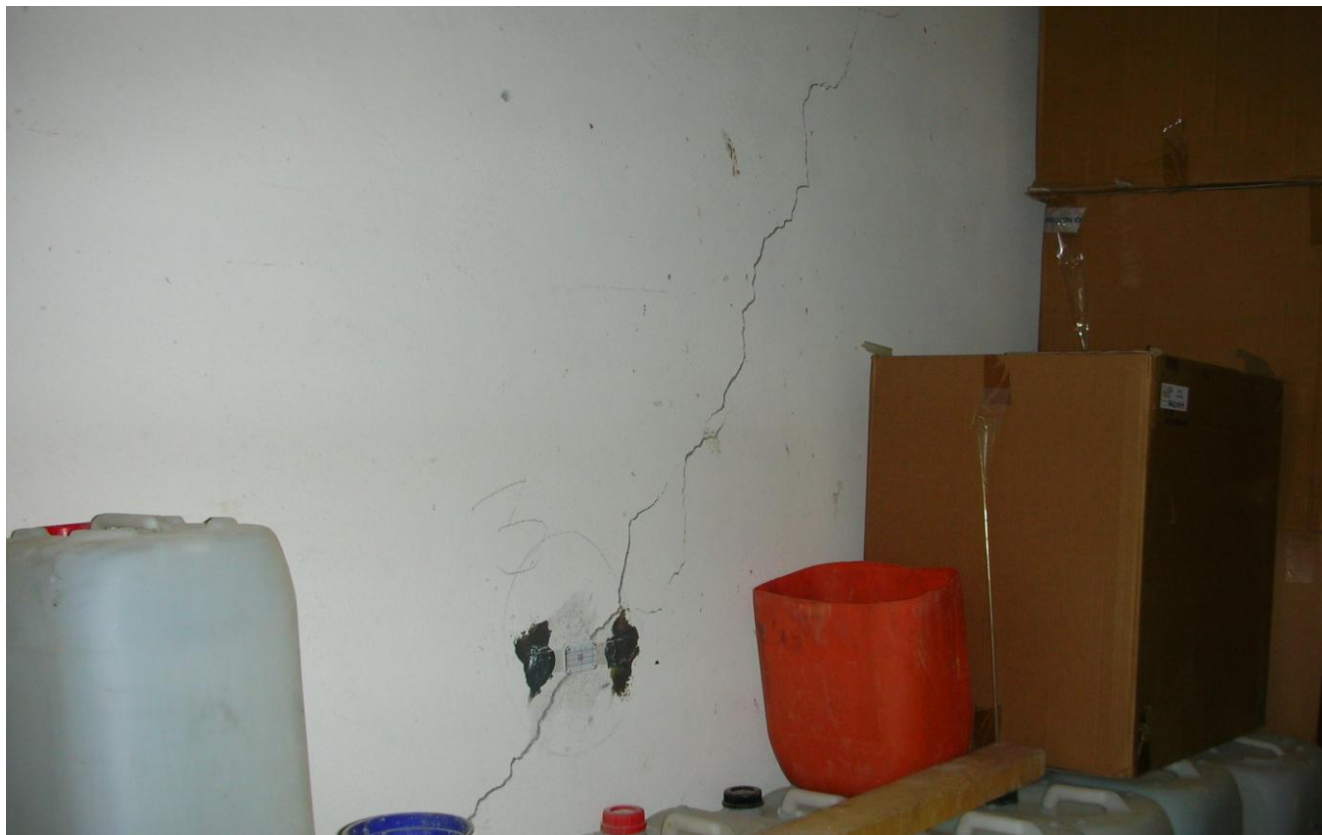
In 2005, quarry operations initiated at the slope toward the broadcasting tower. In May 2006, tension cracks developed in the ground at the top of the hill and many cracks appeared in the walls and floor of the building (Figures 2 and 3). The cracks were parallel to the slope face, suggesting a downward movement of the slope. In October 2006, after two days of medium-high intensity rains, a landslide with a volume of about 27000 m<sup>3</sup> occurred in the pit (Figure 4 and 5) at a distance of about 45 m below the warehouse area (Figure 6) and the cracks in the warehouse and in the ground increased, the latter reaching openings of some centimeters. The intense rains of the winter 2006 quickened instability phenomena (Barbero et al., 2008).

*Figure 2. Wall damage inside the warehouse.*

As crack opening and spreading are important signs of the instability evolution, crack gauges were placed across the larger cracks observed in the warehouse and a continuous monitoring of lengths and openings was performed. Unfortunately, no measurements are available for the cracks that appeared outside the warehouse (tension cracks in Figure 6). The cracks in the warehouse appeared to become more frequent toward the slope in the landslide direction, suggesting that the down slope movement of the rock mass affects the foundation of the warehouse.

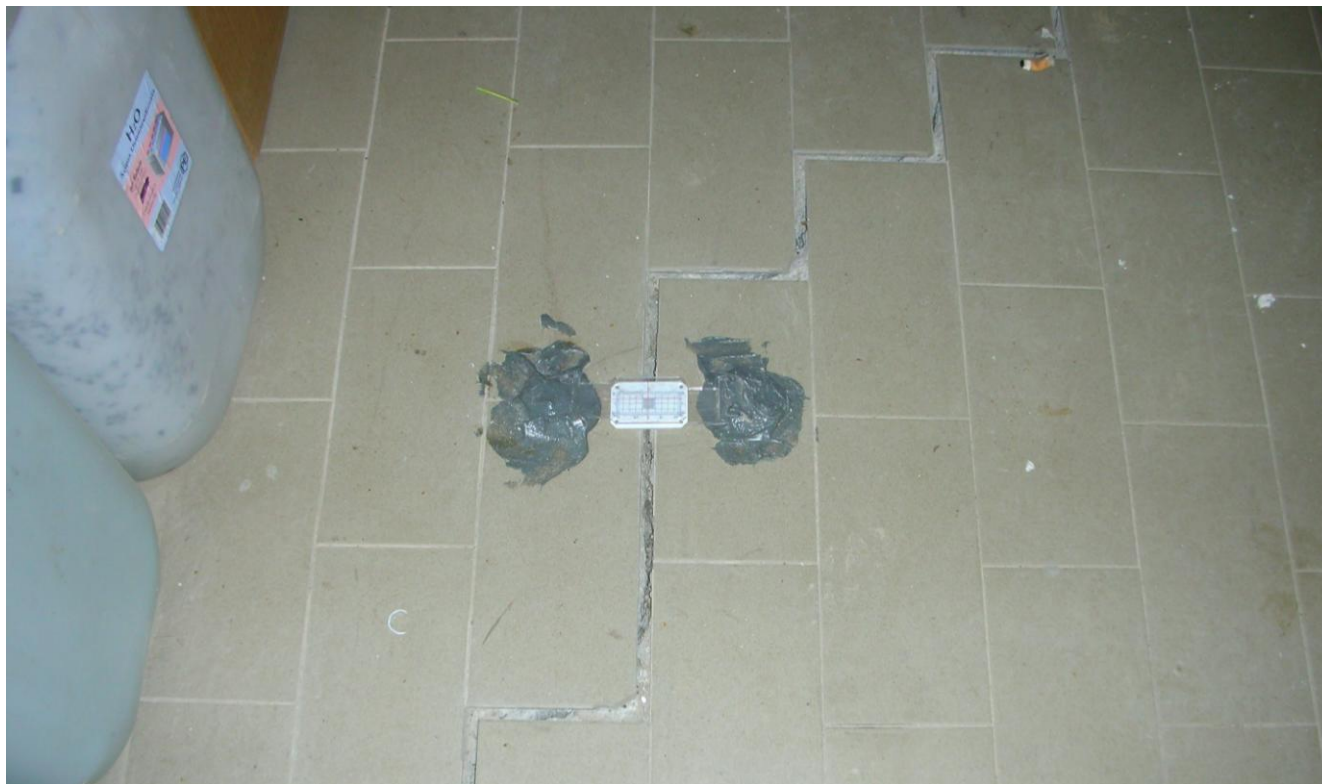
*Figure 3. Floor damage inside the warehouse.*

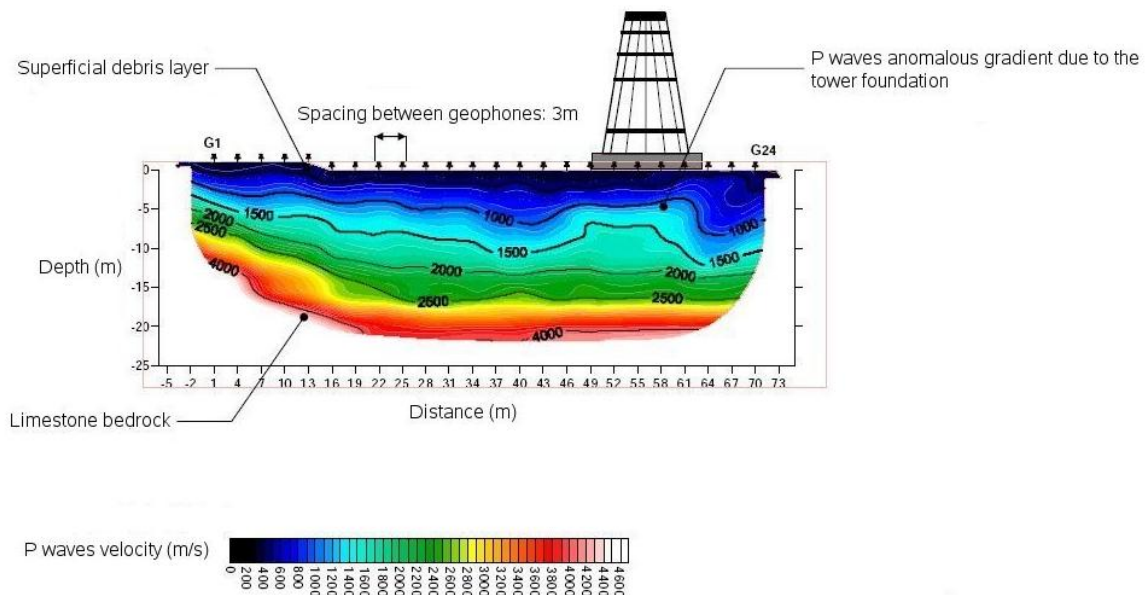
One seismic refraction and two geo-electrical soundings were located near the warehouse on the unstable slope, toward the pit. Another pair of seismic and geo-electrical outlines was located close to the broadcasting tower base (Figures 6 and 7). The data were processed with tomographic technique (Hampson & Russel, 1984; Olsen, 1989) and then interpreted considering the conventional exploration with core-drilling data. Similar results were generated in the slope and in the tower area. Upslope of the warehouse, in the tower area, there is a superficial layer of fill about 3 m deep, underlain by a layer of fractured limestone overlying apparently intact bedrock at a depth of about 16 m, as shown in Figure 8. Near the warehouse, upslope from the landslide, a pit showed the same stratigraphic sequence is observed in the tower area, as well as evidence of the two main faults A and B (Figure 9). Because of fault B, the apparently intact limestone is found at a depth of more than 20 m. The seismic survey thus confirmed the likelihood that the sliding surface was located above a depth of 20 m.

Figure 8. Seismic refraction survey results: P waves velocity trend inside the rock mass near the broadcasting tower.

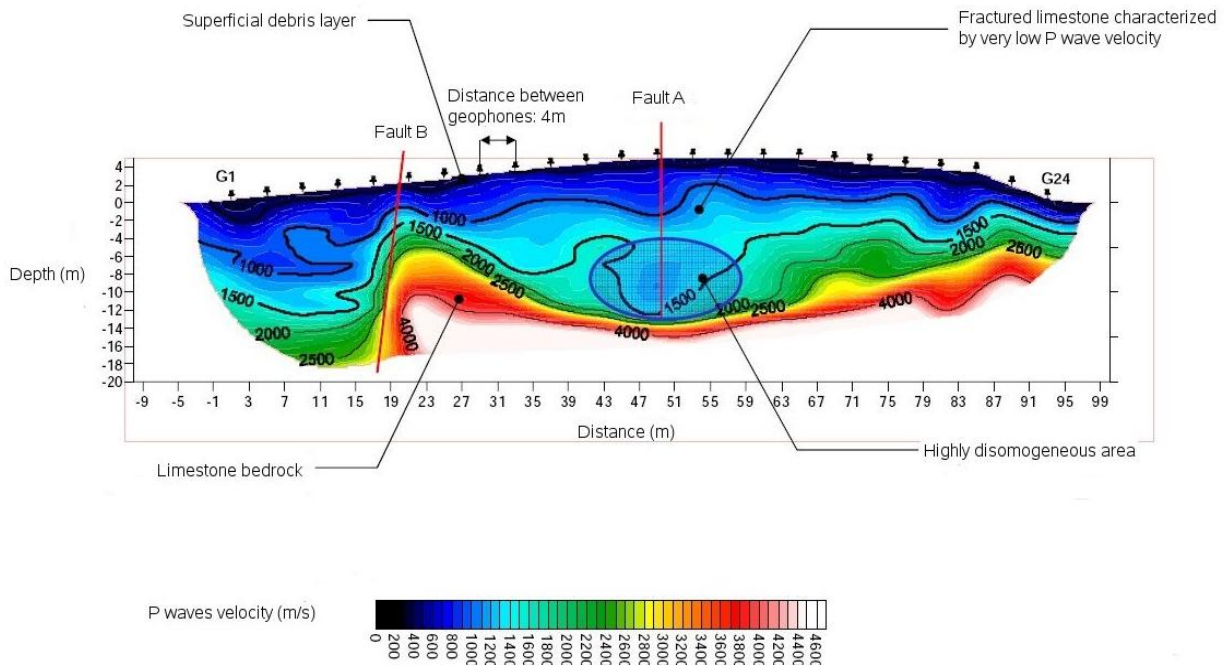
Figure 9. Seismic refraction survey results: P waves velocity trend inside the rock mass, below the warehouse area.

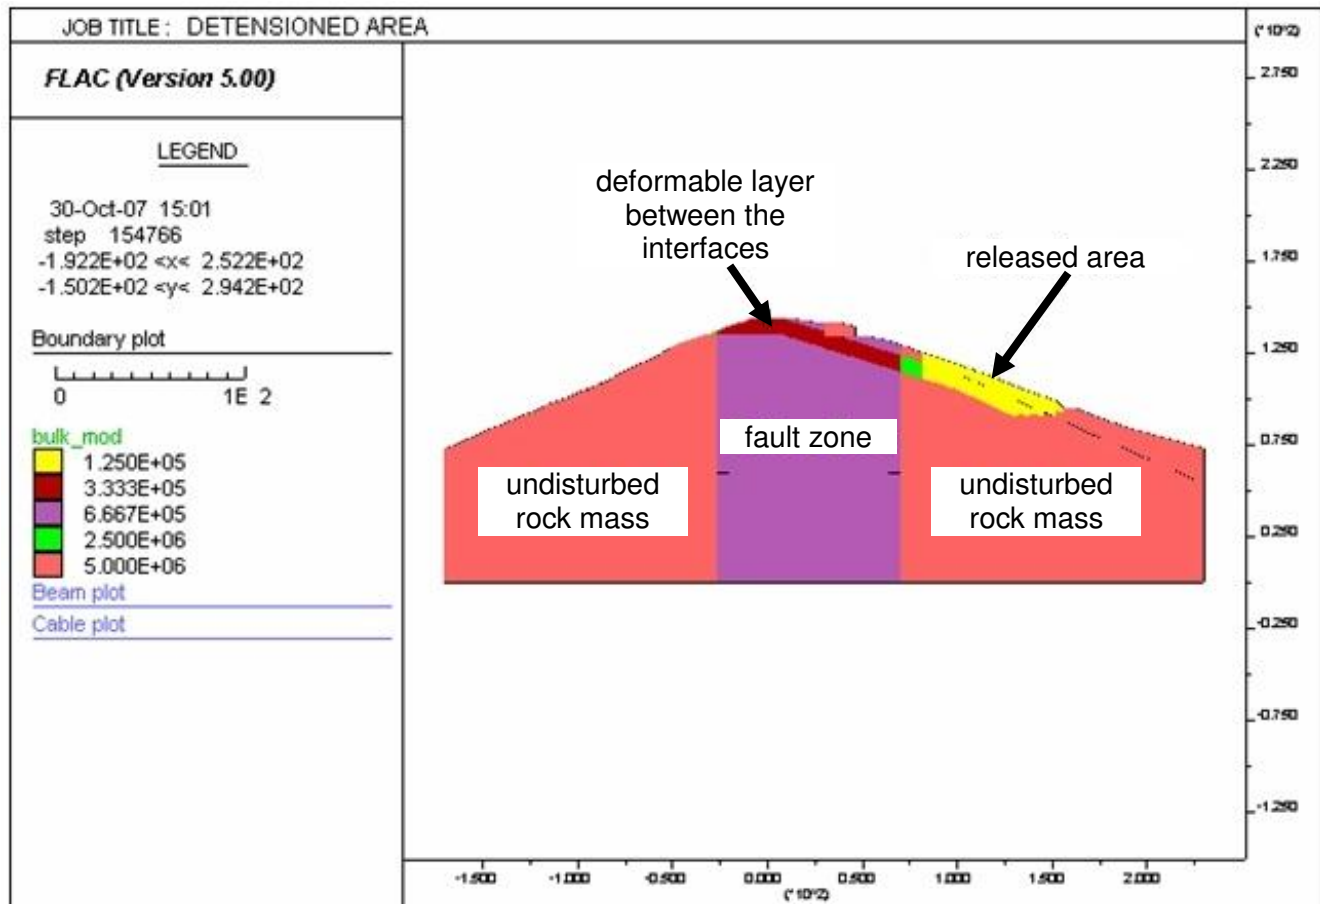
The slope behavior after the landslide in the pit area was simulated. It was assumed that the landslide induced a stress release in the slope beside it, between 1345 m and 1375 m above sea level with down slope displacements. For this purpose, a 20 m thick layer of the rock mass (equal to the estimated depth of the landslide) has been relieved between 1345 m and 1375 m above sea level. In order to simulate the progressive failure along the critical layer, the deformability and strength properties of the corresponding elements were progressively reduced (Table 6 and Figure 12).

The results show an important displacement increase in the upper part of the slope. The displacements in the warehouse area are appreciable only in the case of water table at 5 m from the level of site (Figure 13). A wide area in the disturbed rock mass reaches the plastic boundary for every hydraulic scenarios. From this, it is possible to reconstruct the slope's stress-strain history. The cuts in the pit area induced a progressive instability in the area immediately below the broadcasting plant, with downwards displacements that started in the pit cut and spread towards the warehouse. The landslide in the pit area quickened the instability phenomenon that worsened with heavy rain falls, leading to considerable displacements in the warehouse area.

Figure 12. Model with released area to simulate the landslide in the pit (FLAC).

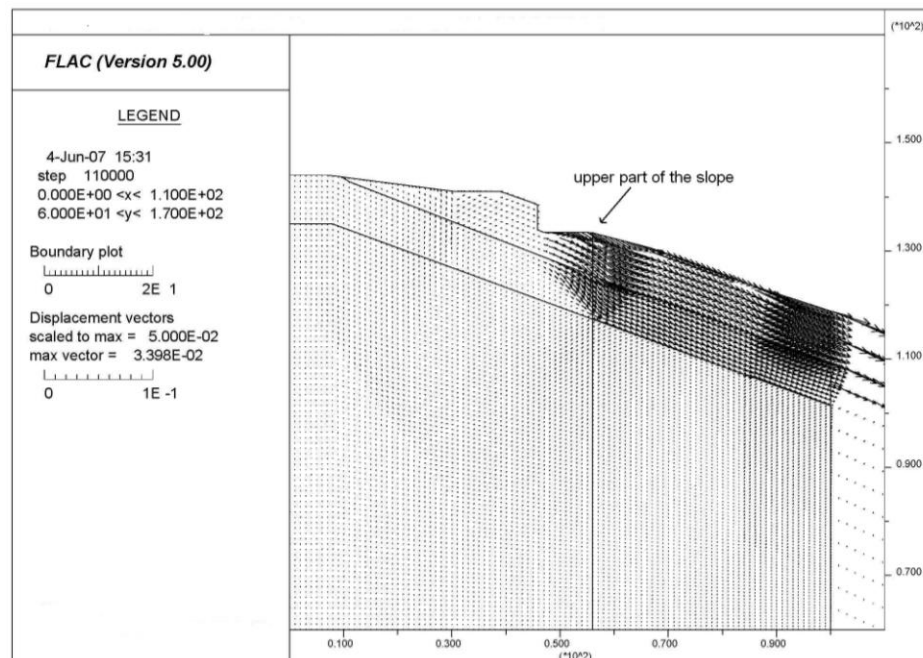
Figure 13. Numerical results: displacements in the upper part of the slope.

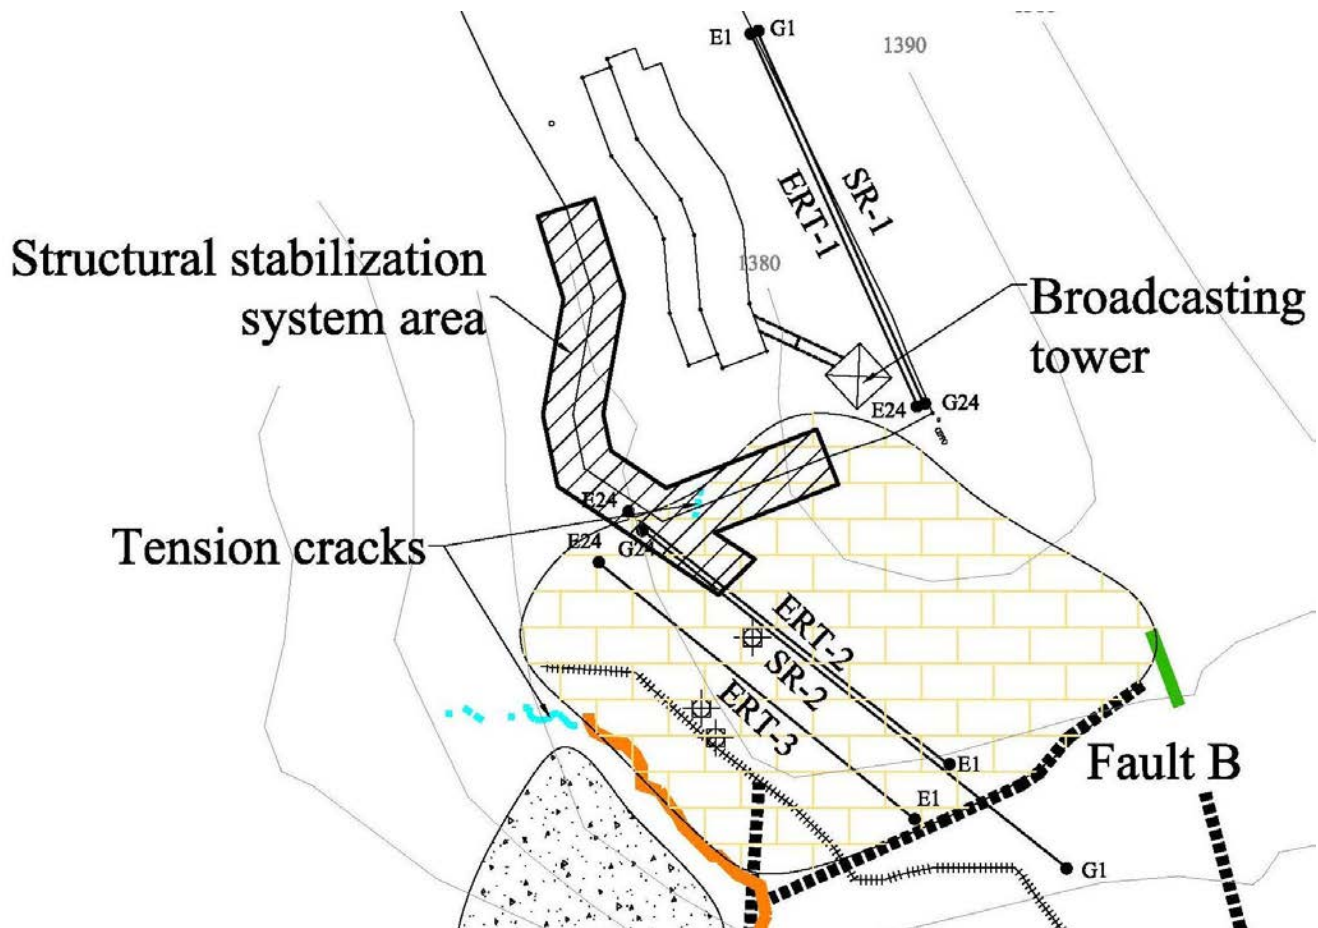
Figure 15. Map of the site with the location of the stabilization system.

In order to confine the strain effects of the stress release induced by the landslide, the broadcasting site has to be isolated from the unstable slope. For this purpose, a structural stabilization system in the warehouse square was suggested (Figure

15 and 17). It was conceived to be a bulkhead consisting of 27 m long micropiles reinforced with steel pipes, 139.7 mm of diameter and 10 mm thick. The micropiles are connected at their head level by a reinforced concrete beam. The bulkhead extends as shown in Figure 15 and is anchored in the head to the undamaged rock mass by means of 28 m long four strands steel anchors, at center distance of 3 m and with a down dipping of 25°. During the construction of the bulkhead, any karst cavities will be filled.

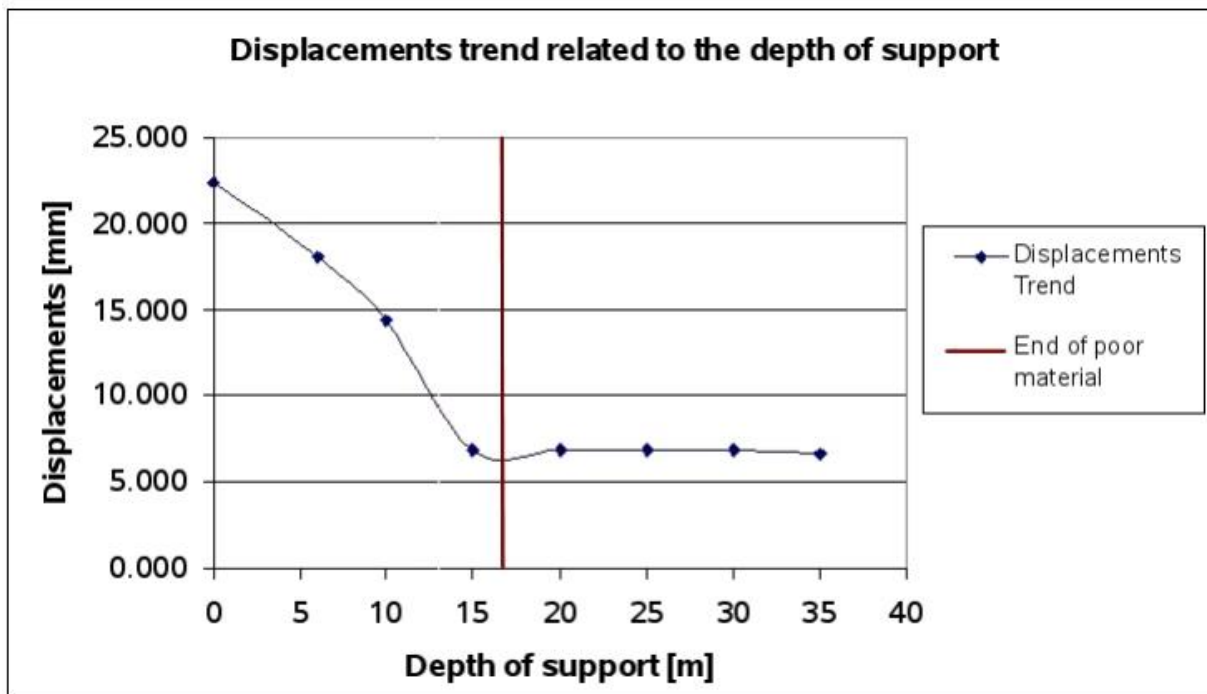
The results (Figure 16) confirm that the minimum length for the micropiles is about 16 m (the depth at which the boundary between the weaker layer and the undisturbed rock mass is located). On the other hand micropile lengths greater than 20 m don't provide further benefit to the plant stability. It is possible to conclude that 27 m is a good estimate of the length for the micropiles.

Figure 16. Model displacements in the area upstream the bulkhead, related to the length of the micropiles (assuming that in-situ bedrock is at 16 m depth).
