## Embankment Failure in Residual Soils at Nivsar, Ratnagiri

**ABSTRACT:** The Nivsar Yard embankment was constructed by the Konkan Railways in 1994. Near the station building, the 22m high embankment runs parallel to the Kajali River for a stretch of about 100m. This stretch has experienced failure and settlement related problems since the record-breaking July 2005 rainfall. Corrective ground improvement measures were implemented immediately after the monsoon. However, these measures were inadequate because the failure surface reappeared during the following monsoon. The failure surface mirrored the shape and size of the failure observed in 2005. Since then after nearly every monsoon, the embankment has moved despite precautionary measures taken by the railway to arrest the movement. The hydrogeological and geotechnical properties which affect slope stability are first discussed. The stability of the embankment is then evaluated at 5 sections drawn along the slope. Two cases are considered. In the first case, the stability of the unreinforced slope is calculated. In the second case, calculations are done using the slope reinforced with soil nails and micropiles installed in 2005

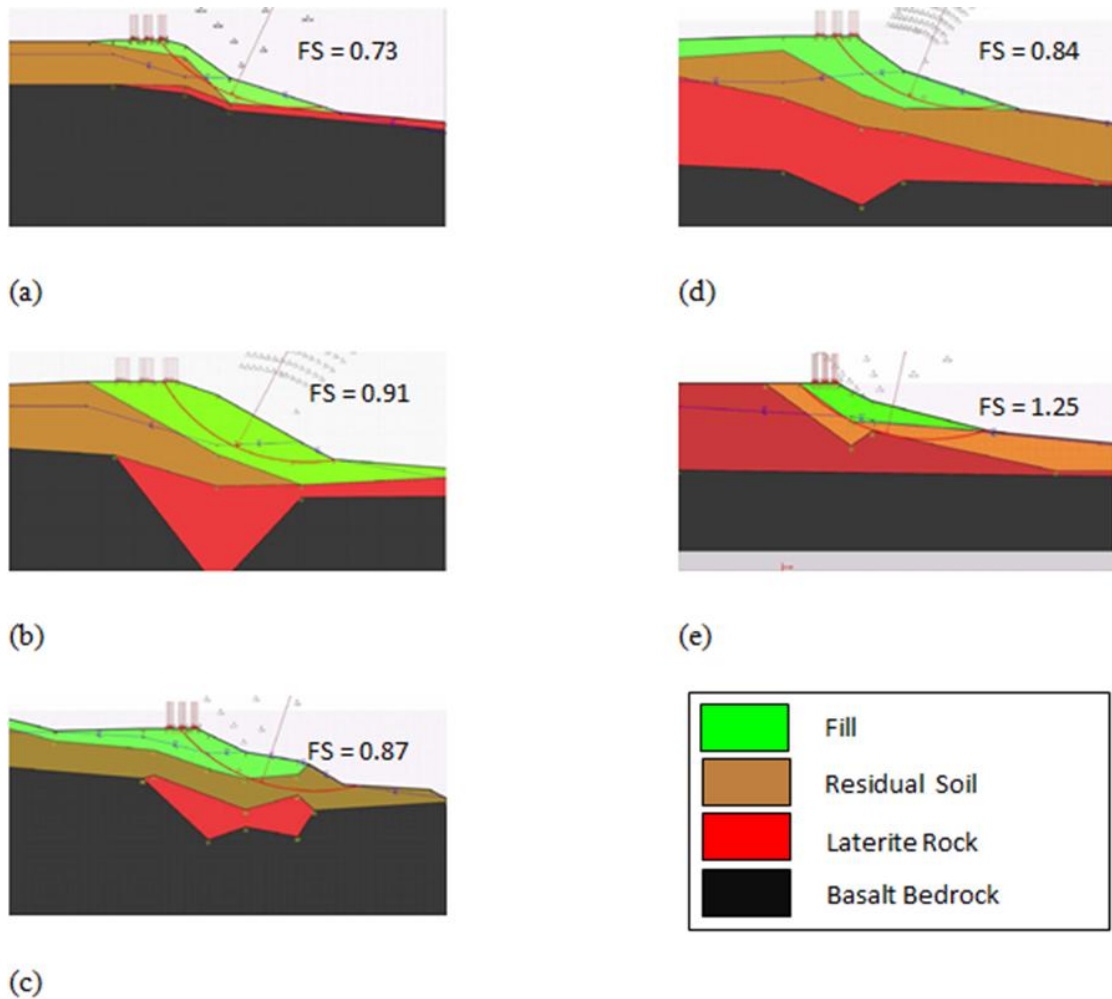
Figures 12a-e. Safety factor during wet season with modified parameters for section: (a) A-A; (b) B-B; (c) C-C; (d) D-D; and (e) E-E.

Figures 12a to 12e show the minimum safety factor and the location of critical circles in sections A-A to E-E for the wet (monsoon) season. In all the figures, the critical slip circle passes through the toe of the embankment, which is similar to the observations made at the site (see Figure 5). Similarly, the top of the circle in Figure 12c intersects the rail tracks and lie close to point X in Figure 2. The safety factor of all the 5 sections for the dry and the wet seasons are compared in Table 8. As can be seen, the safety factor reduced to less than one with the rise in ground water table in all sections, except in section EE. Figure 12e shows that only section E-E was stable during the wet season. This section was far beyond the failure zone shown in Figure 7. Regardless of the above observation, it is plausible that factors such as deep-rooted trees present at the site may have affected the safety factor. All the same, the effect of vegetation on the slope stability cannot readily be incorporated within this simplistic framework (Bernhardt et al. 2011).

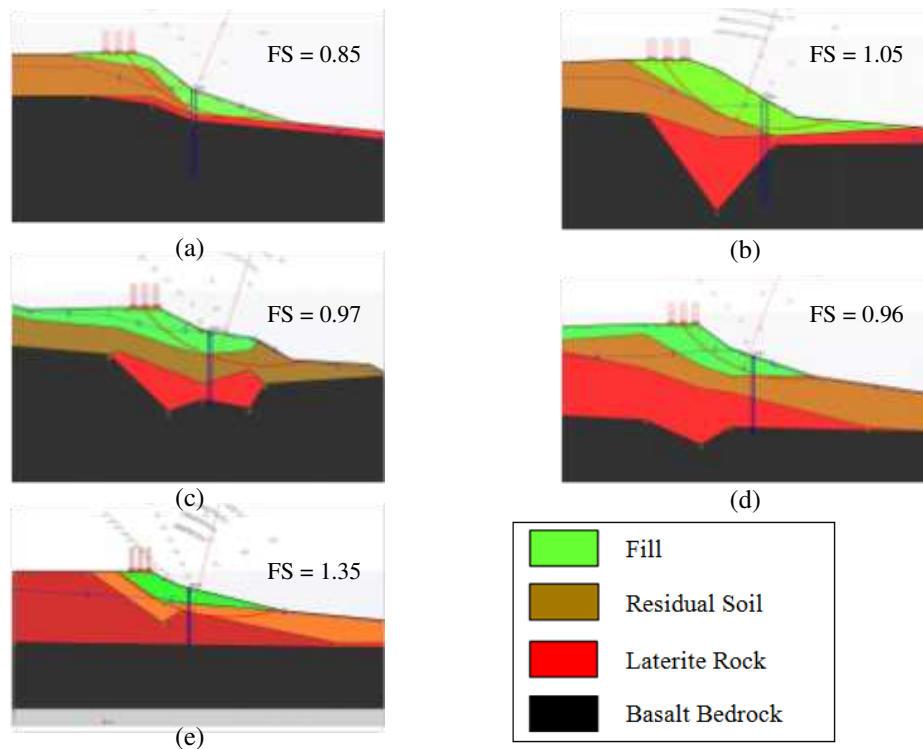
Figures 15a-e. Safety factor and critical slip circle during wet season with January 2007 ground improvement scheme for section: (a) A-A; (b) B-B; (c) C-C; (d) D-D; and (e) E-E.

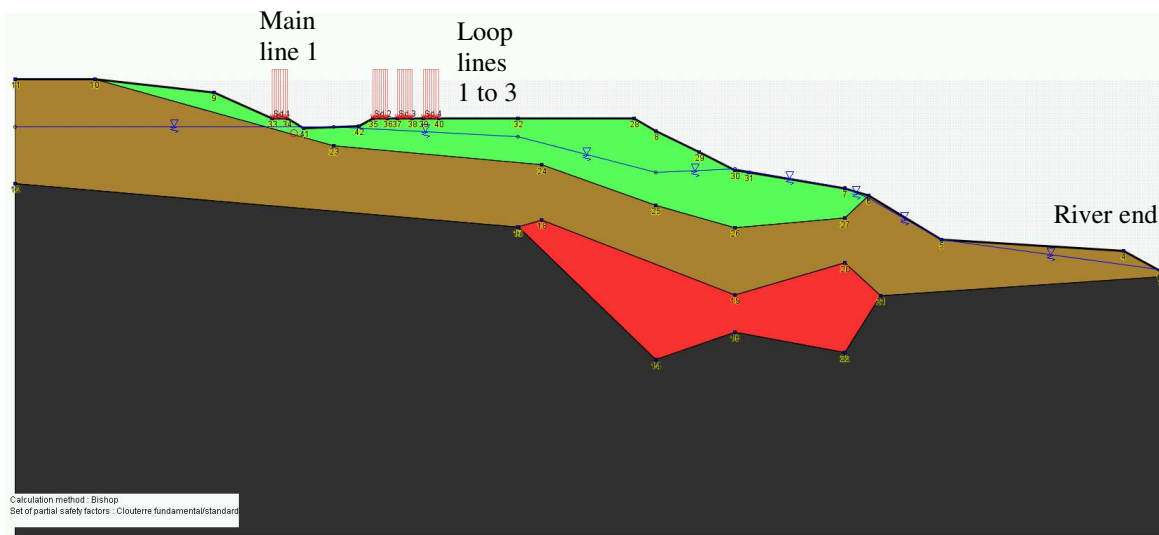
*Figure 18. Section C-C with new rail alignment. The main alignment consists of 3 loop lines and 1 main line.*

more than 1.4. The slope was therefore considered to be safe and unlikely to fail under the new loads. This new alignment has been implemented since 2011. It has been constructed at less than 20 percent of the cost incurred to improve the ground. The railways have also removed the speed restriction at Nivsar which has resulted in additional savings during the monsoon.
