## The July 10 2000 Payatas Landfill Slope Failure

**ABSTRACT:** *This paper presents an investigation of the slope failure in the Payatas landfill in Quezon City, Philippines. This failure, which killed at least 330 persons, occurred July 10<sup>th</sup> 2000 after two weeks of heavy rain from two typhoons. Slope stability analyses indicate that the raised leachate level, existence of landfill gas created by natural aerobic and anaerobic degradation, and a significantly over-steepened slope contributed to the slope failure. The Hydrologic Evaluation of Landfill Performance (HELP) model was used to predict the location of the leachate level in the waste at the time of the slope failure for analysis purposes. This paper presents a description of the geological and environmental conditions, identification of the critical failure surface, and slope stability analyses to better understand the failure and present recommendations for other landfills in tropical areas. In addition, this case history is used to evaluate uncertainty in parameters used in back-analysis of a landfill slope failure.*

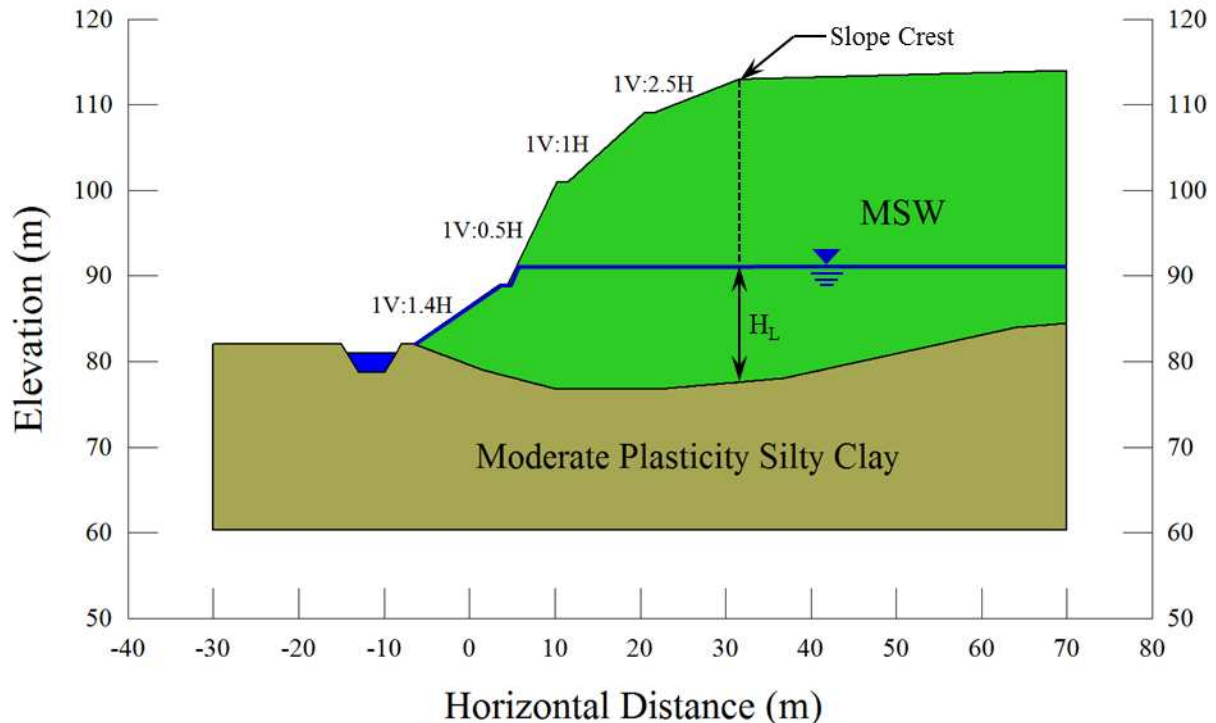
Figure 7. Two dimensional cross-section of failed waste slope.

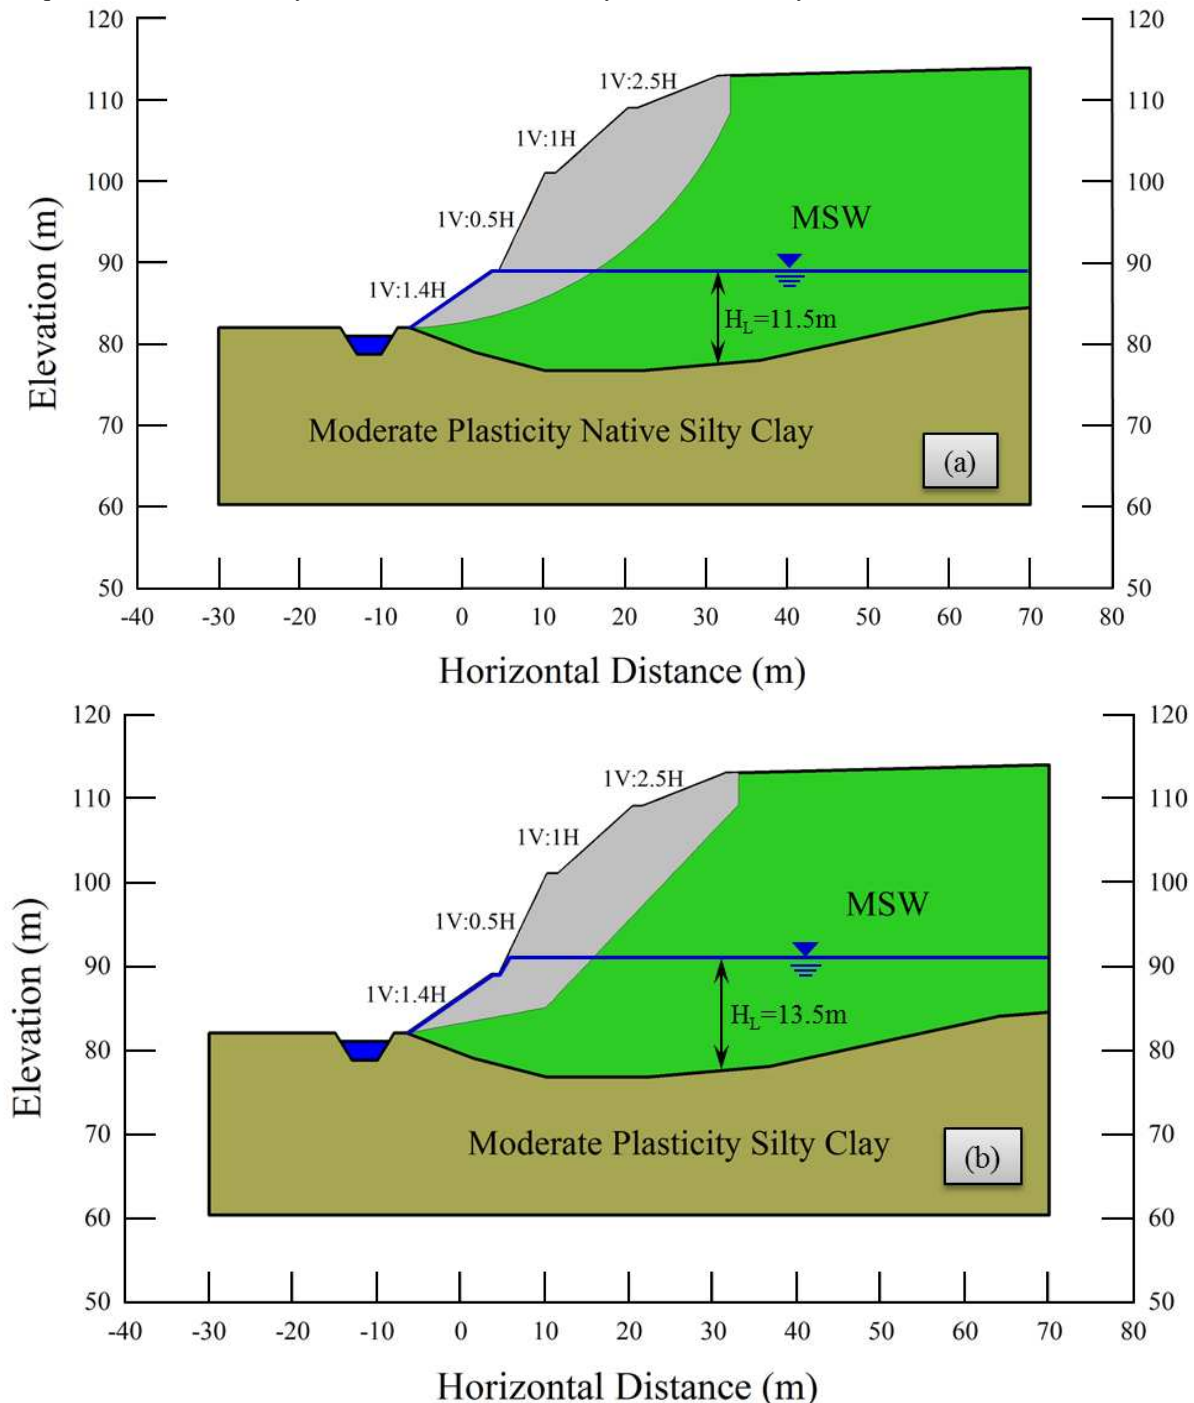
The cross section in Figures 11(a) and 11(b) show the estimated circular and planar failure surface, respectively, based on available photographs (see Figures 2, 3, 5, and 6) and site reconnaissance. The cross sections show the MSW is approximately 31 m thick and is underlain by the brown native clayey silt that slope downward towards the center of the landfill. A leachate trench is shown at the toe of the slope to model the pre-failure slope condition. These cross-sections were used in the inverse analysis described below.

Figure 11. Cross- sections showing location of (a) circular and (b) planar failure surfaces.

The failure surfaces shown in Figure 11 were estimated from photographs in Figures 2, 3, 5, and 6 and consist of a shallow circular and shallow planar failure surface through only the MSW. From Figure 3, the authors surmise that the failure surface is shallow in nature, and the waste mass slid down the side slope as a mass, i.e., a slab or sliver slide. Subsequently, ledges developed along the main scarp formed from vertical blocks toppling over or sliding down (see Figure 3). Therefore, it was concluded that the failure surface passed from the crest of the slope through the MSW, and exited at the slope toe without entering the underlying brown native clayey silt.

Although a circular failure surface indicates a homogenous material, a planar failure surface starting at the toe and daylighting at the top of the landfill was also analyzed. Because the exact location of the failure surface at the crest is not known, the scarp of the waste slide was used to estimate the location of the failure surface at the top of slope that yielded the lowest factor of safety. Furthermore, after the waste slide, the waste was regraded (see Figures 2 and 5) such that the actual slide mass geometry does not represent the possible progression of failure. A helicopter video from a news report (<http://www.abs-cbnnews.com/video/nation/metro-manila/07/10/11/payatas-tragedy-commemorated>) shows an aerial view of the landfill prior to regrading, which was also helpful in estimating the location and geometry of the failure surface. From this video, the failure progresses from the main slide mass and regressing from the initial head scarp to a final scarp that is about 5 m behind the slope crest. Then, an ensuing block of waste toppled from the scarp creating the final geometry shown in Figure 2. Merry et al. (2005) report that a steep (vertical at the top) head scarp remained above the area where heavy machinery had reworked the waste mass.
