# Preliminary Field Assessment of Sinkhole Damage in Pokhara, Nepal

**ABSTRACT:** Since November 2013, numerous sinkholes have been forming in the Armala area of Pokhara Valley, Central Nepal, posing serious threat to local residents. In order to provide measures aimed at reducing sinkhole risk, investigations into the cause and features of the sinkholes are crucial. This paper presents early research results based on two damage surveys conducted in June 2014 and November 2014 in the Armala area. Comparison of photos, taken in the two surveys, clearly indicates not only the formation of new sinkholes, but also the re-activation of filled sinkholes. By means of dynamic cone penetration tests and surface wave method investigations, qualitative characterization of the soil profile was attained, and shallow weak soil layers which are believed to be the location for future sinkholes could be identified. On the basis of the field investigation results, possible sinkhole formation mechanisms are identified for the Armala area. Furthermore, results of a reconnaissance survey conducted in the Armala area in early May 2015 (following the 2015 Gorkha Nepal Earthquake, which occurred on April

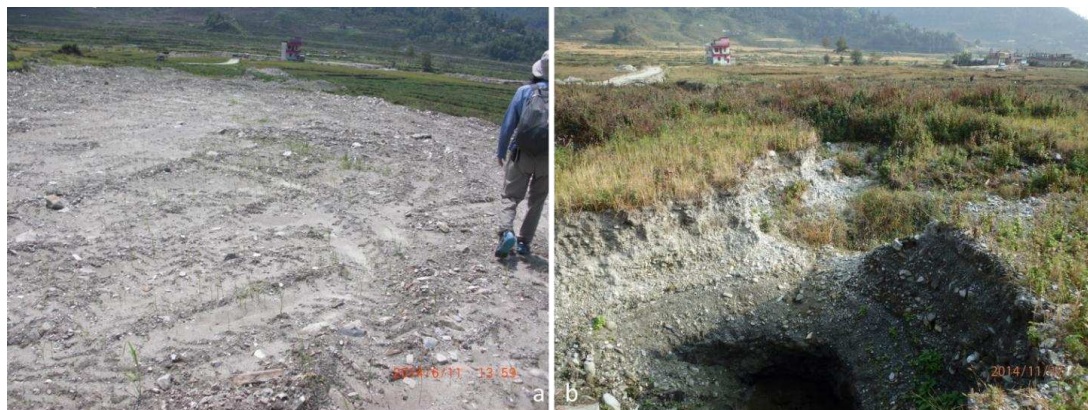
Immediately after the occurrence of the sinkholes, a wide area affected by the cave-in was backfilled by using gravelly soil retrieved from nearby quarries, which is identified by a yellow color filled area in Figure 2. Though, at the time of the first damage survey in June 2014, most of the sinkholes had been fully backfilled (Figure 7a corresponding to photo point 5), the photos taken in November 2014 at the same location clearly show that the backfilling was not an adequate solution as most of the former sinkholes were re-activated (Figure 7b) likely in August 2014 during the peak rainy season in Pokhara Valley.

Figure 7. (a) Sinkholes backfilled area (photo point 5) as seen in June 2014; and (b) Re-activated sinkholes as observed in November 2014.

As mentioned earlier, as an immediate mitigation work, all the old sinkholes were filled by the local government. This practice could disrupt the underground water flow so that ultimately the caving process caused the re-activation of sinkholes. Note that due to loose conditions of backfilled material, it is expected that the development of a re-activated sinkhole is much quicker than that of the original sinkhole where natural compacted soils was gradually eroded by water.

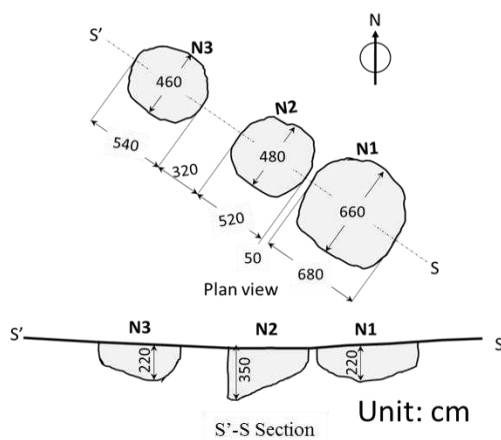
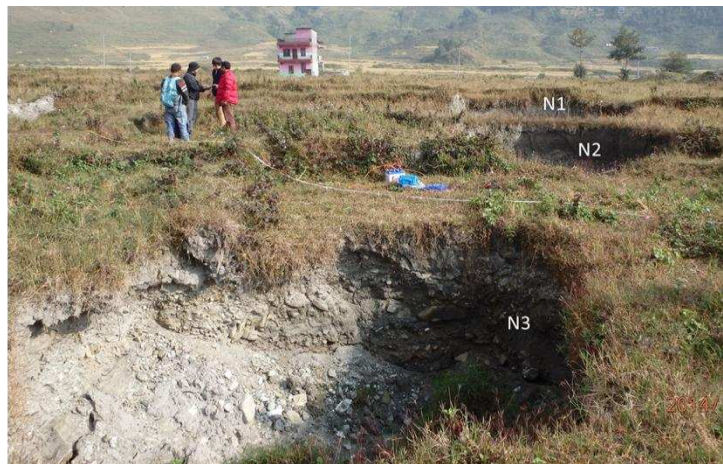
Among many, sinkholes N1, N2 and N3 in the area X shown in Figure 2 were found to be of particular interest. They were developed in a delimited area of approximately 10 m × 20 m, as shown in the schematic map shown in Figure 8. They have a circular pattern and diameters ranging from 4.6 m (N3) to 6.8 m (N1). Their depth measured at the top of the collapsed soil varied from 2.2 m (N1, N3) to a maximum of 3.5 m (N2). According to witnesses, N1 was the first sinkhole to be formed. A few days later, N2 caved-in and finally N3 developed. This progressive formation of several sinkholes along a straight line (moving along the uphill direction from N1 to N3) may suggest that the collapse of N1 caused the complete disruption of underground water flow. Consequently, water started to erode the soil just adjacent to N1 until a new cave-in (N2) was formed. In a similar way, N3 was later developed. The same pattern of sinkhole formation occurred often since November 2013. Most of the newly developed sinkholes are located on the upstream side of the underground water flow.

Figure 8. Series of sinkholes appeared in the area X in Figure 2 (photo point 6).

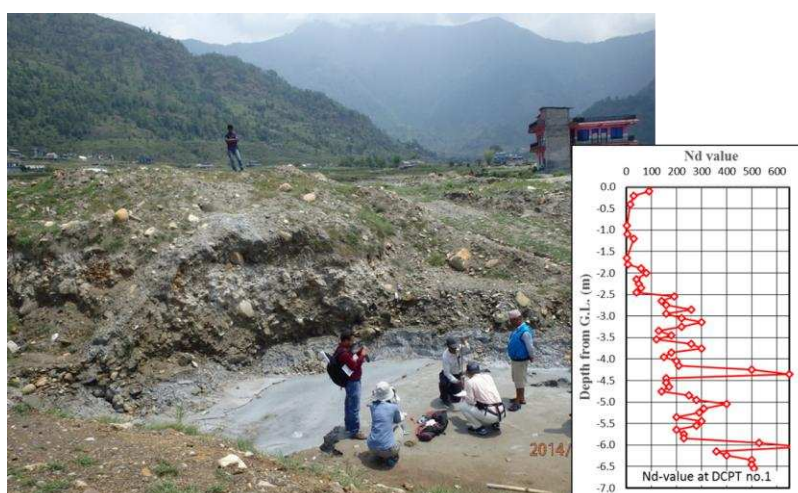
DCPT-1 was carried out at the bottom of a non-filled sinkhole as shown in Figure 10 (corresponding to photo point 7 in Figure 2). As already mentioned, this area is composed of recent flood plain deposits, including a thick gravel layer at shallow depth. Thus, DCPTs could not penetrate more than 6.55m. However, the test results would suggest that the probable depth of the sinkholes should be approximately 4.5-5m, or more precisely 6.5-7 m below the ground level considering that the actual ground level was approximately 2m above the sinkhole bottom.

Figure 10. Result of the Dynamic Cone Penetration Test at DCPT no. 1 at the bottom of a sinkhole.

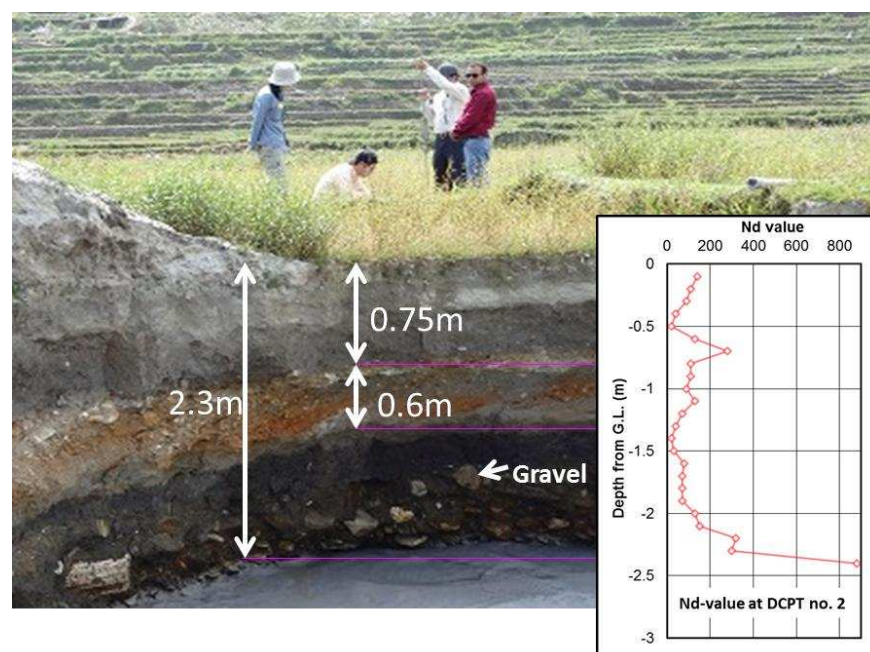
On the other hand, DCPT-2 (Figure 11) was carried out just adjacent to the sinkhole at photo point 8 in Figure 2. The test results were correlated with stratigraphy and structure of the deposits (Figure 11). The converted DCPT  $N_d$ -values are plotted in Figure 11. The upper layers of the surface soil could be penetrated until reaching a layer of gravel at a depth of 2.4 m, where even by hitting more than 150 times the penetration process stopped.

By comparing the  $N_d$  -values obtained from DCPT-2 and DCPT-3, it is noted that the filled materials are looser than the natural soil. Therefore, the filled material can be easily caved-in and induce the re-activation of filled sinkholes during the rainy season.

Figure 11. Soil profile and DCPT result at DCPT-2 obtained for the sinkhole in photo point 8 (Photo in June 2014).

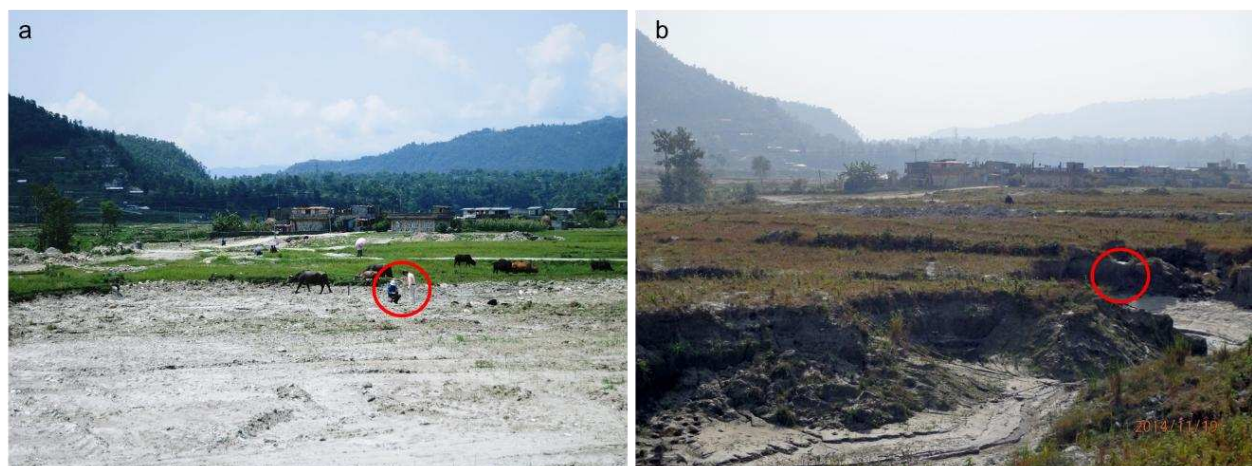
DCPT-3 was carried out at the top of the filled material at photo point 9. As shown in Fig. 12a and 12b, the testing location disappeared due to the collapse of filled material during the rainy season between June and November 2014. From the test results shown in Fig. 13, it is concluded that the used filling materials are sand and gravelly soils. However, the compaction at the surface is not good enough because the  $N_d$ -value measurement is low. The DCPT results suggest that the cavity bearing formation is below the gravel layer, and then progressively the cavity size increased and finally the loose upper layer collapsed.

Figure 12. a) Dynamic Cone Penetration Test at DCPT no. 3 (photo point 10) on the filled material (photo taken in June 2014) and b) re-activated sinkhole at the same location (photo taken in November 2014).

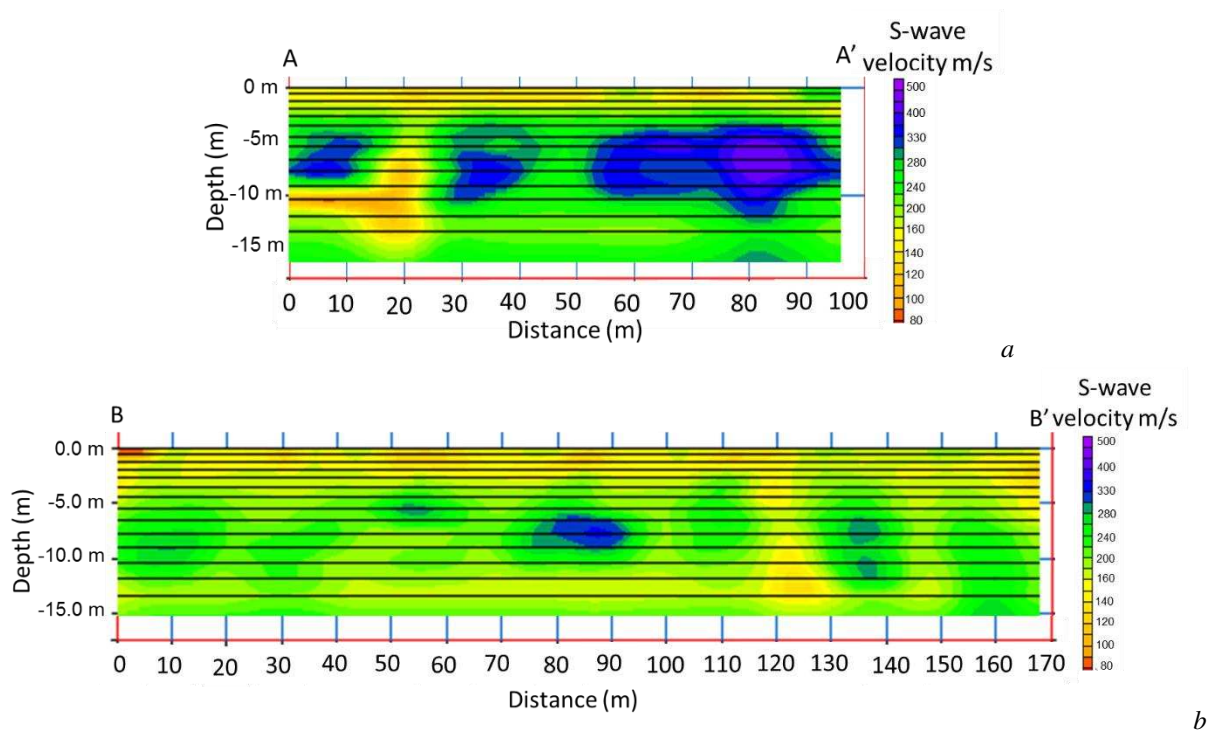
The results of SWM test along sections A-A' and B-B' are shown in Figure 15. It can be seen that the shear wave velocity for the surface layer is in the range of 100-160 m/s, confirming the presence of a loose sand layer of 1.5-m thickness. The underlying gravel has a higher velocity than the surface layer with a shear wave velocity of about 240 m/s. Moreover, the stiff soil below 4 m depth has a shear wave velocity greater than 300 m/s. The velocity of the layer around 10 m depth denotes water flowing path and loose material. A low velocity section observed 20 m far from the starting point in profile A-A' indicates possible cavities in the ground. Similarly, in profile B-B' the loose material at a depth of about 12 m indicates a possible water flowing layer and the weak strata between 120 m to 130 m is a possible future sinkhole.

Figure 15. Profiles of surface wave method: (a) section A-A'; and (b) section B-B'.
