# The May 25<sup>th</sup> 2011 Railroad Embankment Failure in Ann Arbor, Michigan, As a Means for Teaching Geotechnical Engineering

**ABSTRACT:** A 30-m long railroad embankment failure that occurred on May 25 2011 in the city of Ann Arbor, Michigan, is presented. Emphasis is given on the field observations of the failure, the characterization of the site conditions and the seepage and slope stability analyses, all of which represent important components of the training and practice of a geotechnical engineer. The failure occurred following a record wet season that resulted in ponding water against the embankment and high enough water pressures and exit gradients that resulted in instability of the railroad embankment. Detailed background material and the methodology for using the case history in geotechnical engineering education are presented.

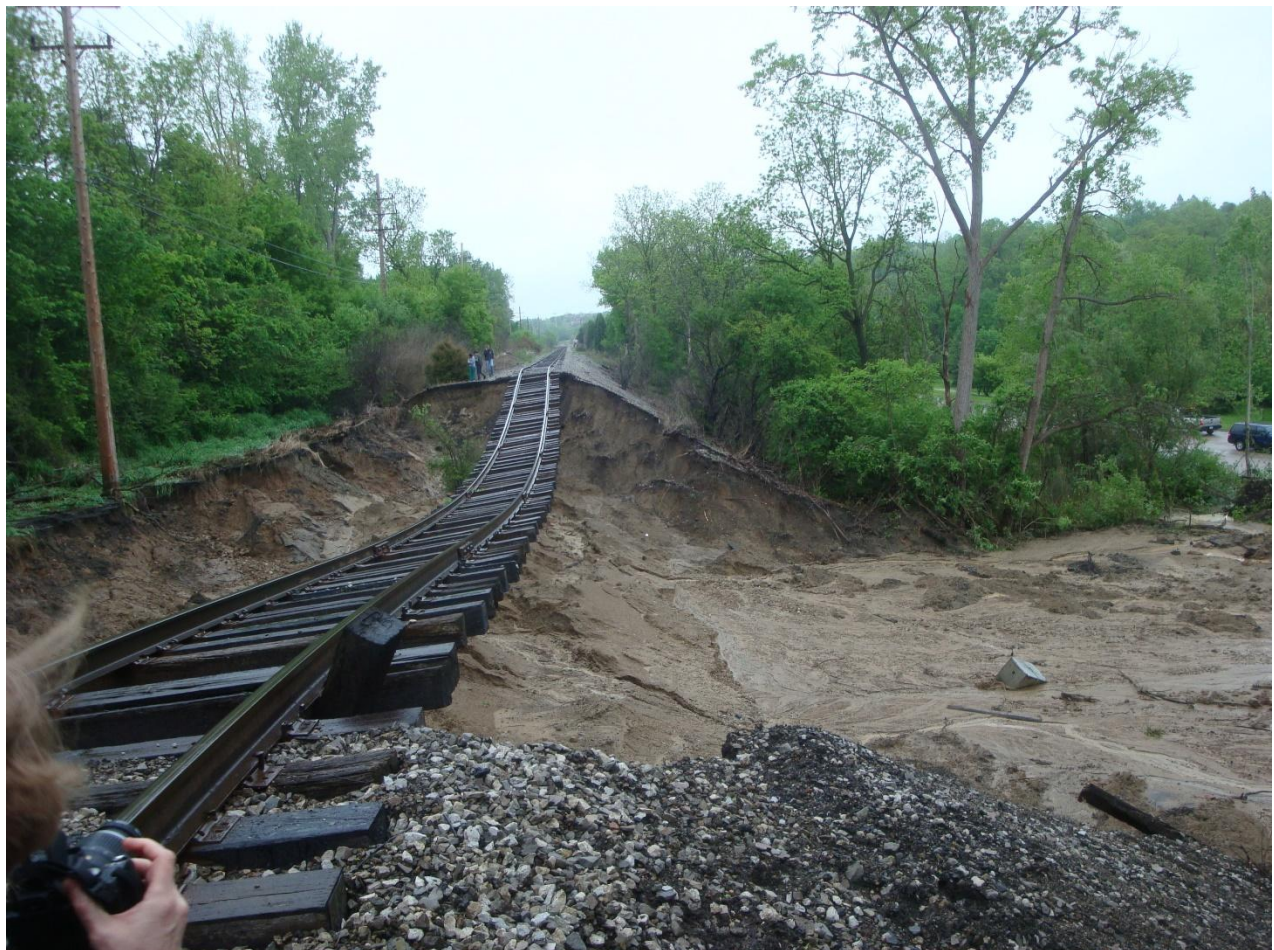
The case history of a railroad embankment failure, shown in Fig. 1, that took place in Ann Arbor, Michigan, on the 25<sup>th</sup> of May 2011 is presented as a means for teaching fundamental principles of geotechnical engineering. An advantage of this case history as an education tool is that it can be taught at different levels and give the instructor the opportunity to emphasize several different topics in soil mechanics and geotechnical engineering. Additional advantages include the impressive nature of the failure, the detailed characterization using in-situ and laboratory approaches, and the wealth of lessons learned that can be readily understood by students.

*Figure 1. View of the railroad embankment failure looking East.*

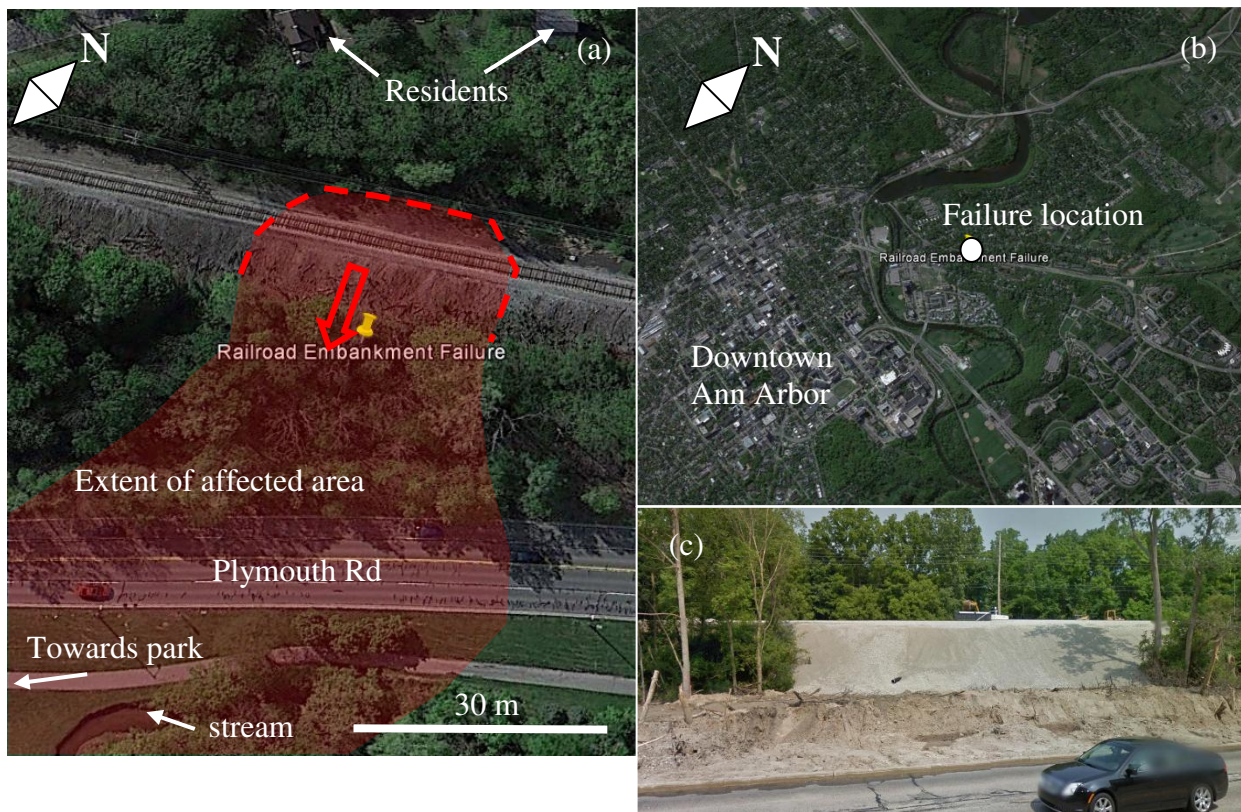
Figure 2. (a) Satellite imagery of the railroad embankment at the failure location; (b) location of the failure; (c) View of the repair works as recorded by coincidence by the Google Earth Camera.

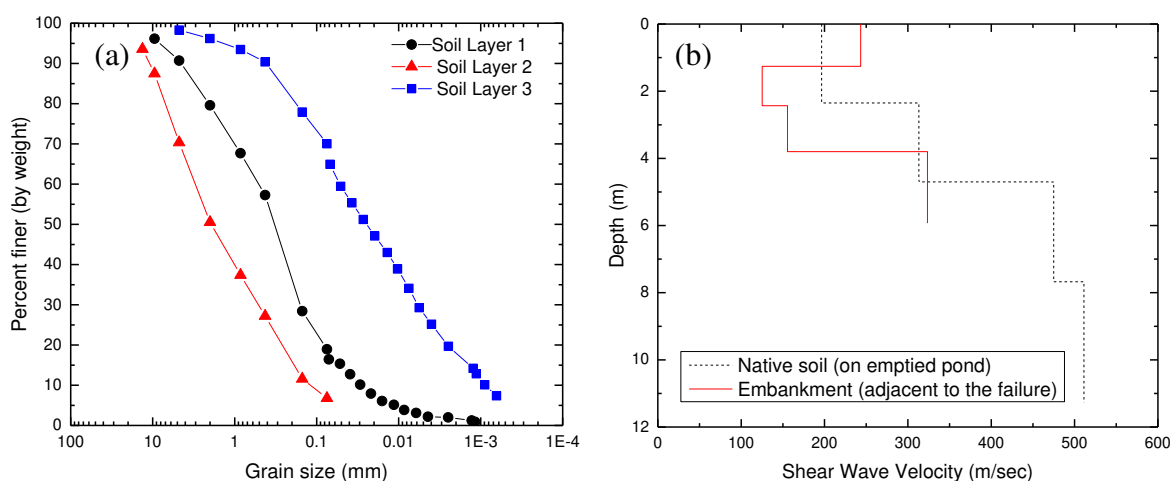
**Soil Layer 1:** This soil layer represents the main embankment layer, as shown in Fig. 5, and is classified per USCS as silty sand (SM). 18.9% of the material are non-plastic fines as shown in Fig. 8a. Since undisturbed samples were impossible to collect for the sandy fill, tests were conducted on reconstituted specimens at two different density states to evaluate the range of shear strengths expected for these materials. The direct shear tests were conducted in dry conditions. The shear strength of the material at a dense state was evaluated on the basis of direct shear testing, and the peak friction angle was found to be equal to  $46^\circ$ , whereas the post-peak was found to be equal to  $38^\circ$  without any cohesion, as shown in Fig. 9. The large-displacement friction angle at a dense state is approaching the peak friction angle of the soil at the loose state that was found to be equal to  $35^\circ$ . The hydraulic conductivity of the soil at a dry unit weight of  $1.71 \text{ gr/cm}^3$ , was equal to  $5.1 \times 10^{-5} \text{ cm/sec}$  based on a falling head hydraulic conductivity test conducted in the laboratory.

Figure 8. Results of (a) grain size distribution analyses and (b) in-situ shear wave velocity

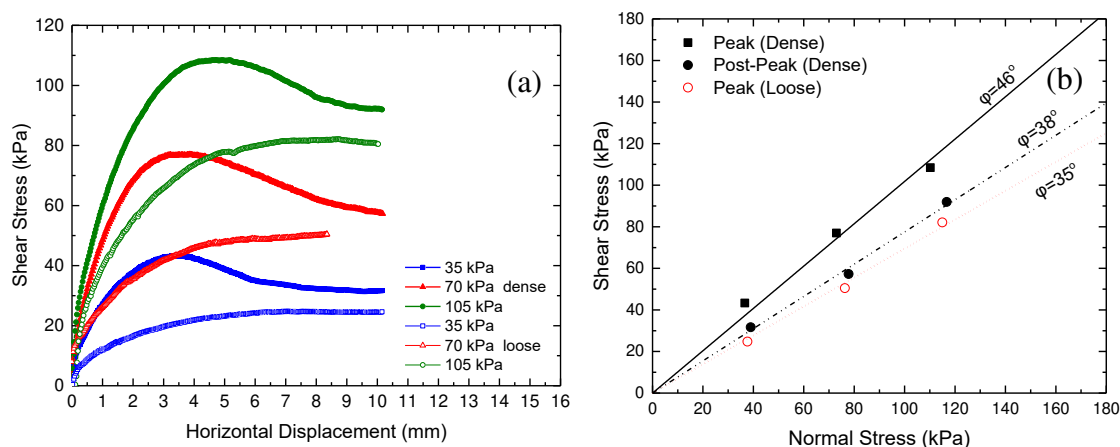
Figure 9. Direct shear results at nominal vertical stresses of 35 kPa, 70 kPa, and 105 kPa on reconstituted specimens of Soil Layer 1.

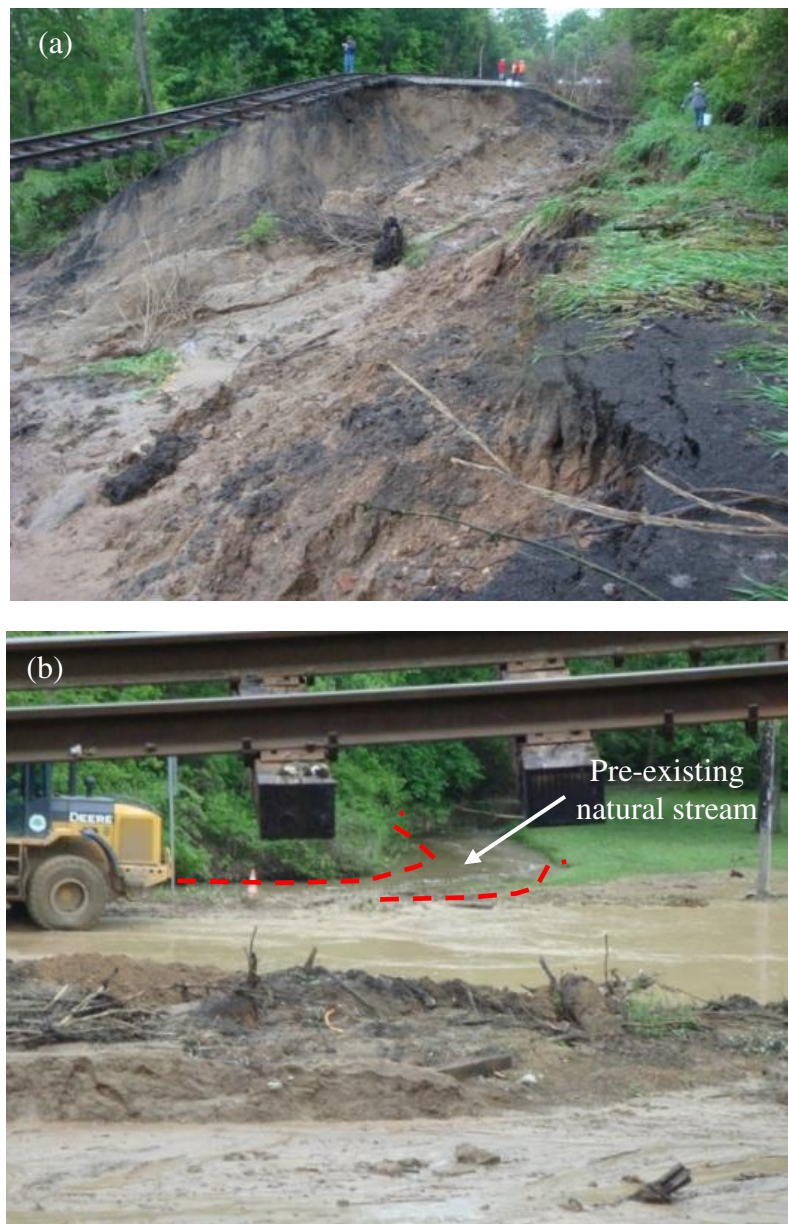
**Soil Layer 2:** This embankment layer is restricted to the top few cm from the surface and is essentially coal ash residuals that are black in color and can be clearly seen in Fig. 10. The fines are non-plastic and represent only 6.8% of the total mass of the soil, whereas the gravelly size particles are equal to 29.6%. It is classified per USCS as well-graded gravelly sand with silt (SW-SM). This soil layer is not expected to have played a significant role in the failure since it is of very small thickness and restricted at the surface only. Thus, more comprehensive testing to characterize its properties was not conducted.

Figure 10. View of the failure from the crest of the failure surface where (a) the left-in-place embankment is shown; (b) the mass of soil with large amount of water is shown at the toe of the failure reaching the pre-existing natural stream.

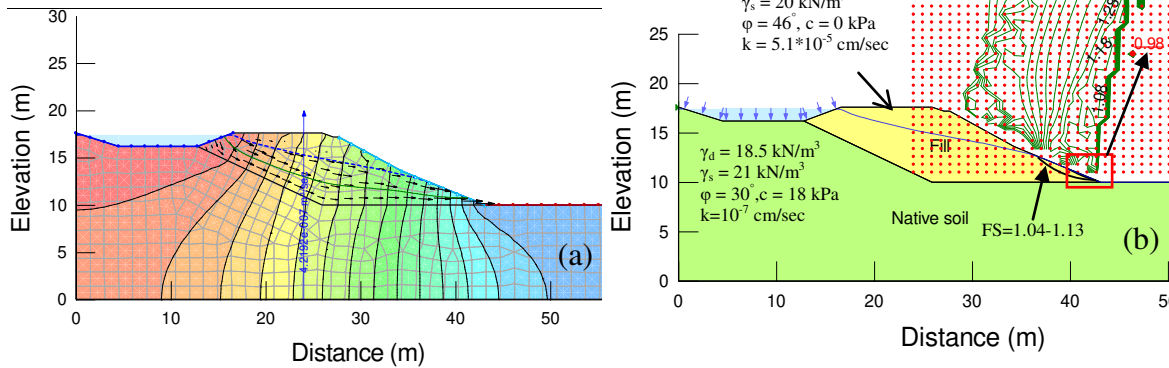
Subsequently, seepage analyses were conducted using the estimated hydraulic conductivities. As described earlier, the natural soil has significantly lower hydraulic conductivity than the embankment soils. Thus, the analyses indicate that when the ponding water depth increases, the exit gradients at the toe of the embankment become high, and vary between 0.48 and 0.78, which are dangerously high and close to critical gradients ( $\sim 0.9$ ). The stability analyses using the calculated hydraulic pressures, indicate failure of the embankment with factors of safety around one, as shown in Fig. 12. Note that this is not surprising as the seepage analysis gives a more realistic pore pressure profile (Fig. 12a) than that of an arbitrarily assumed piezometric surface (e.g., Fig. 11) with the flow concentrating more on the higher hydraulic conductivity soil. The results, indicate that the failure is caused by the high pore pressures that may even cause piping. The numerical results, are supported by the following interesting field observation: The reeds in the ponding water area adjacent to the embankment were found to be bent sideways and positioned horizontally with a direction that was pointing with great accuracy to the exact location where the ponding water initially drained quickly, as shown in Fig. 12.

Figure 12. Indicative results of combined (a) seepage and (b) stability analyses using seepage analyses results
