# A Large Scale Landslide in a Coal Mine in Marly Formations: Evaluation, Analysis and Rehabilitation

**ABSTRACT:** *This paper describes a large scale landslide in a coal mine in Servia area in Kozani, Greece, which occurred in February 2011. The landslide, of ~250m width and ~350m length, took place in marly lacustrine sediments. The main factors for the manifestation of the landslide were a temporary interruption of works, the existence of a specific weak surface, the clayey nature and the sensitivity of marl to environmental agents, the action of water and the large slope height. Due to the magnitude and the position of the failure, a geotechnical solution was proposed that involved rearrangement of ground masses. The proposed solution led to successful rehabilitation and unimpeded continuation of the exploitation process.*

Reference: Prountzopoulos, G., Fortsakis, P., Marinos, V. and Marinos, P. (2016). *A Large Scale Landslide in a Coal Mine in Marly Formations: Evaluation, Analysis and Rehabilitation*. International Journal of Geoengineering Case histories, Vol.4, Issue 1, p.29-45. doi: 10.4417/IJGCH-04-01-03

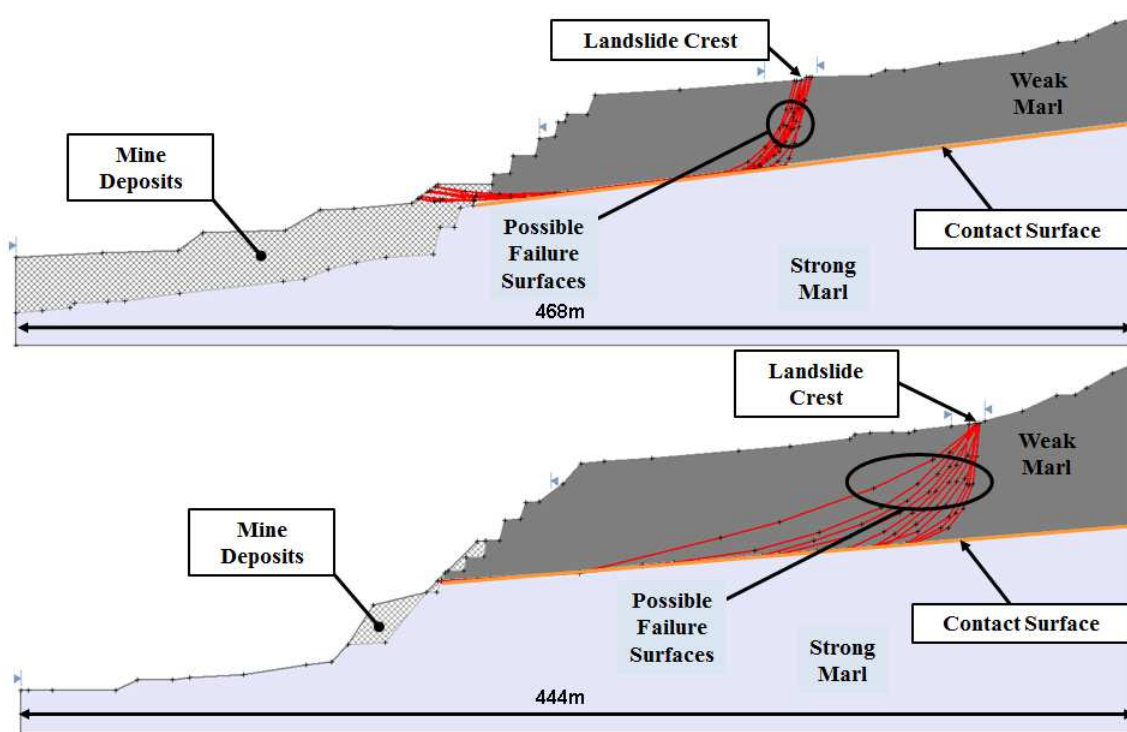
Given the three dimensional character of the landslide, as mentioned earlier, two analysis sections were systematically checked (Sections 2 and 3) so as to estimate some rational parameters for the assessment of rehabilitation proposals. Figure 5 illustrates the analysis sections along with their main features. The process that was adopted is summarized in the following steps:

1. After in-situ inspection and study of available surveying mapping, conclusions were reached concerning the general shape of the failure surface along Section 2 (subvertical near the crest) and Section 3 (with more gentle slope near the crest). Based on these conclusions, a set of possible failure surfaces was considered for each Section, with varying inclination and part of the surface passing through the weak marl formation and along the contact surface between the weak and the competent marl.

Figure 5. Analysis Section 2 (up) and 3 (down). Slide software model.

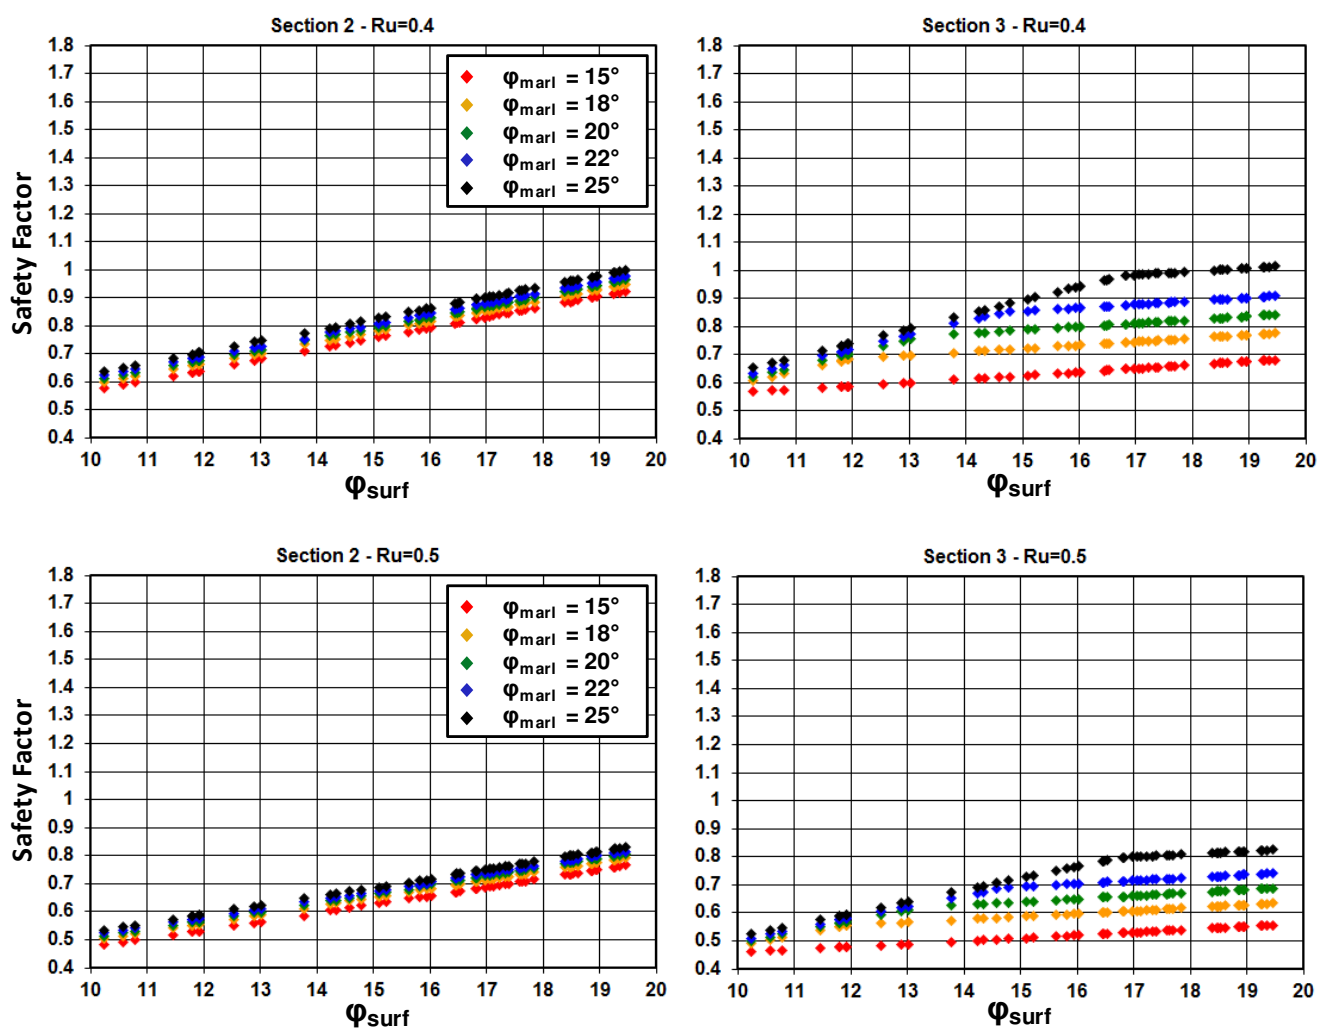
3. Values of the safety factor for values of the pore pressure ratio  $R_u=0.4-0.5$  were generally well below unity for both analysis Sections (see Figure 8), especially for  $\phi_{surf} < 17^\circ-18^\circ$  and were not considered likely. Values of the safety factor for  $\phi_{surf} > 18^\circ$ , given the nature of the specific surface and the fact that are assumed to refer to residual strength, were not considered reasonable.

Figure 8. Variation of safety factor for different values of  $\varphi_{marl}$  and  $\varphi_{surf}$  for  $R_u=0.4$  (up) and  $R_u=0.5$  (down), as computed for Section 2 (left) and Section 3 (right)

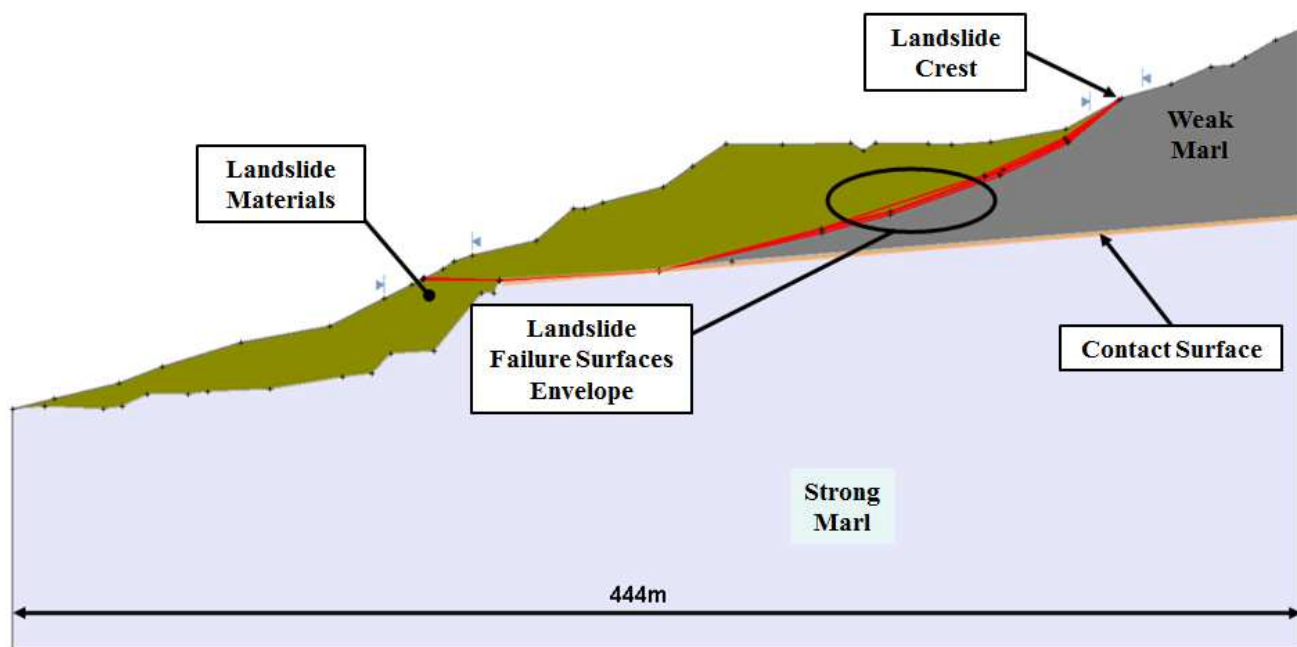
Figure 10. Analysis Section 3 after the landslide

The relevant analyses yielded results of the safety factor between 1.06 and 1.11, which were considered marginal, given the possible further deterioration of the shear strength of the materials involved in the slides, due to ongoing movements, especially during the rainy season in the area. Specifically, analyses of Section 2 resulted in a minimum value of the safety factor equal to 1.11, whereas the corresponding minimum value from Section 3 was 1.06. Analyses with free selection of surfaces by the software were not performed, as these would yield unrealistically low values of the safety factor (considerably  $<1$ ), under the assumption that the total mass included in the landslide envelope had been downgraded to its residual strength (zero cohesion and low friction), which was not the case due to monolithic, undisturbed blocks existing within the slid mass. The fact that the resulting safety factor values were rational, i.e. marginally larger than unity, indicating a temporarily stable situation after a main landslide event, enhanced our confidence in the assumptions that were made.
