## A High Rock Cut Stabilization in Muscat City, Oman

**ABSTRACT:** A large road box cut was constructed in hilly terrain of Muscat city, Oman, in an area underlain by the geologically complex Sahtan and Mahil formations comprising of limestone, dolomite, sandstone and siltstone with interbedded soft calcareous mudstone. The rockmass contains a large number of small scale faults, shear zones, minor folds and solution cavities. The maximum height of the cut was 50 m with slope angle of 1V:0.25H, and intermediate benches generally 3 m wide. To control vibrations in the urban neighborhood located nearby and avoid damage to the rockmass, a very cautious and time consuming excavation approach was adopted using rock breakers. The excavation work was completed in 2010. Oman has a hyper-arid environment with scarce rainfall for many months. However, occasionally the area is hit by intense rainstorms. During Cyclone Phet and accompanying rains in June 2010, part of the cut slope failed with a downslope movement of about 800 m<sup>3</sup> of massive rock. This necessitated a post-excavation re-evaluation of the cut slope, which culminated in design modifications, and construction of long te

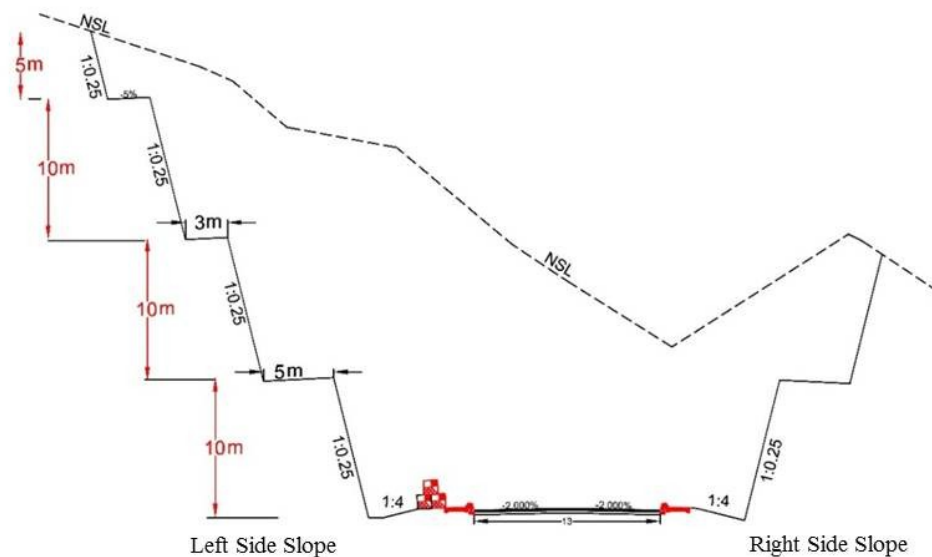
The maximum height of the rock slope in these cuts reaches 50 m with a cut slope of 1V:0.25H (76°) and 3 m wide benches at every 10 m height interval. A typical section of box cut at RD 0+420 m is shown in Figure 2. The initial design included slope protection measures such as short length rock bolts and reinforced shotcrete.

Figure 2. Slope and roadway configuration at station RD 0+420 m in Box Cut#1.

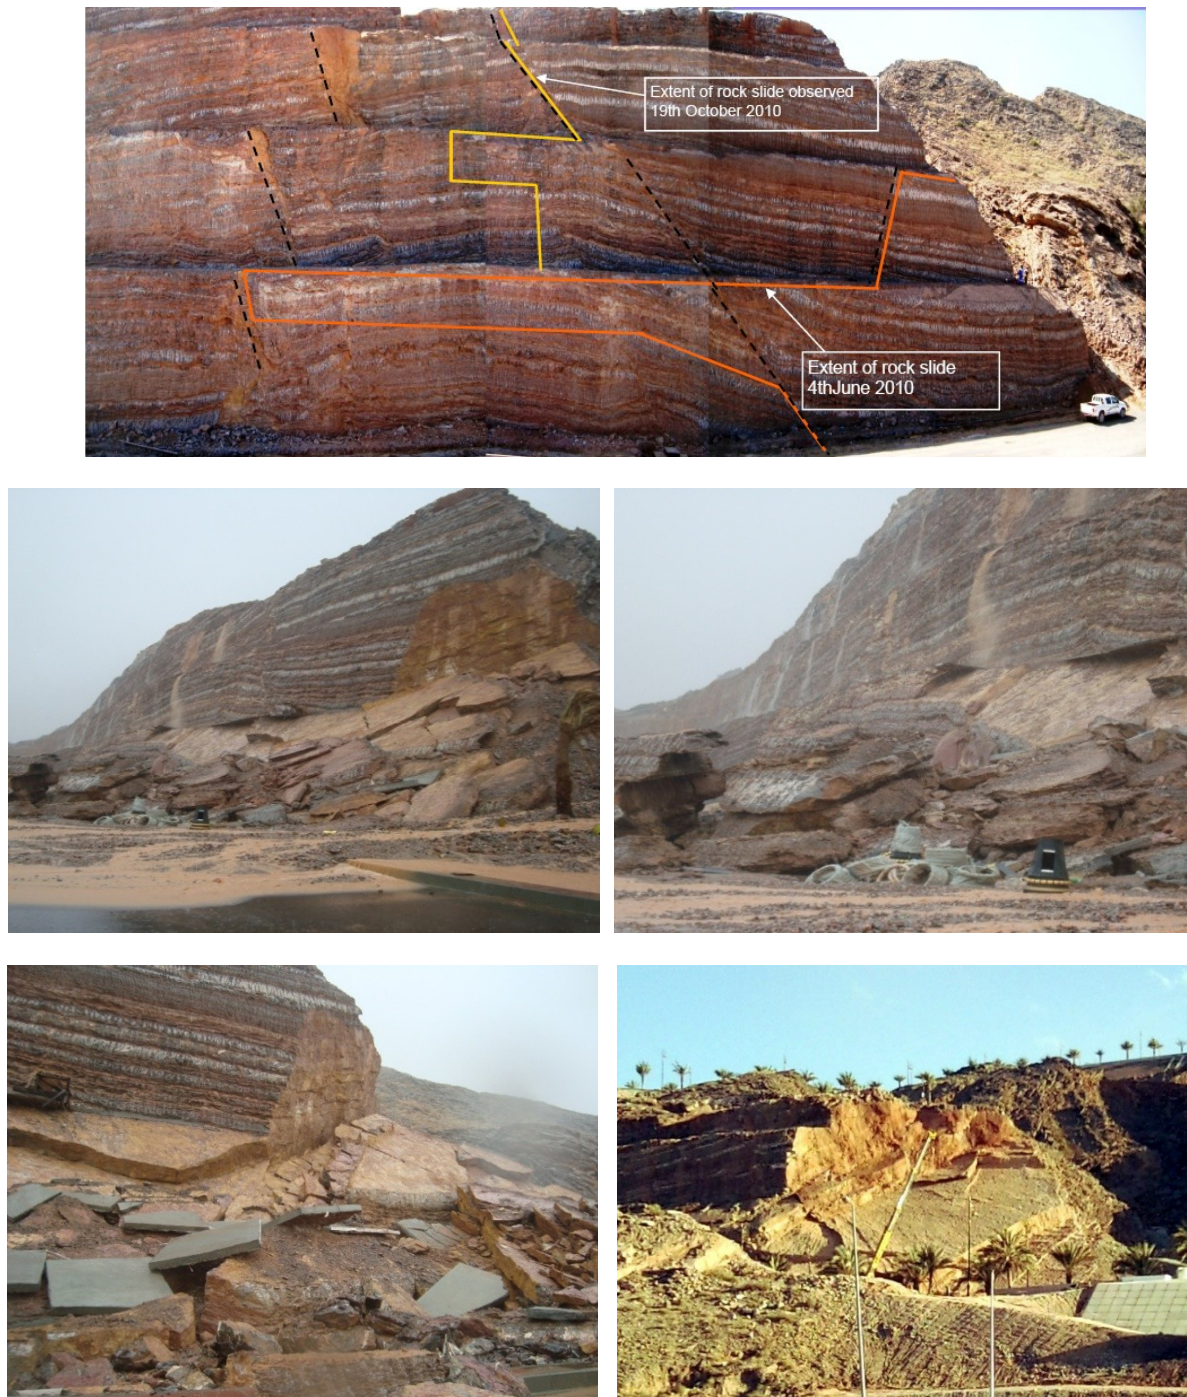
Photographs taken just after the rain storm showed that the failure had occurred initially as a single event. Failure occurred along a 40° dipping bed in the lowest slope, which extended to the inner edge of the first berm and a near vertical joint forming the release plane. The photographs taken at that time also showed a large amount of water transported debris coming out from the above mentioned wadi adjacent to the failed area. Water was also noticed cascading over the crest of the main rock cut.

With the passage of time, the extent of the initial failure grew in size as more and more rock mass adjacent to the initial failure area failed progressively. Within a couple of weeks of the initial event, the failure grew to the top of the 35 m high cut, extending about 20 m along the crest and reaching as far as a steep joint with a strike of about 260° (N100 deg W), and dip of more than 70°. The total volume of failure was estimated at 800 m<sup>3</sup> (Figure 4).

From site observations, it was concluded that the failure initiated along a laminated bed of argillaceous rock layers, which had the least shearing resistance of all the rock mass at the site. The failure undermined the slopes above it and caused their failure, which progressed in the weeks ahead of the initial event.

The main triggering factor was the increase in water pressure associated with the rainfall event. The Box Cut # 1 slope at the farthest end was exposed to weather on three sides; the front cut face, the edge face and behind in the wadi (valley). It is likely that the water in the wadi overflowed and infiltrated the loose jointed and bedded rock mass. It is also likely that the small solution channels formed conduits for water that entered the formation, contributing to the failure. Although the rock mass appeared visibly stable in the area after a few weeks, there were other bedding / joints in the area that could cause further instability in the future, especially under wet conditions.

*Figure 4. Top photo provides an overall view of the slope face prior to sliding and the extent of two episodes of sliding on June 4<sup>th</sup> and October 11<sup>th</sup> 2010. The lower frames, except the lower right corner view, show sliding during Cyclone Phet, while the lower right corner view shows the resulting slope face after the final collapse on October 11<sup>th</sup> 2010. The sliding along the bedding and a vertical joint, a free release plane along the overspilled wadi, is an obvious reason of sliding during cyclone Phet.*
