# Geotechnical Damage Caused by the 2016 Kumamoto Earthquake, Japan

**ABSTRACT:** On the 16<sup>th</sup> of April 2016, the Kumamoto earthquake ( $M_w$  7.0) hit the Central Kyushu Region, Japan, following a  $M_w$  6.2 shock on the 14<sup>th</sup> of April. The earthquake sequences caused severe damage in Kumamoto Prefecture. This paper presents quick reconnaissance results focusing on geotechnical damage features, which were observed during field investigations immediately after, one, and two weeks after the main shock. The damage surveys were carried out in southern Kumamoto City, Mashiki Town, Aso Caldera area and their suburbs. In southern Kumamoto City, evidence of liquefaction was found at many locations, and some buildings and river levees suffered from significant settlement and deformation; damage to an embankment of Kyushu Highway also seemed to be the result of liquefaction. The majority of the damaged residential houses were found in Mashiki Town and its suburbs, which may be linked to intense earthquake motions associated with the seismic fault location. In Aso Caldera area, a number of moderate to large scale landslides and their significant impact to structures wer

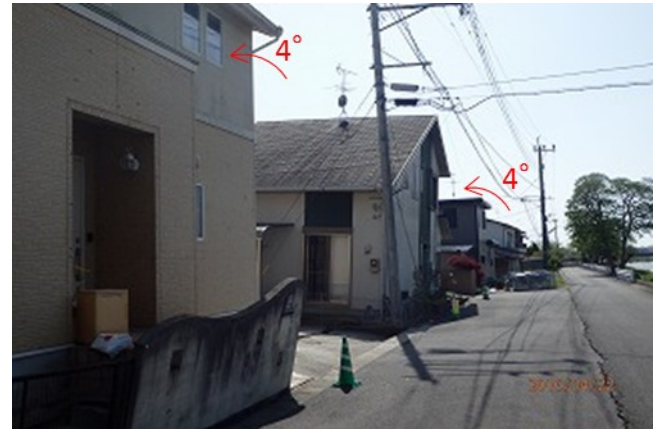
Figure 5. Liquefaction-induced damage to residential houses in Majima district (Site 2 in Fig. 3) ( $32^{\circ}45'52.69''\text{N}$ ,  $130^{\circ}46'7.49''\text{E}$ ).

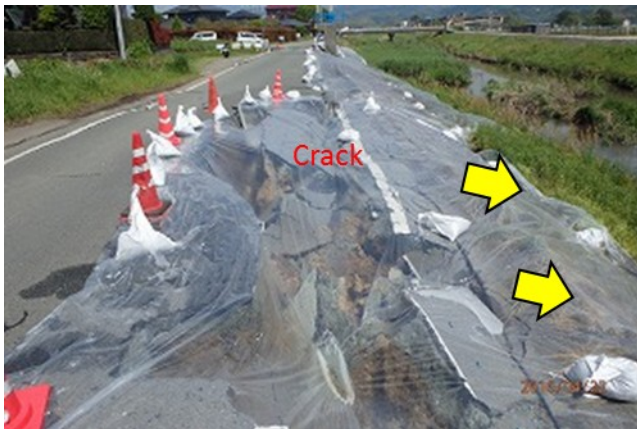
Figure 6 shows the typical liquefaction-induced damage to a river levee (site 3). Large settlement and lateral deformation was found at the levee along Akitsukawa-River. According to a landform classification map for flood control, provided by Geospatial Information Authority of Japan (GSI) shown in Fig. 7, the damaged levee is located at the old river channel, which suggests that a shallow soft deposit liquefied, inducing lateral spreading toward the river. Kyushu Regional Development Bureau of MLIT (2016) reported damage of variable severity to the levees of the Midorikawa-River and Shirakawa-River. They identified a total of 171 sites, however, their emergency restoration was almost completed as of middle of May. The settlement of levees, for example, caused a large gap between the embankment and bridge girders leading to a transportation problem (Figure 8, site 4). As of the end of April, such problems have occurred at many locations, however, they have been temporally solved by the installation of a filled slope (Figure 9, site 5). Although the locations of liquefaction are widespread in Kumamoto City (Wakamatsu et al., 2016), there have been no official report of serious liquefaction-induced damage; there are neither collapse of buildings nor washout of levees due to liquefaction.

Figure 6. Liquefaction-induced damage to levee along Akitsukawa-River (Site 3 in Figs. 3 and 7) ( $32^{\circ}46'43.56''\text{N}$ ,  $130^{\circ}47'40.27''\text{E}$ ).

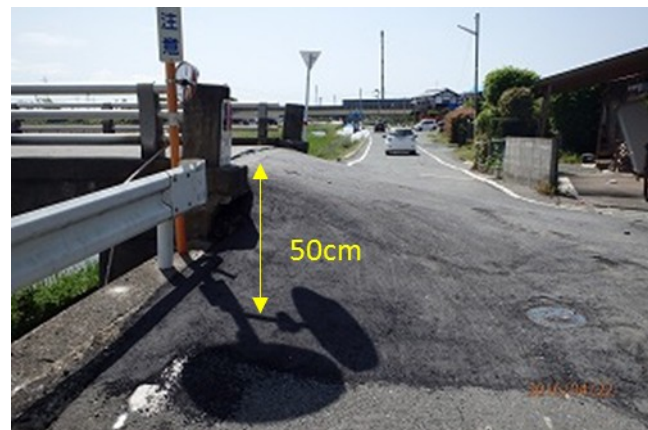
Figure 9. Temporary restoration work (filled slope) for settlement of levee (Site 5 in Figs. 3 and 7) ( $32^{\circ}46'44.47''\text{N}$ ,  $130^{\circ}47'45.43''\text{E}$ ).

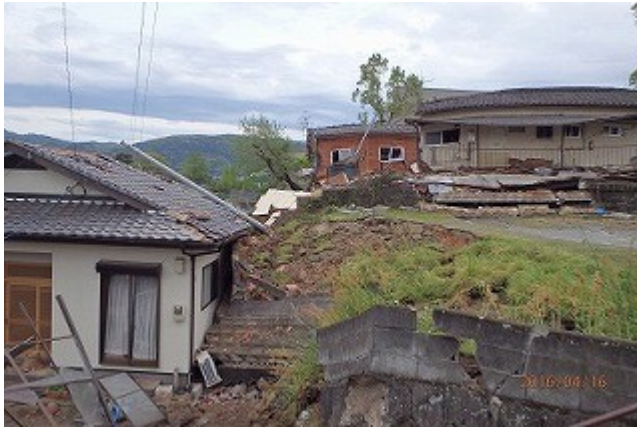
*Figure 16. Ground displacement-induced damage to a residential house (Site 8 in Fig. 12) ( $32^{\circ} 47'24.96''\text{N}$ ,  $130^{\circ} 49'12.75''\text{E}$ ).*

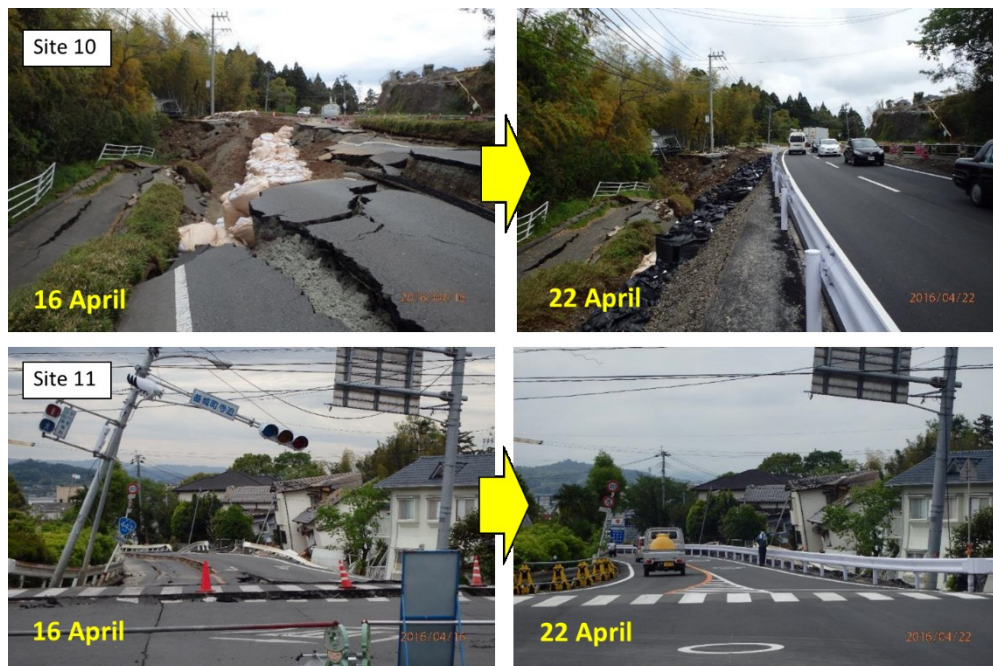
Approximately 150 m south of the above damaged site a differential settlement was observed (Photo 12b, site 11). According to the landform classification map in Fig. 14, it is indicated that the damaged site was recently constructed on the alluvial soil deposit. The damage, therefore, is attributed to strength reduction of foundation ground due to a process of liquefaction and/or that of the embankment, if the compaction work was inadequate. Immediately after the earthquake, emergency restoration work was rapidly conducted in the affected areas. As shown in Fig. 19, the restoration work for the damaged sites along Route 443 was completed a few days after the main shock.

Figure 19. Damages to Route 443 and their restoration for (a) site 10 and (b) site 11 (c.f. Figs. 12 and 14)  
(Site 10:  $32^{\circ}47'29.71''N$ ,  $130^{\circ}49'17.58''E$ , Site 11:  $32^{\circ}47'24.33''N$ ,  $130^{\circ}49'15.82''E$ ).

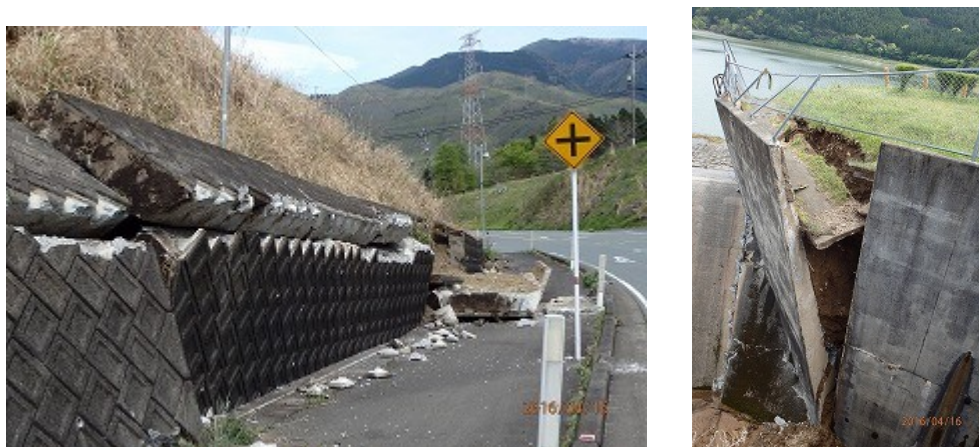
Mashiki and the surrounding areas were close to the seismic fault and suffered from a variety of geotechnical and structural damage due to the earthquakes. Damage to gravity-type and cantilever-type retaining walls (2-3 m high) was found at several locations due to surface manifestation of fault rupture. The retaining wall and dam spillway retaining wall at site 12 in Fig. 12 were structurally damaged as a result of the fault movement (Fig. 20).

Figure 20. Damage to retaining wall and spillway retaining wall (site 12 in Fig. 12)  
( $32^{\circ}50'29.22''N$ ,  $130^{\circ}55'55.83''E$ ).

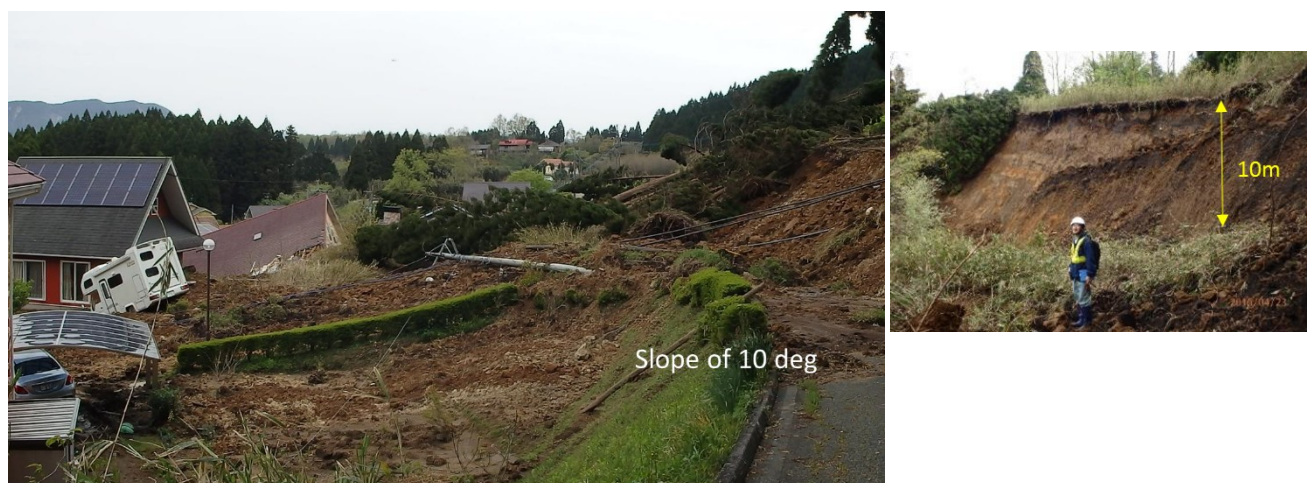
Figure 30. Landslide at gentle slope and its scrap (site 19 in Fig. 26) ( $32^{\circ} 52'29.42''N$ ,  $131^{\circ} 00'49.36''E$ ).

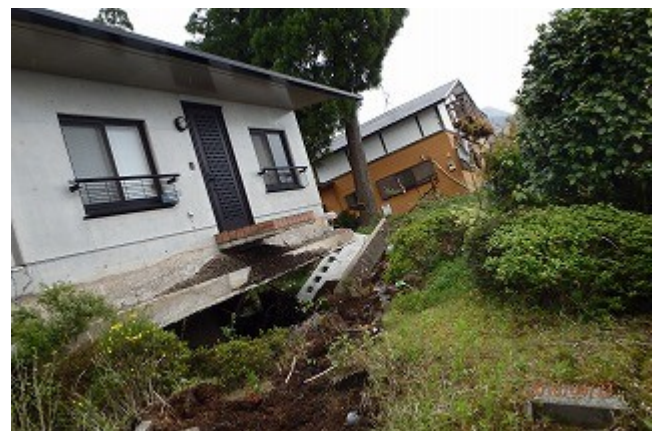
Figure 32 and 33 show damage of the road and house at site 21. Although this area reportedly survived the earthquake on the 14<sup>th</sup> of April, significant distortion of subsurface ground occurred during the main shock on the 16<sup>th</sup> of April. The spatial distribution of damage was severe at the northern part of the residential area. Figure 34 shows a comparison of aerial photos taken in 1975 and in 2016 (GSI, 2016), indicating that the damaged area used to be a paddy field but had subsequently been infilled during the construction of the housing estate. The filled soil in the damaged area is a local volcanic ash soil. Tanoue et al. (2005) reported that it is usually hard to construct a stable embankment from the ash deposited in the Central Kyushu area. It seems from Fig. 34 that the ground level of the northern part of the residential area was comparatively low in 1975, the filled soil might have been thicker for the northern side than the southern side. This might be why the earthquake-induced damage to the land was found to be severe in the northern side, however, structural damage to the residential houses in this area was negligible despite large ground deformation.

Figure 33. Damage to the house in residential area developed by filling (Site 21 in Fig. 26) ( $32^{\circ} 52'45.06''N$ ,  $131^{\circ} 00'1.44''E$ ).
