# Uplift of an Underground Tank in Northern Malabar Region, India

**ABSTRACT:** An underground reinforced concrete tank was constructed for a project in the southwest region of India. The tank was 90 m x 35 m in plan and 7.3 m deep resting on partly filled-up and partly native soil. During the peak monsoon, a sudden uplifting of the base slab by about 300 mm and subsequent failure of the foundation raft and a partition wall was observed. Laboratory testing was executed and hydrogeological survey was carried out using ground penetrating radar, seismic refraction and infiltrometer testing, and an analytical study was carried out to identify the root cause of the tank uplifting. Based on this study, it was observed that the uplifting and structural failure was essentially due to the peculiar land terrain and soil properties and the development of excess hydraulic head below the bottom of the tank. After considering different options, the rectification measures were carried out by provision of dewatering wells along the tank periphery to release the excess hydrostatic pressure and stabilize the foundation raft. The structural repair of the top of the foundation raft and partition wall

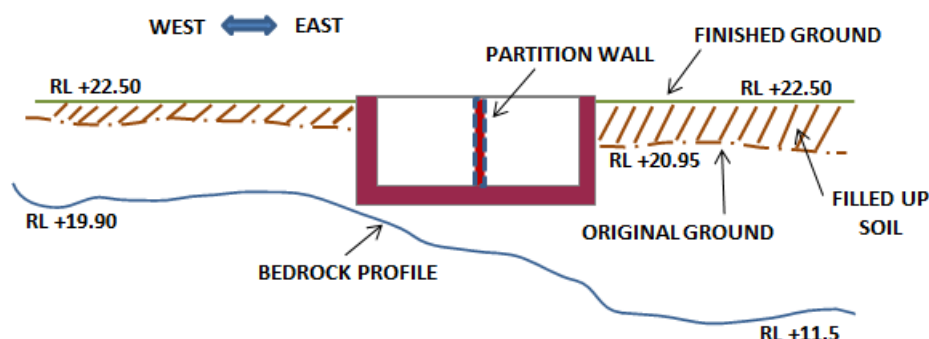
*Figure 1. Topographic features near the tank.*

The overall topography of the project site was sloping from west towards the east. The profile of bedrock was also dipping down from west towards the east as shown with varying reduced levels (RL) in Fig. 1 along with the relative location of the tank.

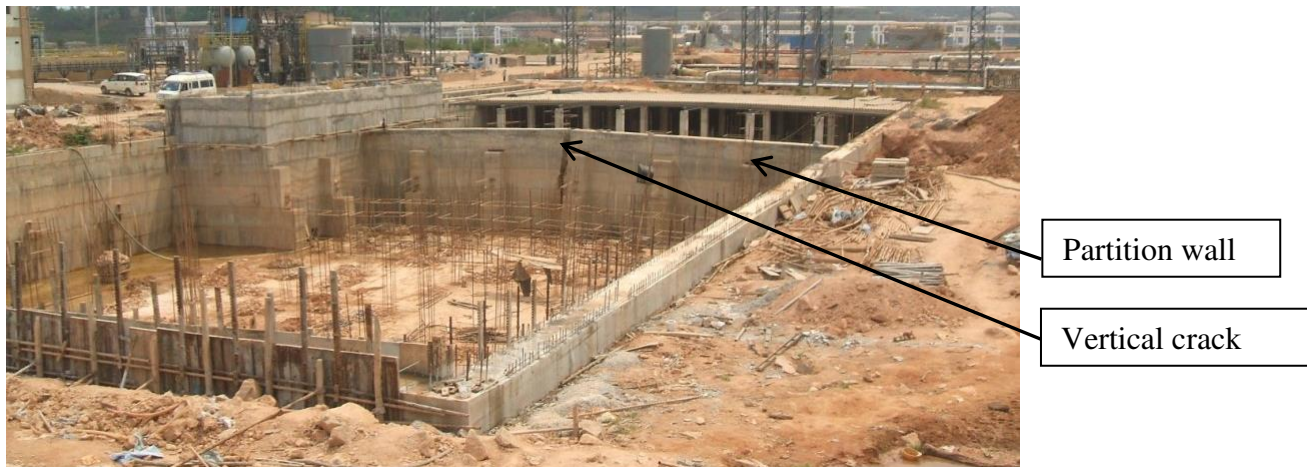
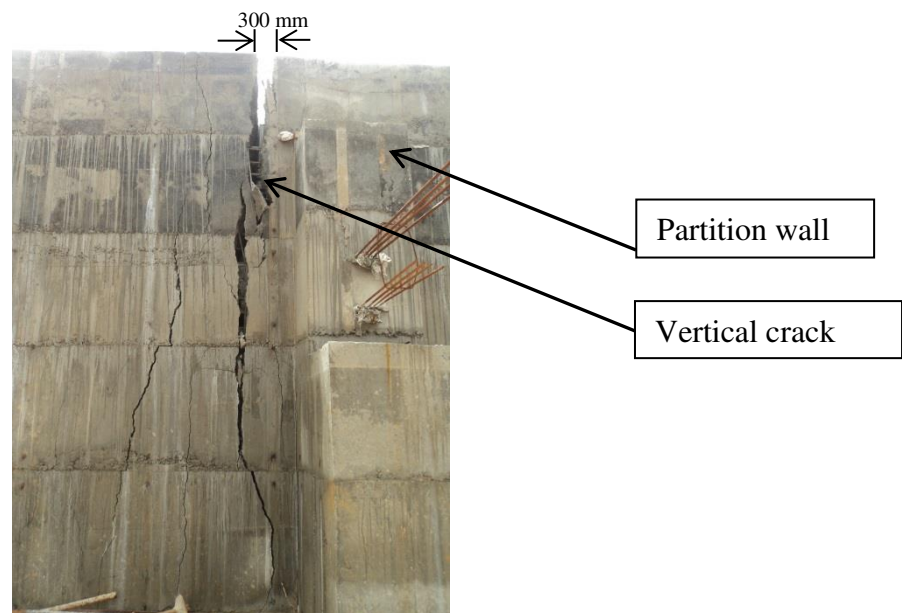
*Figure 2. Uplifting and cracking of tank partition wall.*

In the southern part of India, the monsoon is at its peak in the months of June & July every year. In mid-June of 2013, the foundation raft of the tank suddenly got uplifted by approximately 300 mm at the center. The review of past rainfall data revealed higher rainfall intensity in June 2013 compared to rainfall in the previous three years as shown in Table 2. During the failure of the tank, the 0.9 m thick reinforced cement concrete (RCC) partition wall inside the tank got cracked in tension at the center due to the uplifting and bending of the foundation raft. However, no uplifting was noticed at the four edges of the tank. Thus, the tank took an inverse saucer shape due to the uplifting at the center.

Fig 2 indicates the curved and cracked partition wall due to the tank uplifting. Several other cracks were observed along the height of the partition wall on either side of the middle 300 mm wide crack, with the crack width decreasing away from the center. Based on daily measurements taken on top of the partition wall after the failure, the uplifting of bottom slab and the crack width of partition wall was observed to be increasing at a rate of 30 mm per day. The cracks, which were observed on top of the foundation raft inside the tank, had maximum width of 12 mm. The seepage of groundwater inside the tank was not observed through these cracks. Thus, the depth of cracks was limited only to the top portion and not penetrating the entire thickness of the foundation raft.

As the crack width in the partition wall was increasing at a rate of 30 mm per day, it was necessary to take immediate corrective measures to stop the cracks from further widening. It was therefore suggested to drill boreholes of 200 mm diameter up to 8 m depth (as the depth of tank is 7.3 m) around the tank periphery so as to reduce the water pressure acting on the bottom of foundation raft by allowing the water under pressure to get released through these boreholes. However, due to the heavy rains, the contractor could not position the drilling equipment near the tank to drill the boreholes. Considering the practical delays in carrying out the borehole activity, another suggested option was to fill the tank with water up to approximately 5.5 m height which would generate additional weight within the tank, to counter the upward buoyant force of groundwater. Thus the accumulated water within the surrounding area was diverted inside the tank. As soon as the tank started filling with water, the settlement of the tank started taking place due to the weight of water. It took more than a month to fill the tank with water up to a height of 5.50 m after which the tank was observed to be completely settled to its original position and the crack width in the partition wall was reduced to 25 mm from 300 mm.

The structural rectification of damaged partition wall was carried out by demolishing the damaged portion, providing new reinforcement, applying epoxy bonding coating on old concrete and reconstructing the demolished portion of the wall.

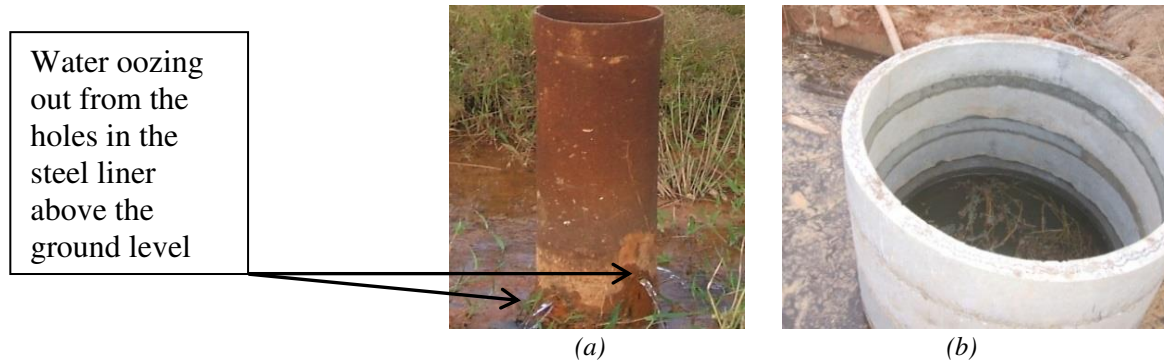
Figure 3. Groundwater level in (a) borehole with steel liner and (b) ring well

In the meantime, when the tank filling was ongoing and the rainfall intensity reduced, the boreholes with steel liner were drilled along the tank periphery and a 1.2 m diameter and 4 m deep ring well was also dug near the tank. The groundwater was observed to be coming out from the perforations in steel liner above the ground level due to high hydraulic head (Fig. 3a). The water level in an open well was also observed to be at the ground level (Fig. 3b).

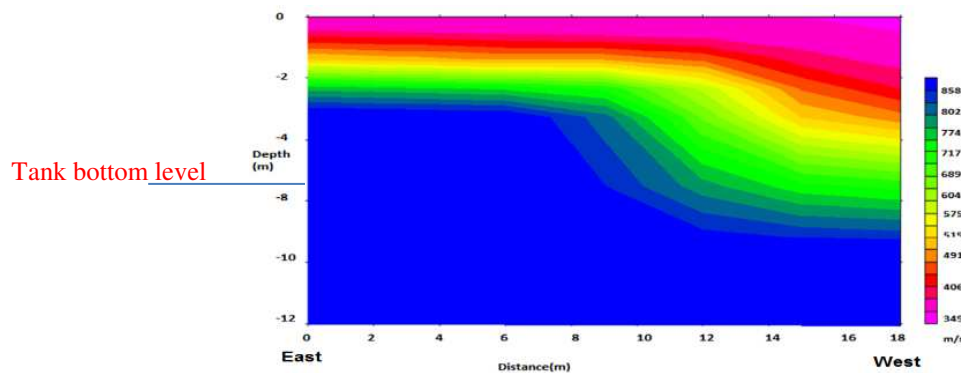
Figure 6. The soil strata profile obtained from SR2 data conducted on the south side of the tank near the closed water well (see Fig. 5 for survey location with respect to the tank).

The seismic refraction survey data was used to classify the soil using correlations between typical velocities, type of formations and the density as suggested by Bourbie et al. (1987). Based on this classification, the top layer consists of clayey soil, which is moderately compacted up to a depth of 1.5 m with P-wave velocity of 349 m/s. It is followed by a layer of clay and gravel with a thickness of 1.5 m, having a velocity range from 377 m/s to 482 m/s and a layer of sandy silt strata up to 10 m with a thickness of about 7.5 m and a seismic velocity range from 491 m/s to 858 m/s, as shown in Fig. 6.

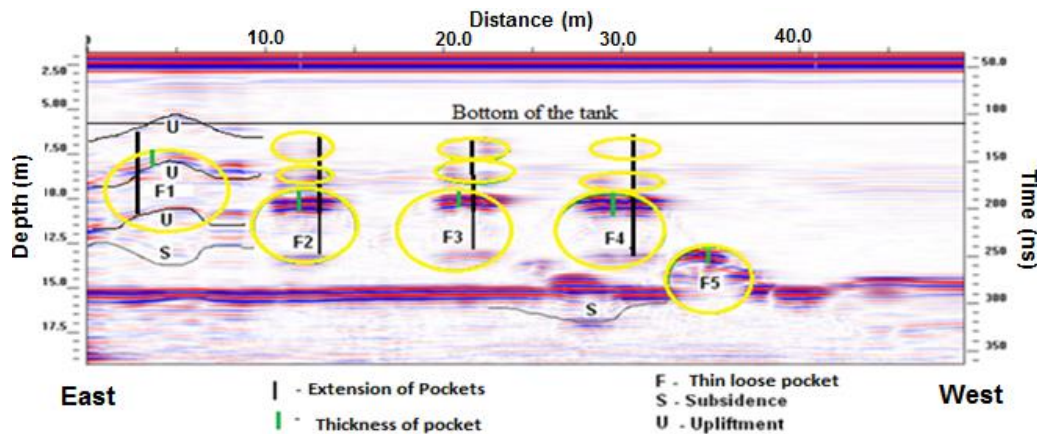
Figure 7. GPR3 profile collected using a 200 MHz antenna inside the tank along East - West direction by placing antenna inside the floating body.

A phase inversion occurred at the concrete and void interface as indicated by a negative amplitude preceding a positive amplitude (see Fig. 8, 9 and 10). The amplitude of the GPR data is represented by red, blue and white colors. Red coloured areas represent a positive reflection and blue coloured areas represent a negative reflection while white areas represent distinct reflected areas, typically indicative of a dielectric uniformity within a given medium.

Loose pockets in the substrata were observed along the East-West direction beneath the tank bottom. The horizontal length of loose pockets below the bottom of the tank (F1 to F5) are observed to be varying between 0.5 m to 5.5 m at different locations. (see Fig. 7). The vertical thicknesses of the loose pockets are approximately 0.5 m each.
