# Lessons Learned from Dike Failures in Recent Decades

**ABSTRACT:** *The paper describes five different dike failures that occurred in recent decades. The case histories were located on different rivers and involved different loading conditions. The observed failure mechanisms involved erosion and stability problems. The types of erosion observed were both internal erosion due to extreme groundwater flow and external erosion caused by the river flow and wave action. The case involving instability was caused by uplift, i.e., increased hydraulic head led to a sharp reduction in maximum shear strength between subsoil layers. Two cases demonstrate the importance of dike management and maintenance. Despite the variations in the loading conditions and failure mechanisms, all the cases show that the strength of a dike depends not only on the material used to build the dike but also on the strength of the subsoil.*

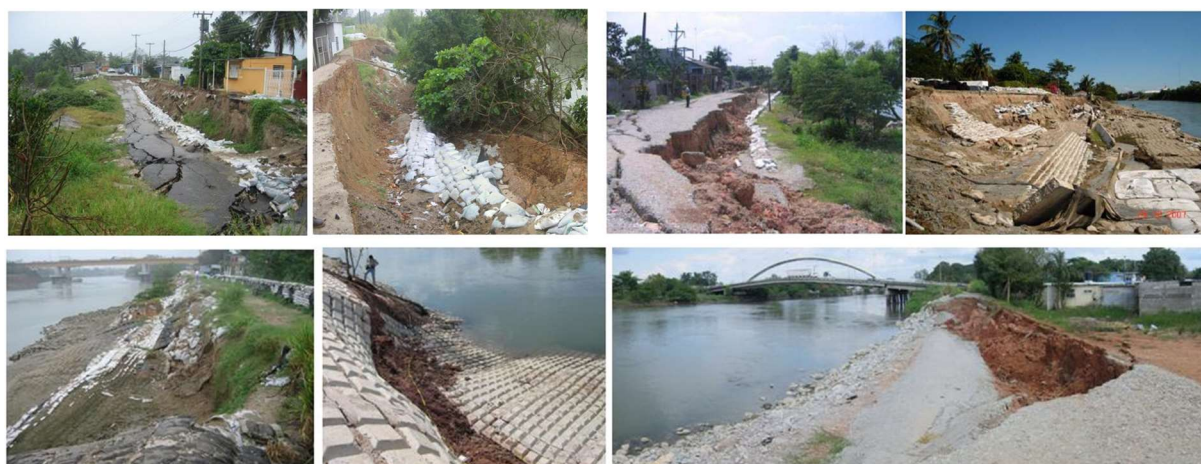
gradients generated by these fluctuations – and rain infiltration in the crests of the dikes (Figure 3). Auvinet et al. (2008) observed that problems in river banks commonly begin with erosion which, depending on the type of soil, can cause piping in some areas, possibly resulting in landslides (Figure 4). These eroded sections are generally protected with dikes consisting of clayey material. Elements that can better withstand erosion by river water are also used, examples being rock fill, systems with concrete bags (*bolsacreto* or *colchacreto*), breakwaters or sheet pile walls. River embankments may also fail when the weight of these structures exceeds the bearing capacity of the foundation soil (Figure 3). Generally, failure occurs in layers with low shear strength such as the highly compressible clays and peats which are found in unpredictable locations along the banks of the rivers in Villahermosa (Figure 1). It has also been found that factors such as scour of the riverbed and overloading caused by the weight of additional protection such as sand bags result in dike instability. In addition, intense rainfall in the region can cause large and rapid variations in the levels of local rivers, lagoons and reservoirs.

Figure 3. Consequences of water drawdown in Tabasco State, Mexico

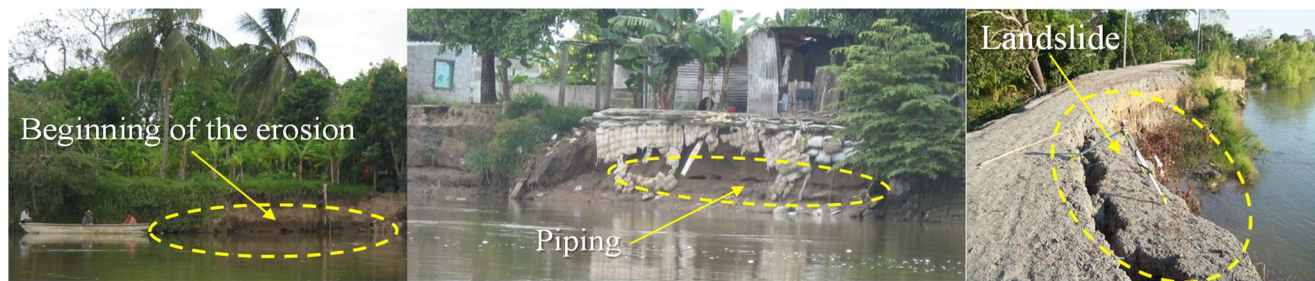
Figure 4. Evidence of instability in river banks and dikes induced by rapid drawdown in Villahermosa.

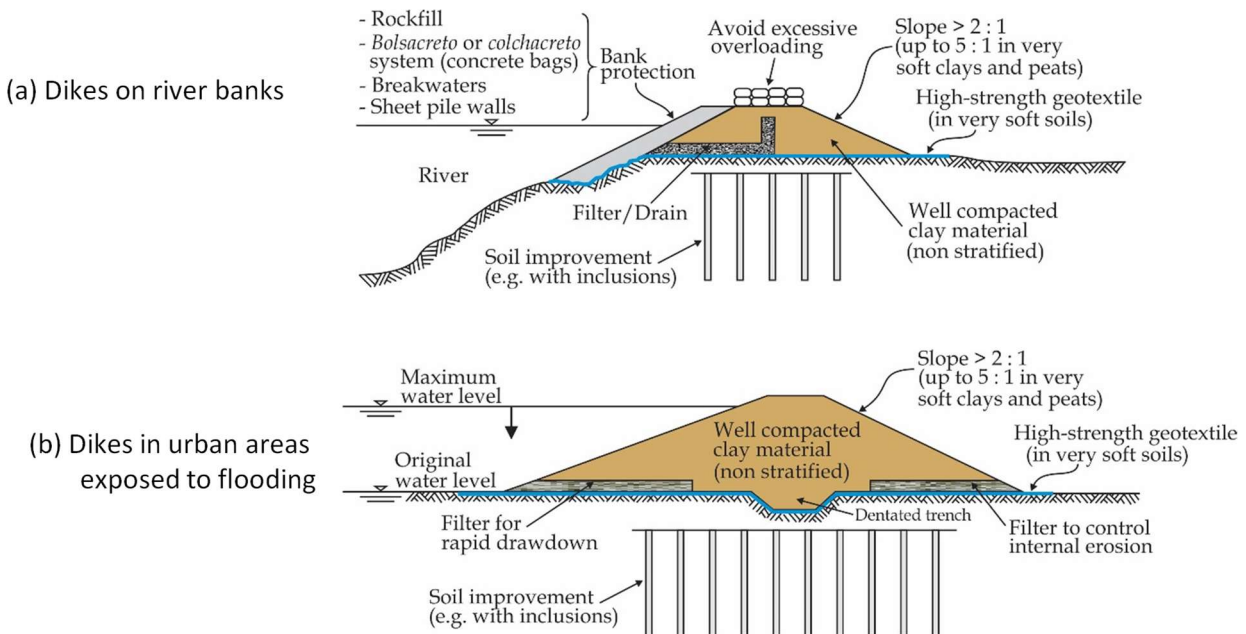
This study focused on one of the main problems affecting the stability of Tabasco dikes: the water drawdown phenomenon caused by sudden changes in the levels of rivers, lagoons and reservoirs. Particular emphasis was placed on the study of exit hydraulic gradients at the toe of homogeneous and isotropic dikes. The effects of different parameters (drawdown rate, hydraulic conductivity and slope ratio) for the dikes were assessed in unsaturated, transient-state, flow analyses based on numerical modelling with the finite element method. Based on the results, it is concluded that analyses should consider the susceptibility to erosion of the material used to build the dike. However, analyses should also include measures – such as the installation of drains and filters – to reduce the hydraulic gradients and seepage forces generated inside the soil mass. The results of the analysis led to the practical recommendations shown in Figure 10, which should be taken into consideration for the protection of the Tabasco dikes.

Figure 10. General recommendations to protect Tabasco dikes

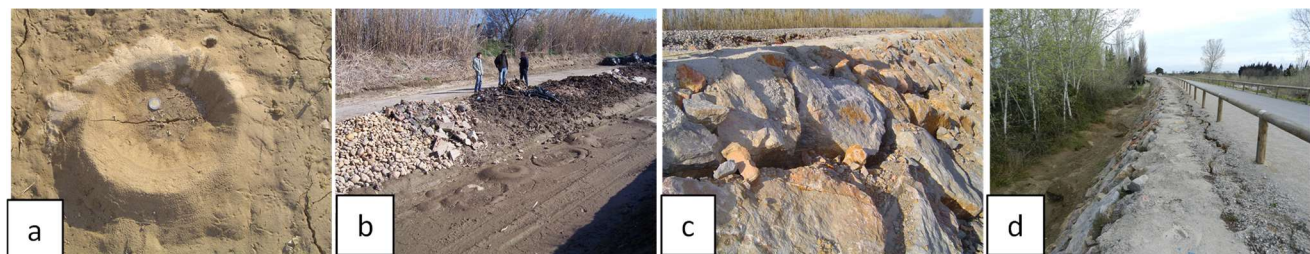
This was also a moderate event: about 800 m<sup>3</sup>/s at Rivesaltes. However, it lasted longer: 18 hours rather than the 12 hours in the November 2005 event. The dikes were loaded up to 1/2 to 2/3 of their height. CEMAGREF quickly conducted an inspection of a section of 500 m which had been identified in 1999 as being prone to sand boils. A recommendation had been made to install a drainage and seepage system on the landward side. Some of this work had been completed in 2000 with supervision from the managing authority at the time (an association of local authorities). During the winter of 2004-2005, the landward side of the dike was reinforced with concreted riprap to render it resilient to overtopping. During the 2006 event, a section of 130 m in the same location suffered damage caused by internal erosion in the form of sand boils (Figures 13a, b) and subsidence over a strip of up to 1-2 m wide in the protected plain close to the dike, including the maintenance track, and cracking of the concreted riprap (Figures 13c, d).

Figure 13. a) Sand boil (photo: Pierre Philippe, CEMAGREF), b) Multiple sand boils close to the maintenance track on the landward side of the dike (photo: Patrice Mériaux, CEMAGREF), c) Damage to the dike itself: cracks on the crest and in the riprap landside revetment (photo: Pierre Philippe, CEMAGREF), d) Damage to the dike itself: crack on the crest; this picture was taken in 2013 but similar damage occurred in 2006 (photo: Patrice Mériaux, Irstea).

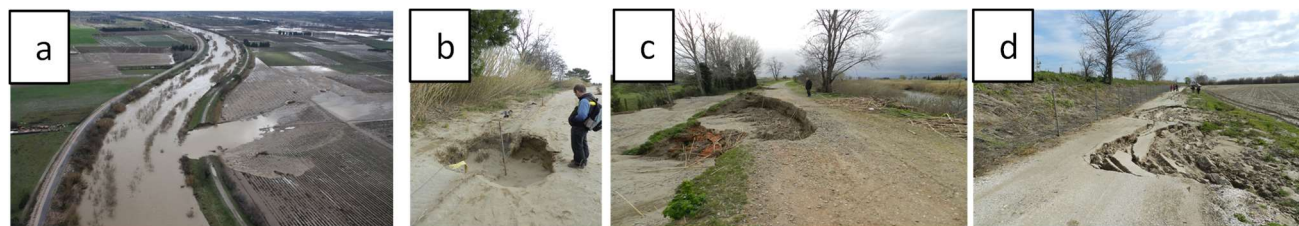
The discharge during this event is also estimated to have been approximately 1000 m<sup>3</sup>/s. There was a breach over a 75-m section in one of the areas prone to sand boils (Figure 14a). The dike itself was eroded, as well as its foundations down to the depth of the minor river bed. The exact cause of the breach is not known because there were no eyewitnesses close to the dike at the time of the breach initiation about 2 hours after the maximum discharge. The breach may have been caused by internal erosion in the dike or the foundation soils, with possible local overtopping following internal erosion and collapse. A large sinkhole was found close to the breach (Figure 14b). Significant additional damage was observed as a result of overflowing (Figure 14c), internal erosion and foundation instability (Figure 14d), as well as internal erosion in the dike itself at one location.

Figure 14. a) The March 2013 breach at the Pia location on the right of the river (photo: DREAL Languedoc-Roussillon), b) A sinkhole close to the breach (photo: Patrice Mériaux, Irstea), c) Damage caused by overflowing (photo: Patrice Mériaux, Irstea), d) Damage to a track on the landward side of the dike caused by under-seepage (photo: Patrice Mériaux, Irstea)

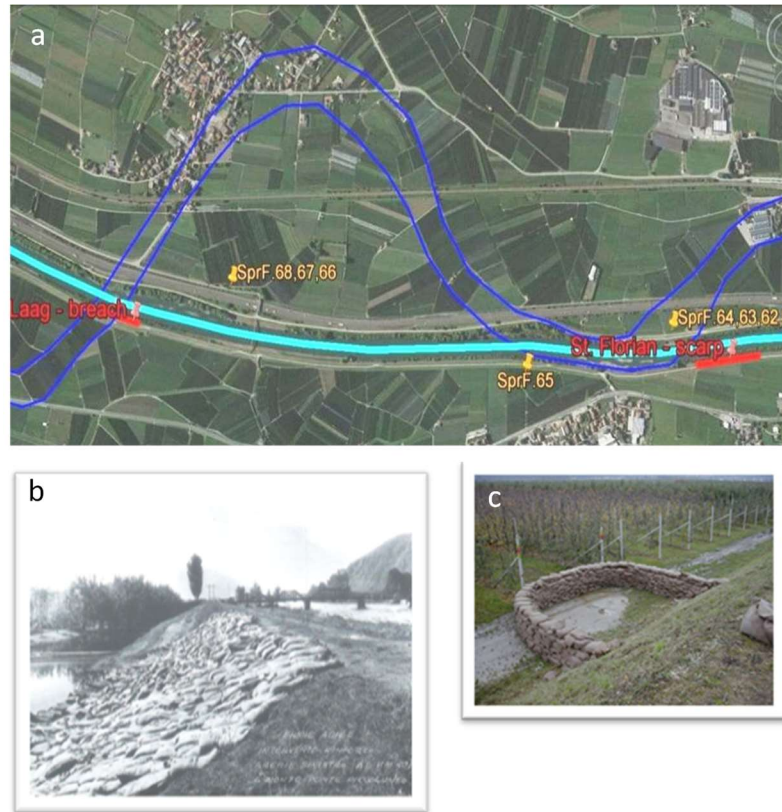
Evidence of water flowing through or underneath the embankment is provided in Figure 18b, c. Ponded backwater often accumulates during a flood event and springs form at the toe of the embankment on the landward side.

The original riverbed meandered through the Adige valley and was straightened at the end of the 19<sup>th</sup> century, as shown in Figure 18a, by constructing the current embankments. The ancient river bed is filled with material that is coarser than the surrounding clayey and silty deposits. At some places the current riverbed intersects the ancient river beds and locally the embankments are founded on the coarse-grained filling. As a result, the hydraulic conductivity of the embankment foundation at these intersections is relatively high and groundwater flows preferentially through these layers.

Figure 18. (a) Current and ancient river bed profiles and spring formation during the flood events in 1997 and 2000 (b) Backwater areas during the 1966 flood (c) Spring formation during the 1997 flood event

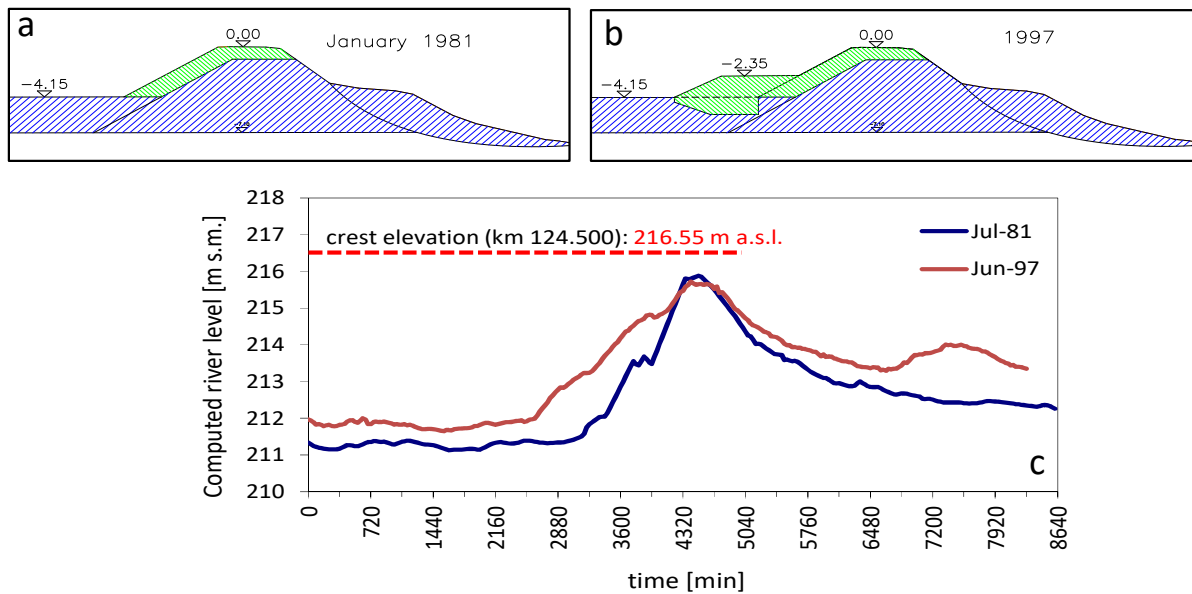
During the flood event in 1997, which was even more intense than the one in 1981 (Figure 19c) no collapse phenomena were observed in the segments that had experienced instability in 1981. This can be attributed to the construction of the berm and the increased stability on the landward side.

Figure 19. a) cross section during the flood event in 1981 b) remedial works consisting of a berm on the landward side, c) the river level during the flood events in 1981 and 1997 The elevation of the embankment crest is also reported as a reference.

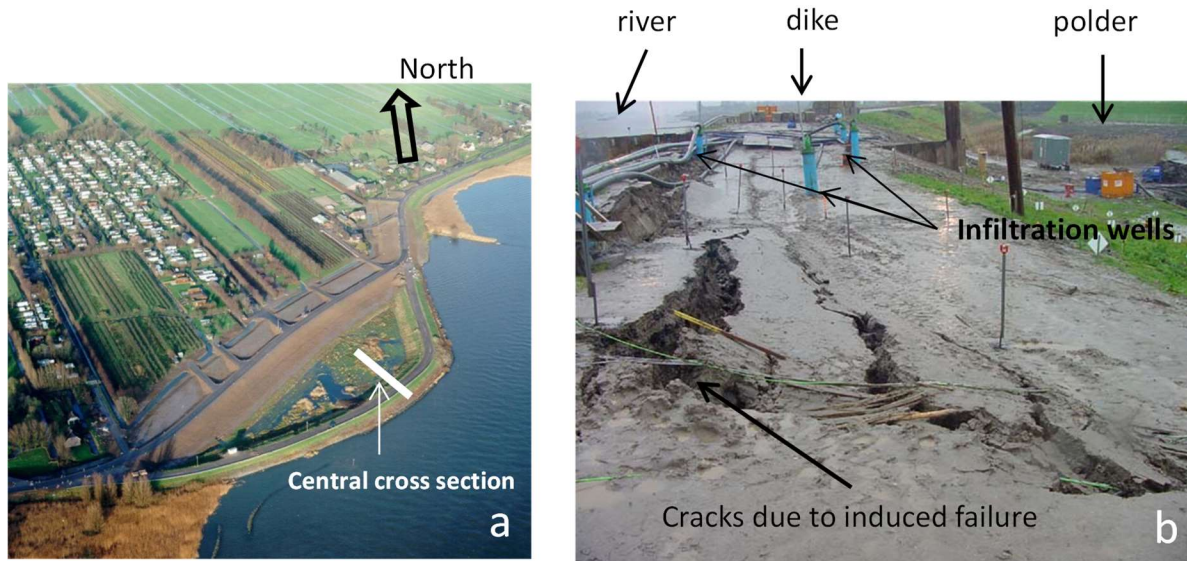
Figure 27. Test site, a; aerial photograph before testing, arrow indicates North direction, white line indicates the location of the central cross section shown by Figure 29, b; failed dike body after testing

The test began at 06.00 on 26 November 2000,  $t = 0$  in the graphs below. Figure 32 shows the river level and the average head in the nine infiltration wells. Infiltration started at  $t = 370$  min, 6 hours after the start of the test. Initially, the hydraulic head in the wells followed the fluctuations in the river level. It should be noted that the test site is close to the sea and that the tidal wave has a pronounced influence on the water level in front of the dike. Although drinking water was used for infiltration, the infiltration wells clogged up after 26 hours,  $t = 1580$  min, reducing well capacity. Due to maintenance, required to regain the full pumping capacity, the hydraulic head was seen to fall between  $t = 1580$  and 2260 min, a period of 11.3 hours (Figure 32). Maintenance was also needed between  $t = 3090$  and 3308 min, a period of 3.6 hours. Failure was observed at  $t = 3450$  min, approximately 2.5 days after the start of the test, in the form of large longitudinal cracks in the dike body accompanied by major subsoil deformation (see Figures 33 and 34). The difference in height at the location of the cracks increased to more than 1.0 m (Figure 27b).

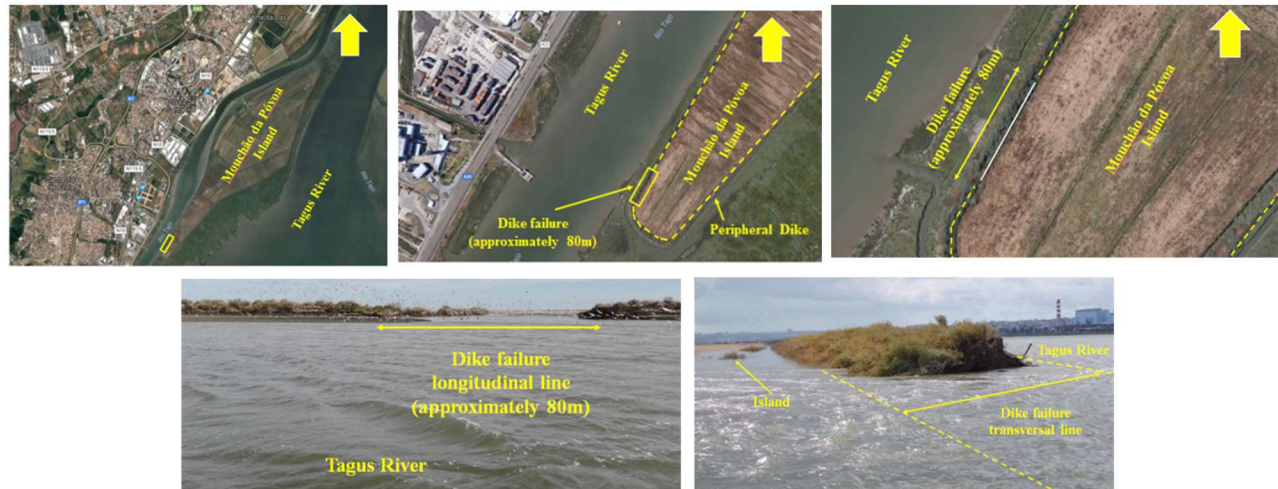
on an alluvium layer protected on the outer face by riprap (rock armour) revetment. The island has been used for agriculture for at least the last 80 years. Figure 38 provides views of the failure that occurred on March 2016.

Figure 38. Location and view of the dike failure.

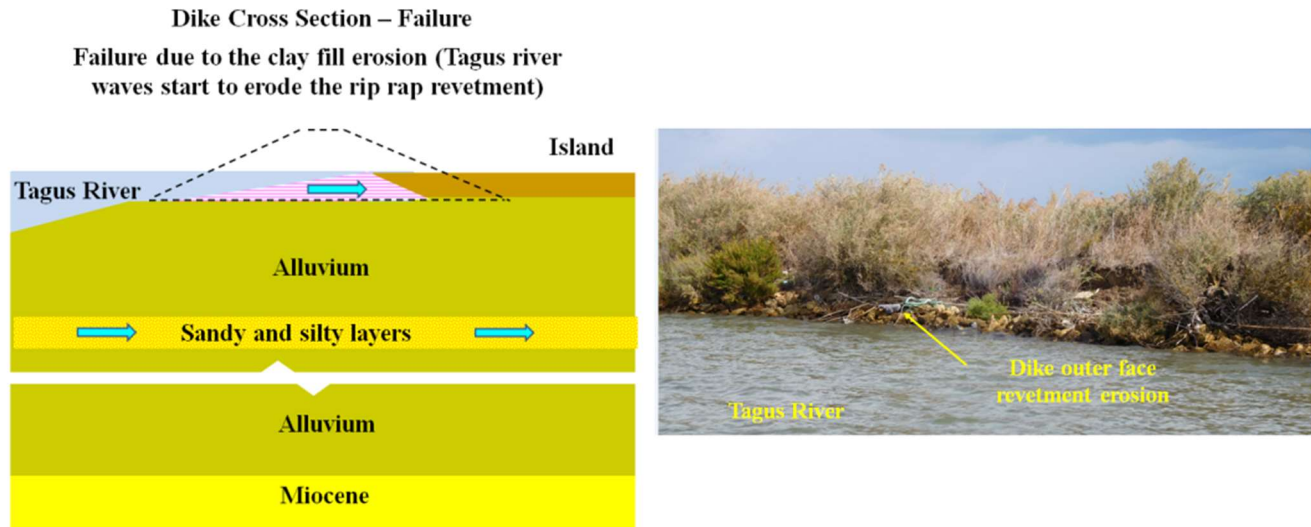
The main failure mechanism is related to the erosion of the clay fill due to water inflow and the mechanical action of the waves on the outer face of the dike. Failure originated with the erosion of the riprap revetment (Figure 39). The presence of a permeable sandy layer below the dike foundations also contributed to the failure mechanism. The actual dike failure began during the severe winter of 2015 - 2016 and involved a section with an overall length of approximately 30 m. When the failure occurred, the water level in the Tagus River was approximately Mean Sea Level, MSL, +4.20 m. In October 2016, the overall length of the dike failure line had increased to approximately 80 m.

Figure 40. Dike failure due to the erosion of the clay fill, cross-section and view of the outer face.

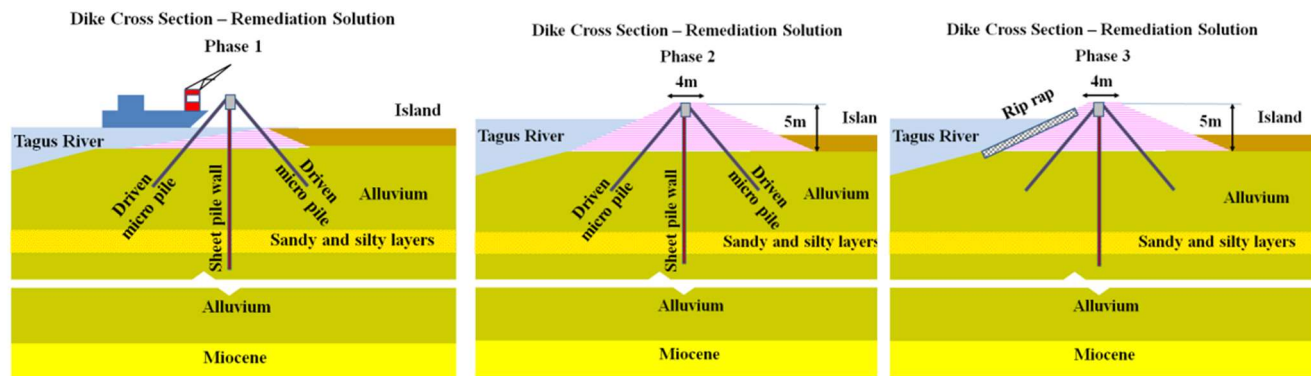
Figure 41. Dike remediation: main construction phases.

The proposed dike remediation solutions comprised the use of a driven sheet-pile wall braced by inclined driven steel micro-piles, all capped with a top and a central, reinforced, concrete beam. Those works are to be performed from a barge at high tide. The depth of the sheet pile walls will have to be enough to pass through the silty and sandy alluvial layers. A protection and stabilisation fill will be required on both the outer and inner sides of the sheet piling. On the outer face of the fill, a riprap protection revetment will be required to protect the fill from hydraulic erosion. Figure 41 illustrates the reconstruction works.
