# Geotechnical Observations of Dams Failed During the 2015 Historic Flooding in South Carolina

**ABSTRACT:** *This paper presents a description of post-flood reconnaissance and geotechnical investigation of four earthen dams that were breached or damaged following an extreme flooding event in South Carolina in 2015. As a result of unprecedented rainfall and flooding that occurred during a five-day period at the beginning of October in 2015, a total of 51 earthen dams failed and nearly 200 were damaged. Many of these dams failed due to overtopping that led to a breach of the dam. Among the four dams investigated, full breach was observed at three dams; two of which were overtopped, and one was not. The fourth dam was not breached but was severely damaged. For each of these dams, the paper documents background information, pre-flood conditions, post-flood field observations and measurements, and laboratory testing results of collected soil samples. Impacts of vegetation on the dams and the effects of dam failure on critical infrastructure are also presented. The detailed descriptions and geotechnical investigations of the dam failures presented herein serve as case histories that ca

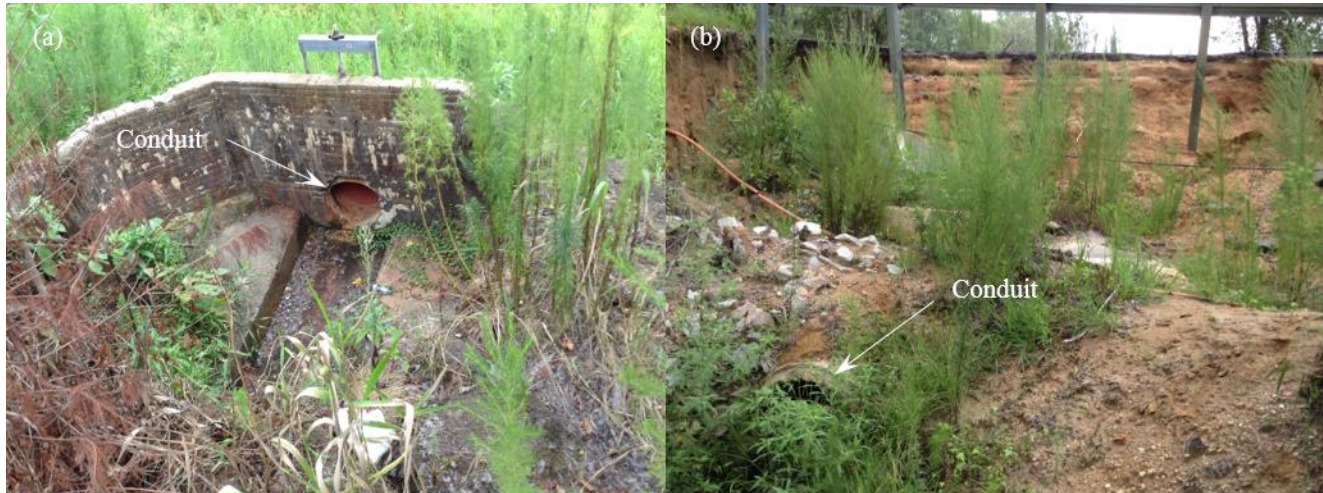
*Figure 4. Spillway structure for Dam A: (a) conduit on upstream side (north view from SR-40-67), and (b) conduit and washed out soil above on downstream side (north view from downstream).*
