## Geotechnical Effects of Hurricane Harvey in the Houston, Beaumont, and Port Arthur Areas

**ABSTRACT:** The Geotechnical Extreme Events Reconnaissance (GEER) Association deployed multiple teams of engineers from academia and practicing firms to the coast of Texas in late August and early September 2017 following Hurricane Harvey. This report summarizes the observations and data from the GEER team that focused primarily on the inland effects of Hurricane Harvey in the Houston area with some observations in the Port Arthur / Beaumont area east of Houston. Rain, not storm surge or wind, caused the observed damage in Houston, Beaumont, and Port Arthur by overwhelming stormwater management facilities and creating high flows and flooding in and near area waterways. The major Houston-area flood structures, Addicks and Barker Dams, performed well from a geotechnical perspective. Observed damages included shallow slides along levees, severe erosion along riverways, isolated road and culvert erosion and uplift, and area-wide flood effects in low and poorly drained neighborhoods.

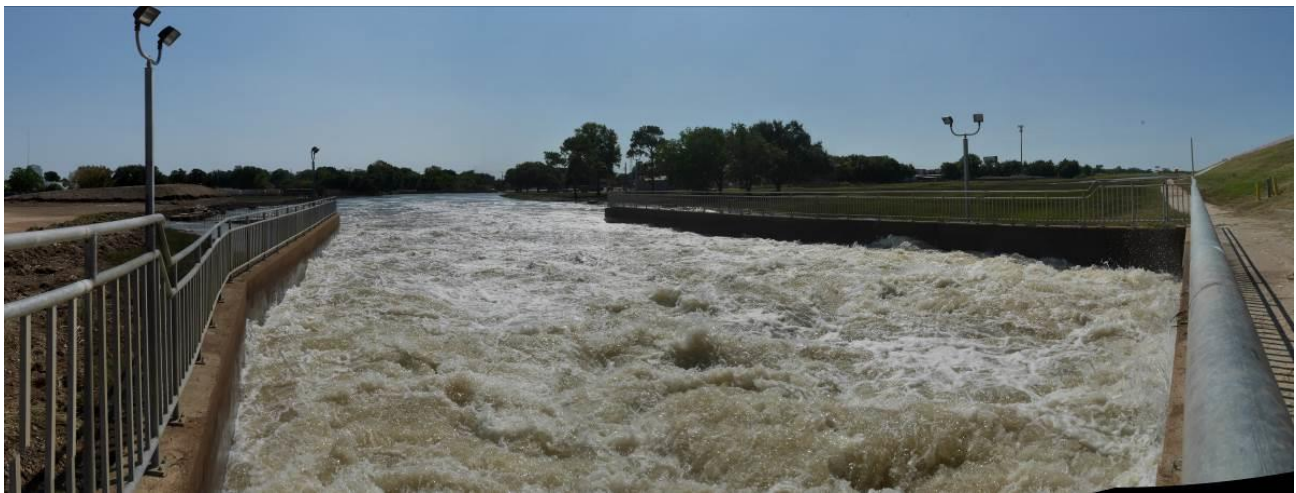
*Figure 6. Barker outlet releasing  $\sim 110 \text{ m}^3/\text{s}$  ( $\sim 4000 \text{ cfs}$ ) (September 9, 2017,  $29.76977^\circ \text{ N}$ ,  $95.64629^\circ \text{ W}$ ).*

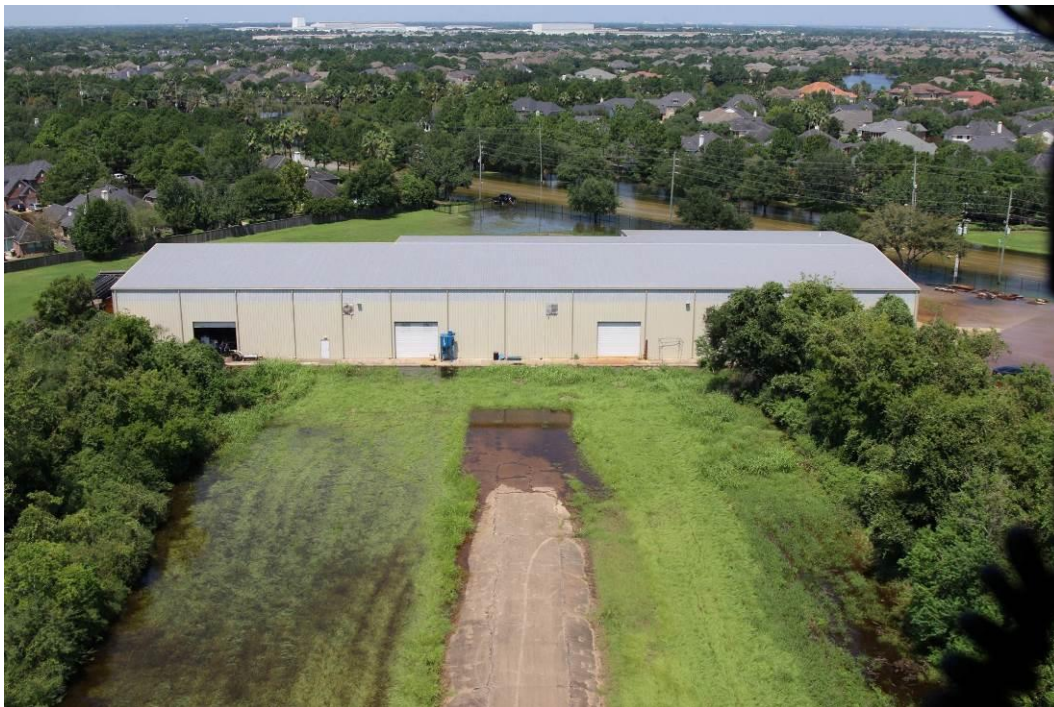
High water in the Addicks Reservoir (~33.3 m [~El. 109.1 ft]) exceeded the elevation of the level ground at the end of the north auxiliary spillway RCC (~El. 108), resulting in small outflows (~6 m<sup>3</sup>/s [~200 cfs]) that began on August 29, 2017. Figure 8 shows this area on September 7, 2017 when some small spillage was still taking place. These outflows were within the design intent of the dam and the auxiliary spillway, and should not be described as dam overtopping. Overtopping implies that the water levels have risen above the main dam, which is typically a serious condition that can lead to rapid erosion of the dam and a dam failure.

*Figure 8. North end of Addicks auxiliary spillway (September 3, 2017, 29.84977° N, 95.58904° W, photo by USACE).*

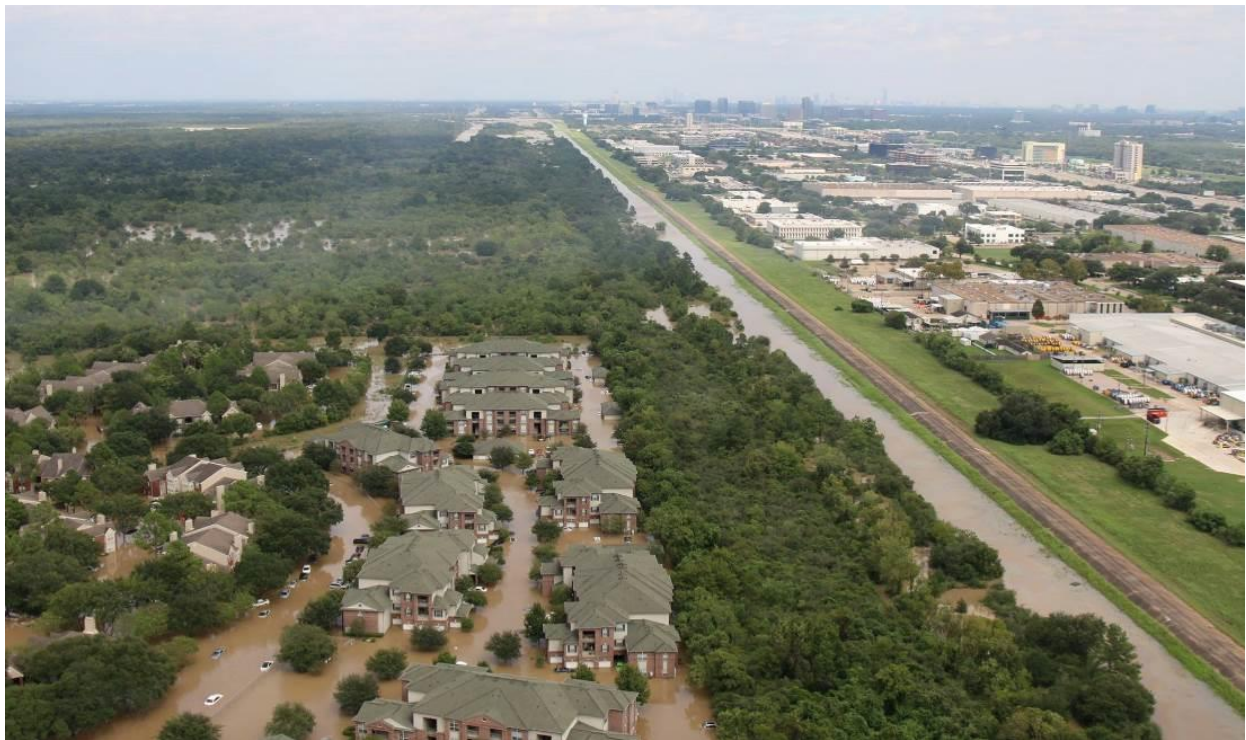
The high-water levels in the Addicks (El. 33.3 m [El. 109.1 ft]) and Barker (El. 31.0 m [El. 101.6 ft]) Reservoirs exceeded not only the April 2016 historic high levels (El. 31.3 m [102.7 ft] at Addicks and El. 29.0 m [95.24 ft] at Barker) but also the elevations at the upstream edge of the USACE property. As noted previously, housing developments extended up to these boundaries and, consequently, were flooded during Harvey (see Figs. 9, 10, and 11). Area subsidence likely contributed to

*Figure 9. Aerial photograph of flooding within the Addicks Reservoir along the south auxiliary spillway (September 3, 2017, 29.79222° N, 95.68830° W, USACE photograph).*

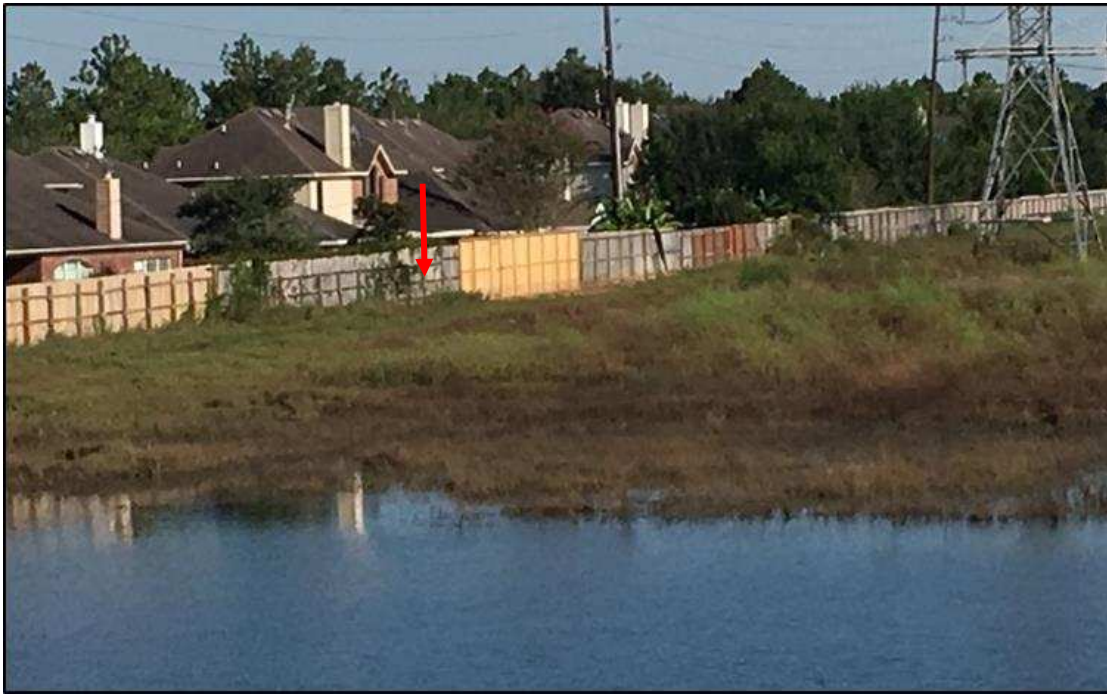
*Figure 11. High water mark on fences surrounding residential area (September 9, 2017, 29.70706° N, 95.72835° W).*

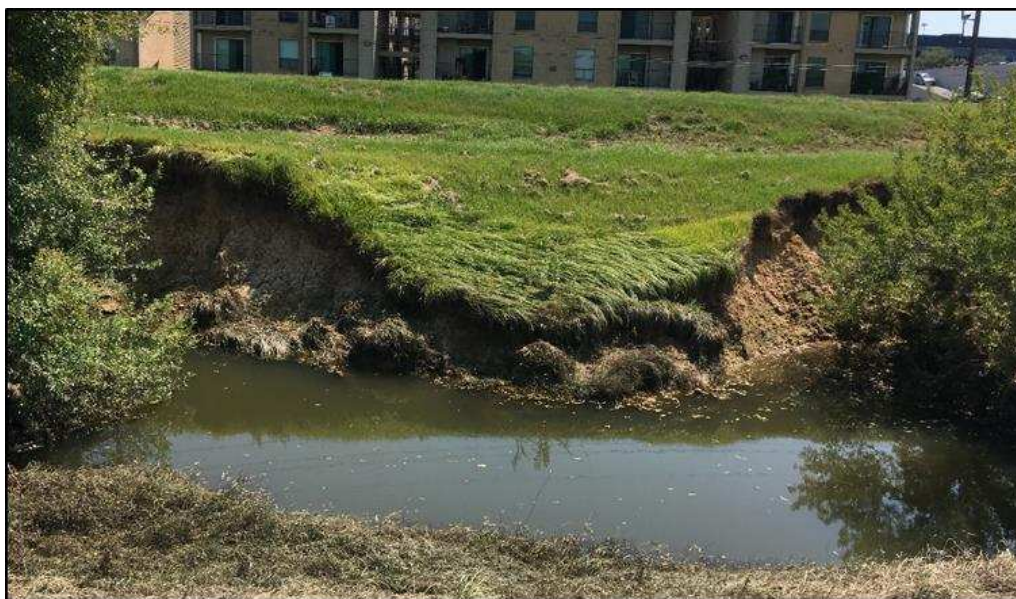
Nearby runoff that is not captured by the dams is managed in drainage ditches or creeks immediately adjacent to the dams' downstream toes. These drainage channels, along with numerous other stormwater / flood management features, are managed by the Harris County Flood Control District. The team observed several slope failures that will require repairs along Turkey Creek near the southeast corner of Addicks Dam (see Figure 12). Contributing factors to the sloughs could have included the steepness of the banks, flow forces acting on trees on the banks or diverted by trees in the waterway, undercutting by flood flows, reduced shear strength in the clay soils, and the drawdown of the creek water level.

*Figure 12. Slope failures along Turkey Creek drainage ditch (September 9, 2017, 29.79009° N, 95.59639° W).*

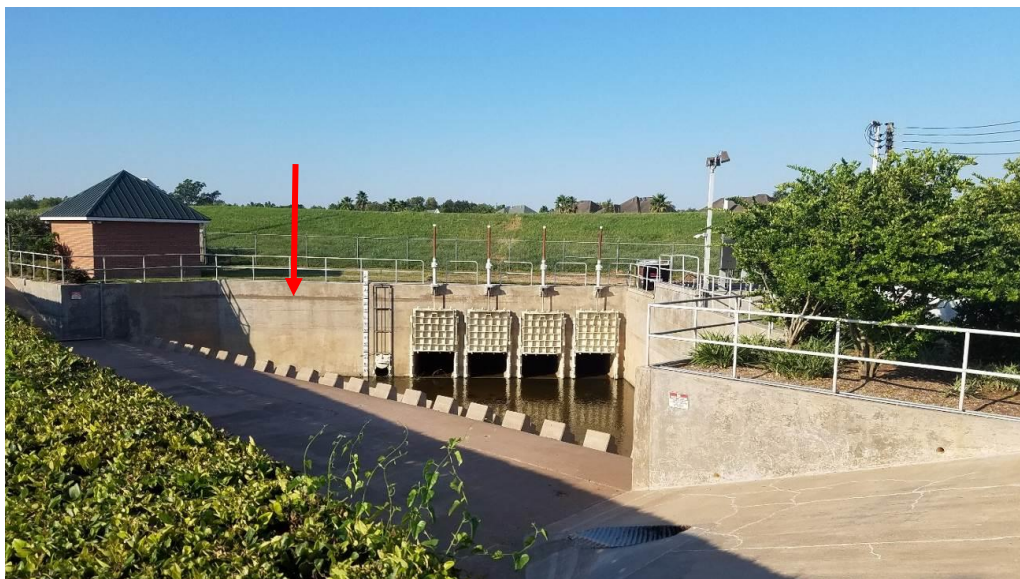
Figure 15. FCLID2 drainage outfall / pumping station basin, showing four 1.4 m (60 inch) flood gates, high water line at ~19.8 m (65 ft) gauge height, levee in background (September 10, 2017, 29.55509° N, 95.61779° W).

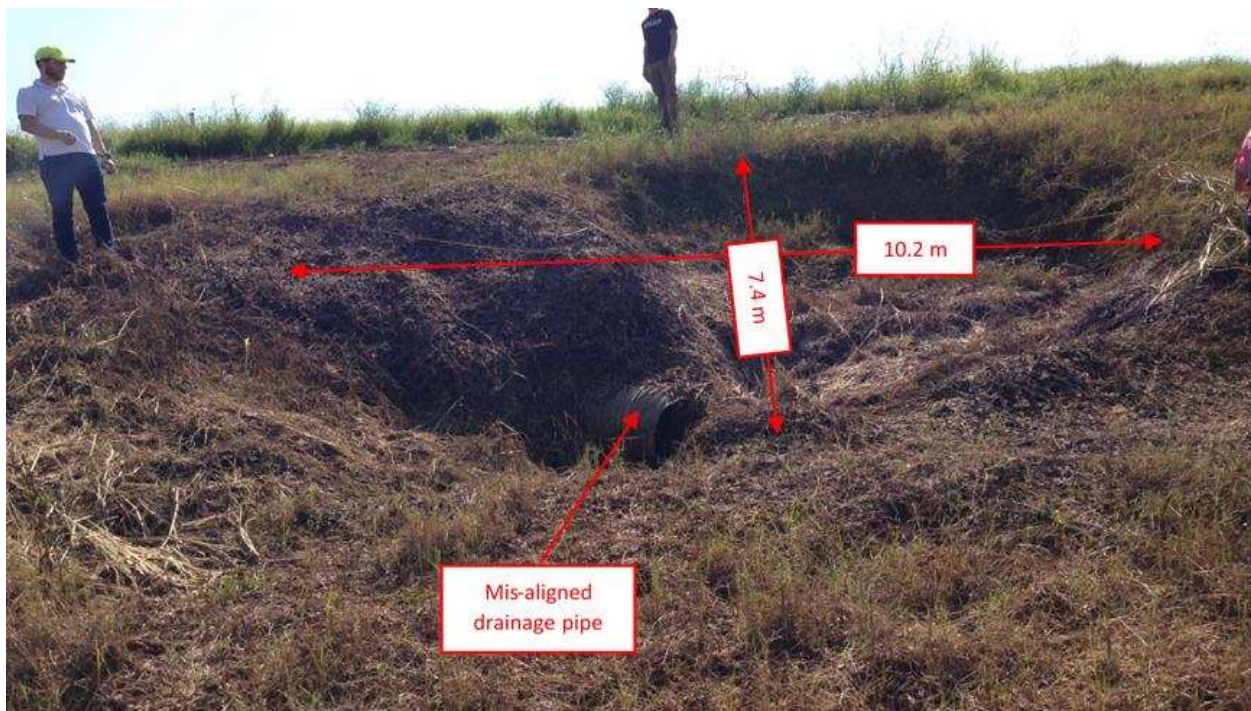
Figure 19. Sour hole at ruptured drainage pipe on Ditch H levee (September 10, 2017, 29.55759°N, 95.63768°W).

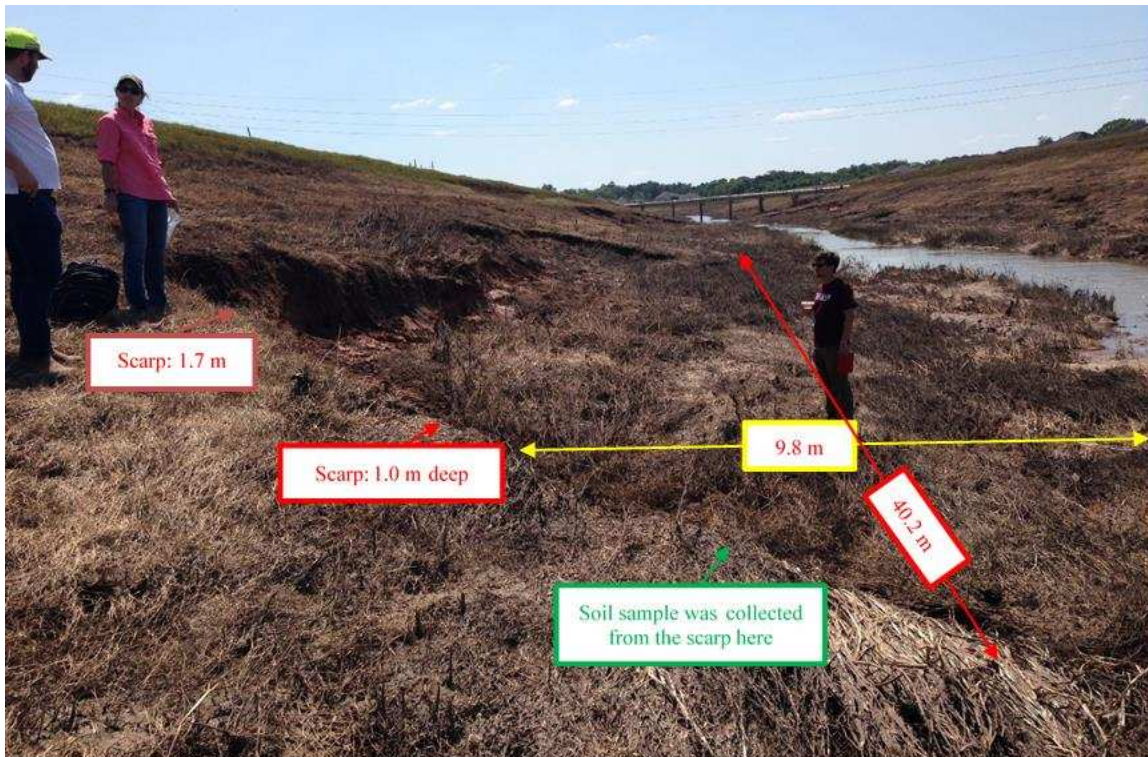
The team observed numerous slope failures along the Flat Bank Diversion Channel (see Fig. 13 for location) between 29.53103° N, 95.56200° W and 29.52572° N, 95.56201° W. Fig. 21 shows the dimensions of one large slide where the team collected a soil sample that was subsequently classified at the Kansas State University laboratory as low plasticity clay (CL) with a 21.3% moisture content. The team noted a drainage CMP outfall on an intact portion of the slope adjacent to this slide and another slide to the south. Figure 22 shows another embankment slough that extended into the base channel.

Figure 21. Slope failure north of damaged drainage pipe on the east side of ditch (September 10, 2017, 29.52647°N 95.56194°W),

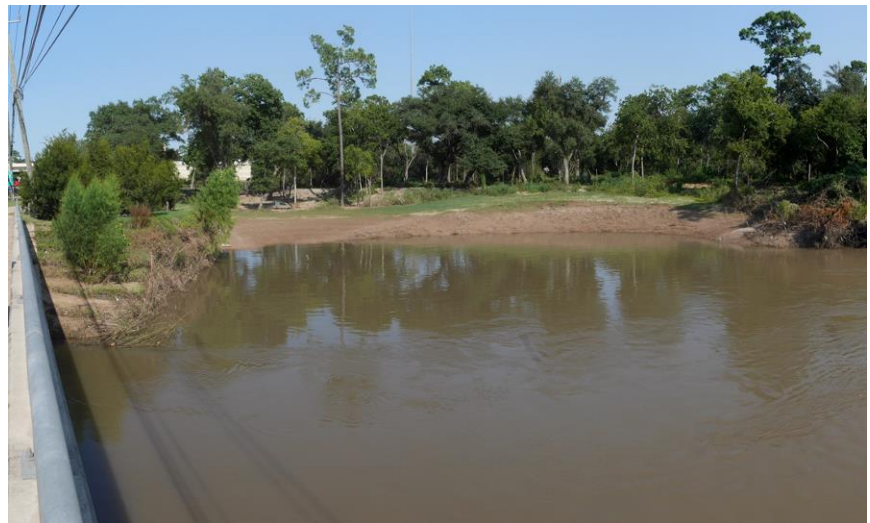
Upon arrival of the GEER team at sites along Buffalo Bayou on September 9, 2017, the observed flows in the bayou were about  $210 \text{ m}^3/\text{s}$  (7,300 cfs) at the USGS Addicks gauge. Flooding of residential areas had been largely reduced by September 9, though much of the former parks and trails along the bayou were still inundated with water. Signs of the previous flooding could be seen with river debris noted on bridge girder and railings (see Fig. 24). No critical geotechnical failures were noted along the observed portions of Buffalo Bayou, but scour areas and a slope failure were observed (see Figs. 25 and 26).

*Figure 25. Buffalo Bayou evidence of scour a) Bridge abutment, and b) Downstream of Woodway Drive Bridge (September 9, 2017, 29.76457° N 95.45815° W).*

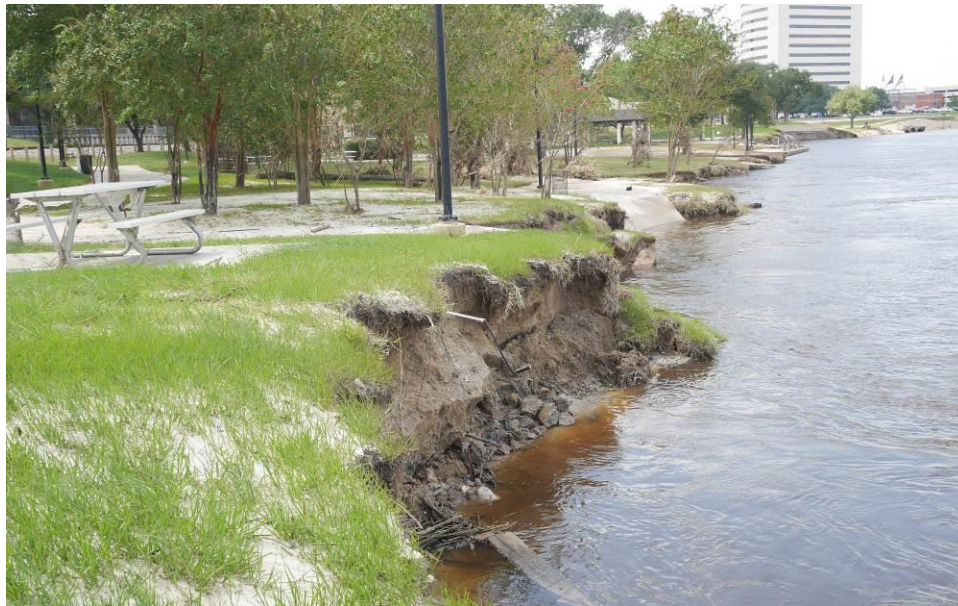
Figs. 29 and 30 show the loss of shoreline and scarps left by the Neches River erosion of the park shoreline, starting from an upstream section protected by riprap and extending through the downriver port area. The pre-hurricane park area shoreline was fronted with a riverwalk/dock (see aerial on Fig. 28), which was largely washed out. Based on pre-hurricane aerials on Google Earth, the shoreline had eroded up to about 15 m (50 ft) from the previous shoreline.

*Figure 30. Downstream end of park. Scarp is estimated to be about 10.7 m (35 ft) back from previous shoreline (September 11, 2017, 30.08184° N, 94.09278° W).*

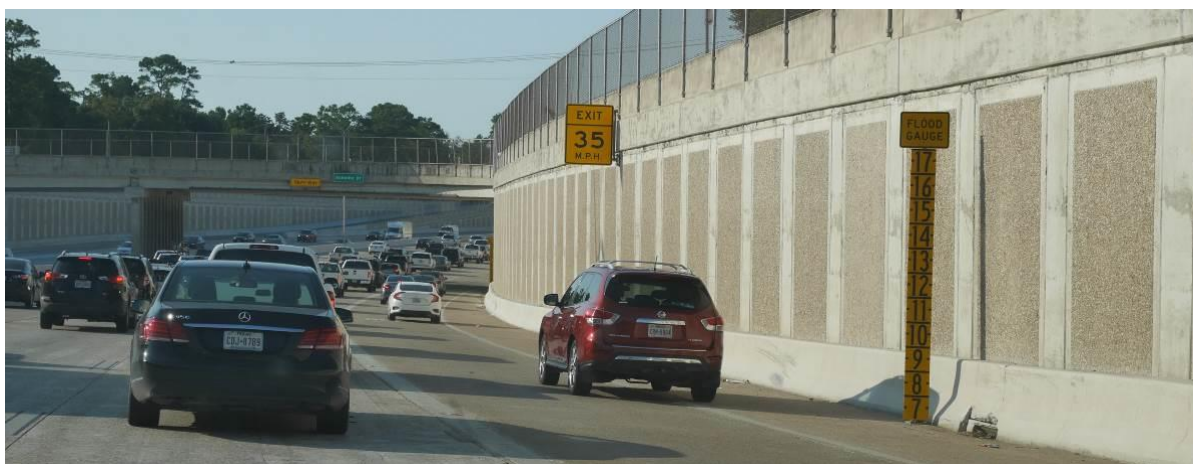
Flooding caused roadway damage to and closure of a major area artery at the underpass intersection of the Sam Houston Parkway / Beltway 8 and Boheme Drive (see Fig. 1 for location, 29.76736° N, 95.56210° W). The parkway is depressed at this intersection and floods often enough that flood depth sign gauges are posted along the road to warn motorists of the standing water depth (see Fig. 31).

Figure 31. Beltway 8 / Boheme Drive underpass and flood depth signs (September 11, 2017, 29.76694° N, 95.56139° W).

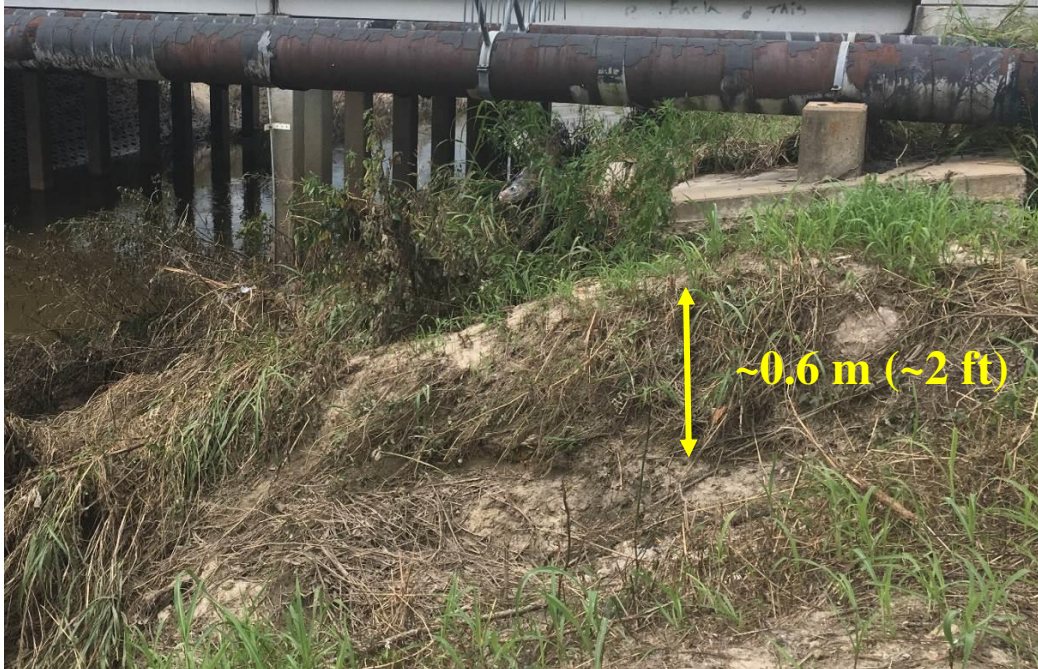
The erosion at the State Highway 35 Bypass bridge and pipe crossing over Mustang Bayou in the city of Alvin (see Fig. 1 for location) was typical for small waterways with high flow. Two shallow soil slump failures with slip depths of about 0.3 to 0.6 m (1 to 2 ft) were noted along the north bank of the bayou, one of which was beside and under a pipeline pile cap (Fig. 44).

*Figure 44. Shallow soil failure along the north bank of Mustang Bayou, adjacent to pipe-support foundation (September 4, 2017, Time 12:48 CDT, 29.40889° N, 95.23234° W).*
