# Geotechnical Extreme Event Site Reconnaissance in Puerto Rico After The Passage of Hurricane Maria

**ABSTRACT:** *The National Weather Service classified Hurricane Maria as a strong Category 4 Hurricane on the Saffir-Simpson hurricane wind scale at the time of its landfall in Yabucoa, Puerto Rico, U.S.A., on September 20, 2017. The immediate aftermath of Hurricane Maria was a devastated island with at least 64 people killed, severe infrastructure loss, a devastated electric power grid, and numerous geotechnical failures related to the intense rainfall and strong winds associated to this extreme event. This paper will summarize the event timeline and the geotechnical consequences of Maria's path across Puerto Rico. The impacts of Hurricane Maria on infrastructure and geomorphology are documented through the data and observations of the engineers and geologists that comprised the Geotechnical Extreme Events Reconnaissance (GEER) team. The main reconnaissance mission took place between October 25 and November 6, 2017, followed by a second field component involving terrestrial LiDAR surveys and UAV photogrammetry performed January 8 to 11, 2018.*

Reference: Silva-Tulla F., and Pand

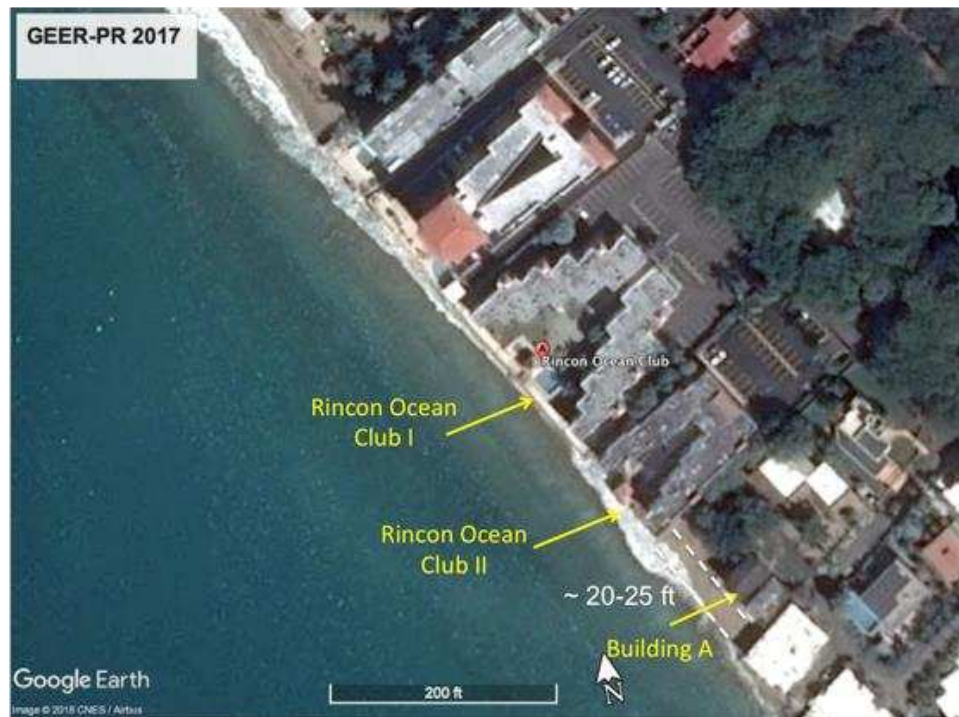
The beachfront in the Córcega Beach area suffered extensive coastal scour. The approximately 6 to 9 m (20 to 30 ft) of beachfront shown in the pre-storm photo (Figure 19) was drastically reduced at the time of the site reconnaissance. The GEER Team did not observe sand washout deposits or shoreline erosion protection measures during the field reconnaissance of Site CE3. Unfortunately, there were no storm tide sensors available near Rincón to help assess tidal levels or the magnitude of wave action during this hurricane. However, NOAA (2017) reported highest water levels of 0.3 to 0.6 m (1 to 2 ft) above maximum higher high water (MHHW) for the northwest coastline of PR, where MHHW is defined as the average daily highest tide. This is consistent with a high-water elevation mark data recorded at USGS Stations (Silva-Tulla et al, 2018).

*Figure 19. Pre-storm aerial image of coastal scour Site CE3 (Silva-Tulla et al., 2018).*

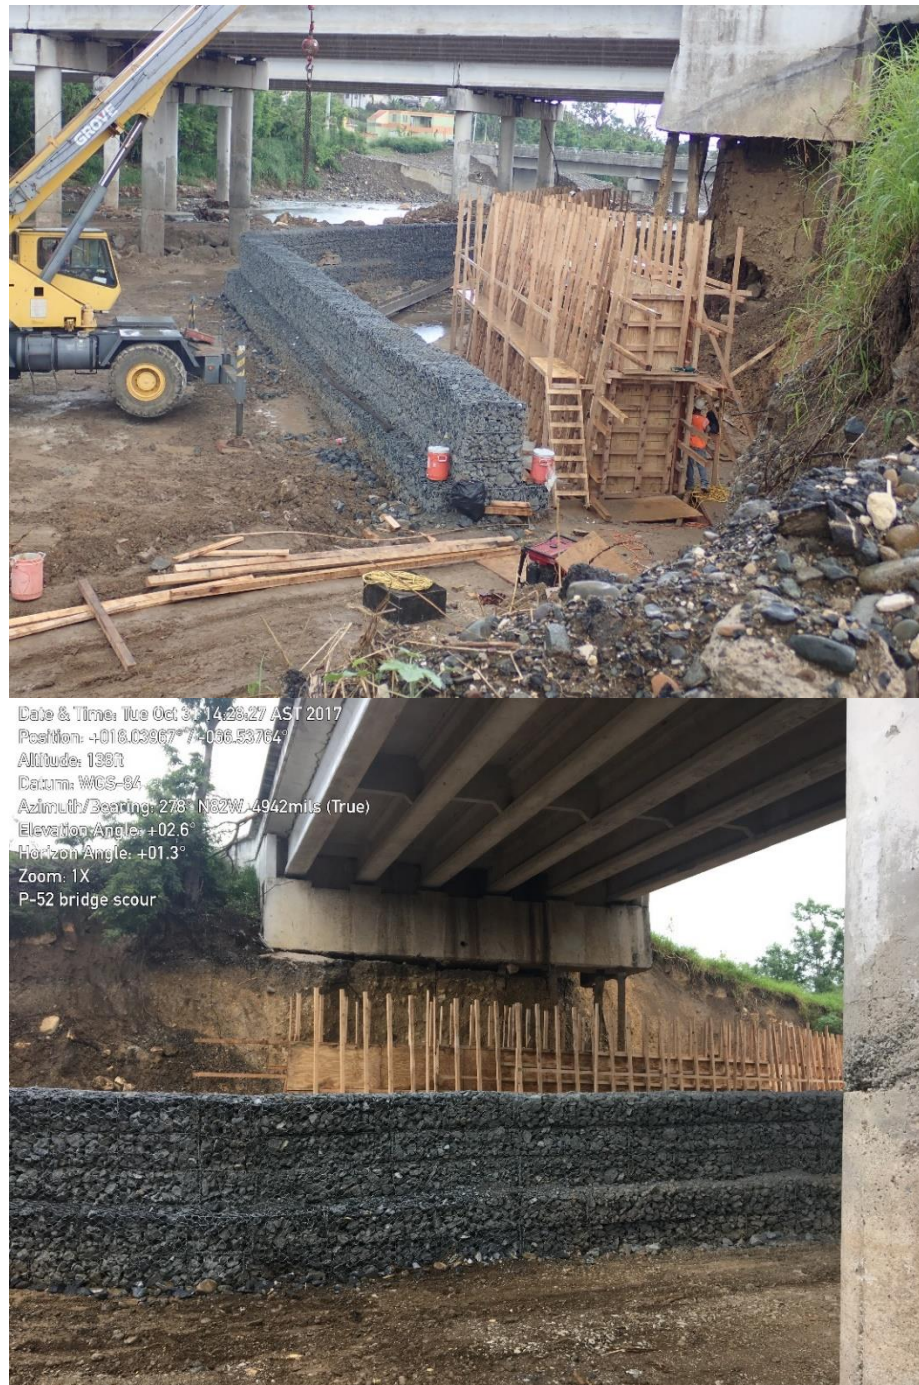
On October 31, 2017, the GEER team observed scour and erosion near the piers and abutments of Highway 52 bridges over the Inabón River at site RE1, just east of the city of Ponce, PR. Figure 21 shows select photos taken during the site visit. The photos show exposed abutment H-piles and ongoing emergency work, including the erection of formwork for abutment repairs and a temporary protective gabion wall. The gabion wall should protect the abutment and reinforced concrete shield under construction in front of the original exposed piles.

Figure 21: Photos of west abutment of westbound Highway 52 Bridge over the Inabón River (October 31, 2017; Silva-Tulla et al., 2018).
