# Hurricane Irma: Consequences of Intense Rainfall and Storm Surge from a Tropical Storm in North and Central Florida

**KEYWORDS:** reconnaissance, hurricane, sinkhole, karst, erosion, scour, beach, dam, infrastructure

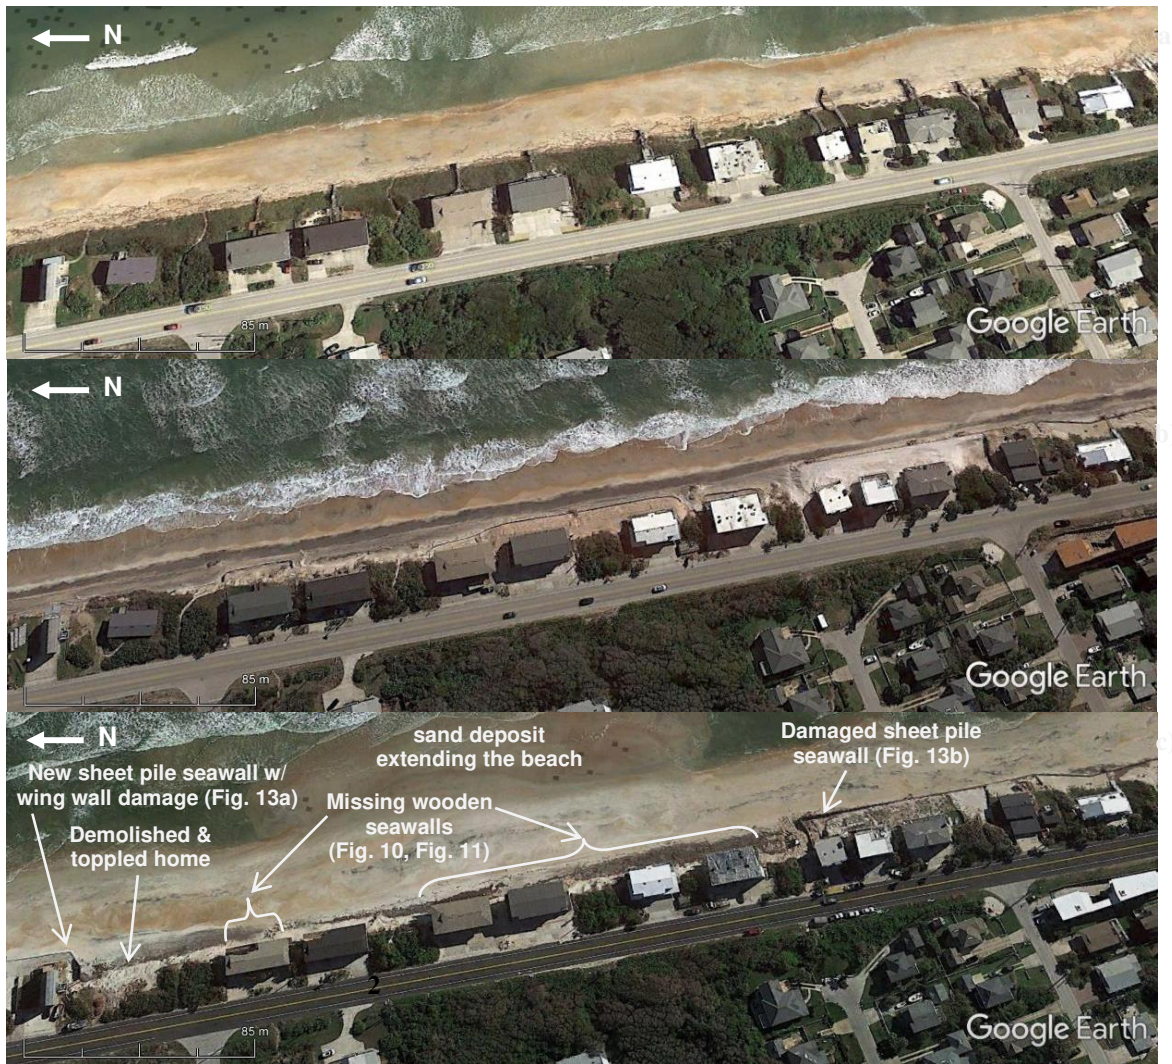
Vilano Beach has been experiencing consistent dune erosion during major storm events since 1994. Figure 9 illustrates how significantly and quickly the seemingly stable dune system changed because of extreme storms. The majority of erosion occurred after 2015 from both Hurricane Matthew (October 16, 2016) and Hurricane Irma (September 11, 2017). Figure 9c is annotated to show Hurricane Irma damage identified by the GEER team. To prevent erosion, seawalls of varying types were installed to protect residences from destructive wave action. The walls ranged from simply constructed walls to more complex walls with anchors. Many of the more complex systems were vinyl sheet pile walls anchored by either helical or dead man anchors connected to either pressure-treated wooden wales 100 mm (4 in) square in cross-section or cylindrical wooden piles secured at the front of the sheet piles. Several residences with more complex seawalls still experienced some damage and scour. The unprotected areas adjacent to seawalls were at greater risk of erosion and scour as the wave energy was directed around the seawalls and focused on the unprotected beach, dunes, and structures. Several residential structures with limited or no seawalls had their timber pile foundations exposed. In one extreme case, a residence supported by shallow foundations was completely undermined and toppled onto the beach.

Figure 9: Changes to the Vilano Beach coastline from 4020 to 3880 Coastal Highway, St. Augustine, Florida, at  $29^{\circ}56'49.30''\text{N}$  latitude and  $81^{\circ}18'9.37''\text{W}$  longitude dated: (a) November 2015, with few seawalls present; (b) March 2017, with seawalls installed following 2016 Hurricane Matthew, and; (c) October 2018, following damage from 2017 Hurricane Irma (Google Earth, 2018).

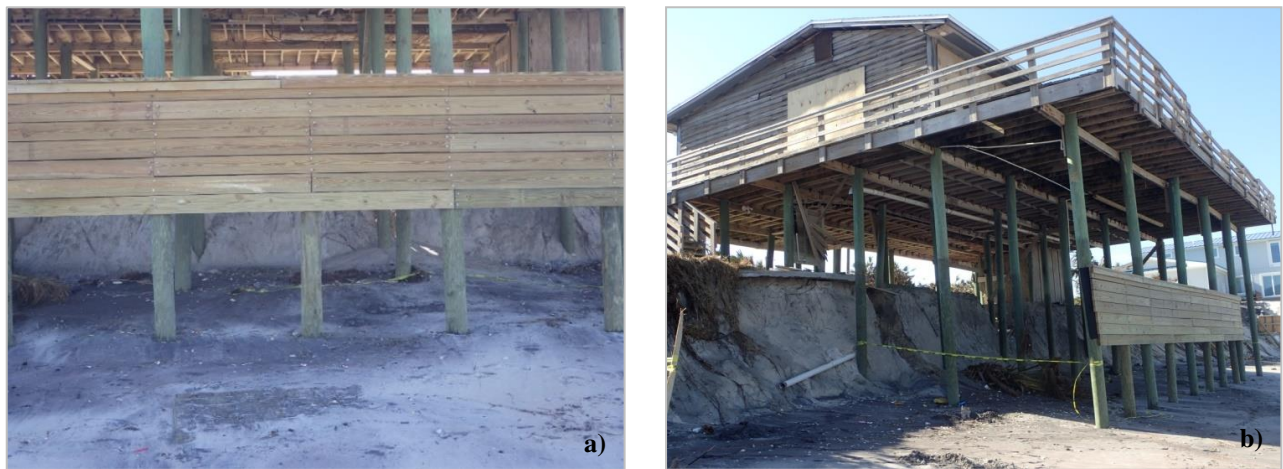
Figure 11 shows a wooden seawall left partially intact after Hurricane Irma. The seawall was constructed from pressure-treated lumber approximately 50 mm by 150 mm (2 in. by 6 in.) in cross-section nailed to pressure-treated timber piles supporting upper levels of the residence. The lumber was either not embedded or minimally embedded into the soil. The wall itself remained intact and undamaged, likely because it was attached to the piles. While the wall may have been initially effective at preventing erosion, soil was eroded from beneath and around the sides of the wall, undercutting three rows of timber piles. Notice also the underside of the elevated structure. The GEER team was uncertain how developed the ground floor of this structure was; however, there was evidence that walls and utilities were eliminated by wind and wave activity.

Figure 11. (a) Shallowly embedded timber seawall at approximately 29°56'49.30"N latitude and 81°18'9.37"W longitude, showing significant erosion (about 2 m or 6.6 ft) below a residential structure; and (b) subsequent beach erosion and removal of the first story walls by wind and water.

Timber pile and wooden lagging did not fare well in the extreme conditions brought on by Hurricane Irma (Figures 11 and 13). Lagging for these barriers may not have extended deep enough into the beach and retained soil was subject to basal erosion, leaving wooden walls unsupported and subject to even greater wave loading. Additionally, the impact of waves carrying entrained debris and sand likely amplified the rate of damage for these timber walls. Nearly all the wooden face

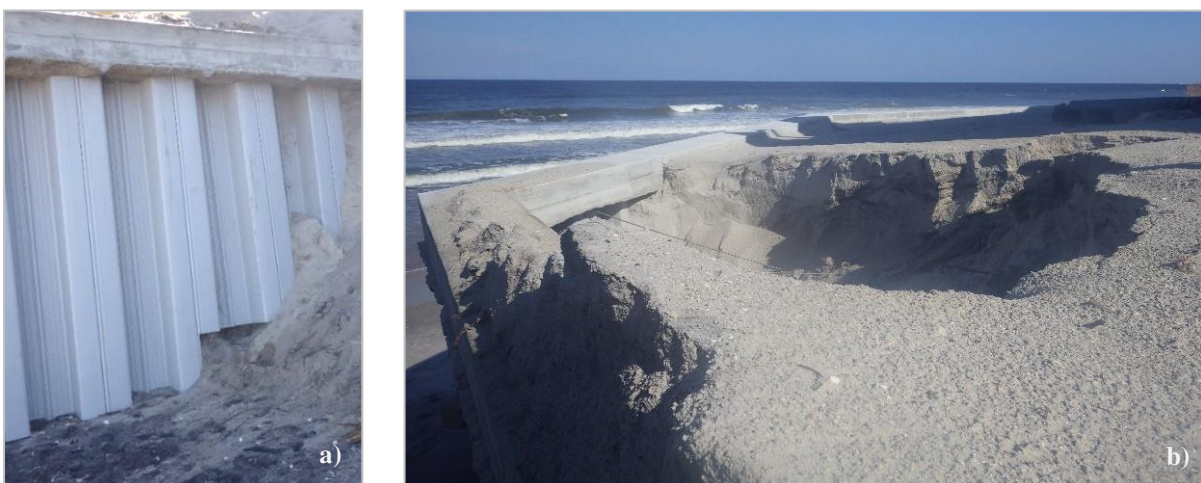
Figure 12: Sheet pile retaining wall failure from undercutting at 29°56'58.16"N latitude 81°18'11.96"W longitude, showing: (a) the exposed wall base, and (b) a funnel-shaped depression following basal soil escape (Hudyma et al., 2017).

The undercutting of shallowly embedded walls is evident in Figure 12a, which shows exposure of the base of a sheet pile wing wall that was scoured to a depth that provided a pathway for retained soil to escape from under the wall. This created a funnel-shaped depression behind the seawall at this location (Figure 12b). Figure 13a shows erosion into the dune and around a wing wall. The face and part of the wing wall were made of embedded vinyl sheet piling. However, the part of the wing wall extending into the dune was of timber pile and wooden lagging. Erosion past the sheet piling into the more open structure of the wooden lagging resulted in break-up of the wall, erosion of the retained soil, and exposure of shallow foundations previously supporting the deck (not shown). Lastly, Figure 13b illustrates the consequences of an incomplete seawall. The wing wall was a temporary timber pile and wooden lagging installed to accommodate a possible future extension of the sheet pile wall face to the neighboring property. The timber seawall was compromised by the storm. The four residences protected by the wall experienced damage, with the most damage adjacent to the temporary wing wall.

The structure with face and wing walls constructed similarly with vinyl sheet pile in Figure 12 experienced some undermining damage; however, the impenetrable material of the wall (vinyl) provided excellent resistance to wave action that was likely intensified by entrained sand and debris from adjacent damaged structures. The walls that the GEER team found to be minimally damaged during Hurricane Irma had sufficient vertical embedment into the beach sands or lateral embedment back into the dune to maintain their structural integrity, even if basal or side exposure of the wing wall resulted in some erosion. The reconnaissance identified two concerns for vinyl sheet pile walls. Walls are installed with weep holes to allow water to drain from the retained sand behind the wall at the beach elevation. Following Hurricane Irma, the weep holes were approximately 0.5 m to 1 m (1.6 ft to 3.3 ft) above the new beach elevation. In many walls with soil still retained, the vinyl sheets bowed out of plumb below the weep holes. This is likely because of both the loss of basal support on the outside face of the wall and pore pressure in the confined soil from trapped water behind the wall. While the vinyl sheet piling is ductile and corrosion resistant, inspection found areas with previous cracks and repairs, possibly due to impact from wave-borne debris.

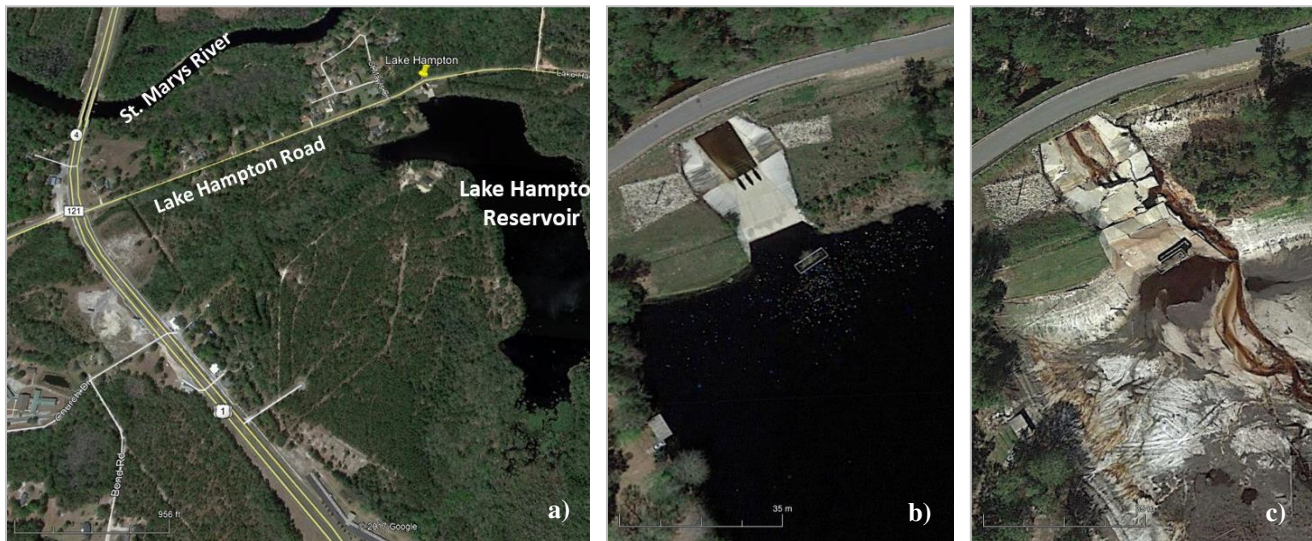
where a concrete structure with four 2.1 m (6.9 ft) diameter concrete pipes passed water from the spillway pool into the downstream tributary (Hudyma et al., 2017). Figure 14 shows aerial images of the dam prior to and after the dam's failure.

Figure 14. (a) Lake Hampton Dam reconnaissance site location with aerial photos of the dam (b) before (March 2017), and (c) after (October 2017) the failure (Google Earth 2018).
