# Post-2017 Hurricane Season Assessment of Civil Infrastructure Impacts on Beach and Near-Beach Environments

**ABSTRACT:** *This paper presents an overview of observations and preliminary measurements of coastal infrastructure in the aftermath of Hurricanes Harvey and Irma in 2017. Two teams mobilized by the Geotechnical Extreme Events Reconnaissance (GEER) Association were sent to document perishable data along the Texas coastline (Port Aransas, Holiday Beach, East Matagorda Peninsula, and Follets Island) and Florida Keys (Simonton Beach, Sombrero Beach, and Coco Plum Beach). Significant damage from sediment overwash and road undercutting was observed at beach access paths and roads that transect dune fields. It was also observed that beach access points weaken the line of coastal defense provided by dunes, vegetation, and structures. The lessons learned from these field reconnaissance missions indicate that longshore non-uniformity in the dune system should be well-documented. Measurements of the geometry of beach access pathways and dunes, including the height, width, length, and vegetation coverage, should be collected prior to recovery of the system post-storm.*

Reference: S

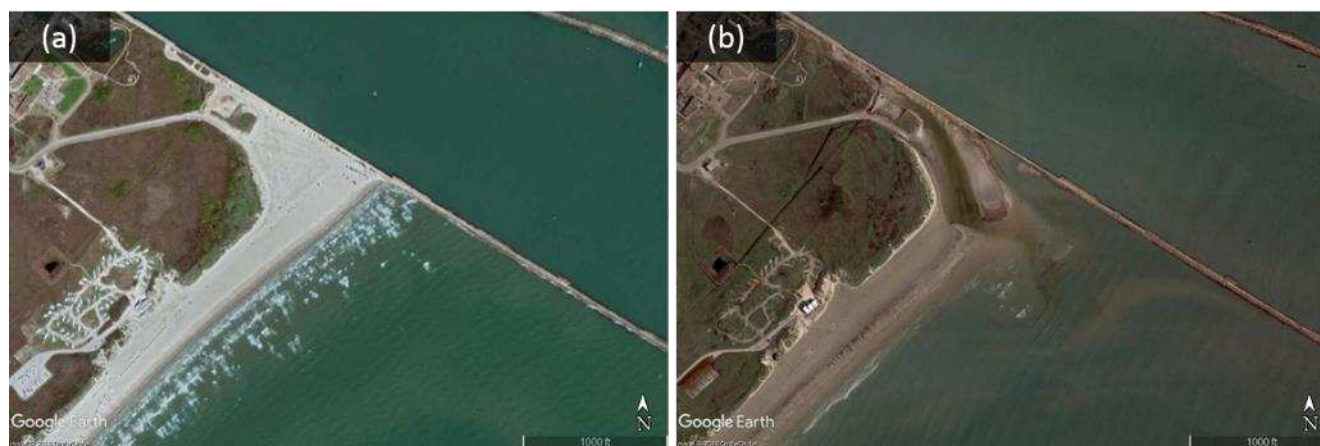
Southwest of the jetties that protect Port Aransas Pass, several paths transect the dune system to provide beach access to Port Aransas. The closest of these beach access points at the end of East Cotter Avenue experienced severe undercutting and paralleled a newly-formed eroded runnel that extended from the road, around a large dune, to the beach (Figure 3). This breach was observed to start at a small culvert under East Cotter Avenue, extend northwest toward the jetty, follow the jetty for approximately 120 m (394 ft), then turn southwest toward the GoM. At the beginning of the breach, a maximum undercut depth of 0.4 m (1.2 ft) was measured on the west side of East Cotter Avenue (Figure 4). The toe of the large dunes between the jetty and East Cotter Avenue and at the end of the beach access road were severely eroded (Figure 5). A scarp measuring approximately 0.9 m (3 ft) was observed and a thick wrack line of debris was deposited at the toe of the scarped dune. This location, along with several other beach access points in Port Aransas, provides evidence that these transects through the dune system provide a pathway for flow channelization, resulting in increased erosion.

Figure 3. (a) Pre-storm satellite imagery (imagery date February 22, 2017) and (b) post-storm satellite imagery (imagery date August 29, 2017) show the eroded runnel created during Hurricane Harvey near Port Aransas Pass (location  $27^{\circ}50'6.39''N$ ,  $97^{\circ}2'50.56''W$ ). Map data: Google Earth, Digital Globe.

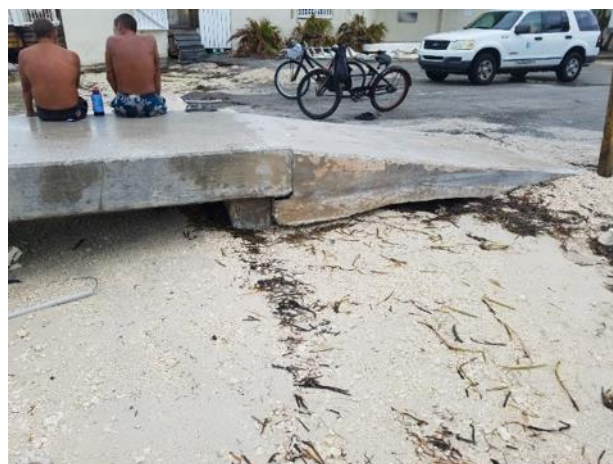
Figure 11. A concrete structure located on the eastern edge of Simonton Beach was undermined due to scour around the structure (collected September 27, 2017; location  $24^{\circ}33'43.32''N$ ,  $81^{\circ}48'20.22''W$ ).
