# Reconnaissance of the New Orleans Hurricane and Storm Damage Risk Reduction System after Hurricane Gustav

**ABSTRACT:** On October 2 and 3, 2008, a group of civil engineers sponsored by the National Science Foundation (NSF) and organized by the Geoengineering Extreme Events Reconnaissance (GEER) Association, visited the New Orleans area to assess levee performance during hurricane Gustav. This paper summarizes the team's observations and understanding of the state of the New Orleans Hurricane and Storm Damage Risk Reduction System (HSDRRS) in the fall of 2008 and the performance of elements of the HSDRRS during Hurricane Gustav. The fundamental conclusion was that the HSDRRS performed well under the surge and wave stresses generated by Gustav. The team's observations led to lessons about dangers to floodwalls from boats and barges, the importance of timely preparation for hurricanes, erosion resistance of clay levees, and the need for continued emphasis on evacuation for life protection.

Reference: Wooten R. L., Gilbert R. B., Marcuson, III W. F., Harder, Jr. L. F., and Nicholson P. G. (2020).

Reconnaissance of the New Orleans Hurricane and Storm Damage Risk Reduction System a

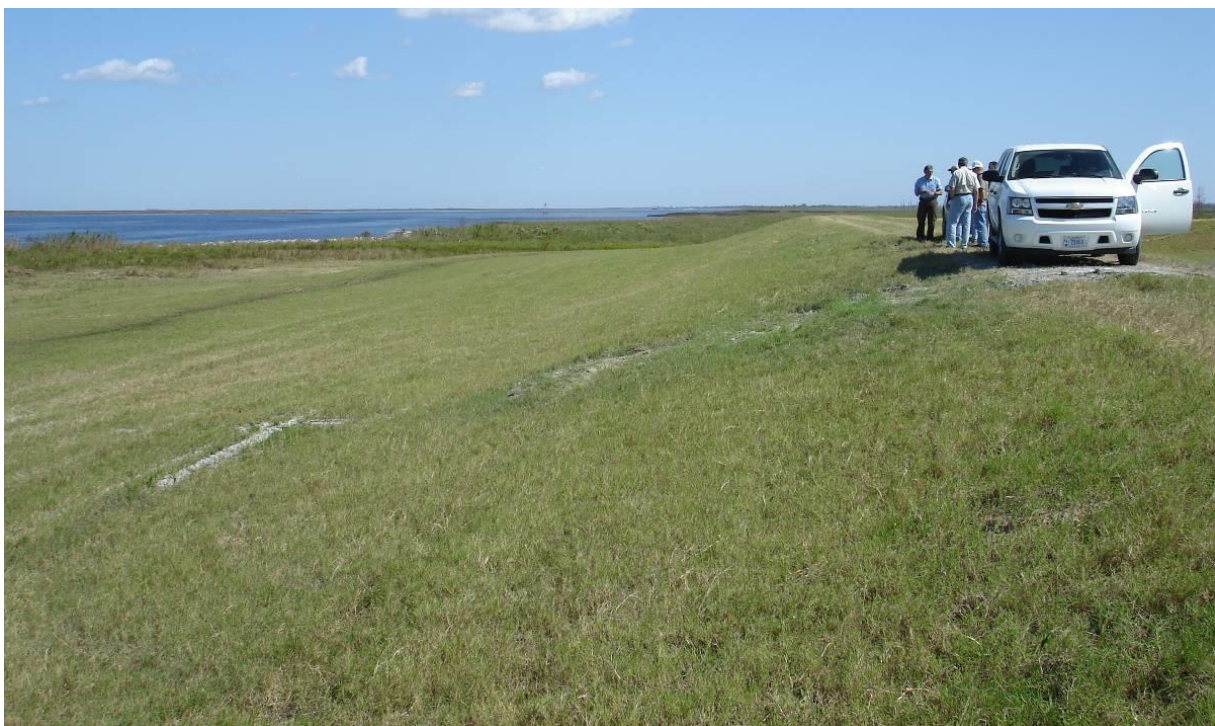
Earthen Levee Reconstruction – The USACE designed and constructed repairs and improvements to the HSDRRS earth levees with two main purposes: (1) to raise the level of protection so that the likelihood of overtopping would be lessened, and (2) to improve the capacity of levees to withstand erosion during overtopping by using clay instead of silty sand fill. Figure 2 shows the eastern part of the HSDRRS plan along the Mississippi River Gulf Outlet (MRGO), which is a typical example of the reconstructed earthen levees, noting the elevations of the pre-Katrina levee crests (blue boxes) and the June 2008 levee crests (brown boxes). Figure 3 is a photograph of the raised earth levee at the southeast corner of the HSDRRS along the MRGO, which is a typical example of the reconstructed earthen levees.

Figure 3. Southeast corner of the MRGO levee, flood side. (October 2, 2008, 29.8889°N, 89.7617°W)

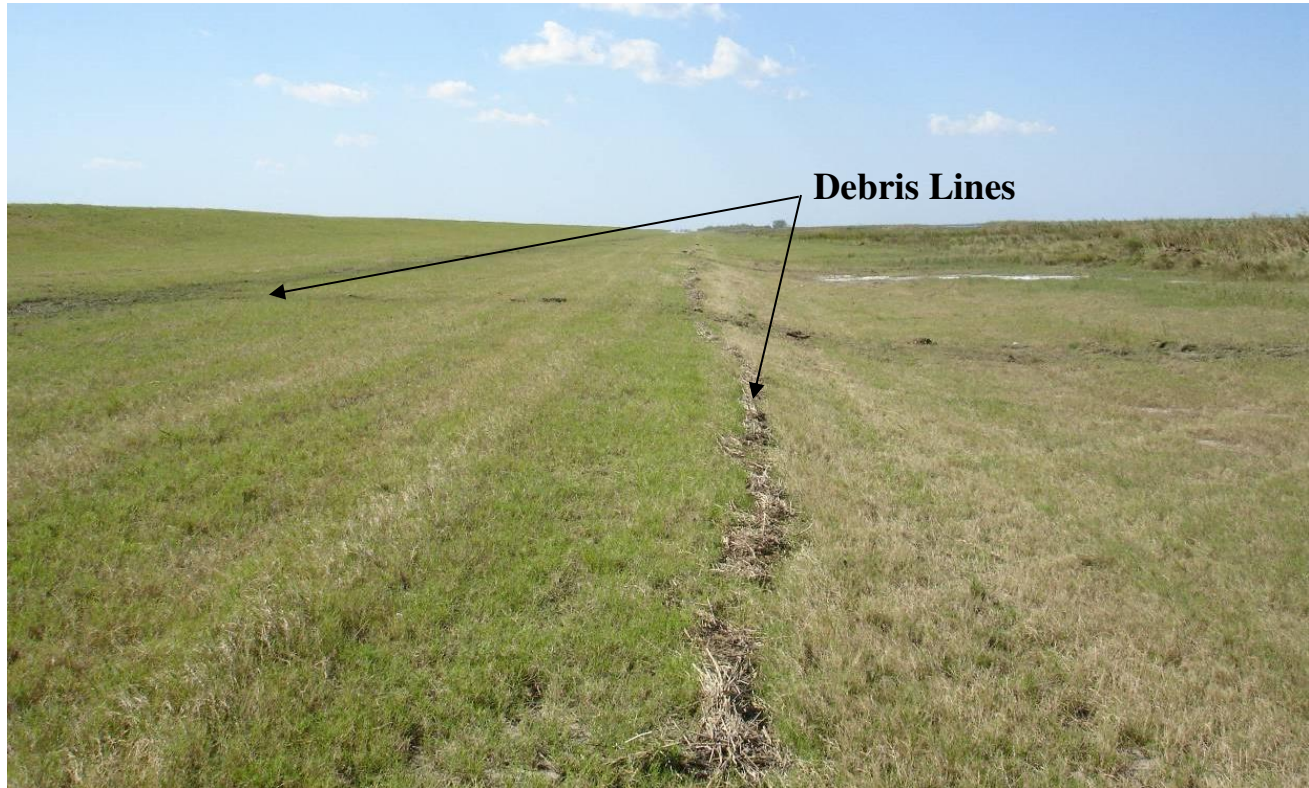
The team observed no signs of either erosion or overtopping during Gustav along the southeast sections of the MRGO frontage levee, which the team believes was representative of the MRGO frontage levees. Based on the limited debris lines along the levee, the high water levels during Gustav were well below the crest of these rebuilt and elevated earthen embankments. The wave and current actions of Gustav also appeared to have caused no erosion on the earth embankments. Figure 12 shows a typical view of the MRGO frontage levee embankment in October 2008.

*Figure 12. MRGO frontage levee, flood side, looking northwest. Upper debris line, believed to be due to Gustav, was cleared prior to our visit, probably as part of the ongoing efforts to maintain the protective grass cover. The lower debris line may represent the high-water level during hurricane Ike, which followed Gustav in September 2008. (October 2, 2008, 29.8889°N, 89.7617°W)*

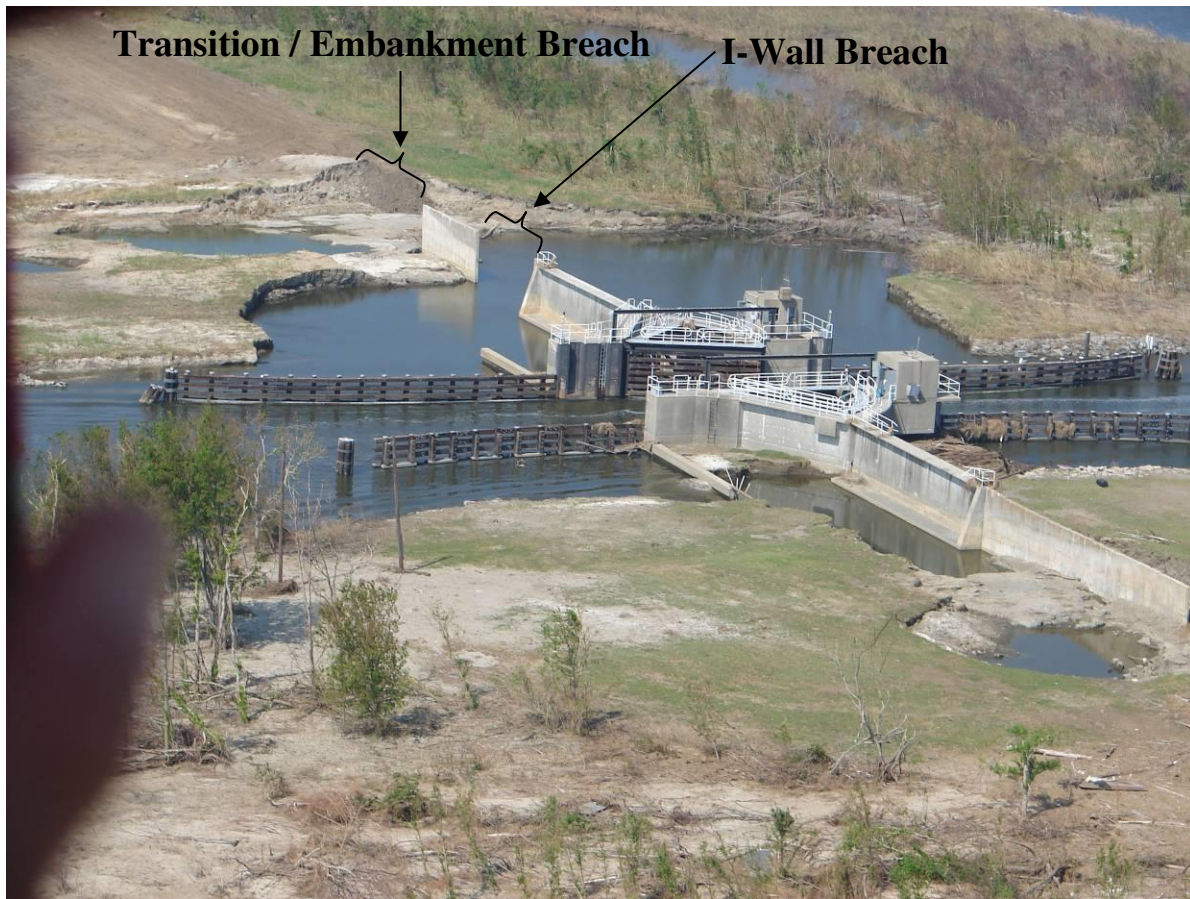
Figure 13. Post-Katrina Bayou Dupree gate. (October 14, 2005, 29.935° N, 89.837° W, L. Harder)

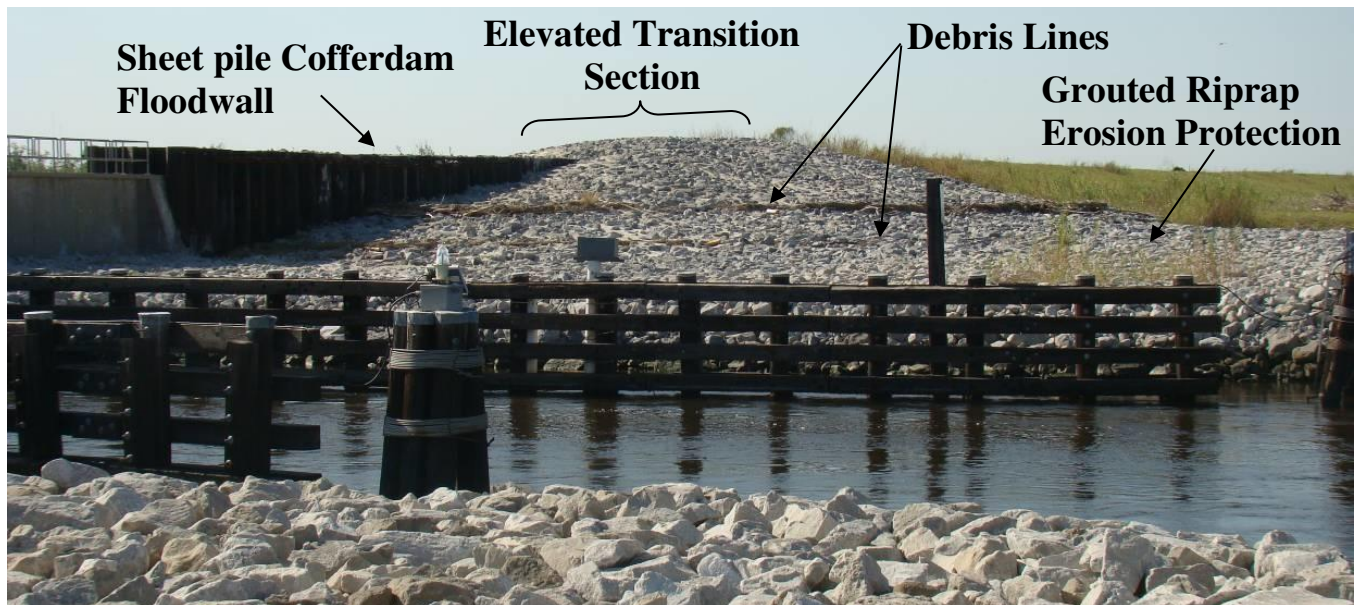
Figure 14 shows the improvements constructed by the USACE to the same Bayou Dupree gate structures. The concrete sheet pile I-wall was replaced with a steel sheet pile cofferdam section, and the transitions to the earthen levees on both sides of the gate were elevated and covered with grouted riprap. The use of grouted riprap to harden vulnerable areas around the gate was extensive, as illustrated in Figure 14. UngROUTED riprap was placed as erosion protection at the toe areas of grouted riprap. The team observed no signs of erosion or damage from Gustav's high water and waves at or near the gate. The limited debris line on the northwest flank appeared to indicate that the highest waters from Gustav were about 1 to 1.5 m (3 to 5 ft) below the crest of any of the gate structure elements (see Figure 14).

Figure 14. Bayou Dupree gate, northwest flank, MRGO side, looking east. The lower debris line may represent the high-water level during Hurricane Ike. (October 2, 2008, 29.9352° N, 89.8358° W)

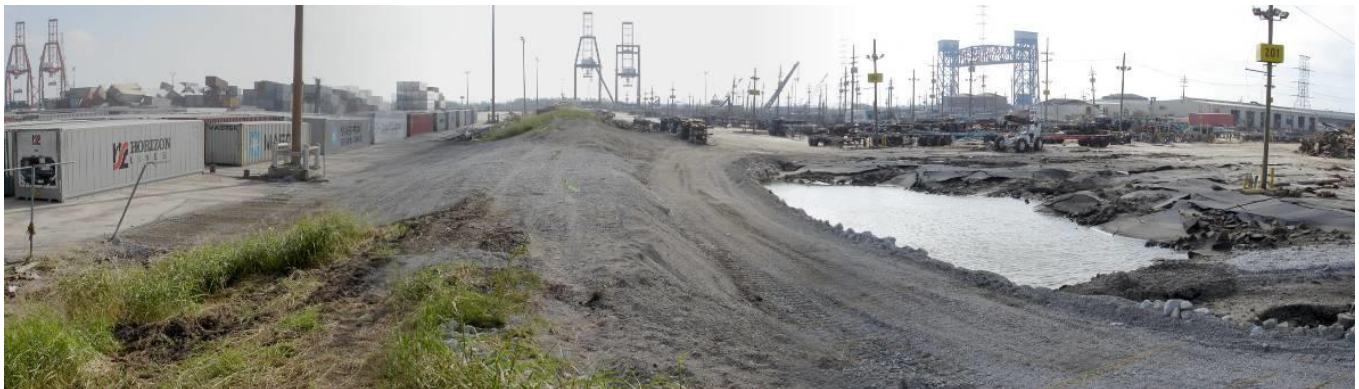
*Figure 16. Post-Katrina IHNC West levee breach site, October 2005 (The breach had been temporarily repaired; note scour hole). (October 4, 2005, 29.9880° N, 90.0263° W, L. Wooten)*

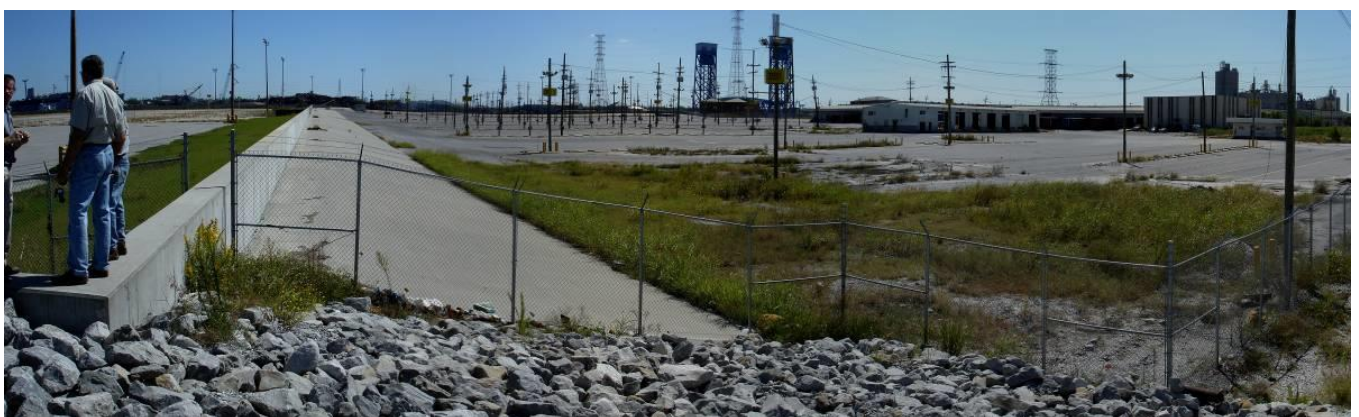
Post-Katrina repairs and improvements of these failed and distressed sections included raising and buttressing embankment sections, armoring of embankment-concrete floodwall transitions, replacement of I-walls with L-walls (T-walls were not used due to space constraints), and buttressing of pre-existing I-wall sections to reduce the stick-up height (the height of wall above finished grade). Figures 16-19 show the post-Katrina (October 2005) and post-Gustav (October 2008) conditions at the locations of the earth levee breach (Figures 16 and 17) and of the I-wall breach (Figures 18 and 19) that occurred during Katrina.

*Figure 17. IHNC West new embankment and floodwall at location of breach, as was shown in Figure 14, in October 2008. (October 2, 2010, 29.9880° N, 90.0263° W)*

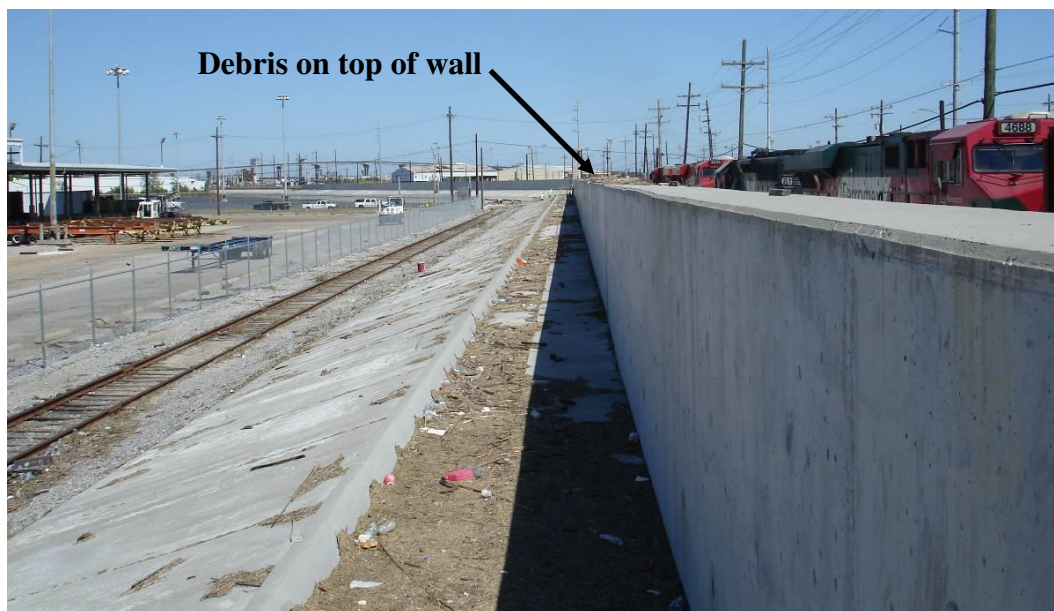
The repairs and improvements of these sections of the hurricane protection appeared to have performed well in light of clear evidence of wave overtopping. Figure 20 shows the debris left by overtopping waves on the protected side of one section of new L-wall along the IHNC West.

Figure 20. Protected side of new L-wall along IHNC West. Note debris left by overtopping on floodwall and slope protection. October 2008. (October 2, 2008, 29.9899° N, 90.0272° W)

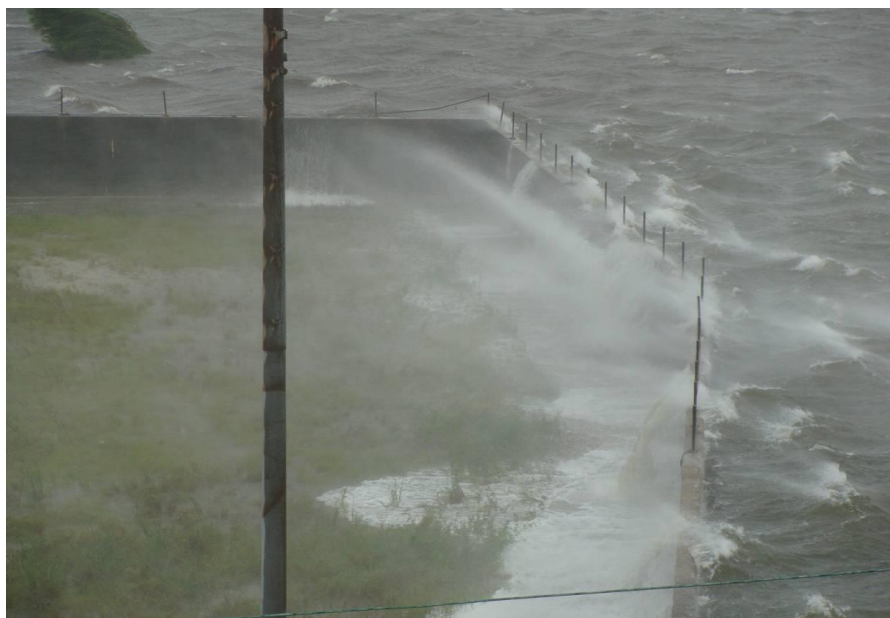
*Figure 22. Gustav's storm surge along IHNC East, taken from Claiborne Ave. Bridge looking north at T-wall southeast on September 1, 2008. (September 1, 2008, 29.969° N, 90.027° W, USACE)*

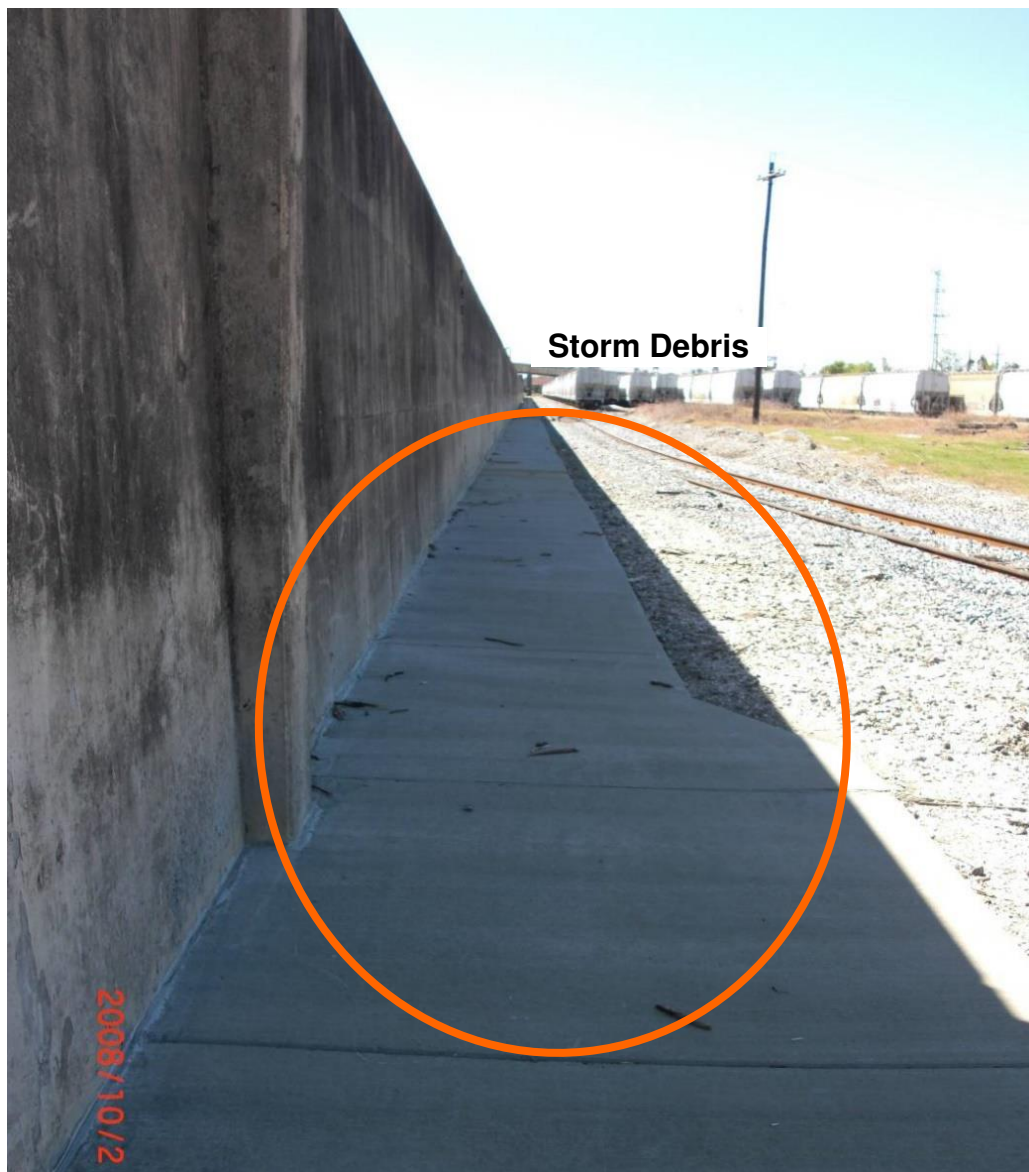
*Figure 23. Photograph from October 2, 2008, of IHNC West T-wall (same section as shown during Gustav in Figures 20 and 21). (October 2, 2008, 29.970° N, 90.026° W)*

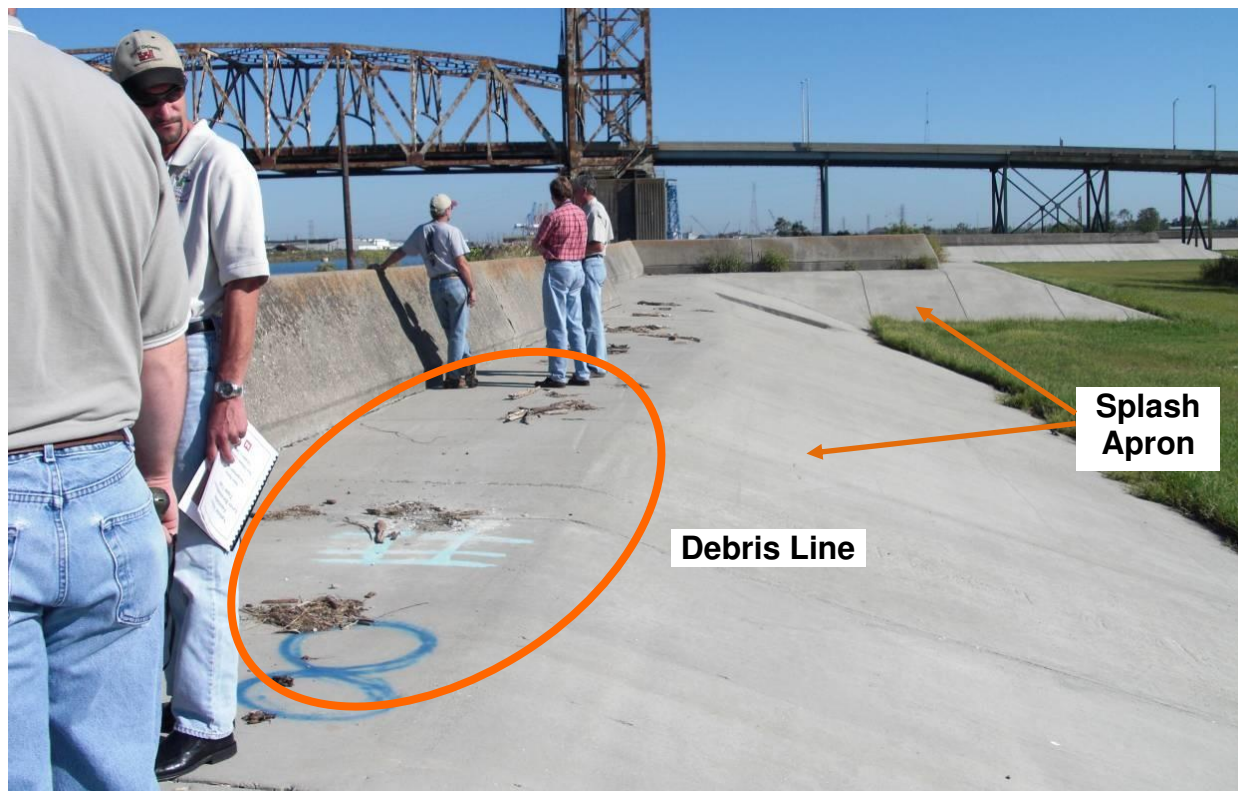
Along the east side of the IHNC south of Claiborne Avenue, the peak still water level was near the top of the old I-wall, and waves apparently overtopped the wall. The top of this wall was at about an elevation of 4.0 m (13 ft), NAVD88. After Gustav, the wall showed no noticeable signs of distress such as movement of the wall due to the surge load or erosion at the toe due to waves overtopping the wall (Figure 26). Also, there was no visible evidence of underseepage on the protected side.

Figure 26. Hardened I-wall along east side of the IHNC south of Claiborne Avenue looking north (IHNC is to the left and Lower 9<sup>th</sup> Ward / Holy Cross to the right). (Oct. 2, 2008, 29.9682° N, 90.0250° W)

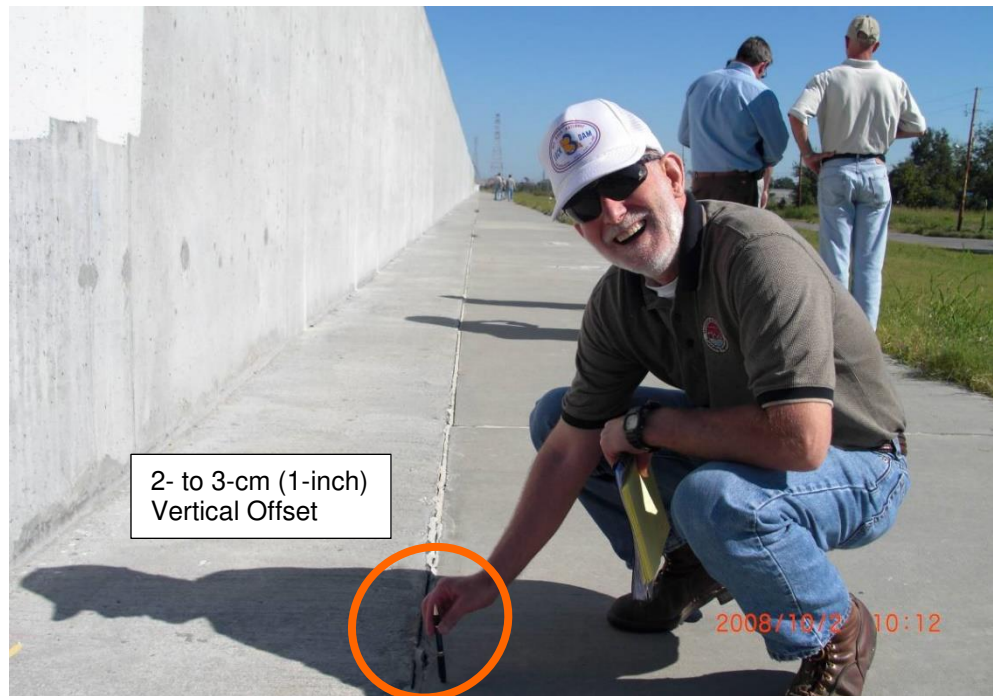
The team noted a 2- to 3-cm-deep (~1-inch-deep) vertical offset between the pile-supported base of the T-wall and the slab-on-grade concrete splash apron (Figure 27). This offset, if the splash apron was cast to be flush with the base of the wall in the summer of 2006, may indicate a differential settlement of the apron relative to the pile-supported T-wall occurring at a rate of about 1 cm per year (0.5 inch per year) in the upper 21 m (70 ft) of the soil profile.

Figure 27. New T-wall section along the east side of the IHNC between Claiborne and Florida Avenues (shown in Figure 23 during Gustav). (October 2, 2008, 29.9691° N, 90.0236° W)

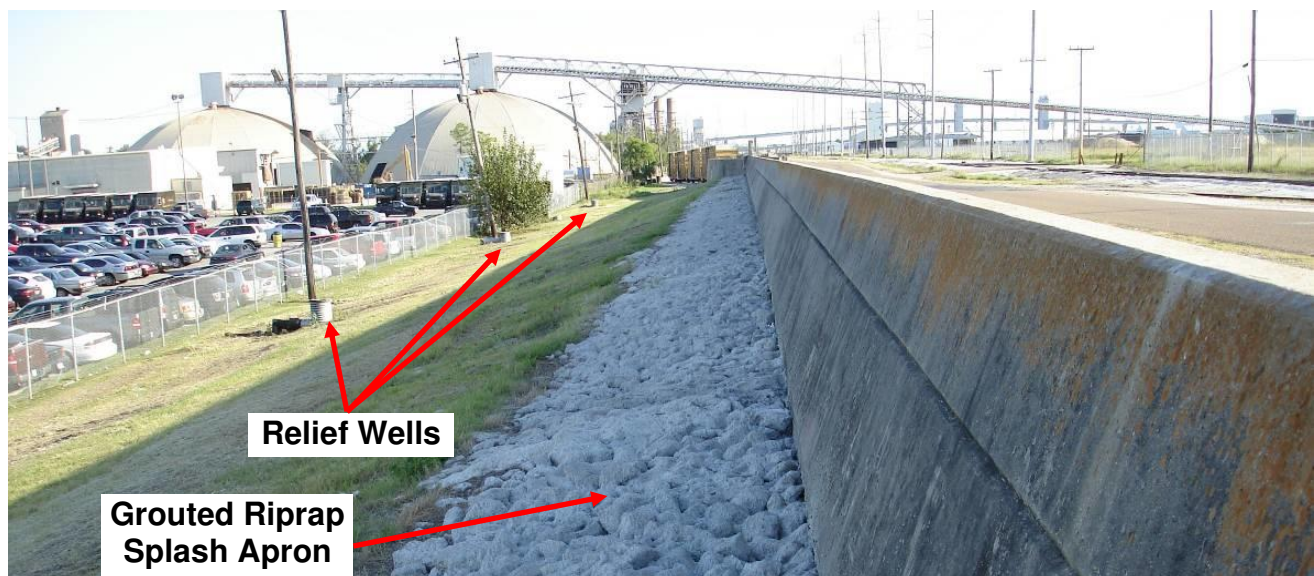
The team visited the section of the HSDRRS near East Morrison Road in New Orleans East to investigate the USACE preliminary reports of damage to the relief wells and of soil moving through the wells. Much of the HSDRRS in this section of New Orleans East along the northeast section of the IHNC consisted of I-walls set in earthen embankments with regularly spaced relief wells located at the toe of those embankments (see Figures 28 and 29). These features were in place at the time of Katrina. After Katrina, the USACE added a grouted riprap splash apron on the protected side of the I-walls.

Figure 28. IHNC floodwall near East Morrison Road. Note splash apron (center) and relief wells (left). (October 2, 2008, 30.0248° N, 90.0295° W)

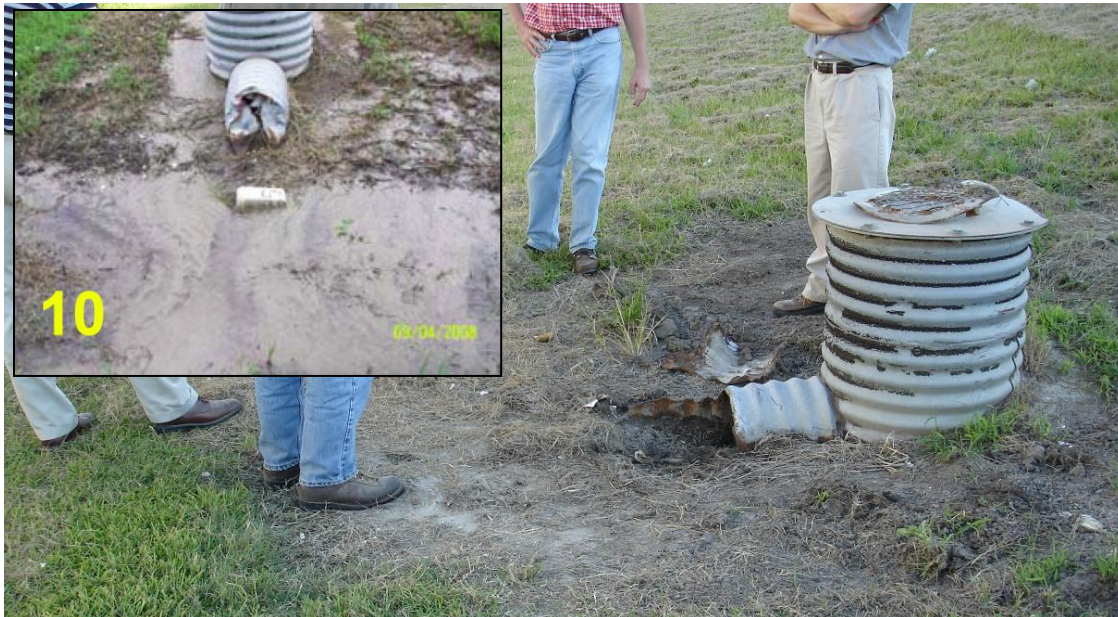
The team observed no signs of damage to the HSDRRS near East Morrison Road due to Hurricane Gustav. The corrugated metal protective casings over the relief well outlets were in various states of deterioration. The team also did not see evidence of extensive sand migration out of the wells, although our observations were made more than a month after Gustav had swept through the region, and the team did not inspect all wells. The inset photo in Figure 28 was taken from the USACE Situation Report dated September 5, 2008, which shows a damaged outlet casing and sand that appears to have discharged from the well.

Figure 29. Relief well cover, as of October 2008, with inset taken from the USACE Hurricane Gustav Damage Assessment Team SITREP on September 5, 2008. (October 2, 2008, 30.0249° N, 90.0294° W)

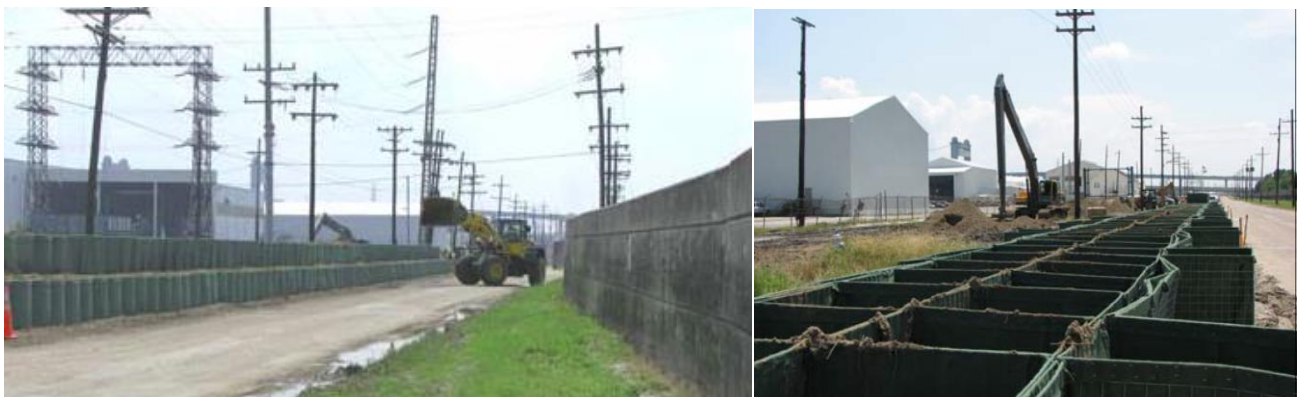
Figure 30. Temporary bin wall under construction, IHNC West along France Road. (August 2008, 30.0157° N, 90.0324° W, [http://www.mvn.usace.army.mil/HPS/Status%20Report%20Newsletters/Sept\\_9\\_2008.pdf](http://www.mvn.usace.army.mil/HPS/Status%20Report%20Newsletters/Sept_9_2008.pdf))

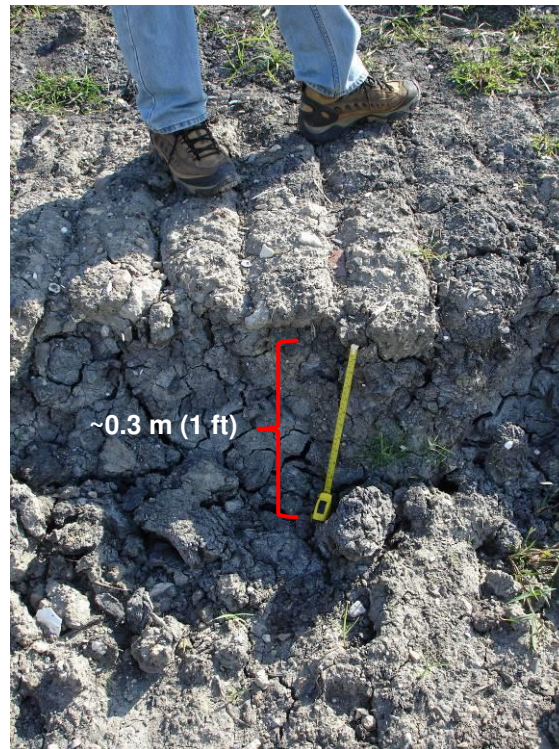
*Figure 36. Scarp above slide on Plaquemines back levee.  
(October 3, 2008, 29.8506° N, 89.9085° W)*

The non-federal local back levee in Plaquemines Parish was overtopped by Gustav flood levels and was in danger of failure at the location of the slope slide. Desiccation cracks on the levee may have contributed to the slide by allowing overtopping water pressures into embankment zones critical to slope stability. The placement water content, compaction, and organic

- The erosion resistance of non-federal local levees in Plaquemines Parish (not part of the HSDRRS) during overtopping was noted during Katrina. The clay back levees in Plaquemines Parish resisted erosion during Gustav but may have demonstrated a potential vulnerability due to desiccation cracks. Improved control of placement water content and compaction, revised material requirements relative to plasticity and organic content, or landscaping measures such as the establishment of dense vegetation and use of irrigation may be required to prevent desiccation.
