## Bridge Abutment Remediation – A Case Study

Reference: Sundaram, M., Sugawara, J. and Sivakumar, S. (2022). Bridge Abutment Remediation – A Case Study. International Journal of Geoengineering Case Histories, Volume 7, Issue 4, pp. 1-7, doi: 10.4417/IJGCH-07-04-01

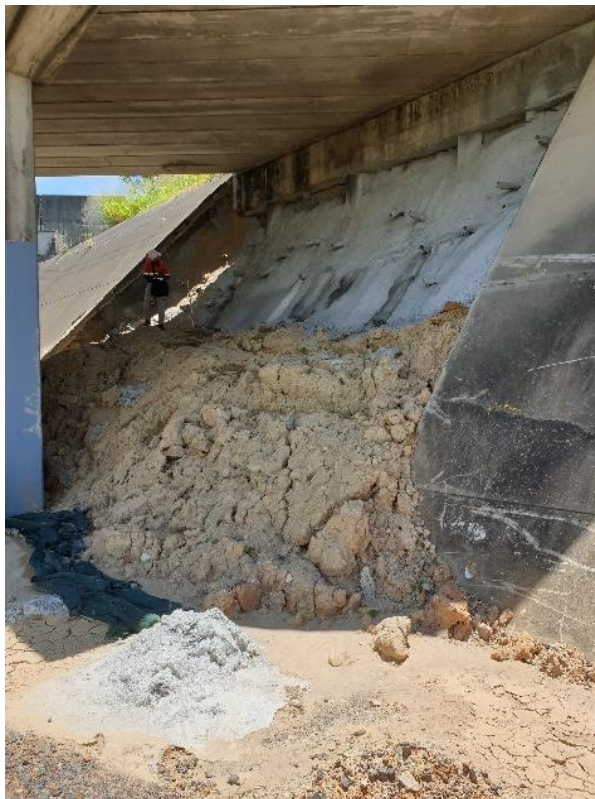
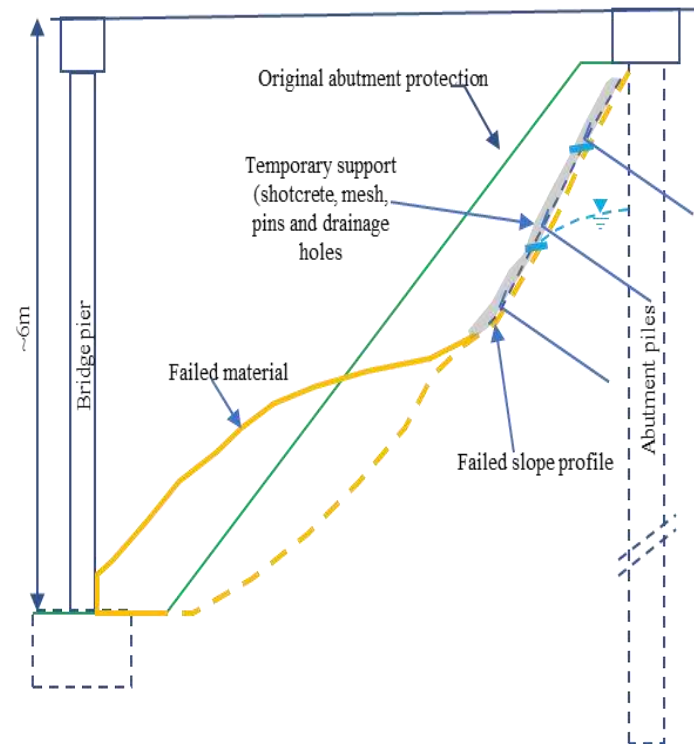
Figure 3. Temporary remediation (shotcrete with mesh, drainage holes, and driven pins) installed within 24 hours of the failure. The sketch illustrates the slope profile and temporary remediation installed. Seepage continued to occur two meters below the headstock at a reducing rate.

Due to a forecast of further rainfall in the days following the failure, there was an urgent requirement to making the abutment safe and prevent further slips from the exposed surface. The following immediate and urgent mitigation measures were implemented within 24 hours (Figure 3):

- Removal of failed material from batter face and abutting against slope toe to provide passive support.
- Installation of two rows of 1-m long drainage pipes.
- Installation of three rows of 2-meter long, 20-millimeters diameter coggled steel reinforcement bars (driven) at 1-meter spacing.
- Application of 160 millimeters (average) thick shotcrete with SL82 mesh.
- Closure of one lane on the road below with temporary traffic lights with contra flow.
- Risk management advice included daily inspections of the site (to later be reduced to weekly, granted there were no further movements) and checks after rainfall events.

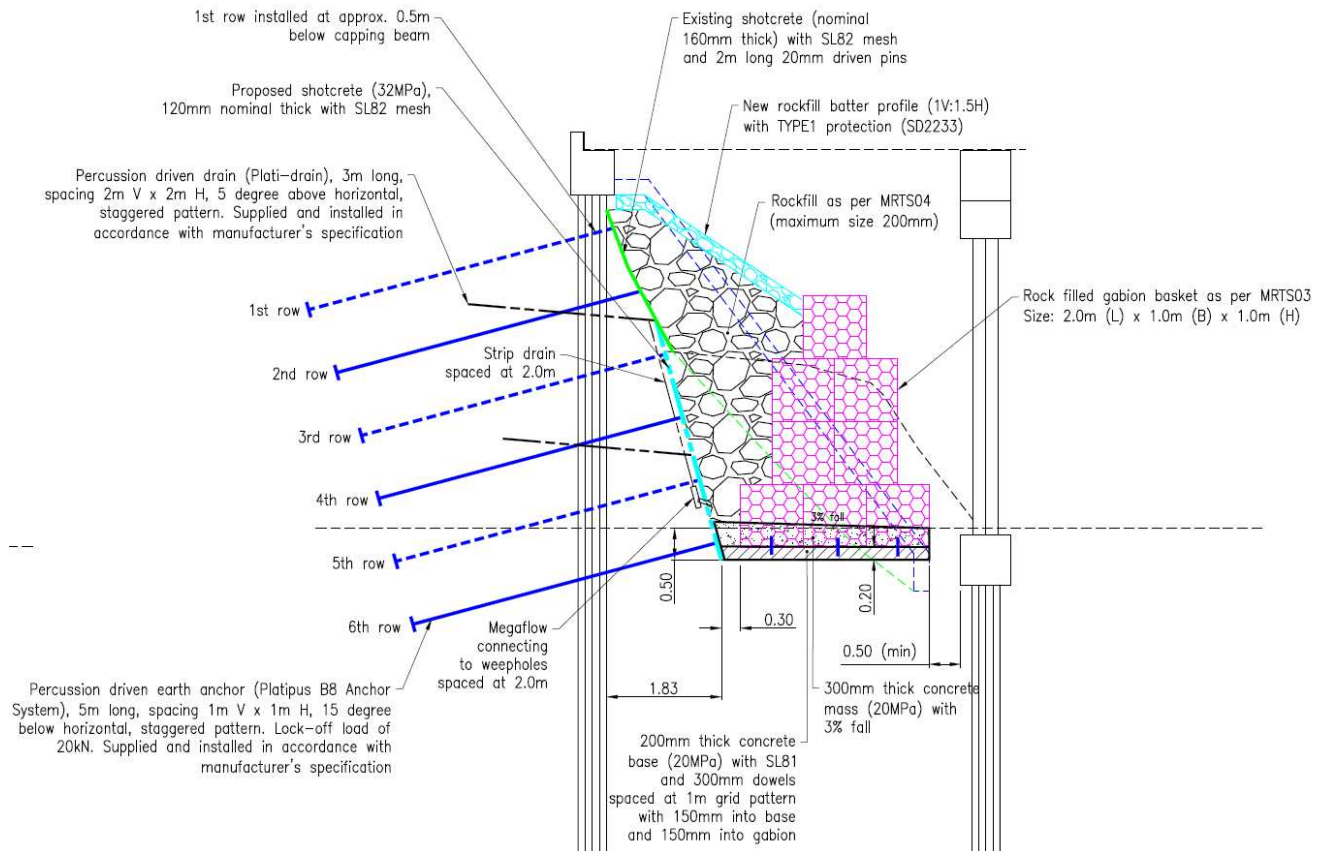
Figure 4. Permanent remediation of the bridge abutment.

- Installation of percussion anchors (300 millimeters wide head, 20 kilo Newton lock-off load) via slots cut into existing shotcrete (urgent works) at 1 meter vertical and horizontal spacing in a staggered pattern.
- Staged excavation at 1.2 meters lifts, followed by installation of percussion anchors, mesh and shotcrete, a row at a time until the toe of excavation was reached for formation of foundation for gabion.
- Installation of percussion drainage (three meters long by two rows at two meters staggered spacing).

It is worth noting that percussion anchors were chosen as they are quick to install, do not need specialized equipment, suit the application in a small space, and can be loaded soon after installation. Figure 4 shows the final design adopted to remediate the bridge abutment.

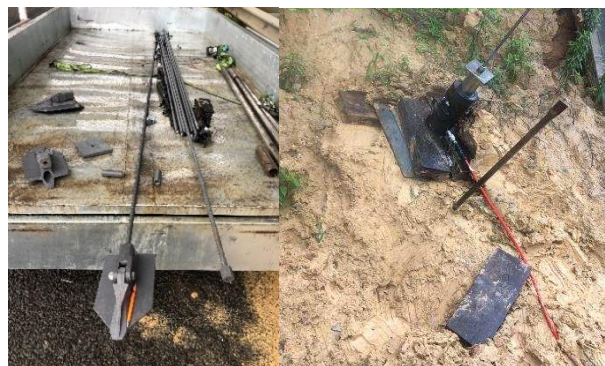
The construction of the remediation works commenced in May 2022. The appointed contractor proposed an alternative anchor head size to the size proposed in the design. This was mainly to accommodate a smaller machine to drive the percussion anchors. The proposal was accepted provided that the working load of 80 kilo Newton could be achieved. Three test anchors (180 millimeters head size) were tested prior to the commencement of production anchors. Two of the anchors achieved >25 kilo Newton and the test had to be terminated due to soft material around the collar (Figure 5). One anchor was tested to 100 kilo Newton (at 850 millimeters extension) and the test was terminated as the load reached 80 per cent of ultimate breaking load of the steel tendon, 120 kilo Newton. On that basis, the proposed 180 millimeters anchor head was accepted as the minimum size that could be used. However, during construction, a mixture of 180-millimeter and 300-millimeter head sizes were used since there was a supply issue with the smaller heads. No issues were encountered during installation of the anchors.

Figure 5. Percussion anchor (180-millimeter head) and load testing.

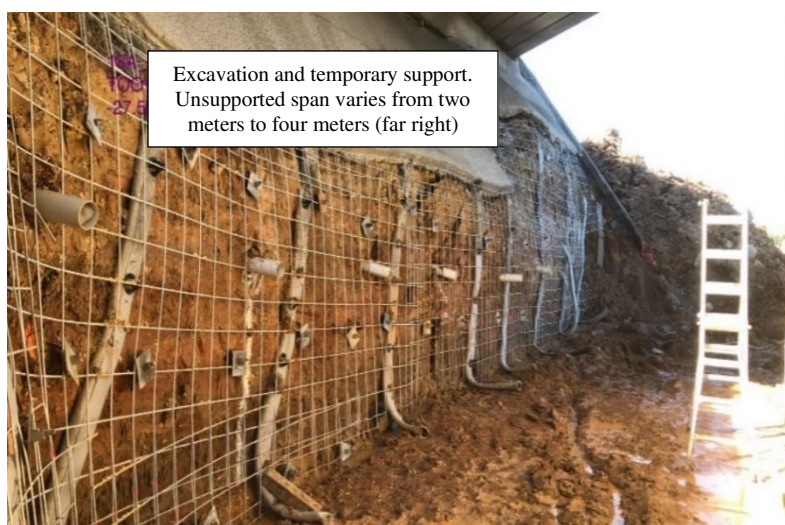
The excavation, anchor installation, and shotcrete application progressed well for the first three rows of anchors, after which, the contractor inadvertently excavated to full depth not following the support sequences specified in the design drawings. This resulted in the exposure of the slope face between 2-4 meters high without full protection. Consequently, approximately, 0.5 meter thick soil movement occurred behind the highest exposed face (Figure 6) with displacement of 250 millimeters in shotcrete below the headstock. On the same day, 13 millimeters of rainfall exacerbated the movement. Additional rows of anchors and steel mesh were installed to stabilize the movement. As a precautionary measure, the highway speed was also reduced to 60 kilometers per hour to minimize any vibration-induced movements. Surveillance was also increased to ensure safety was not compromised. The rate of the movement reduced after the installation of additional support measures and ceased two days after shotcrete application was completed (Figure 7).

Figure 6. Excavation completed to formation level. The abutment is supported with percussion anchors and reinforced shotcrete. Note larger unsupported span on the far right.

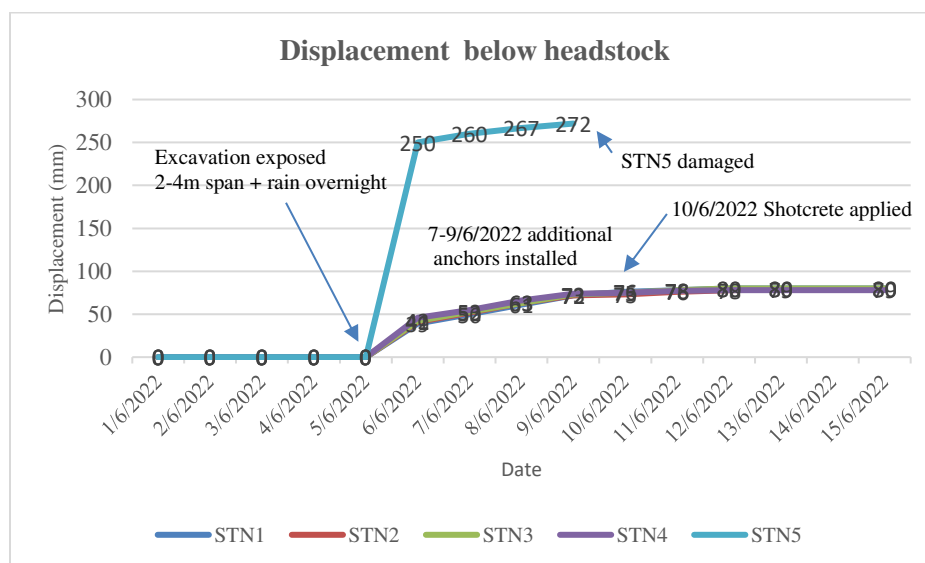
Figure 7. Displacement (mm) in shotcrete below headstock. Station 5 (STN5) located on far right. Displacement ceased two days after shotcrete application.
