# Images Collected from the Internet Reveal the Failing Mechanism of the Tailing Dam Breach at Kolontar, Hungary

**ABSTRACT:** The failure of the red sludge tailing dam at Kolontar in 2010 was the most severe environmental disaster in the history of Hungary. The official investigations are confidential because the legal case has not been closed. The publicly accessible information from the breach of the dam are the photographs taken by the media and news agencies. Collecting these images and analyzing the recorded fractures and displacements of the dam reveal the failing mechanism. The breach of the dam resulted from failing to sliding, which had been developed in three stages. This conclusion is consistent with the observed movements of the dam deduced from a persistent scattered radar interferometry deformation analysis conducted between 2003 and 2010.

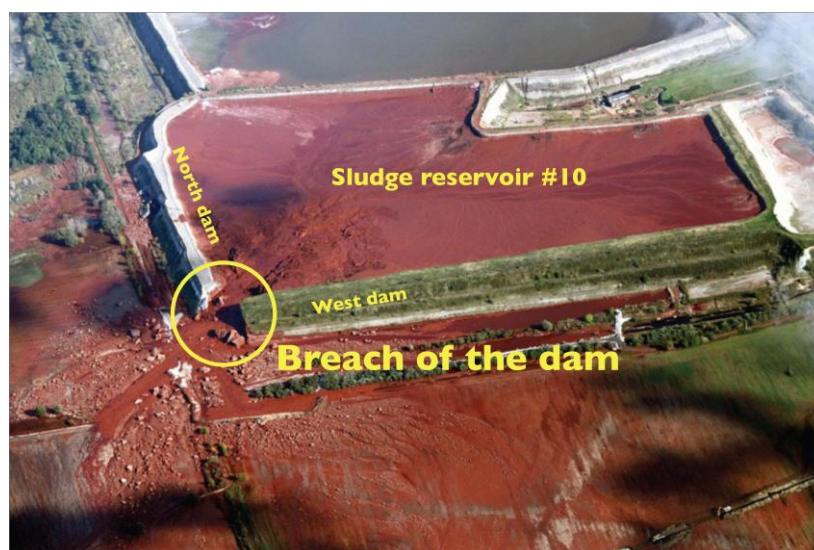
**Figure 2.** Aerial photo of the breach of the tailing dam.  
(Source: <https://www.ndtv.com/world-news/hungarys-toxic-sludge-spill-as-big-as-gulf-oil-leak-435094>.)

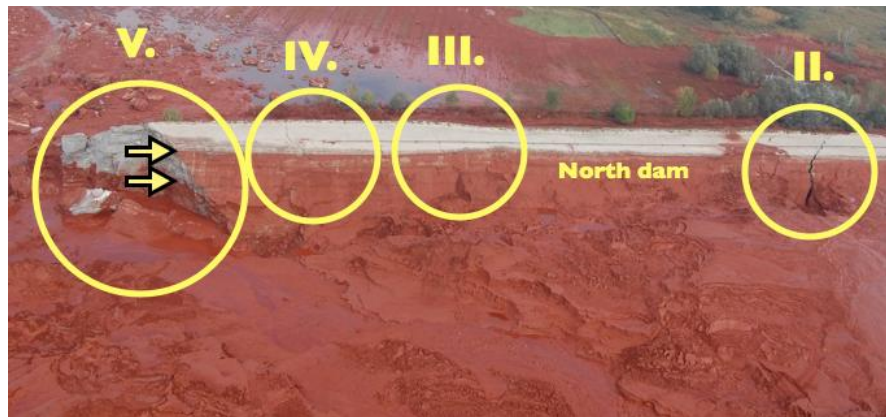
At Location V, the mark of the red sludge on the fracture (Figure 8) is lower than the original one, which indicates that this fracture occurred after the breach, when the sludge level in the reservoir was already lowered.

**Figure 8.** Photo showing fracture Locations II-V. The red mark of the sludge on the open surface of the fracture at Location V is shown. This mark is much lower than the original level in the reservoir, indicating that this fracture was formed after the breach, when the sludge level was significantly lower. (Source: <http://toleducation.org/achievements/red-legacy/>.)

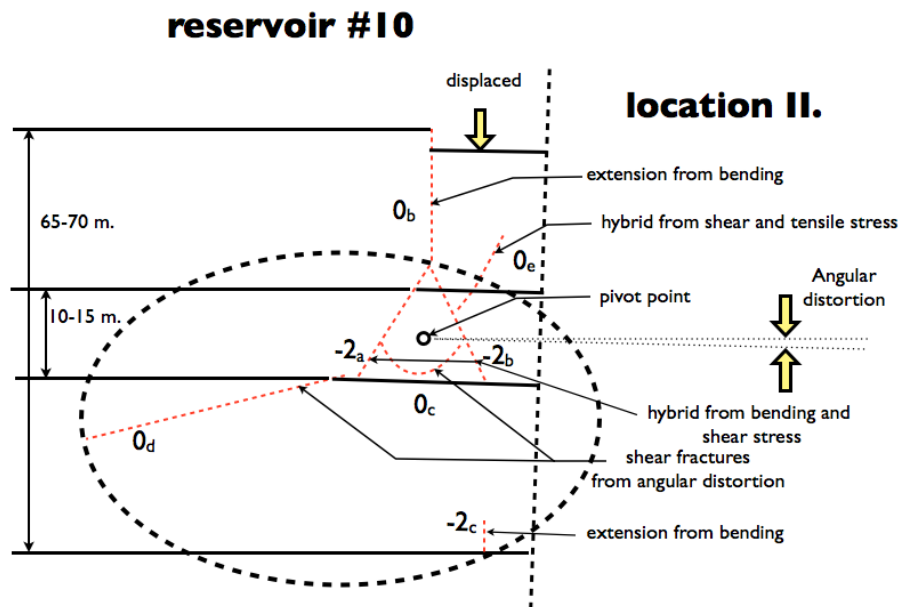
Location II is in the middle of the North dam. The fracture pattern is quite complex. Based on the fracture pattern, it can be identified that the fractures  $-2_a$  and  $-2_b$  relate to bending (Figure 6). The tension side of the bending was the outer side of the reservoir. However, on this side (outward from the reservoir), shear fractures  $0_c$  and  $0_d$  are also present, indicating compression stress on the same side (Figures 4 and 5).

**Figure 13.** The identified fractures at Location II are shown. Dashed circles mark fractures, formed from compression and tension in the same location. The coexistence of the extension and shear fractures in the same location can only be possible if the stress conditions changed in time.
