## Effect of Dredging and Axial Load on a Berthing Structure

Muthukkumaran K., Sundaravadivelu R., Gandhi S.R. (2007). *Effect of Dredging and Axial Load on a Berthing Structure*. International Journal of Geoengineering Case histories, <http://casehistories.geoengineer.org>, Vol.1, Issue 2, p.73-88.

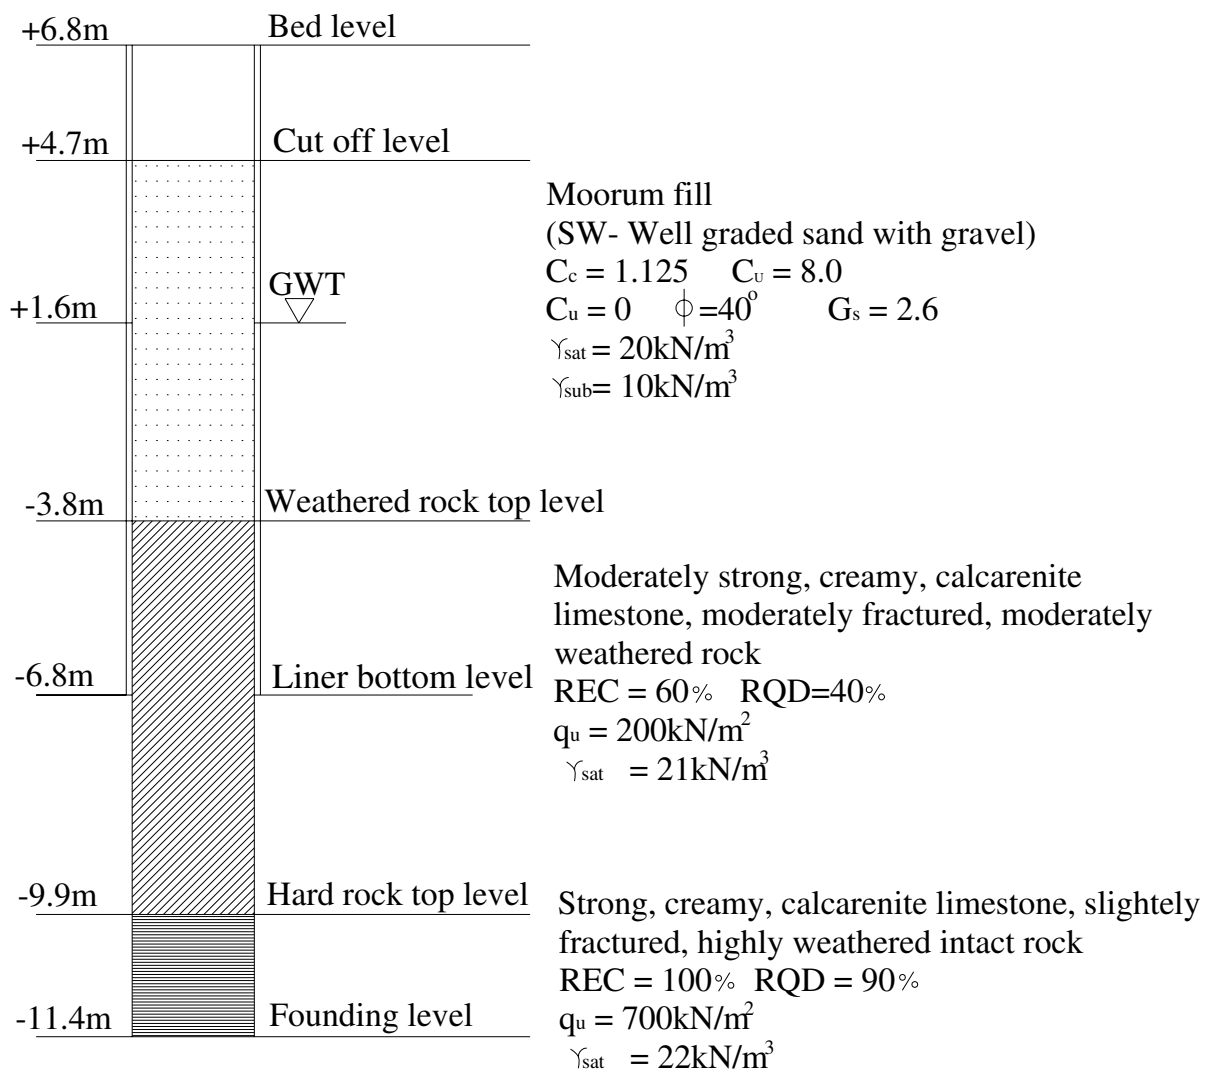
Figure 1. Typical Soil Profile at Pile Load Test Location.

A typical soil profile at the location of pile load test is shown in Fig. 1. The top 10.5 m consist of filled moorum soil, followed by rocky formation. The index and engineering properties of the encountered soils and rock are as follows.

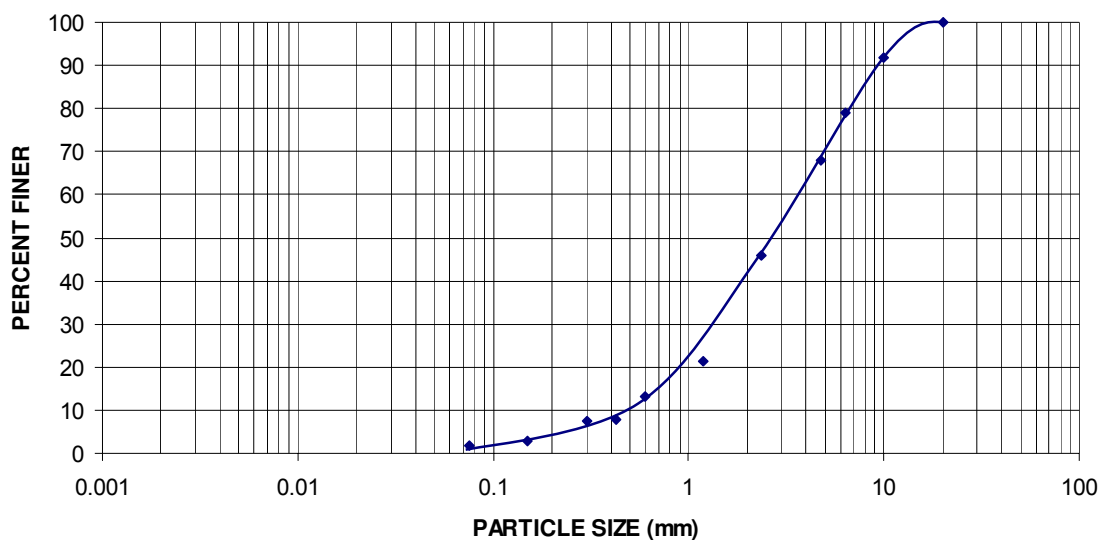
A typical grain size distribution curve of moorum fill is shown in Fig. 2. The effective particle size ( $D_{10}$ ) is 0.5 mm, average particle size ( $D_{50}$ ) is 2.7 mm, Coefficient of Uniformity ( $C_U$ ) is 8.0, Coefficient of Curvature ( $C_C$ ) is 1.125 and Specific Gravity ( $G_s$ ) is 2.6. As per ASTM D-2487, the moorum fill soil is classified as well graded sand with gravel (SW). To obtain the value of angle of internal friction, direct shear tests were conducted on the moorum soil. The average angle of internal friction of the moorum soil was estimated to be  $40^\circ$ . Typical direct shear test results are presented in Fig. 3.

Figure 2. Grain Size Distribution Curve for Moorum Soil.

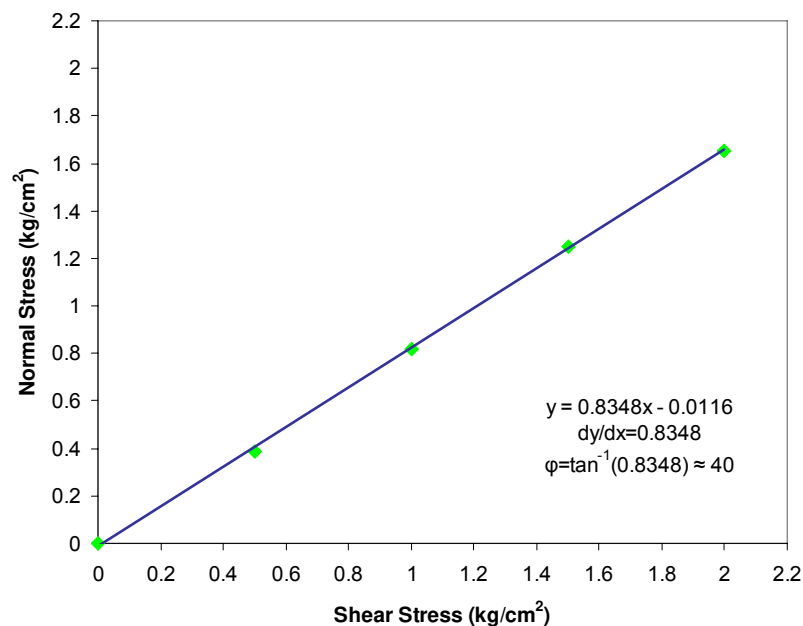
Figure 3. Direct Shear Test Result of Moorur Soil.

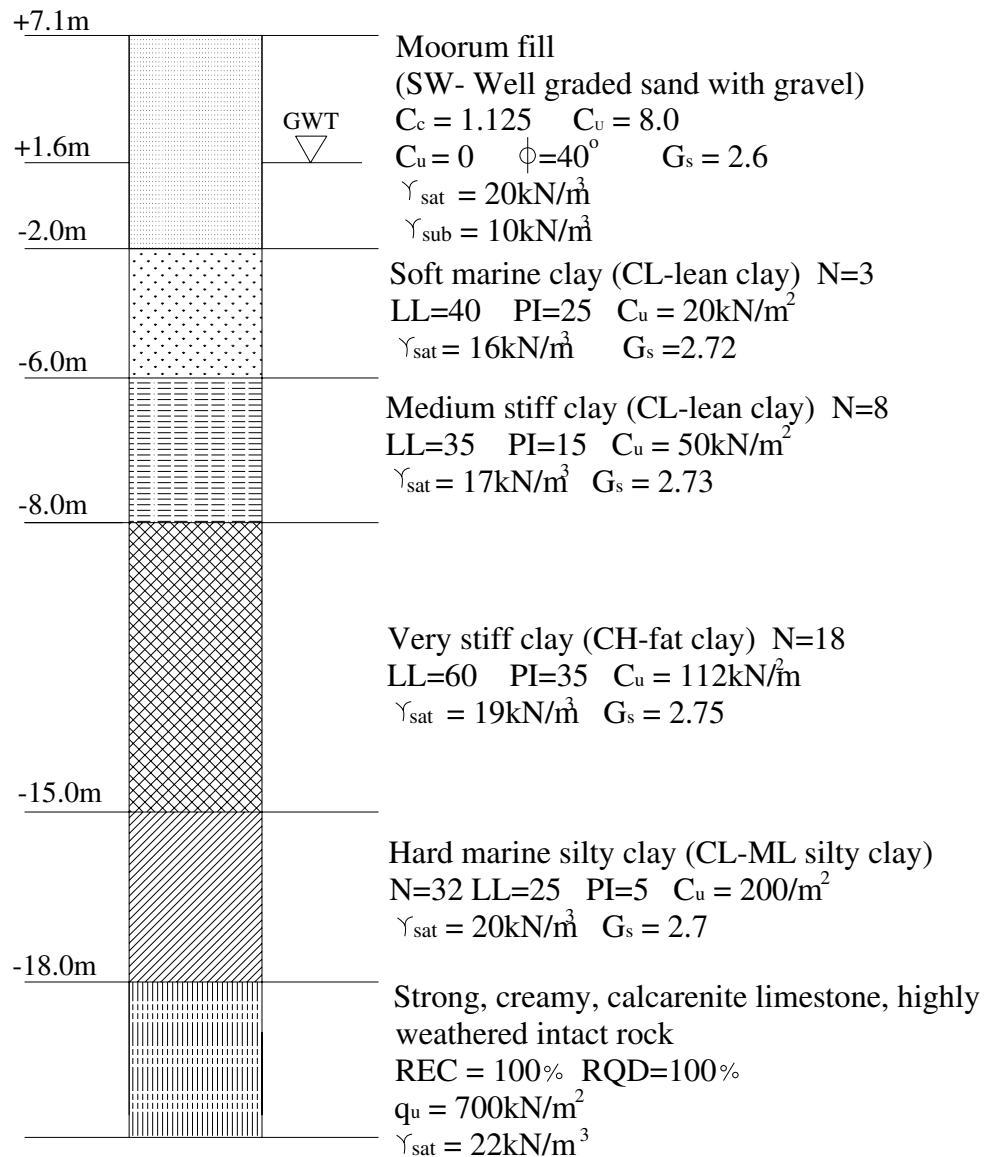
Fig. 4 shows the typical soil profile at the pile and diaphragm wall panel locations where the inclinometer was installed. The top soil is moorum fill of 9.1 m thickness followed by 4 m soft marine clay with an average SPT (N) value of 3, followed by 2 m thick medium stiff clay with an average SPT (N) value of 8, followed by 7 m thick, very stiff clay with an average SPT (N) value of 18. The clay is underlain by 3 m thick hard marine silty clay with an average SPT (N) value of 32 which in turn is underlain by strong, creamy, calcarenite limestone, highly weathered intact rock with REC value of 100% and RQD value of 100%. Based on the RQD values, the encountered rock formations are classified as excellent rock. The index and engineering properties of the moorum soil are identical to the pile load test location moorum soil, presented previously. The encountered fine-grained soils index and engineering properties are presented below.

Figure 4. Typical Soil Profile at Inclinator Test Locations.

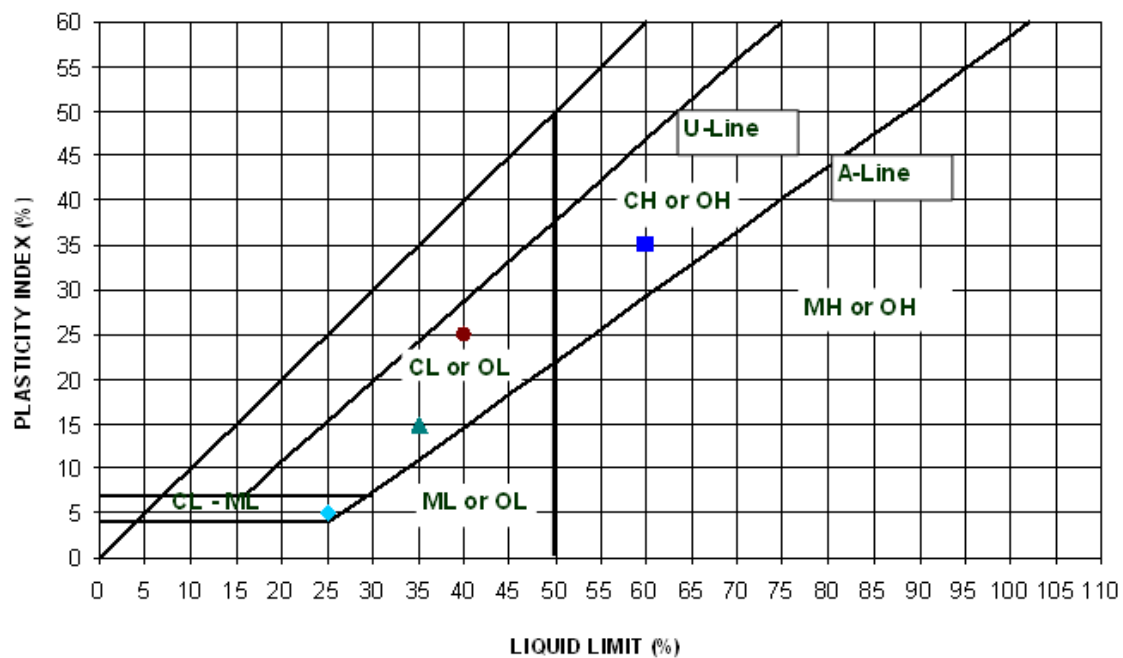
| Elevation (m) | Symbol | LL (%) | PI (%) | Passing # 200 Sieve, (%) | USC Classification |
| -2.0 to -6.0 | ● | 40 | 25 | 70 | CL (Lean Clay) |
| -6.0 to -8.0 | ▲ | 35 | 15 | 60 | CL (Lean Clay) |
| -8.0 to -15.0 | ■ | 60 | 35 | 80 | CH (Fat Clay) |
| -15.0 to -18.0 | ◆ | 25 | 5 | 40 | CL-ML (Silty Clay) |

Figure 5. Classification of fine grained soil (ASTM D2487)

To obtain the index and engineering properties of the fine-grained soils, disturbed and undisturbed soil samples were collected at different depths. Liquid limit and plastic limit tests were conducted on the collected soil samples, to classify the soils based on the Unified Soil Classification System (USCS). The classification of the encountered fine grained soils is presented in Fig. 5. The undrained shear strength of the encountered fine grained soils was evaluated by conducting in-situ field vane shear tests in the soft clay soil and unconfined compression tests in the collected undisturbed soil samples. Two vane shear tests were conducted at elevations -2.0 m and -4.0 m. The average undrained shear strength of the layer (elevations between -2.0 m & -4.0 m) was obtained as 20 kN/m². The vane shear computations are presented in the appendix. The unconfined compression tests were conducted on the undisturbed soil samples collected at elevations of -6.0 m, -8.0 m, -11.0 m, -13.0 m, -15.0 m and -17.0 m. The typical unconfined compressive strength variation plot for elevations of -6.0 m, -11.0 m and -15.0 m are shown in Fig. 6a, 6b and 6c respectively. The average undrained shear strength of lean

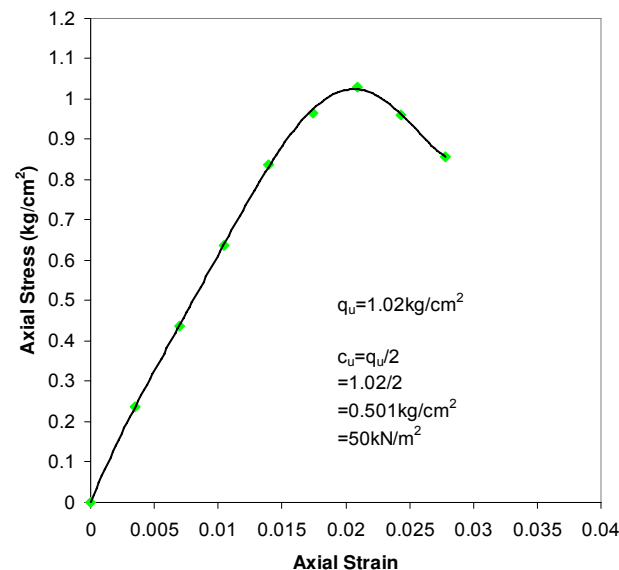
Figure 6a. Unconfined Compression Test Result at -6.0m depth.

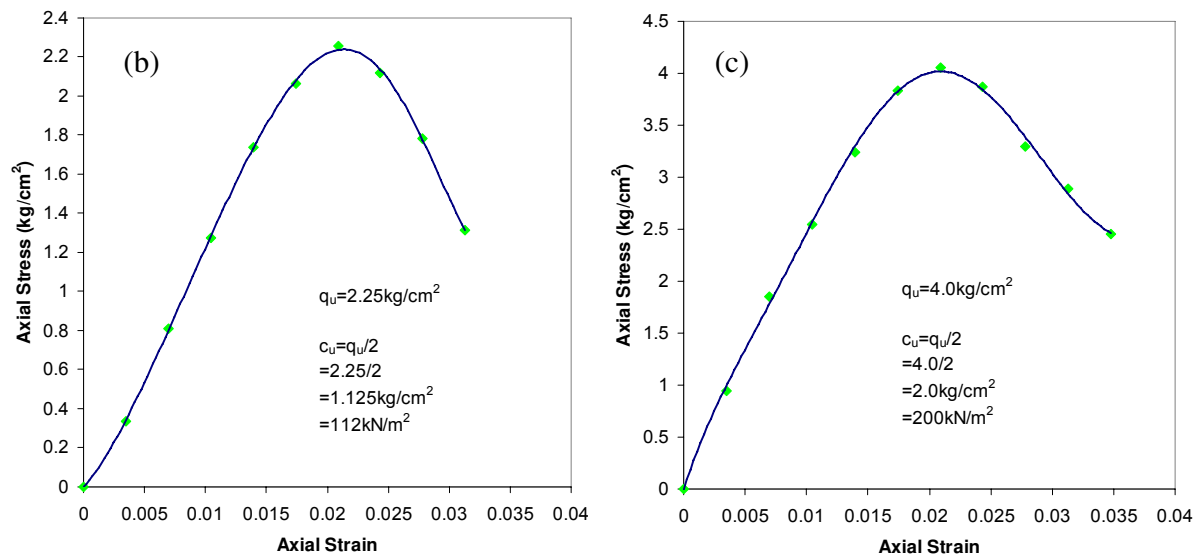
Figure 6b. Unconfined Compression Test Result at -11.0 m depth; 6c. Unconfined Compression Test Result at -15.0 m depth.

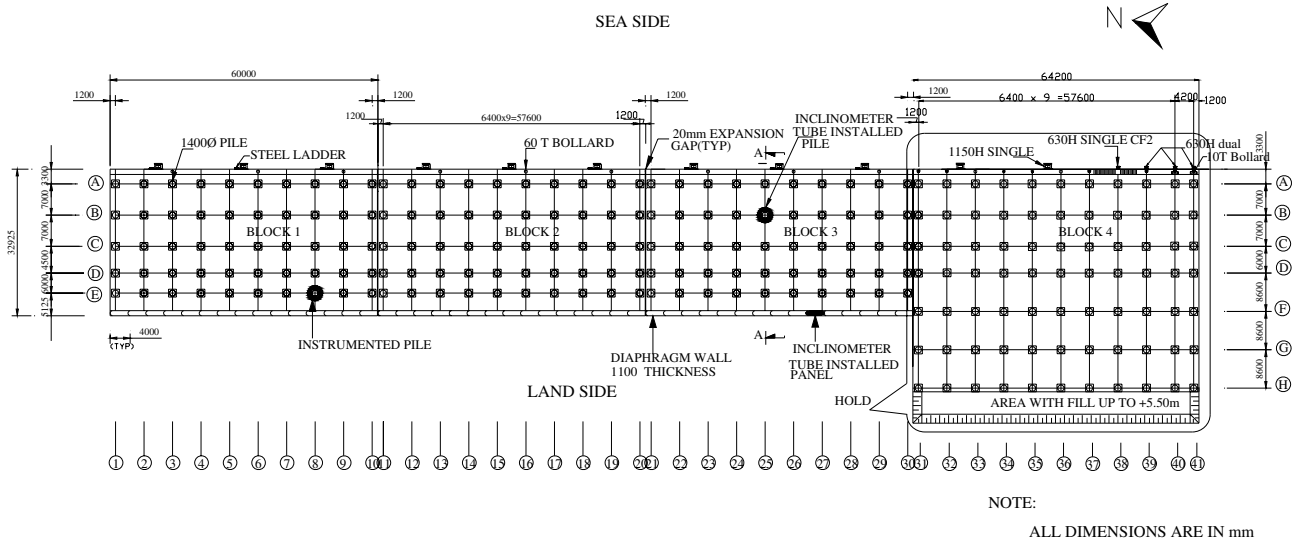
Figure 8. General Layout of Berthing Structure.

The general layout of the berthing structure and a cross section of the berth is shown in Fig. 8 and Fig. 9 respectively. The total length of the berth is 252 m and the width is 33 m. The berth is supported by both piles and the diaphragm wall. The diaphragm wall thickness is 1100 mm and extends to an elevation of -25.7 m. The construction of guide walls for the diaphragm wall is shown in Fig. 10. The diaphragm wall is constructed with the appropriate number of panels and each panel has a length of 5.0 m. Bored cast in-situ concrete piles of 1400 mm diameter are used and the founding elevation is varied between -11.4 m and -22.0 m based on the soil profile. The axial load test pile is terminated at an elevation of -11.4 m and the instrumented with inclinometer pile is terminated at an elevation of -22.0 m. The construction sequence of piles is shown in Fig. 11. The bored cast in-situ concrete piles were constructed using piling gantry. The natural seabed level at the structural location is +0.0 m elevation. To satisfy the berthing facility of the vessel, the ground level is required to be dredged up to an elevation of -9.5 m. The dredging was done in three stages, in each stage 3.0 m thick material is dredged. The inclinometer readings were collected when the water elevation in front of the structure was -3 m (prior to dredging) and -9.5 m (after -9.5 m dredging). Two sets of readings were collected at -9.5 m elevation, one immediately after dredge level reached an elevation of 9.5 m and the other 3 months after the first set of readings to evaluate time effects.

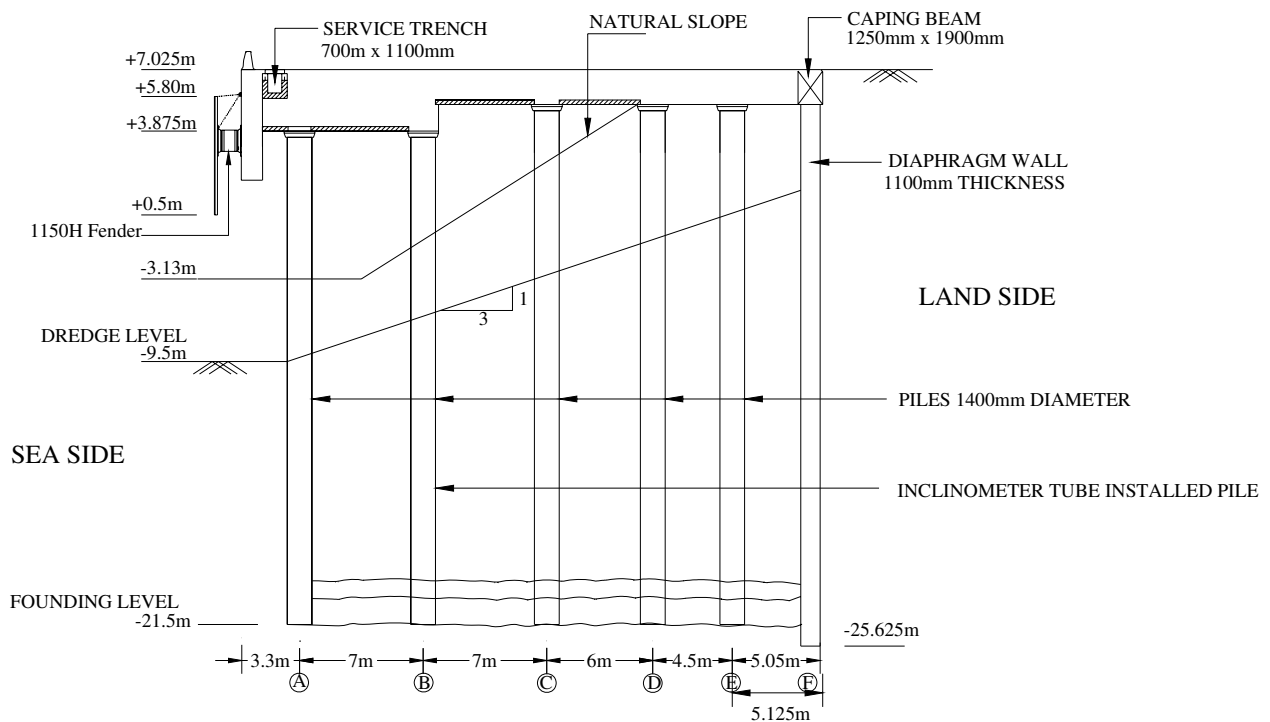
Section A-A  
Figure 9. Typical Cross Section of Berth.

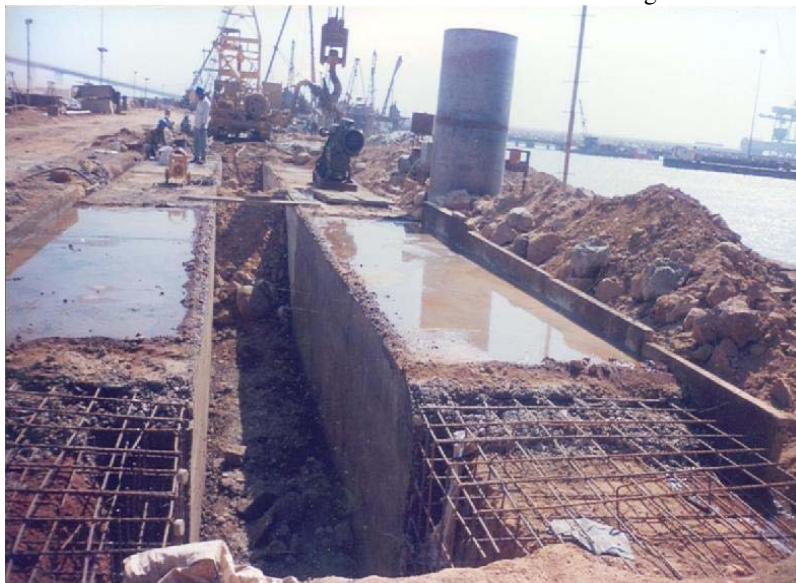
*Figure 10. Construction Of Guide Walls For Diaphragm Wall.*

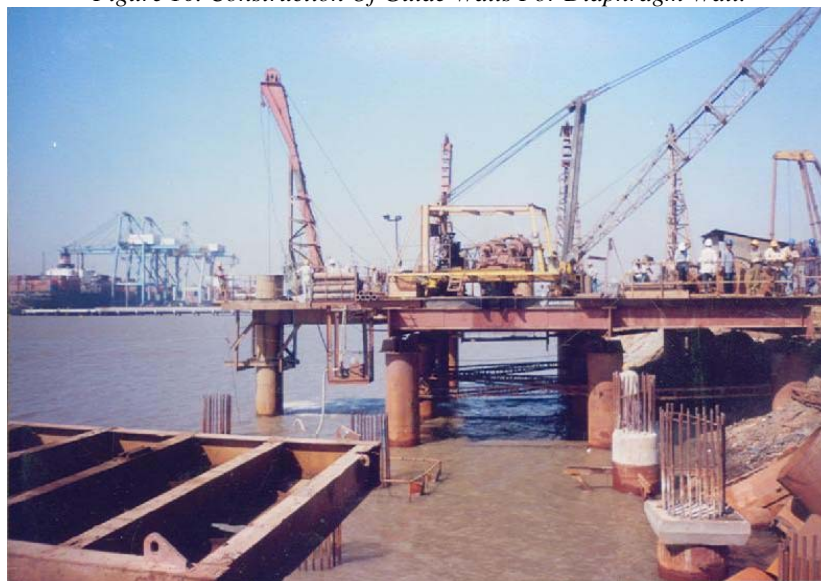
*Figure 11. Construction of Piles.*

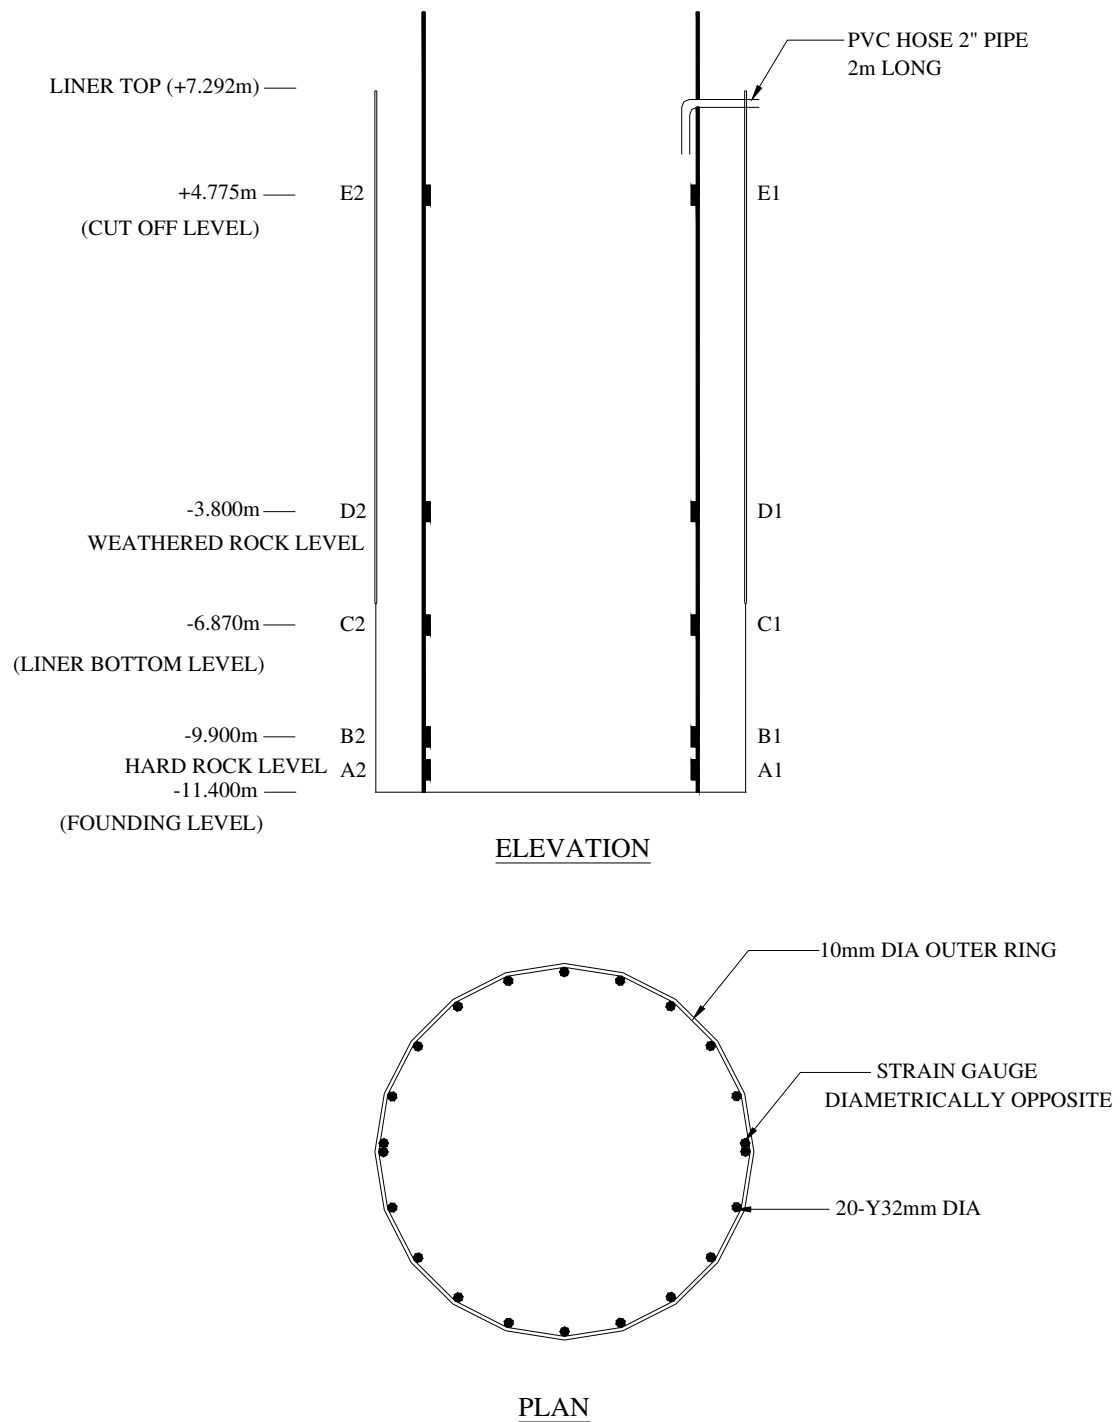
Figure 12. Pile Instrumentation with Strain Gauges.

The test pile is instrumented with electrical resistance type strain gauges. The gauges are attached at five different elevations as shown in Fig. 12. Two diametrically opposite main reinforcement rods are selected to mount the strain gauges. After mounting the gauges, the electric cable from each gauge is safely secured along the reinforcement bar to minimize the possibility of damage by the Tremie pipe during concreting. The cables of the gauges on the same reinforcement rod are bundled together and tied with a plastic wire to the reinforcement rod every 30 cm. The electric cables have a minimum length of 5 m beyond the cut off length to enable connection to the measuring instrument during the load test. All the strain gauges are aligned vertically.

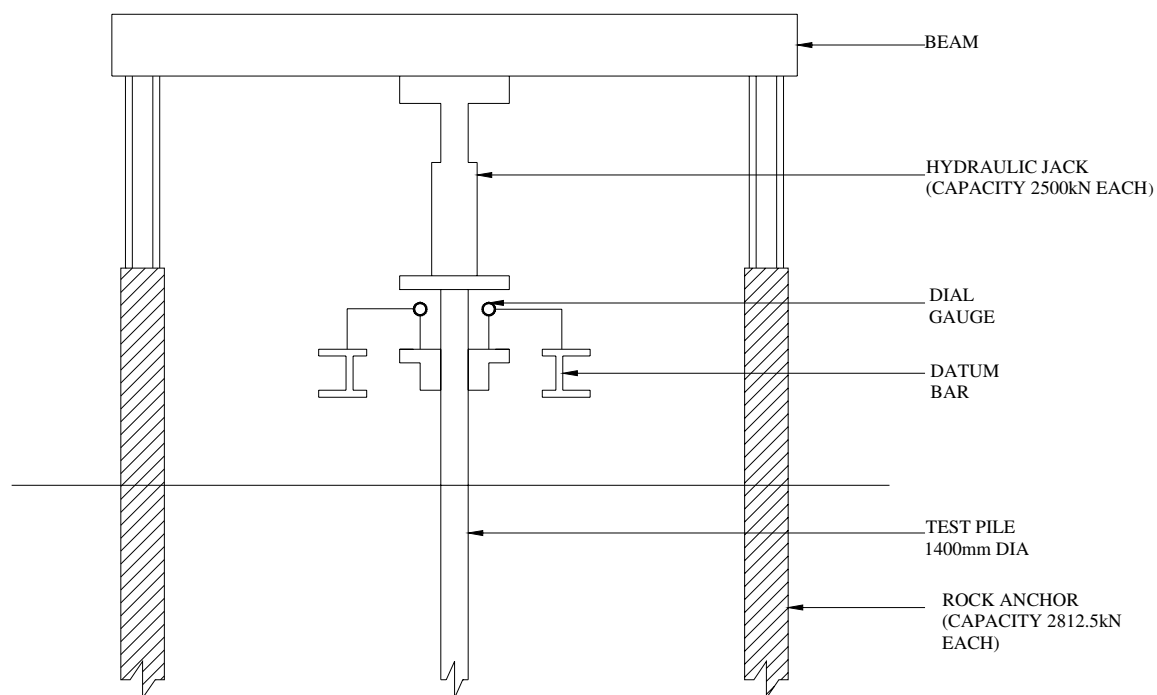
For the axial load test, the load applied on the test pile is obtained by the reaction forces from 4 pre-stressed rock anchors. Each anchor has a capacity of 2812.5 kN. The load on the pile is applied via 4 hydraulic jacks each of 2500 kN capacity. The settlement of the pile is recorded by 4 fixed dial gauges located at the same distance from the center of the pile. These dial gauges are installed on two datum bars with immovable support, at a distance of 3.6 m from the edge of the pile. A schematic view of the pile load test arrangement is shown in Fig. 13.

*Figure 13. Schematic View of Pile Load Test Arrangement.*

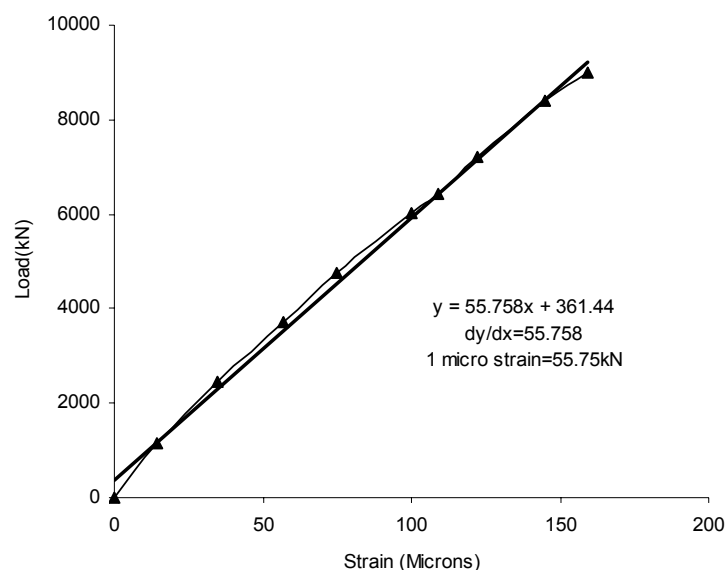
load test, the axial strain of the pile at each level was measured by the read out unit for every increment of loading. Strain gauge readings were taken 10 to 15 minutes after the load increment was applied. To estimate the mobilization of axial load along the pile shaft, the measured strain readings were converted to equivalent axial load by using a calibration constant. To obtain the calibration constant, one strain gauge was embedded in a concrete cylinder of 150 mm diameter and 300 mm long. The strain gauge was oriented such that the axis of strain gauge was parallel to the concrete cylinder axis. The cylinder was cured for 28 days and then tested in compression. The strain readings were observed to be almost linear with applied load. Fig. 14 shows the load as a function of strain. From the graph, the calibration constant of 55.75 kN was obtained, 1 micro strain being equal to 55.75 kN load.

Figure 14. Strain Gauge Calibrations.

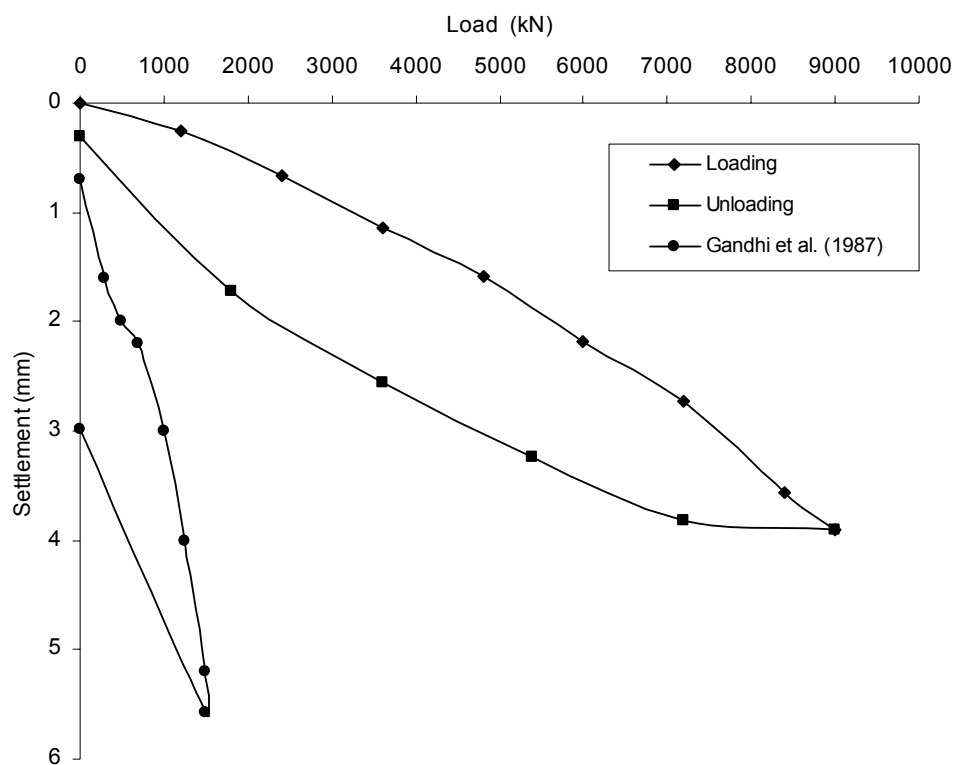
The pile was tested up to 1.5 times the design load, i.e., up to 9000 kN. The load settlement curve is shown in Fig. 15. As per IS 2911 (Part-4) 1985, the maximum settlement at working load (1.5 times design load) may not exceed 12 mm. In the present study, the total settlement was 3.9 mm, rebound was 3.6 mm and net settlement was 0.3 mm, indicating that the pile

behaved well and has not reached its capacity. The pile load test results were compared to the Gandhi et al. (1987) pile load test results, which are also shown in Fig. 15. As presented in that paper, the pile load test was conducted on a 6.5 m long and 0.5 m diameter pile. Out of the 6.5 m, 0.5 m are socketed in hard rock strata. The test was conducted at the NALCO project site, Angul in India. The soil profile at this location includes 3.0 m of red soil with an average SPT (N) value 35, followed by yellowish grey weathered rock with SPT (N) values of about 100. Dark grey hard rock is present at 6.0 m below the ground level. The subsurface stratigraphy of the present study area (JNPT, Mumbai) and Gandhi et al. (1987) study area (NALCO project site, Angul) are not the same and thus, the load-settlement response of the test piles is different.

Figure 15. Load Settlement Curve.

- (1) The total settlement of 3.9 mm was within the settlement limit of 12 mm as per IS 2911 (Part-4) 1985, which indicates that the pile has not reached its capacity.

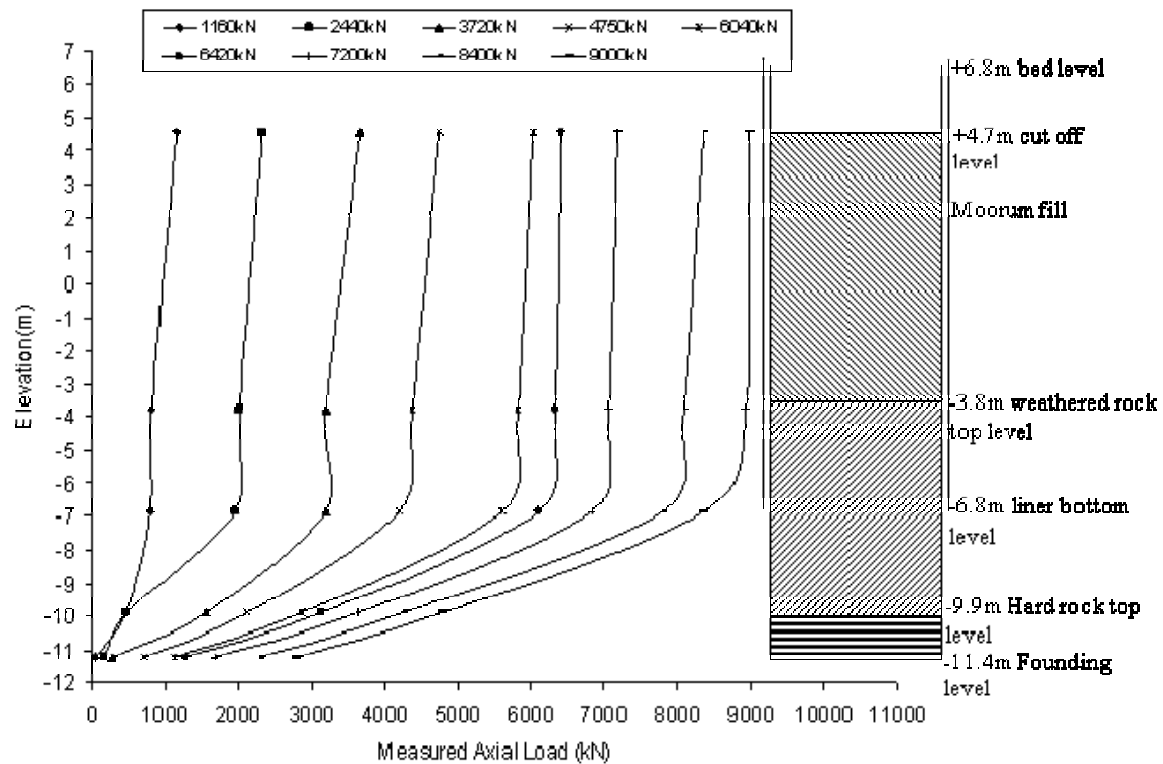
Fig. 16 shows the load resisted by each soil layer. The maximum load is mobilized from an elevation of -6.87 m to -9.9 m, where the weathered rock is present. The mobilization of frictional resistance is not significant at the top layer of moorum fill. Nearly 4000 kN load is mobilized in the weathered rock, 2000 kN mobilized in hard rock, and 2000 kN mobilized in the moorum fill strata under a total applied load of 9000 kN. Only 1000 kN load is resisted by end bearing by the hard rock.

Figure 16. Mobilization of Axial Load.

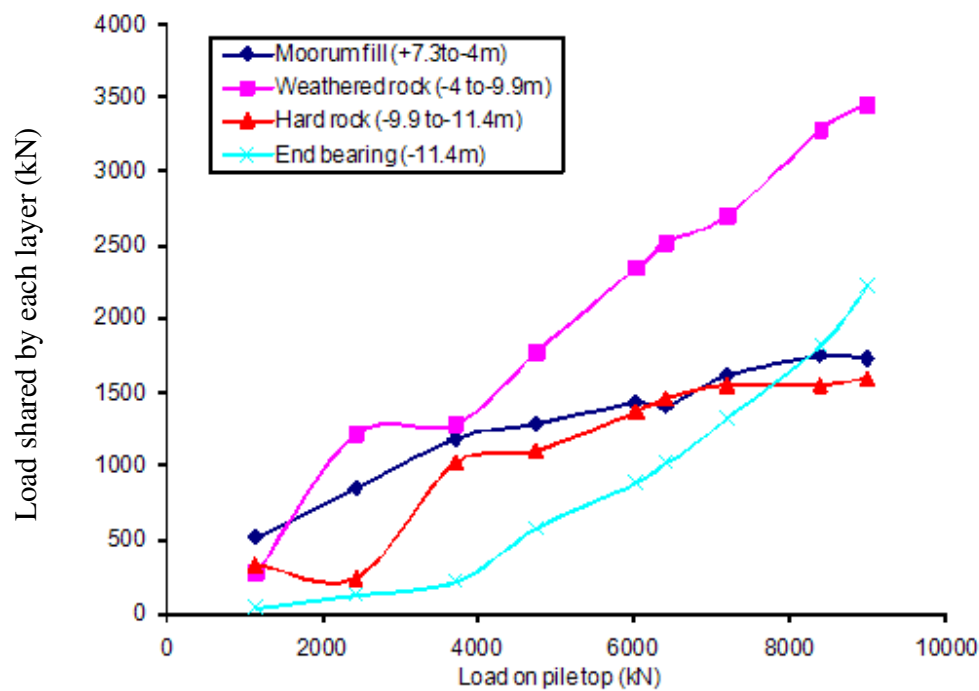
Fig. 17 shows the load shared by each layer for all applied load increments. For all cases except the load increment of 8400 kN and 9000 kN, the frictional resistance was significantly increased in all soil layers compared to the end bearing resistance. For the test load of 9000 kN, the end bearing resistance was higher than the frictional resistances of the moorum fill and the hard rock. However, the mobilization of end bearing was less than the frictional resistance in weathered rock. Nearly 75% of the load is resisted by friction and 25% of the load is resisted by end bearing. The weathered rock contributed about 20% to 45% of the total pile resistance.

Figure 17. Axial Load Shared by Each Layer.

- (2) The weathered rock at the site offered substantial frictional resistance, i.e. about 20% to 45% of the total resistance.
- (3) A maximum of 75% load is mobilized by frictional resistance and the remaining 25% load is mobilized by the end bearing resistance. At higher loads the contribution of the end bearing resistance increases.
- (4) The use of strain gauges was successful in measuring the axial load distribution in concrete piles.

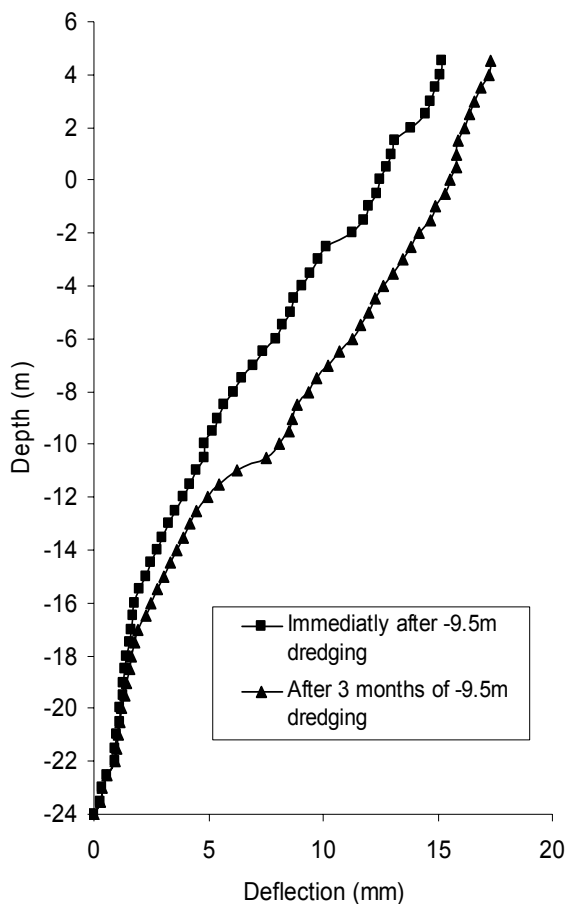
After construction of the full berth, the inclinometer readings were collected in 3 stages. First set of readings were taken after construction of the berth and prior to dredging. This reading represents the initial position of the diaphragm wall and pile. The second readings were collected immediately after dredging to an elevation of -9.5 m. The difference between the second and first reading is the deflected shape of the diaphragm wall panel and pile. The third readings were collected 3 months after dredging to an elevation of -9.5 m. The difference between the third and second reading is shown in Fig. 18 and 19.

It can be observed that for the diaphragm wall immediately after -9.5 m dredging, the maximum deflection is 15.2 mm at the level of +4 m, while at the same level the maximum deflection increased to 17.3 mm after three months. The increase in deflection is probably due to the consolidation and associated pore pressure dissipation effects of the soft clayey soil. The same behavior was observed for the pile also. For both the pile and the diaphragm wall the deflection from -16 m elevation and lower is small compared to the upper layers due to the lower hard layers of marine silty clay and rock.

Figure 18. Deflected Shape of Diaphragm Wall.

- (1) The maximum deflection of 30 mm was measured in the berthing structure after dredging to an elevation of -9.5 m. The permissible lateral movement of the berthing structure was 150 mm and thus the deflections observed were considered small.
- (2) About 87% of the maximum deflection was mobilized at the soft top layers, probably due to the presence of the underlying harder ground materials.

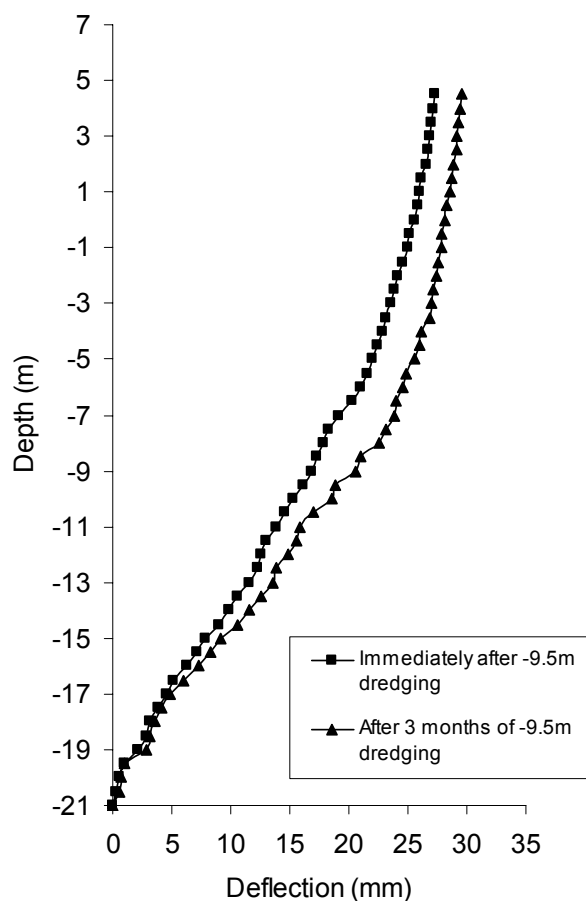
Figure 19. Deflected Shape of Pile.
