## Seismological and geotechnical aspects of the $M_w=6.3$ L'Aquila earthquake in central Italy on 6 April 2009

**Giuseppe Lanzo**, Professor, University of Rome, Italy; email: [giuseppe.lanzo@uniroma1.it](mailto:giuseppe.lanzo@uniroma1.it)

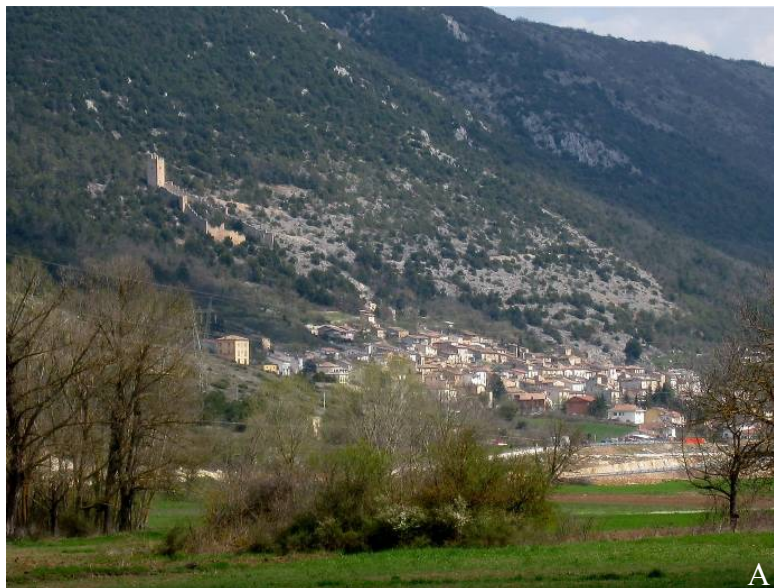
*Figure 61. (A) The village of San Pio delle Camere built on Mesozoic limestone. This picture was taken from the lower flanks of Castelnuovo (from location 42.2898°, 13.6297° looking southeast).*

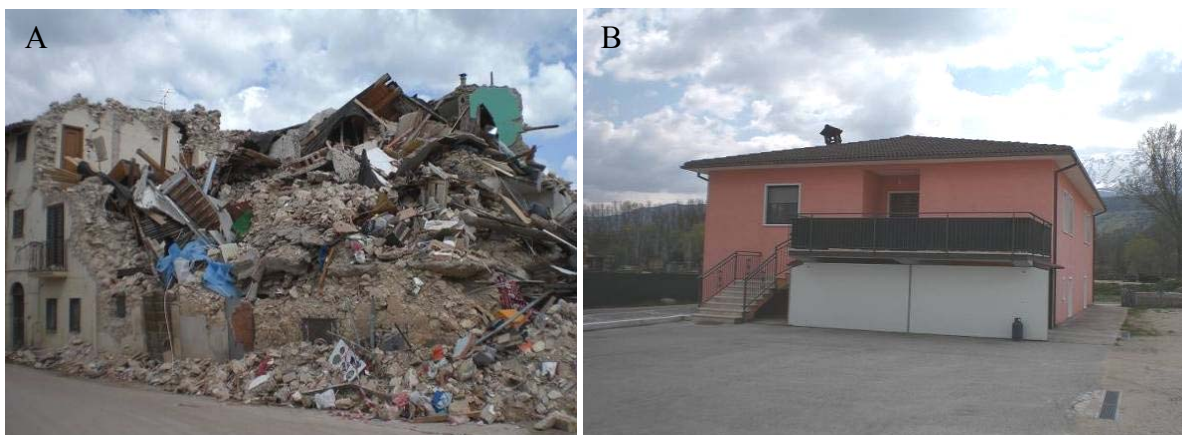
Figure 67. Onna. (A) D5 damage level on masonry building structures, (B) D0 damage on a RC building (except for the tilting of the chimney).

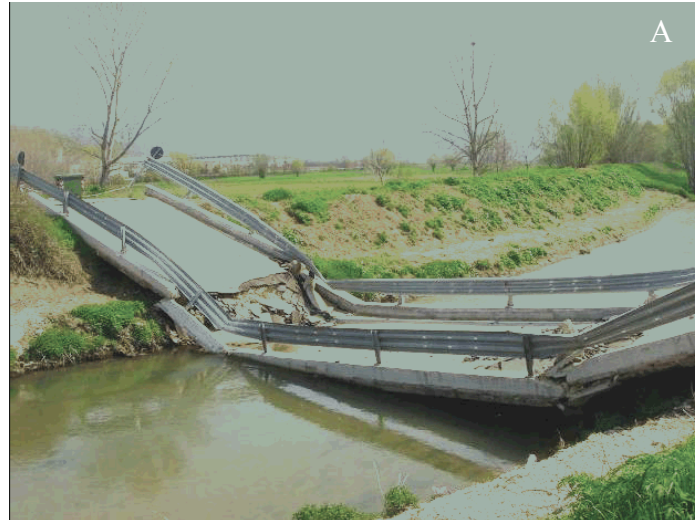
*Figure 68. Onna. (A) Collapse (D5).*

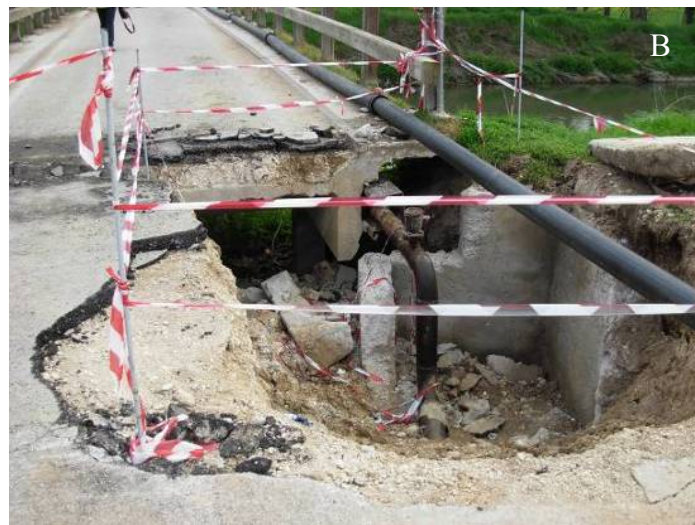
*Figure 68. Onna. (B) Intense damage (D4) of RC bridges on the Aterno river.*

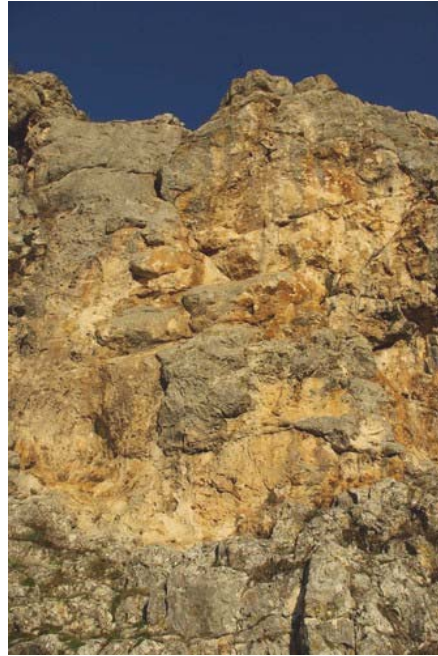
*Figure 69. Monticchio: outcrop of the Jurassic limestone formation.*

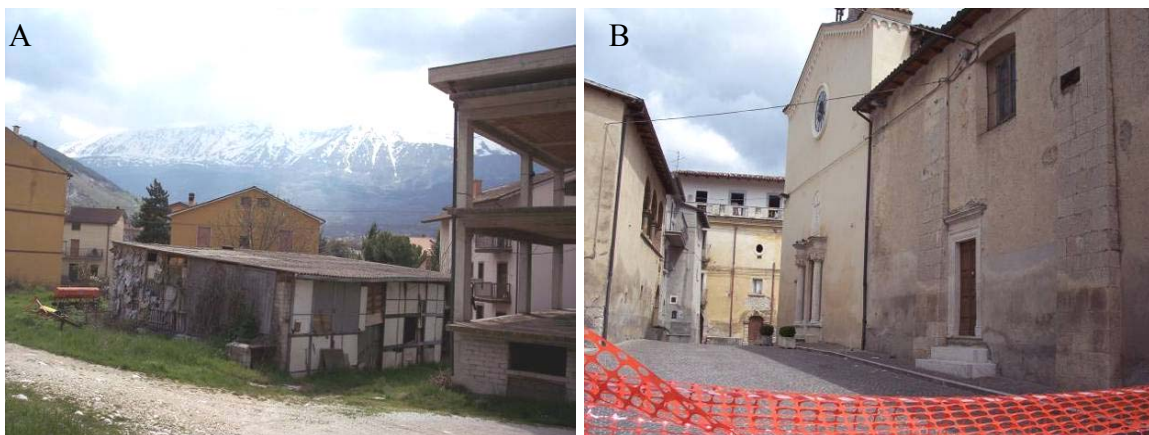
*Figure 70. Monticchio. (A) D0 damage level on different building structures, (B) D0 damage on monumental masonry buildings.*

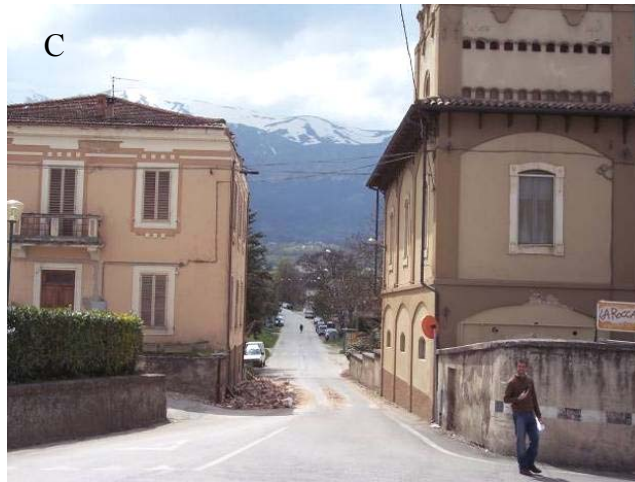
Figure 70. Monticchio. (C) D1 damage (fall of the cornice) on a masonry building.

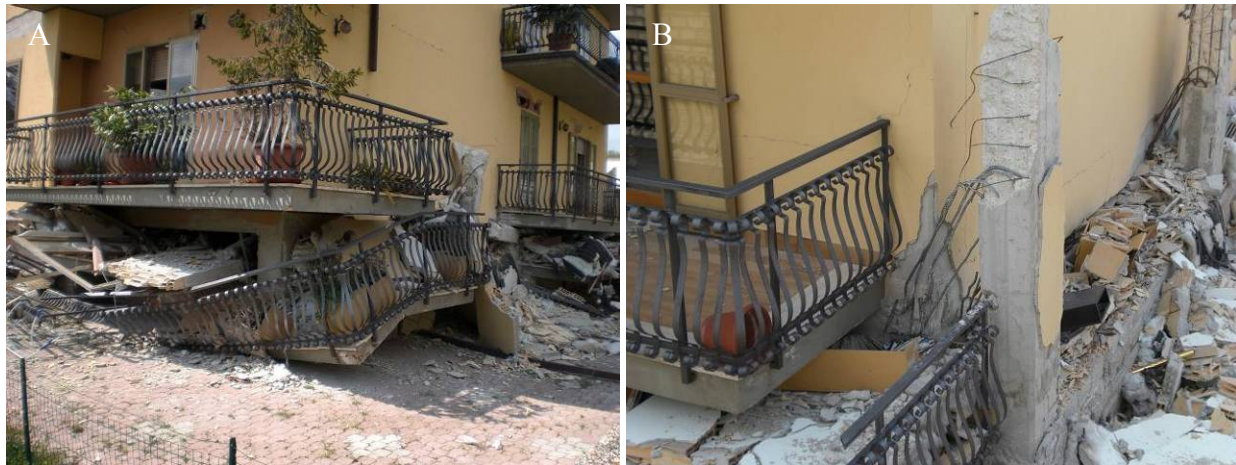
Figure 74. San Gregorio eastern part. (A) RC building “pancake” collapse, (B) Detail of sheared pillars.

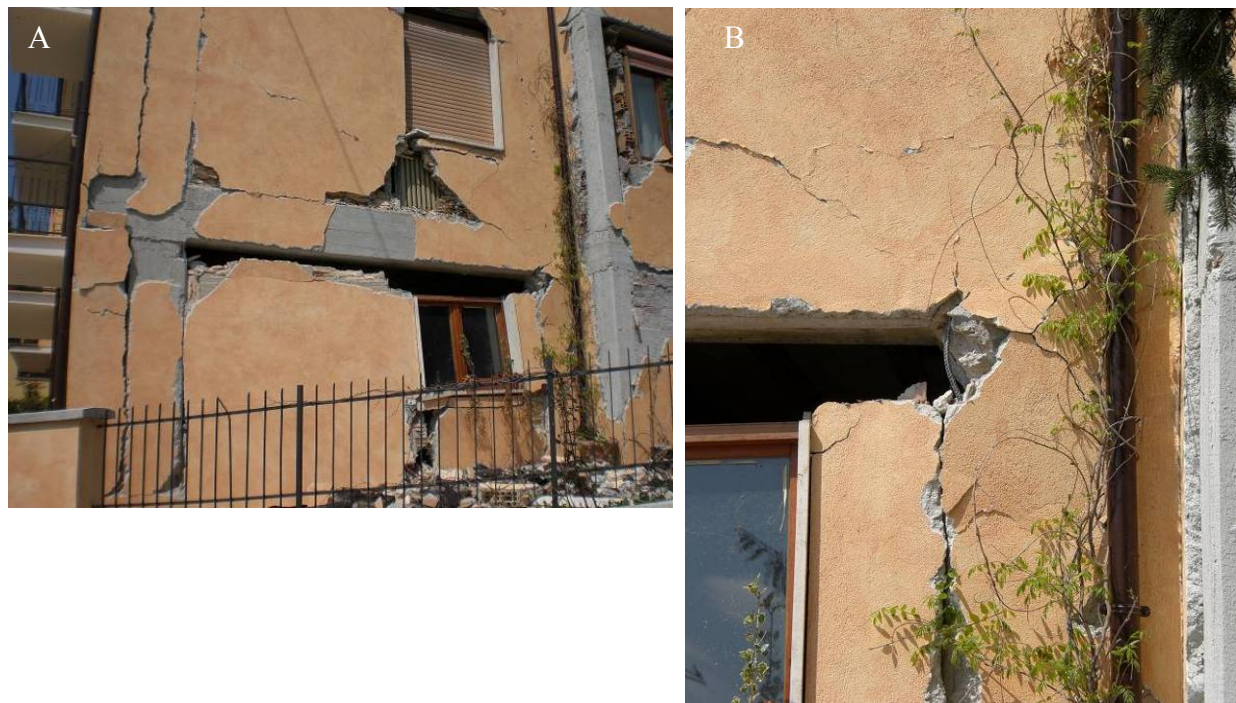
Figure 75. San Gregorio eastern part. (A) RC building with structural damage, (B) Detail of the damage to the beam-column connection.

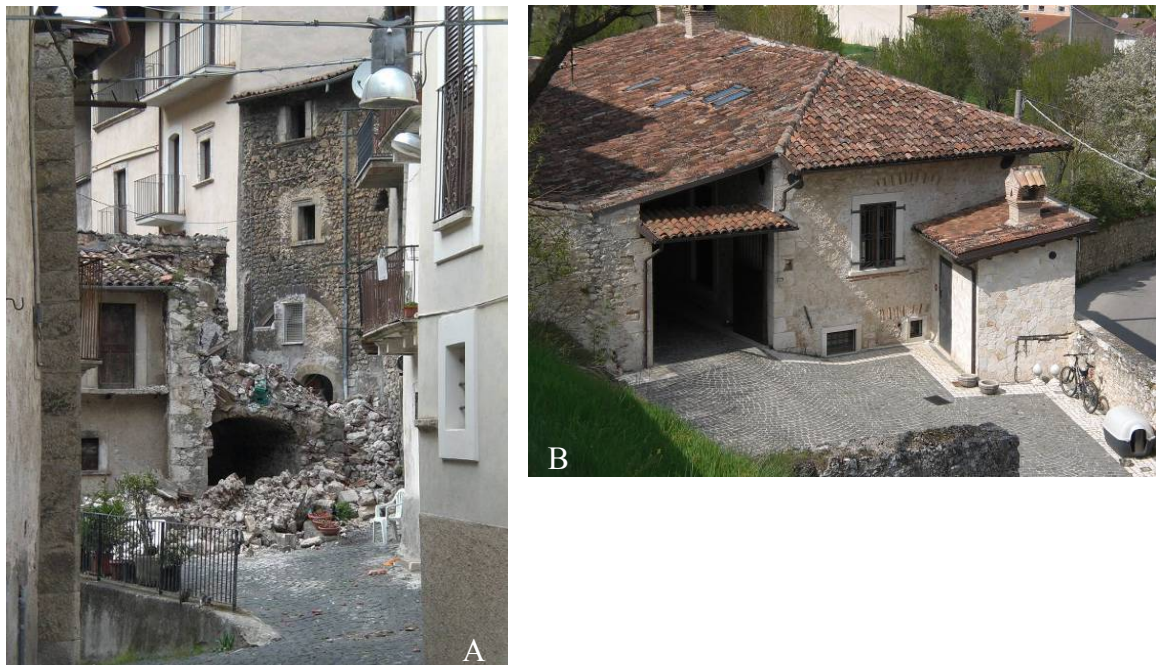
Figure 77. Fossa. (A) Collapse of masonry constructions in the historic center, (B) Strengthened masonry construction with no damage.

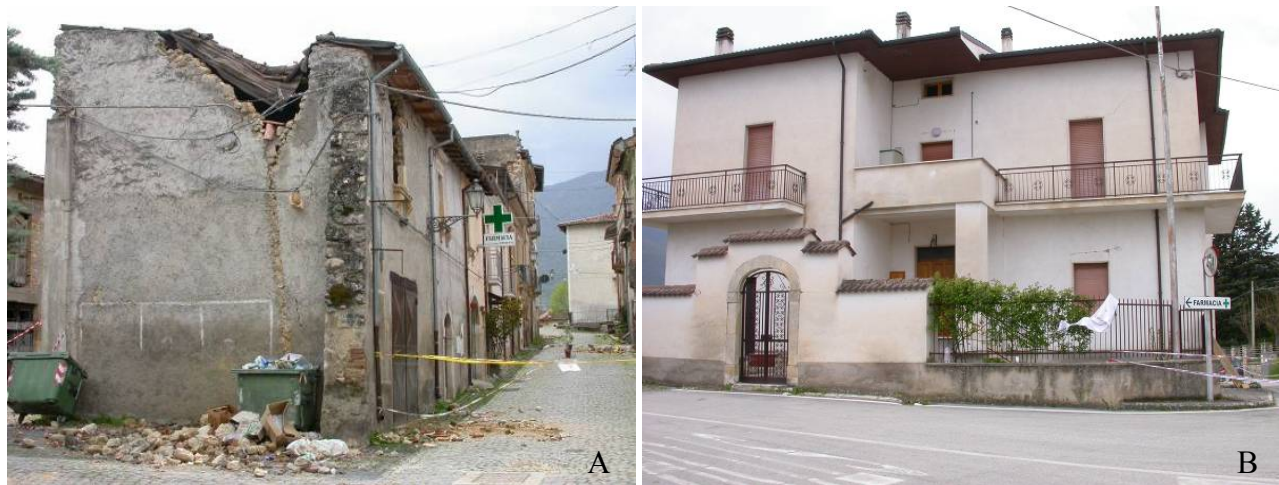
Figure 79. S. Eusanio Forconese village. (A) Partial collapse of masonry building (D4), (B) Slight damage to a RC building nearby (D1).

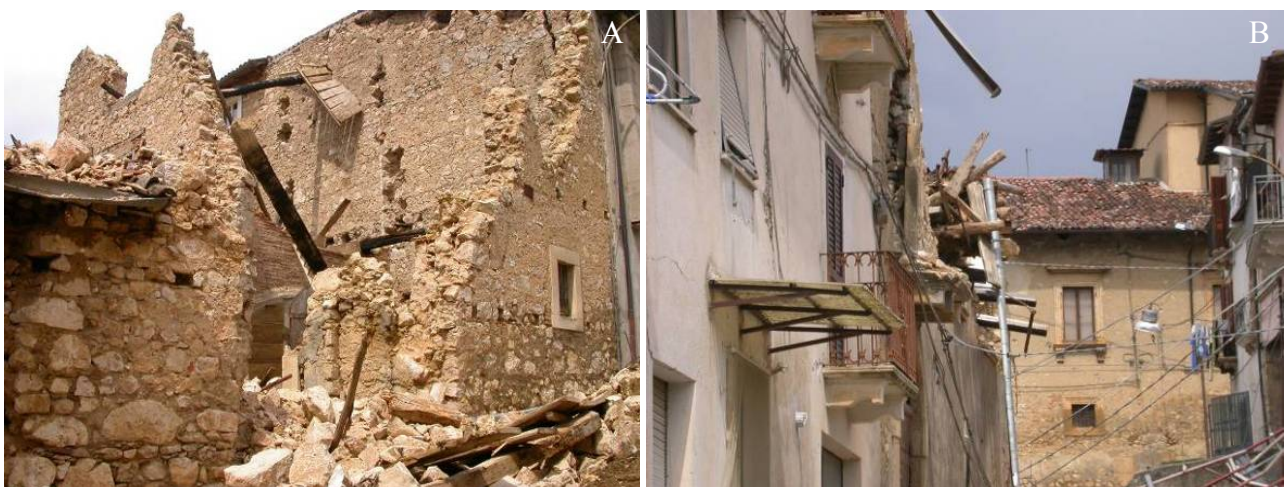
Figure 80. S. Eusanio Forconese. (A) Collapse of old masonry building (D5), (B) Partial collapse of masonry building (D4).

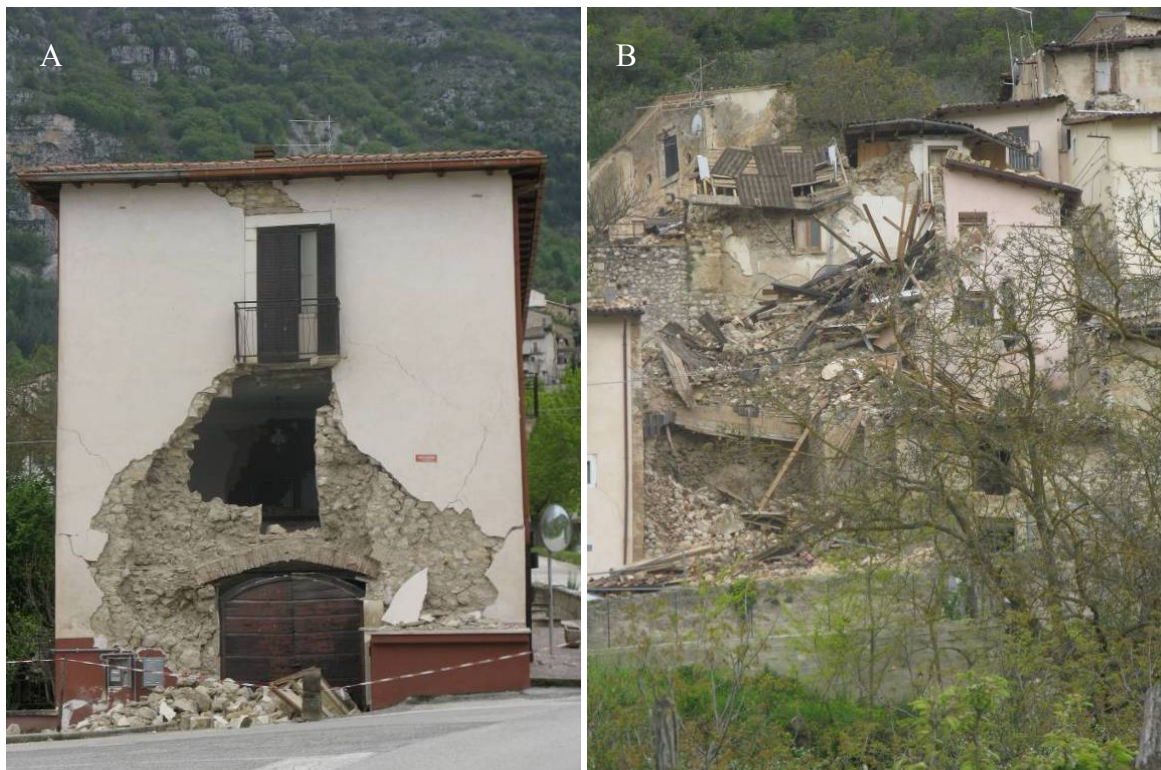
*Figure 82. Casentino. (A) Partial collapse of the masonry building at the entrance of the village, (B) Collapse of old poor quality masonry buildings in the historic center.*

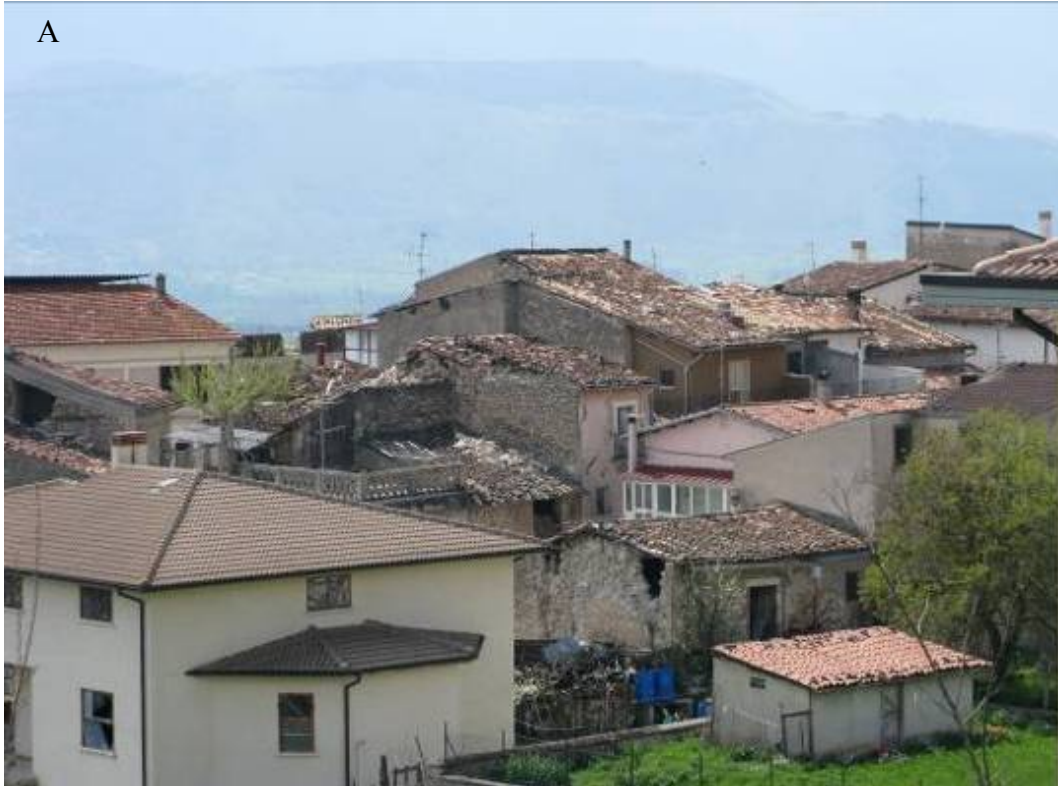
Figure 86. Poggio Picenze. (A) Variable damage (D3-D4) on masonry buildings of different style.

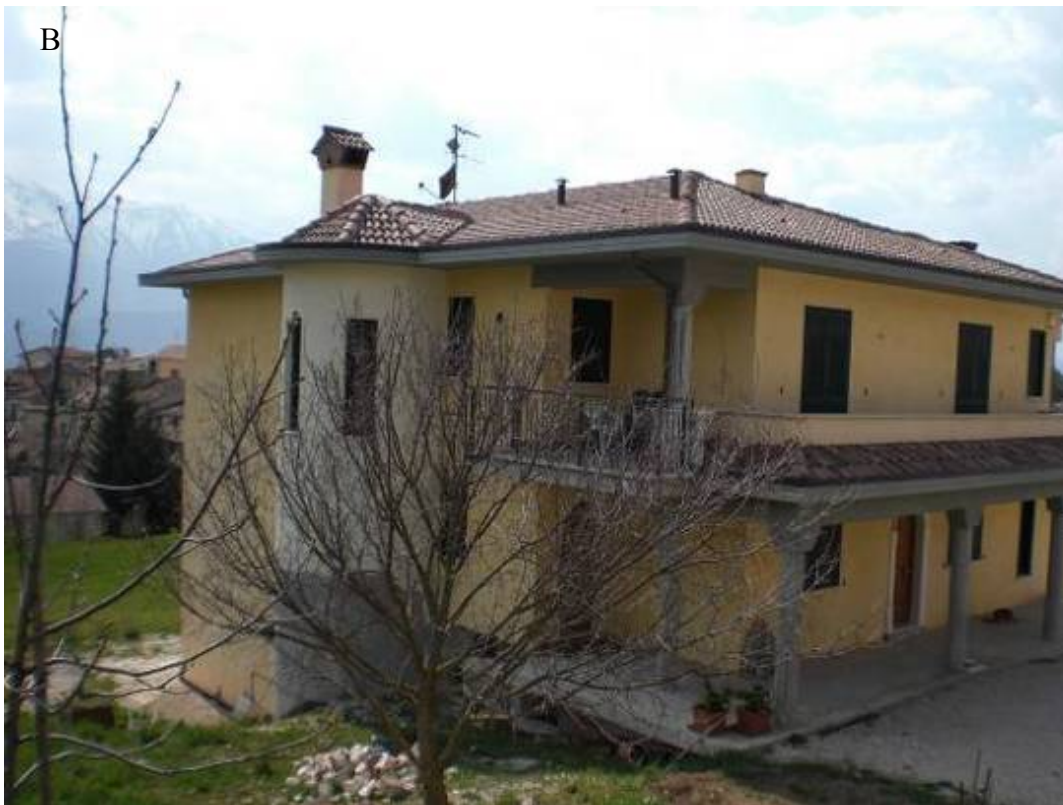
Figure 86. Poggio Picenze. (B) Undamaged RC house (D0) close to the (C) monumental church (D3).

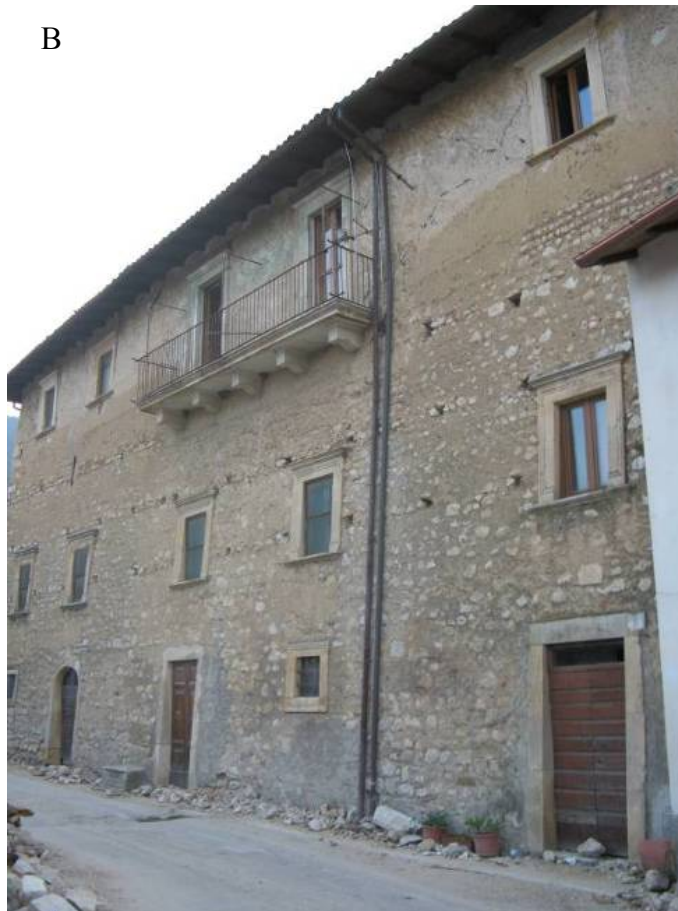
Figure 88. Villa S. Angel. (B) Reinforced masonry in the historic center with minor cracks in the highest story (D2).

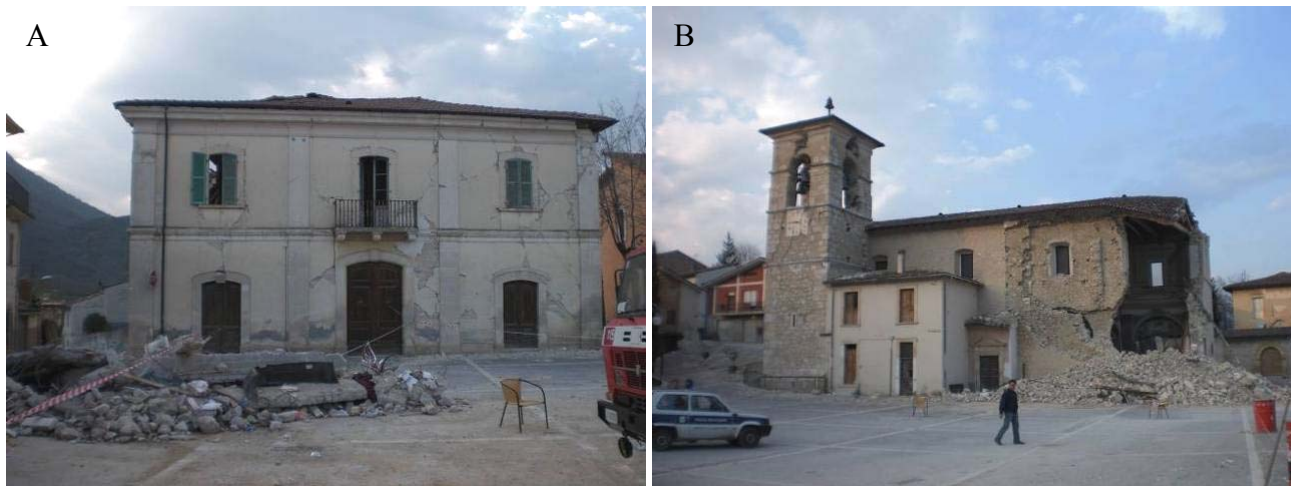
Figure 89. Villa S. Angelo, historic center with (A) masonry building crack,; (B) partly collapsed church.

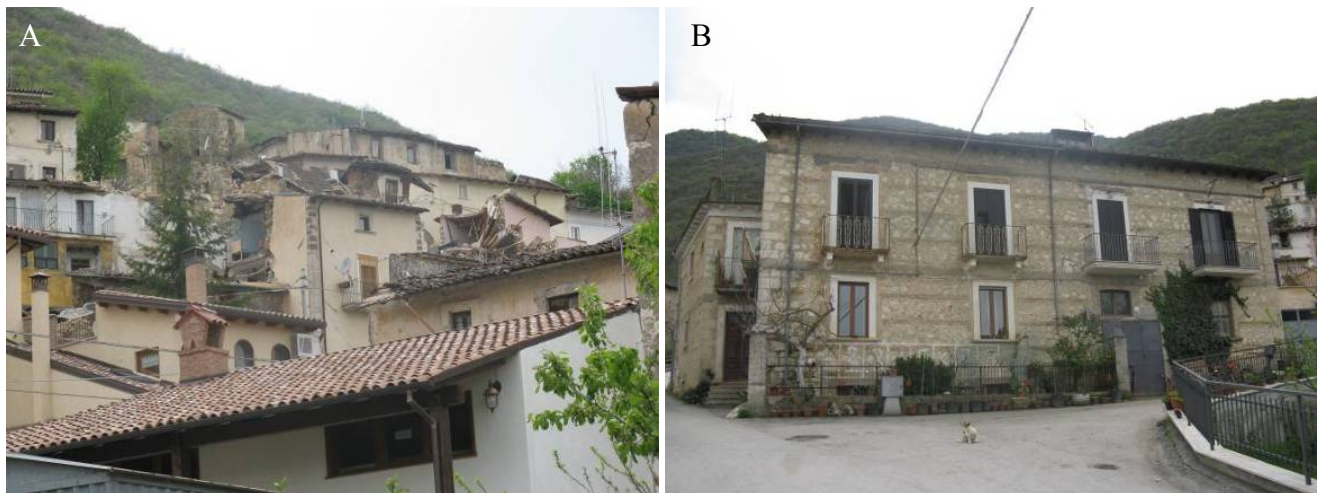
Figure 90. Tussillo. (A) View of the historic center with some collapsed masonry buildings on the background, (B) Masonry building at the entrance of the village showing no damage.

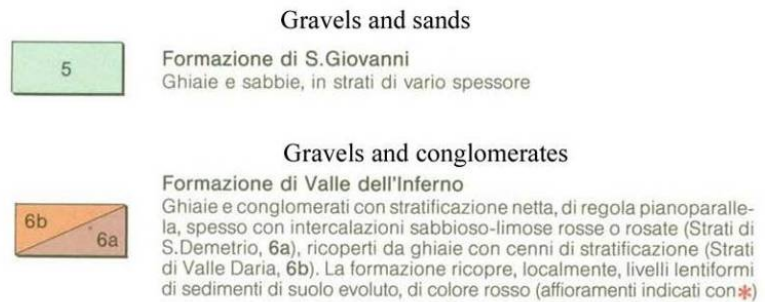
Figure 91. Geological map of S. Demetrio ne' Vestini (Bertini et al., 1989).

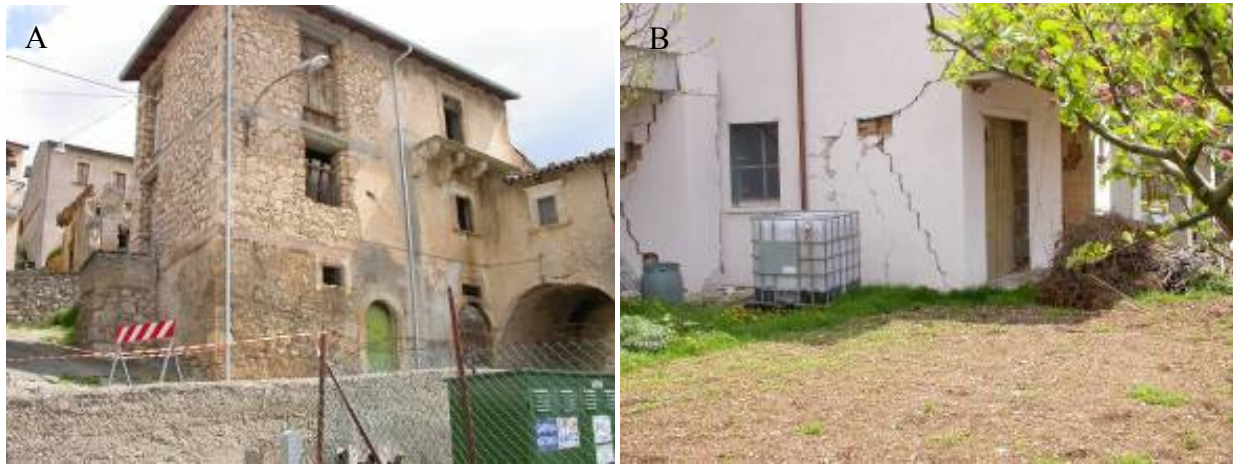
Figure 96. Barisciano. (A) Collapse (D5) of an old masonry building in background, (B) Damages (D1/D2) to RC buildings.

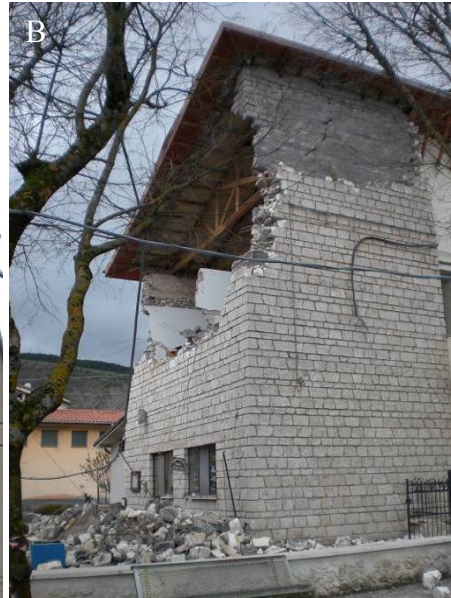
Figure 98. Goriano Sicoli. (A) Diagonal cracks in a masonry building (D3, (B) Partially collapsed masonry school (D4).

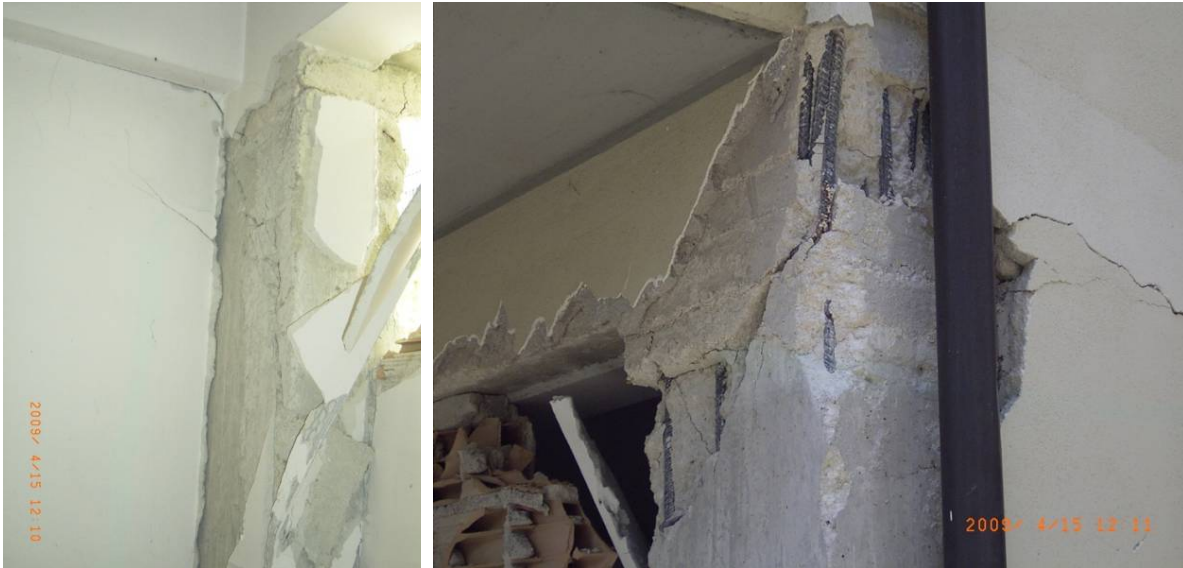
Two photographs showing the aftermath of an earthquake. The left photo shows a collapsed balcony with a metal railing and debris on the ground. The right photo shows a damaged brick wall and a collapsed metal railing.

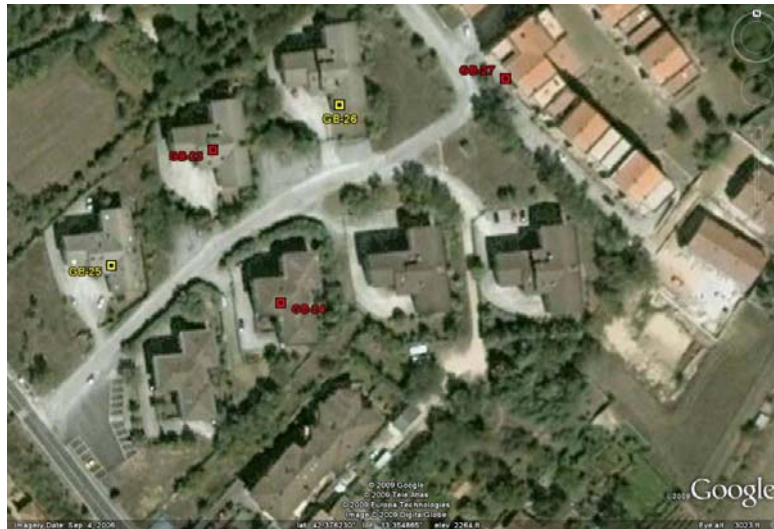
Figure 108. Cluster of damage in zone (d).

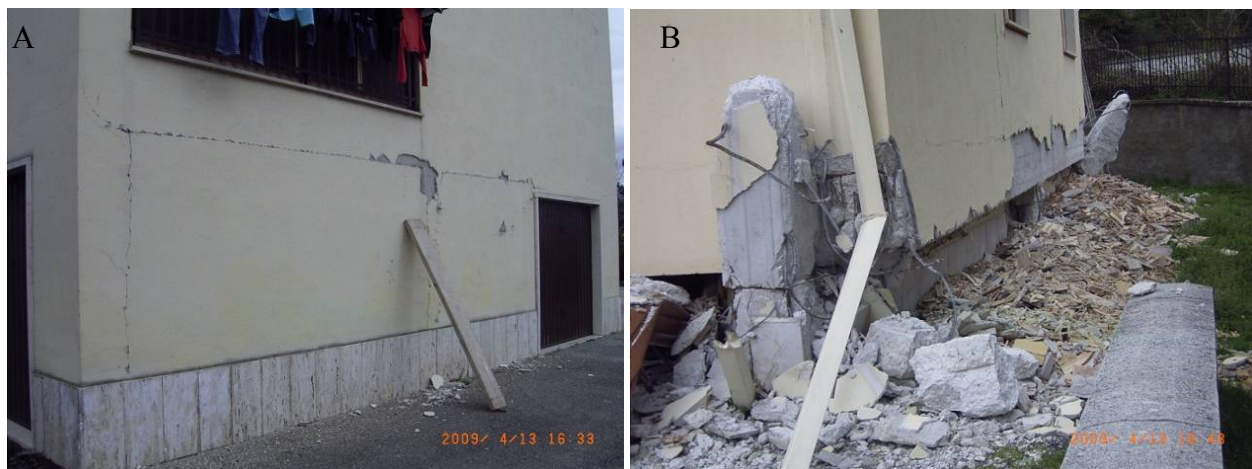
Figure 109. Damage on the structures in the cluster in zone (d). (A) Waypoint GB-22-1 (D1), (B) Waypoint GB-23-1 (D5).

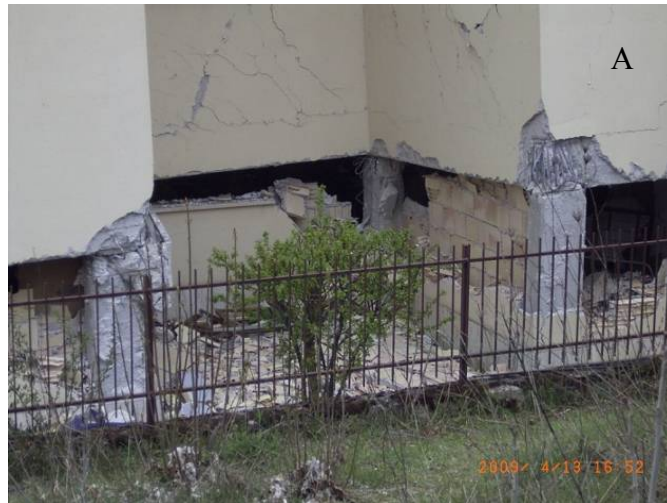
Figure 110. Damage on the structures in the cluster in zone (d). (A) Waypoint GB-24-1 (D5).

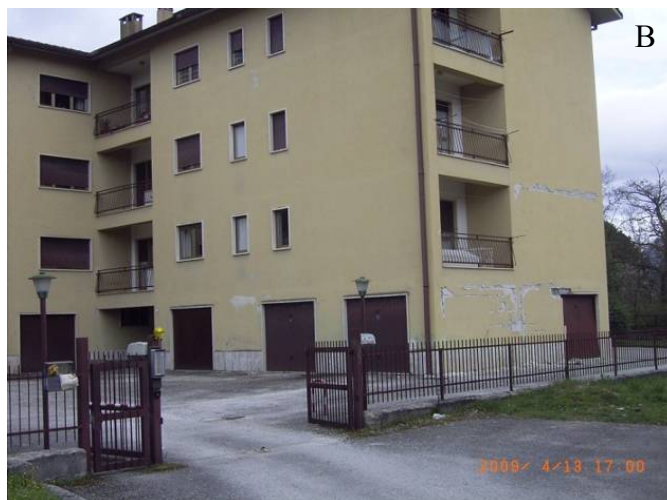
Figure 110. Damage on the structures in the cluster in zone (d). (B) Waypoint GB-25-1 (D2).

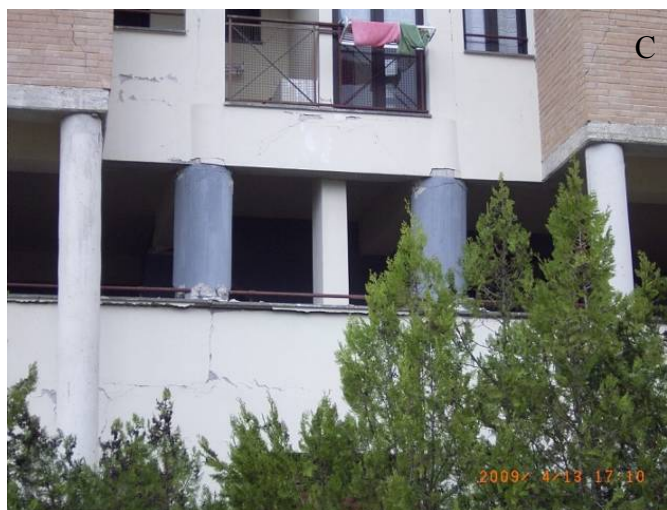
Figure 110. Damage on the structures in the cluster in zone (d). (C) Waypoint GB-26-1 (D2).

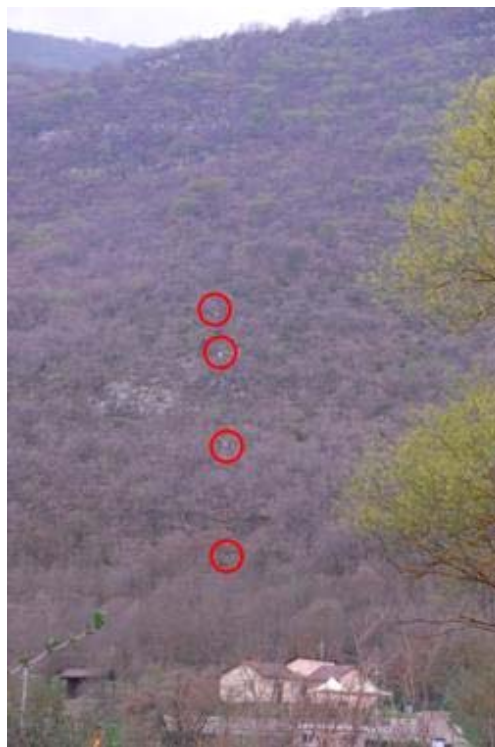
*Figure 116. Additional impact marks as indicated by an alignment of fresh scars (42.255N 13.547E).*

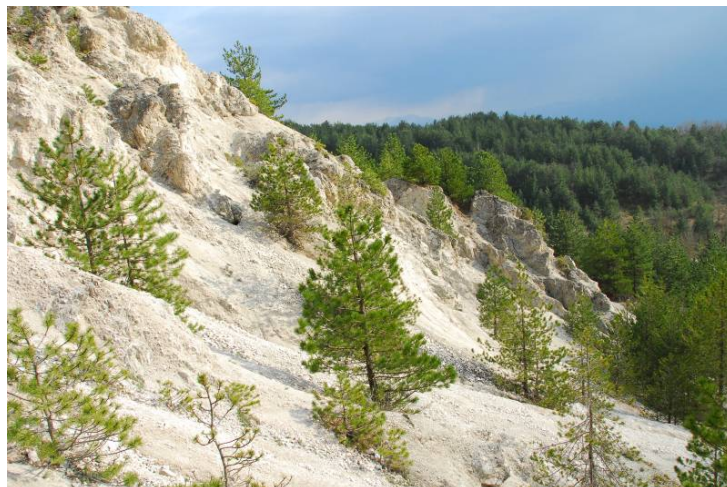
*Figure 132. Characteristic erosional scars developed in cataclasite (42.434N, 13.334E).*

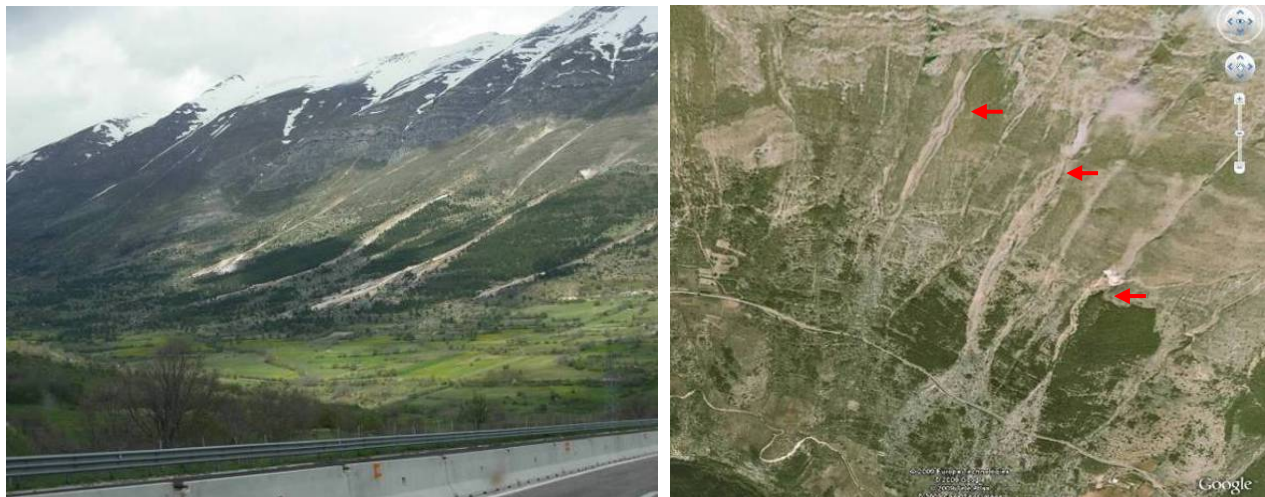
*Figure 136. Left view of the Mt. San Franco flank on 4-30-2009. Right: image from Google Earth taken before the earthquake showing the debris flows (42.4368N, 13.5796E).*

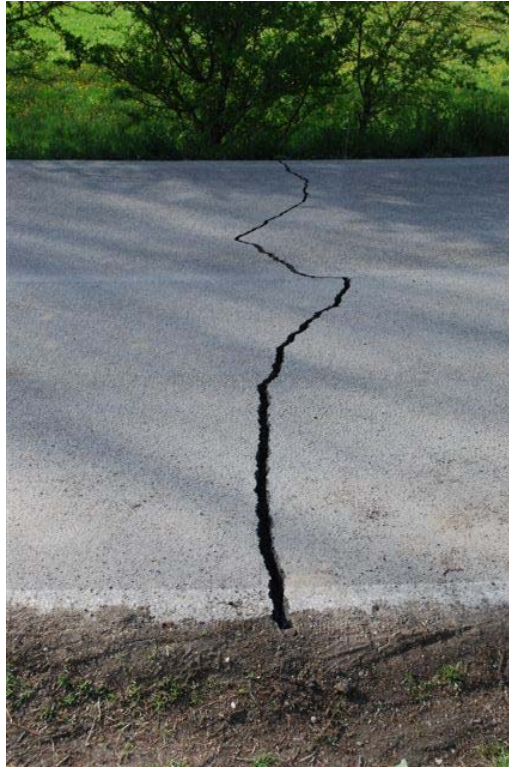
*Figure 142. Typical tensile condition of road cracks, not extending into neighboring sub-base or approach fill embankment (42.324N, 13.478E).*

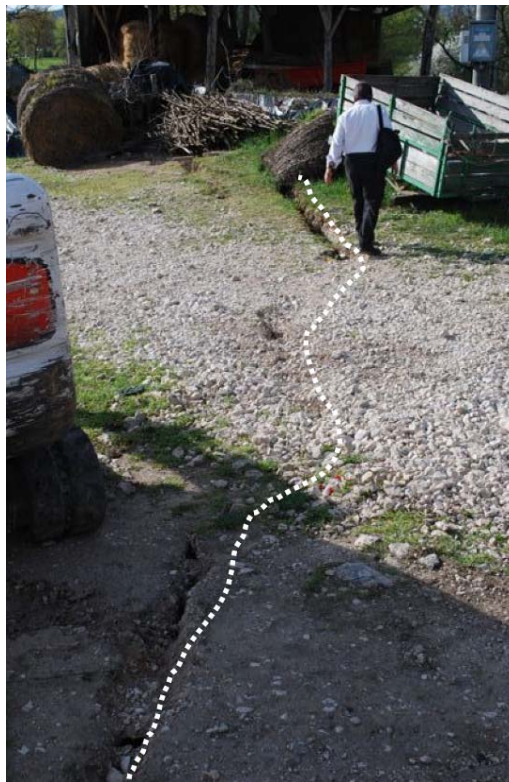
*Figure 143. Ground cracks up to 1.0 m deep, 20 m long, and with maximum of 15 cm vertical displacement (down-dropped toward river) developed directly adjacent to bridge abutment (42.324N, 13.478E).*

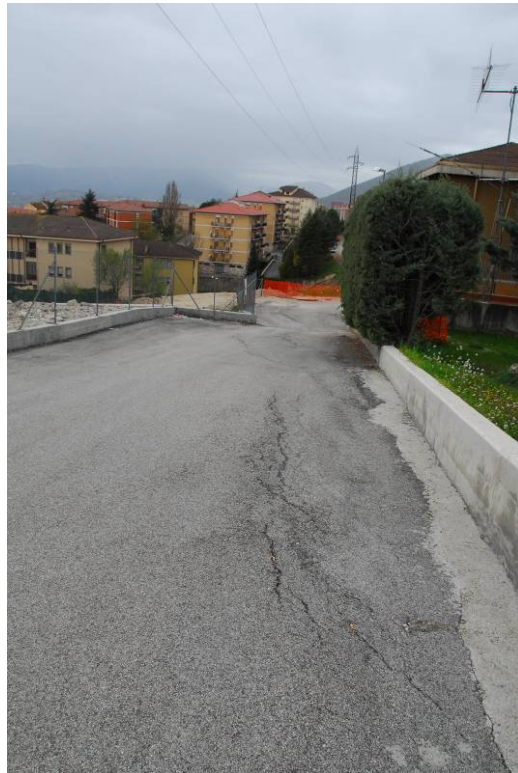
*Figure 154. Cracks in the overlying asphaltic surfaces and a narrow settlement trend along the sidewall of the cut-and-cover structure (42.358N 13.415E).*

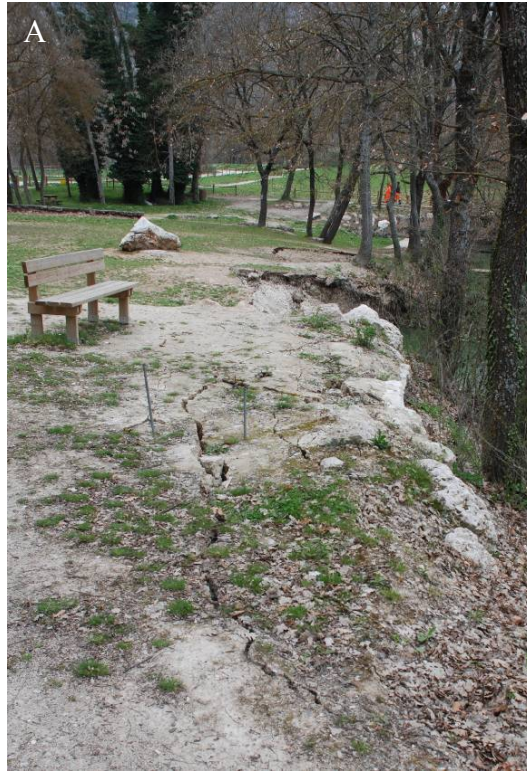
*Figure 162. Ground cracks at the southwest corner of Lake Sinizzo (location WP 18) as observed on (A) 11 April 2009.*

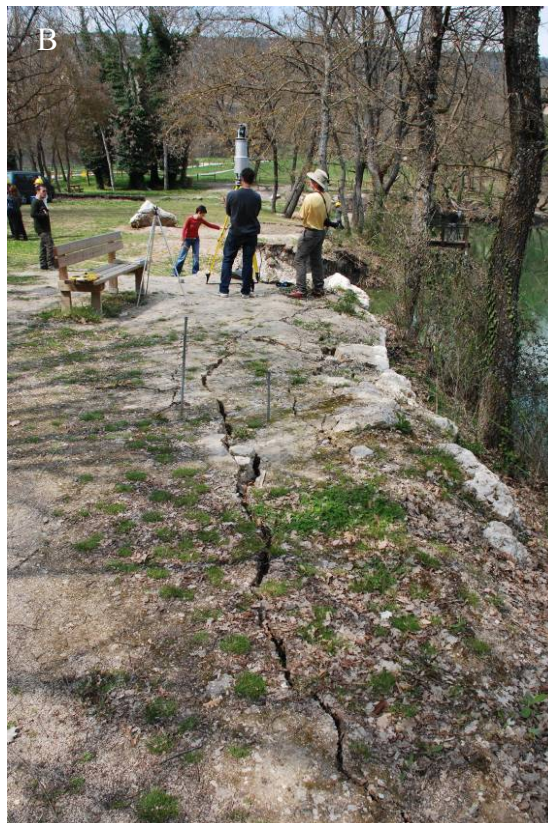
*Figure 162. Ground cracks at the southwest corner of Lake Sinizzo (location WP 18) as observed on (B) 15 April 2009.*

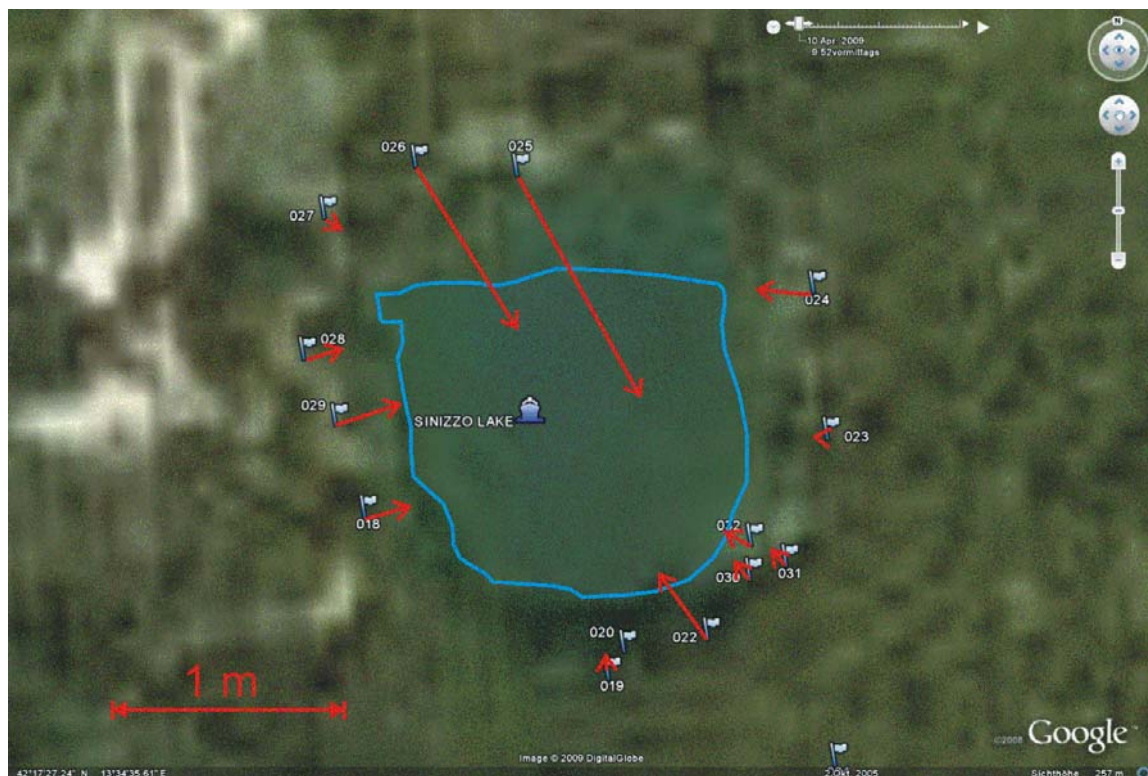
Figure 163. GPS way points indicating measurement locations around Lake Sinizzo. The red arrows indicate the orientation and maximum cumulative crack opening measured at each location.

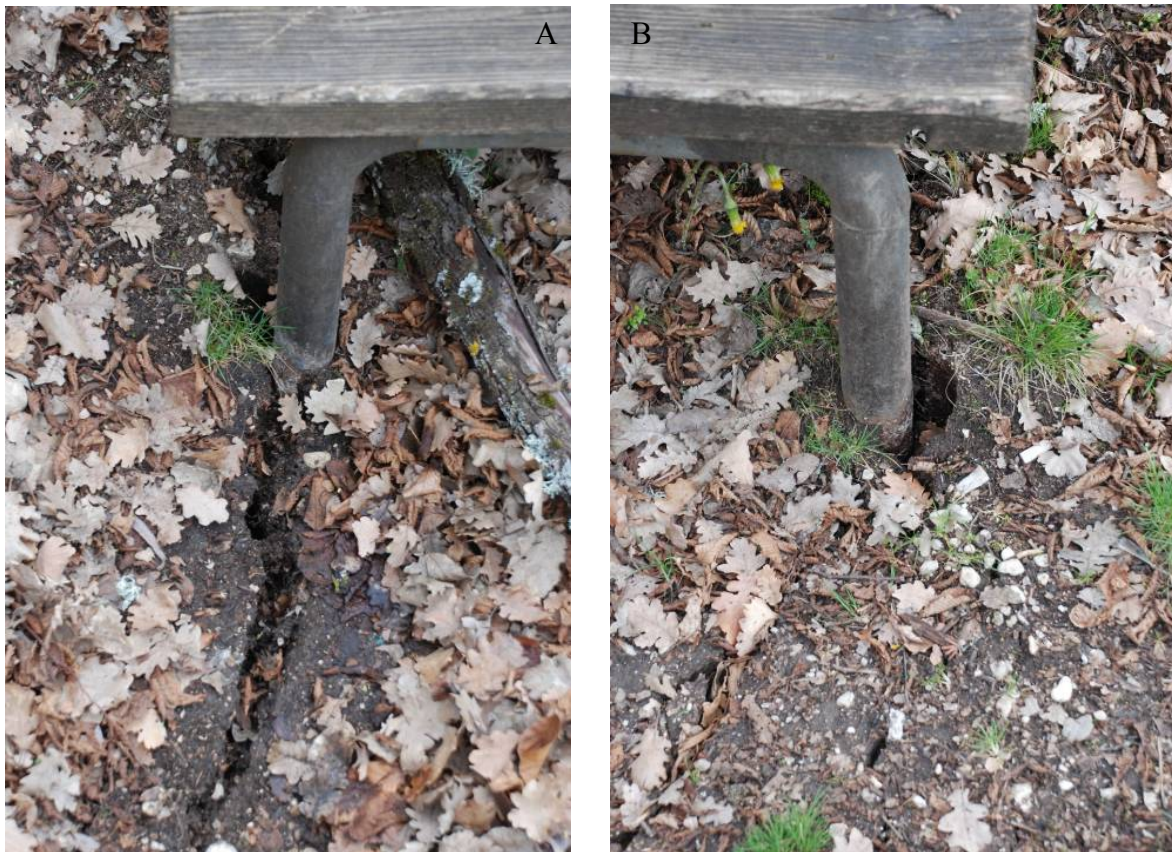
Figure 167. Characteristic deformations associated with the corners of the park bench at WP 31. (A) corner C2, (B) corner C3.

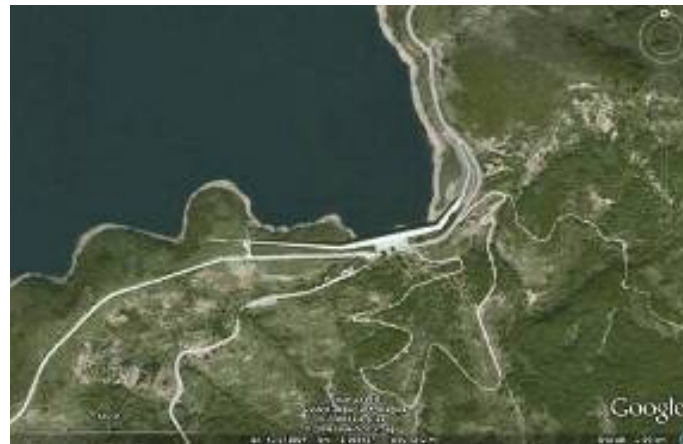
### Earthfill Dam Cross Section

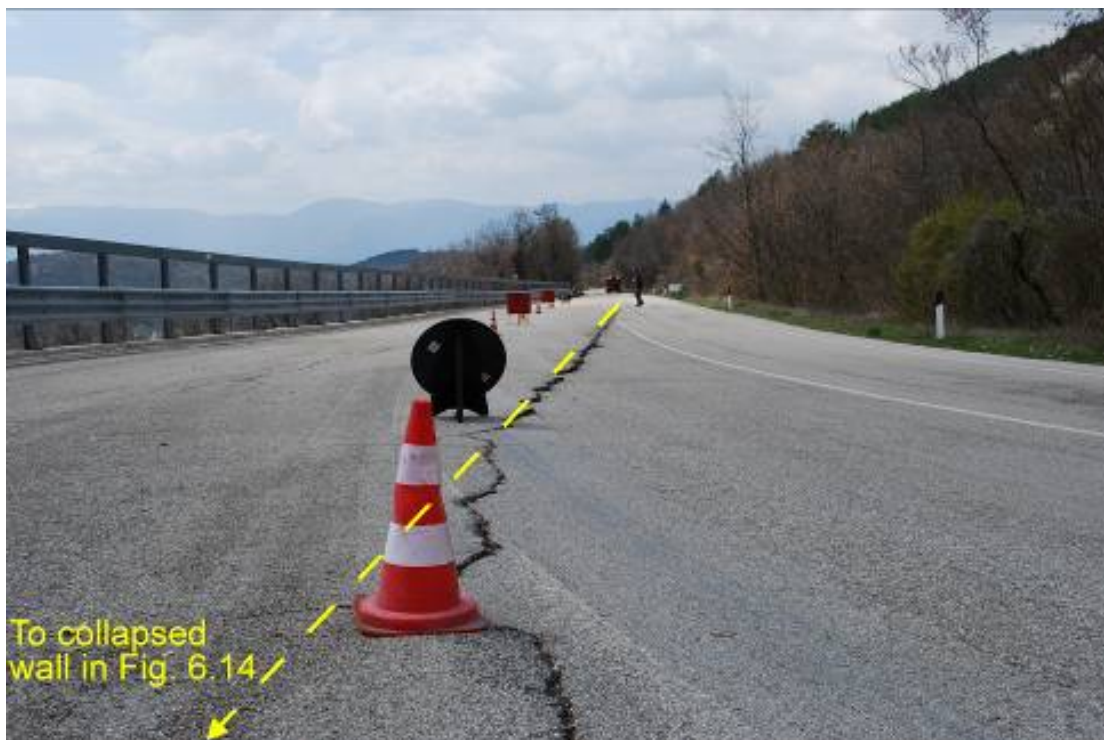
Figure 190. Pavement cracking in SS80 roadway (from L' Aquila to Campotosto) in the location of collapsed masonry retaining wall ( $42.420510^{\circ}\text{N}$ ,  $13.358394^{\circ}\text{E}$ ).

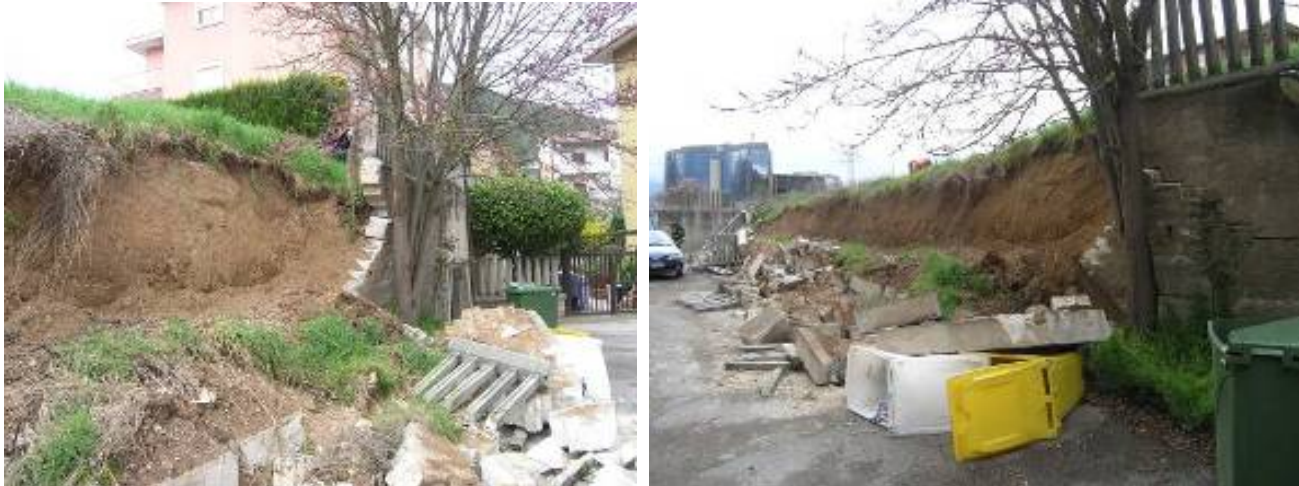
Figure 193. Toppling of masonry retaining wall at the outskirts of L'Aquila (42.366803°N, 13.376561°E).
