# Expedient Mitigation of Collapsible Loess in Northern Afghanistan

**Christopher T. Senseney**, Assistant Professor, U.S. Air Force Academy, Colorado, 80840-6232, USA; email: [christopher.senseney@usafa.edu](mailto:christopher.senseney@usafa.edu)

Reference: Senseney, C. (2013). *Expedient Mitigation of Collapsible Loess in Northern Afghanistan*

International Journal of Geoengineering Case histories,

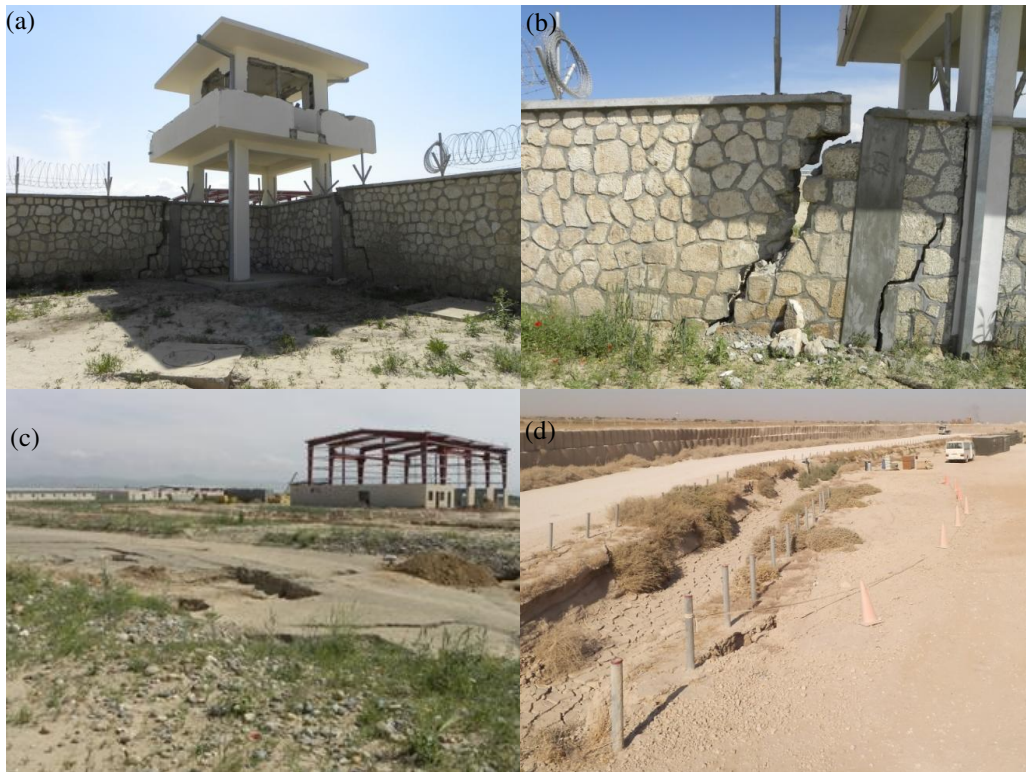
Figure 2. a. Damaged guardhouse and security wall in Kunduz, b. security wall damaged in Kunduz, c. settlement basin through a road in Kunduz, d. slope failure next to earthen drainage ditch in Mazar-e-Sharif as evidenced by coned off area.

The magnitude of collapse and resulting damage to infrastructure and facilities is primarily dependent on the amount of wetting. In low lying areas where water pools or flows after heavy rains, soil collapse often manifests itself in settlement basins or slope failure. Settlement basins typically occur near the perimeter of a facility beneath downspouts or on the edge of roads near drainage ditches. The facilities, in turn, experience differential settlement and structural damage, as evidenced by building settlements up to 10 cm (4 in) around Mazar-e-Sharif and Kunduz (Meier et al. 2009, SIGAR 2010). Settlement basins also cause failure to security walls (Fig. 2a-b) and damage roads (Fig. 2c). Slope failures damage the drainage system and render limited real estate unusable (Fig. 2d). Repairing damage wastes valuable resources that could be better utilized elsewhere.
