# Estimation of the Hydroconsolidation Susceptibility of the Anthropogenic Fill of the Historical Center of Thessaloniki, Greece

Reference: Hatzigogos, N.P.T., Makedon, T.K., Tsindaris, G.E., Tsotsos, S.C. and Christaras B.C. (2016). *Estimation of the Hydroconsolidation Susceptibility of the Anthropogenic Fill of the Historical Center of Thessaloniki, Greece*. International Journal of Geoengineering Case histories, Vol.4, Issue 1, p.46-56. doi: 10.4417/IJGCH-04-01-04

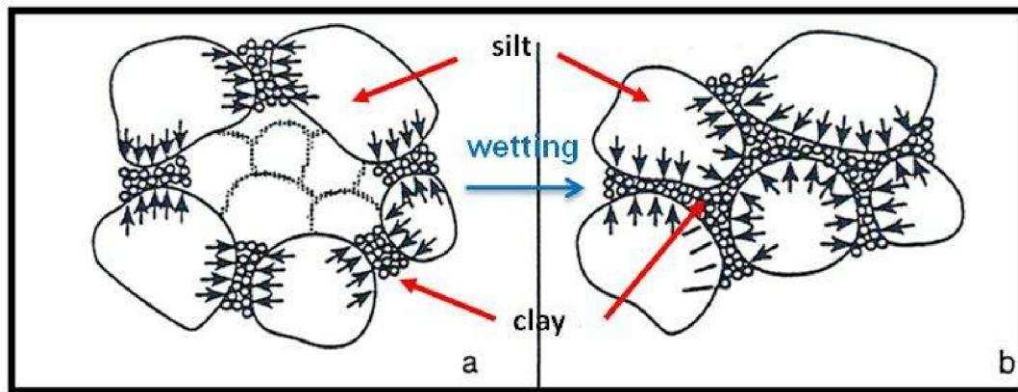
Figure 1. Collapse of a soil structure under load due to wetting (Knight, 1961).

The volumetric change behavior of a saturated soil is generally controlled by effective stress. However this behavior under unsaturated conditions cannot be estimated on the basis of effective stress alone but it is controlled by the changes of the soil moisture that result in changes of soil's matric suction (Khalili et al, 2004). The phenomenon of soil collapse can be manifested gradually and not necessarily as an immediate settlement, depending on the initial moisture content and the moisture variation range. If the soil is loaded under saturated conditions then it will consolidate without collapsing. If however its moisture content under constant loading is initially low (partially saturated) and is subsequently increased, then for low stress levels the soil will swell, whereas for higher stress levels it will sustain volume decrease due to structure collapse. Figure 1 shows the phenomenon of gradual collapse with increased wetting which is called hydroconsolidation; it occurs once and results in a new more stable soil structure (Knight, 1961).

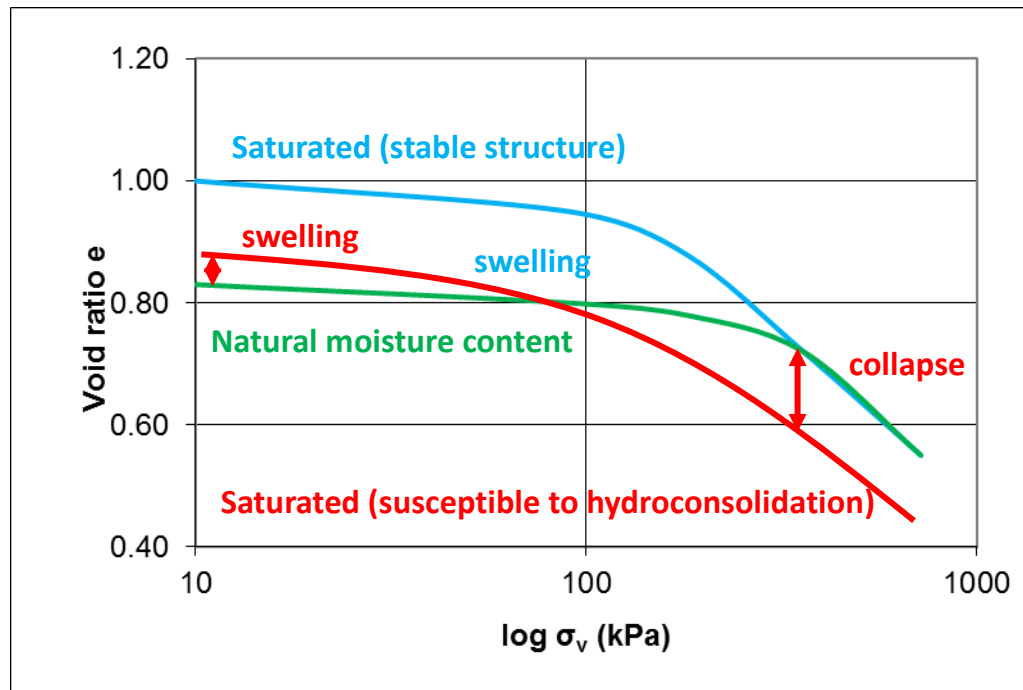
Figure 2. Soil swelling and collapse behavior after wetting under constant load (modified from Jennings & Knight, 1975).

Hydroconsolidation usually occurs in cases of wetting in soils of unstable granular structure due to technical interventions, in residual soils and in non cohesive man-made historical and urban non-engineered fills. The magnitude of settlements due to soil collapse depends on the soil's void ratio as well as the applied load. For low foundation stress levels from 100-300 kPa, research shows observed volume changes up to 10% and settlement as much as 15% of the thickness of the susceptible layers (Tromp, 1985). Hydroconsolidation is estimated via oedometer test with simulation of the loading procedure followed by sample inundation as in Figure 2 (Jennings & Knight, 1975).

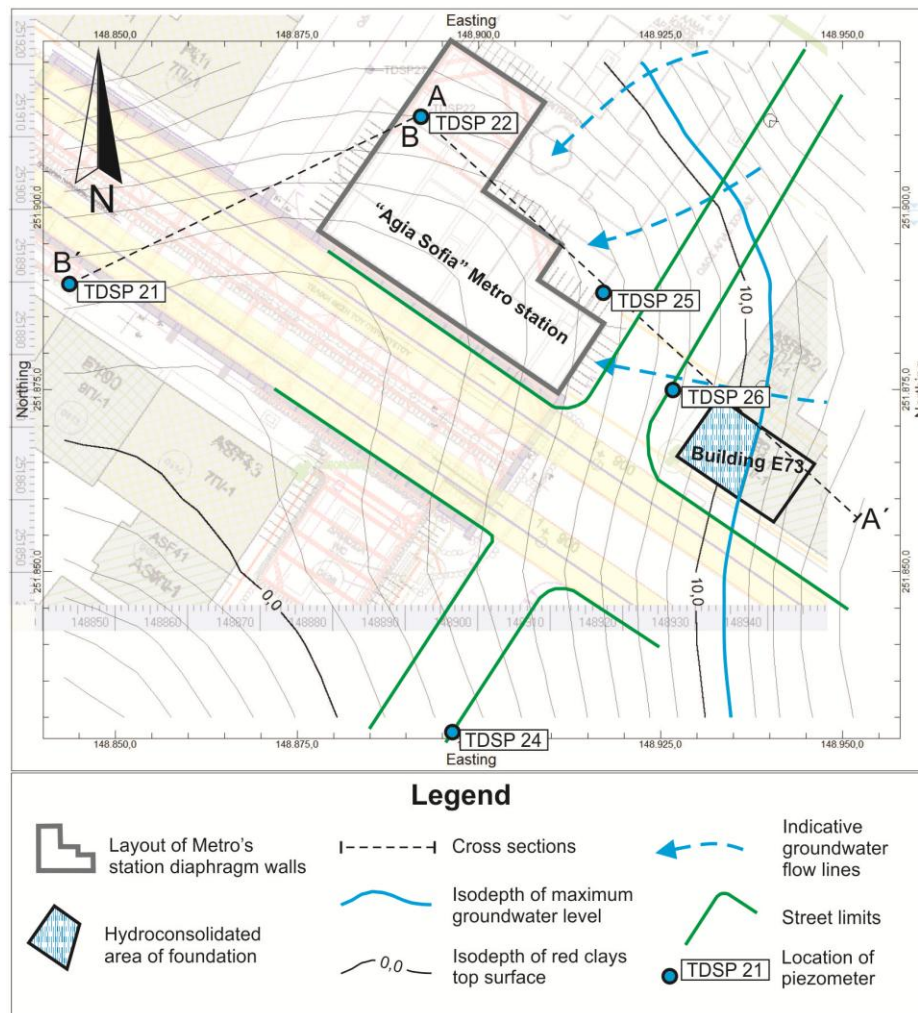
Figure 5. Map of the investigation area with the isodepths of the red clays.

The data used in the analysis were obtained by exploration boreholes that were drilled for Thessaloniki's Metro in the study area. Based on these data the historical fill has a local thickness of 9-10 m whereas the Quaternary deposits that are encountered only at the western part of the study area overlying the red clays have a thickness of 3 m. This stratigraphy forms a perched water table in the historical fill as shown in Figures 5 and 6, with an underground flow direction NE-SW that follows the morphology of the red clays. The underground flow is oriented by a backfilled underground flow network formed on the red clays that were in the past, before urbanization, the surface level formation. Figure 5 shows a map of the isodepth curves of the red clays formation which is the natural boundary of the historical fill. The groundwater level presents insignificant seasonal changes due to the existing structure that prohibits surface water percolation. As a result an unsaturated zone of significant thickness is created above the groundwater table and the geo-materials of this zone have not sustained any wetting during the past.

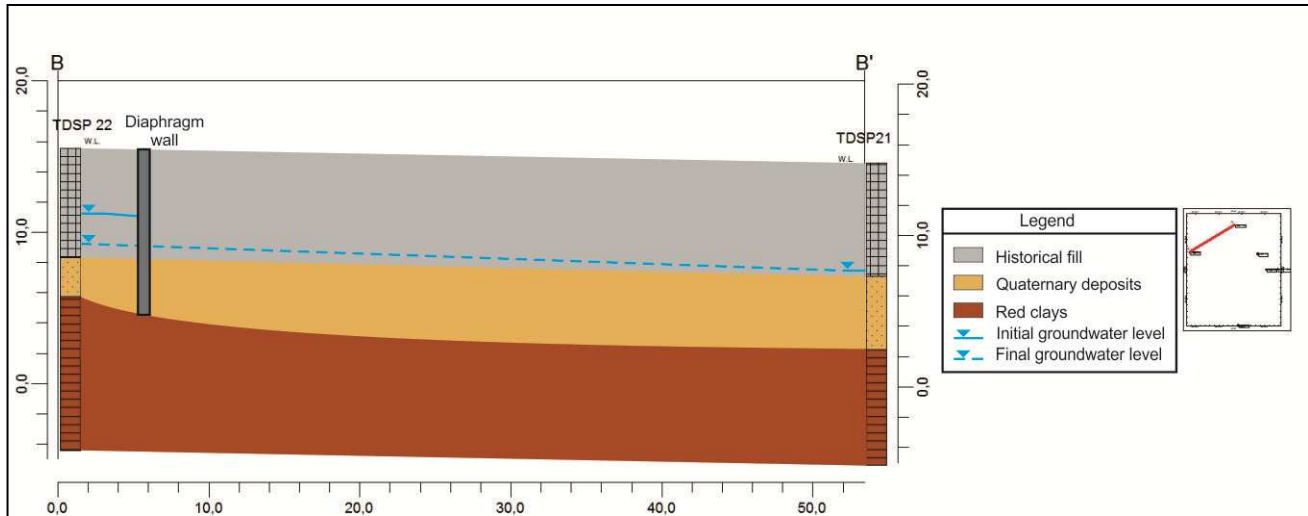
Figure 6. Geological cross section in NE-SW direction along boreholes TDSP22-TDSP21.

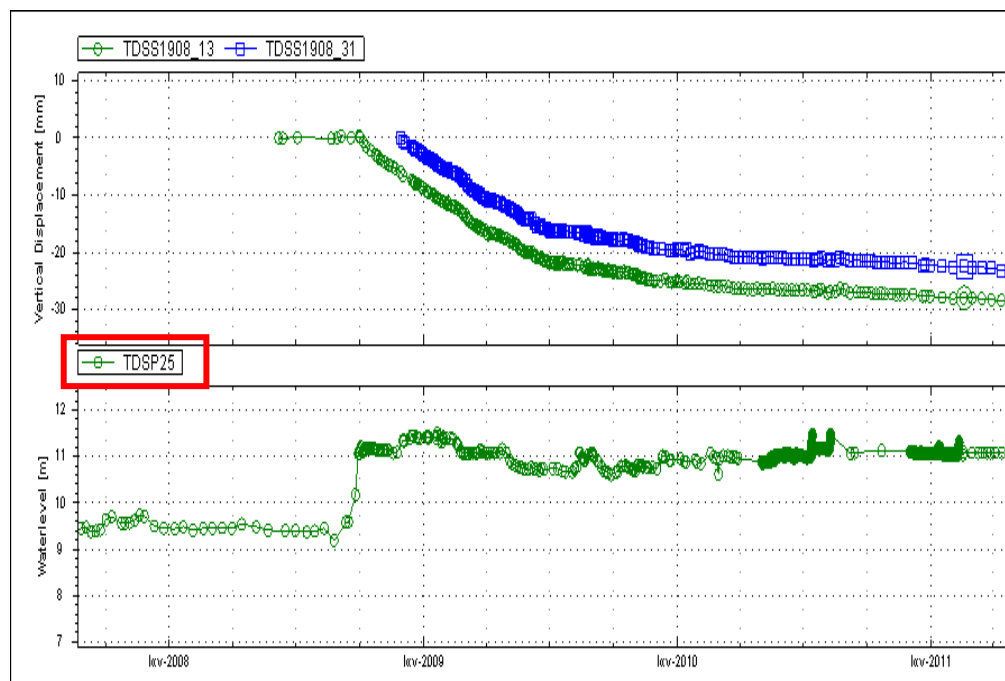
The works in the station begun with the construction of the northern side diaphragm walls. This created a cutoff barrier to the underground flow of the perched water table resulting to a significant local rise in piezometers TDSP22, TDSP25, TDSP26 and TDSP27 shown in Figure 7, as water flow is bypassing around the diaphragm walls. After the bypass to the SW the water level drops back to the normal level and that is why no rise is detected in piezometers TDSP21 and TDSP24 that are located S-SW of the diaphragm walls. The total rise reached 1.5 m and displacements - settlements were simultaneously observed on the aforementioned building (E73) at the corner of Egnatia and Agia Sofia streets. These displacements resulted in a deflection (inclination) of the building towards Egnatia str. (the free face of the building). The displacement reached 30 mm in a time period of 3 years starting from September 2008 (Figure 8). An additional issue that required interpretation was that the displacements did not affect equally the entire area of the building foundation but only its W-SW section and they were observed during a rise and not a drop of the groundwater level.

Figure 7. Settlement in building E73 following the rise of the water table (borehole TDSP25).

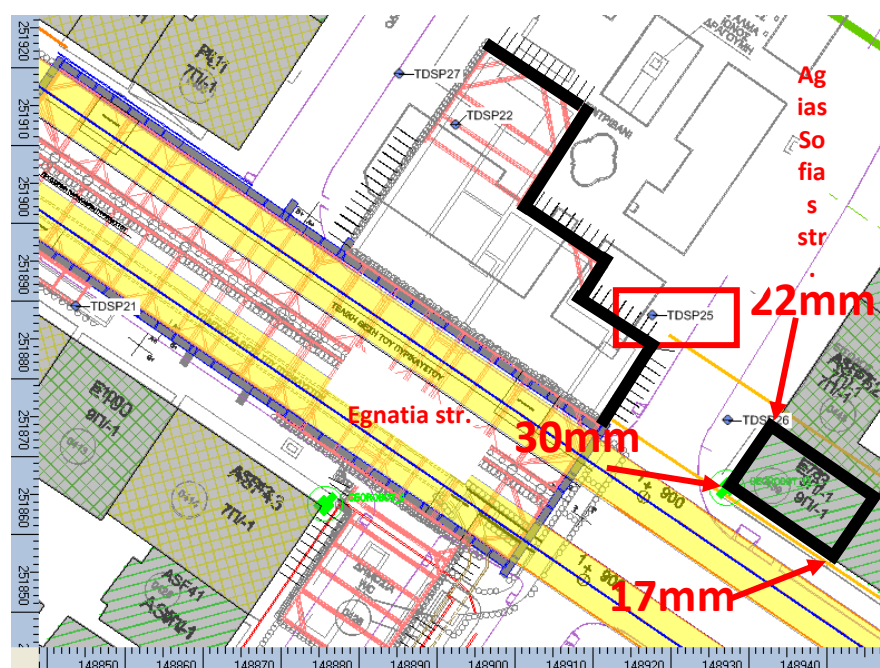
Figure 8. In situ measurements of vertical displacements.

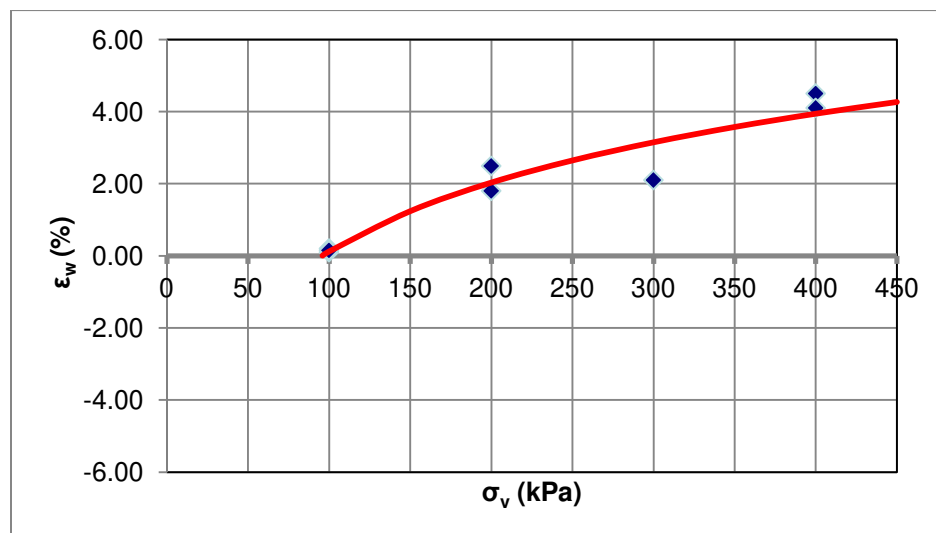
Figure 10. Axial strain due to wetting of Thessaloniki's historical fill at different stresses

The test program was carried out for samples from the historical layer and Table 1 presents the results for  $\epsilon_w$  values due to wetting of the samples under constant load. Figure 9 shows the change of void ratio due to hydroconsolidation of sample 4 for constant load (200 kPa) during wetting. The results of Table 1 produced the characteristic hydroconsolidation curve of the studied layer as seen in Figure 10, which describes the volume change behavior of the layer after wetting under constant load. There is swelling of the layer for stress <95 kPa and volume decrease for stress >95 kPa. As an example, the volume change calculated due to wetting under constant stress of 400 kPa is  $\epsilon_w=4.1\%$ .
