# Remediation of The Pissouri Landslide in Cyprus

**ABSTRACT:** During the winter of 2001-2002, a landslide of 80.000 m<sup>3</sup> was activated and moved downslope at the Northeast outskirts of the Pissouri village in Cyprus (Limassol prefecture), displacing a section of a country road that was crossing the upper part of the sliding mass and destroying three newly built residences. This paper presents the geologic and hydrogeologic regime of the landslide and its implication on the landslide's mobilization. Geotechnical site investigation and post failure monitoring, in conjunction with slope stability back analysis formed the basis for the study of the slide and subsequently guided the remediation strategy. Various possible interventions to stabilize the slope and allow the safe reconstruction of the displaced road have been investigated and compared considering both economic and environmental criteria. The performance of the remediation measures has been studied in terms of stability safety, using numerical models previously calibrated via back analyses. Observations made during the execution of the stabilization works provided additional data verifying and supplementing the o

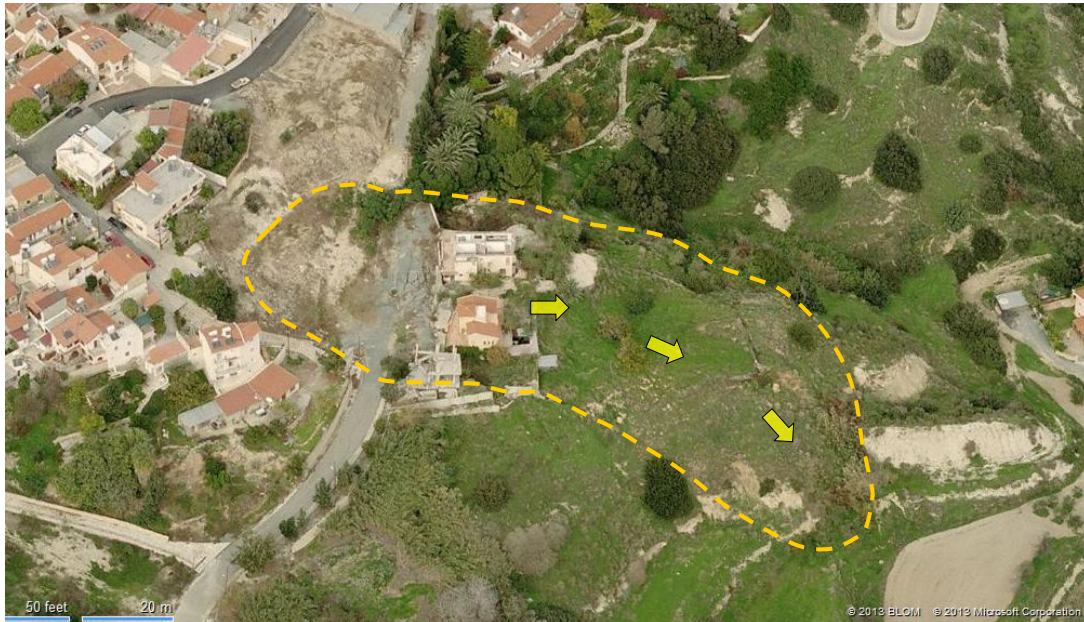
*Figure 1. Aerial view of the Pissouri landslide. Dashed line indicates the border of the sliding mass. Notice the distorted road and the damaged residential buildings resting on the sliding mass.*

of the build-up area, approximately 80,000 m<sup>3</sup> of ground mobilized and moved 0.5 m to 1.0 m downslope. The landslide distorted a section of a country road which was crossing the upper part of the slide and three residential buildings built adjacent to it. It continued to move the following years, at low rates during the dry seasons and at an accelerating rate during the wet seasons. With an average movement rate of 3 cm per month the landslide displacement accumulated up to 3.00 m – 3.50 m during the next 10 years. The landslide was immediately followed by water springing at the toe of the sliding mass, and continued the following years to seasonally gush out water and mud, pinpointing the significance of groundwater seepage through the sliding mass to its mobilization. An aerial view of the landslide, the distorted road and the damaged buildings is presented in figure 1, which can also be seen on the photographs of figure 2.

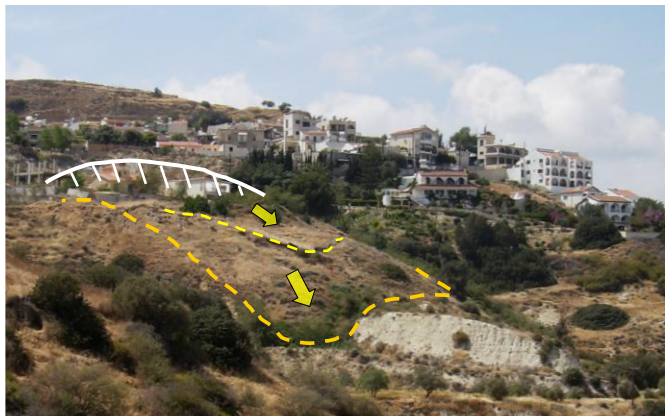
*Figure 2. Left: Northward view of the Pissouri landslide. Dashed line marks the border of the sliding mass. Back scarp is also marked. Right: The distorted road and damaged buildings resting at the upper part of the sliding mass.*

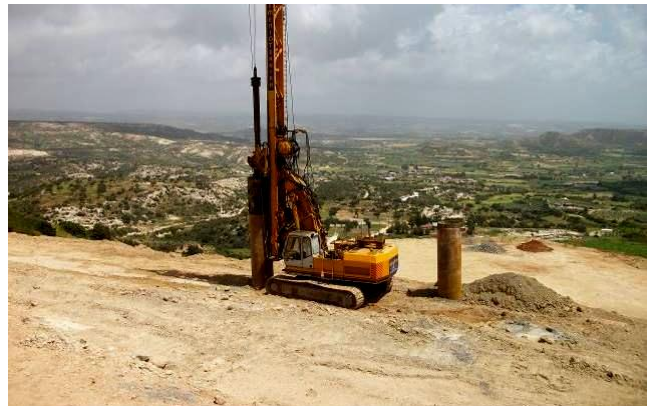
*Figure 19. Installation of bored piles at the trimmed slope surface.*

The construction activities started by constructing the toe buttress (Figure 18) and this stage was followed by the trimming of the upper part of the sliding mass and the subsequent construction of the bored piles (Figure 19). During the execution of the earthworks at the back scarp area, groundwater seepage continuously recharging the sliding mass was indeed encountered as shown in the photograph of Figure 20. Continuous gravel subdrains protected by geotextile shown in Figure 21, were constructed upslope all along the discharging zones, in order to collect and dispose the groundwater before it enters the landslide area. The next construction stage involved the building of a temporary fill ramp, necessary to reach high up to the back scarp area and construct the piles for the anchored wall (Figure 22). The last stage was the removal of the temporary fill, the anchoring and surfacing of the wall and the paving of the road. Figure 23 presents the landscaping before and after the interventions which shows that the works although substantial, had a limited visual impact in the landscape. Monitoring of the structures during the first two years after construction, showed that ground movements were completely ceased.
