St. Isaac Cathedral (St. Petersburg, Russia): A Case History

ABSTRACT: *St Isaac's Cathedral in St. Petersburg was completed in 1858 after 40 years of construction; it is today the fourth largest domed Cathedral in Europe. The underlying soil is a relatively soft saturated sediment and carries this 3155 MN structure that is 100 meters high with an imprint of 92 m by 100 m. It is founded on a 7.5 m thick mat of granite and limestone blocks resting on relatively short timber piles of different lengths. The Cathedral has progressively experienced significant deformation including differential settlement causing cracks in the pillars and tilting of the porticoes. The paper summarizes the available geotechnical engineering and engineering geology aspects of the soil on which the Cathedral is built as well as classical issues such as foundation ultimate capacity and settlement analysis through simple calculations and numerical simulations. It also includes some less classical issues such as the influence of microbial activity on the behavior of the Cathedral through the changes the microbes and their activity create in the engineering properties of the soil and in the groundwater compos

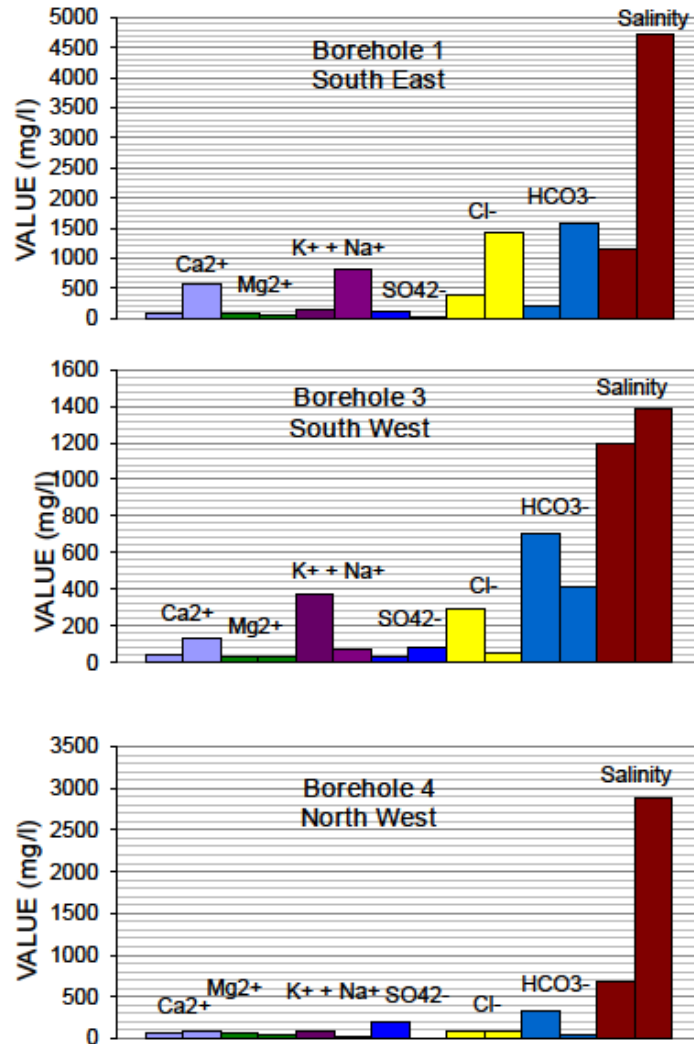
A comparison between the groundwater chemistry in 1954 and 2009 shows that during that 55-year span there has been a considerable change in groundwater chemistry (Fig. 6). In the bar graphs, each chemical is represented by two side-by-side columns; the first column gives the concentration in 1954 and the second column in 2009. During that period (1954-2009), a dramatic increase in water salinity can be observed indicating an increase in groundwater contamination. The salinity of uncontaminated groundwater is typically around 1000 mg/l. High contents of chlorides (1418 mg/l) and sulphur (81.8 mg/l) also indicate contamination by sewage. Furthermore, the increase in calcium content suggests leaching from the limestone blocks and the limestone-based mortar from the foundation mat located below the groundwater level.

Figure 6. Chemistry of groundwater (1954 and 2009 data).

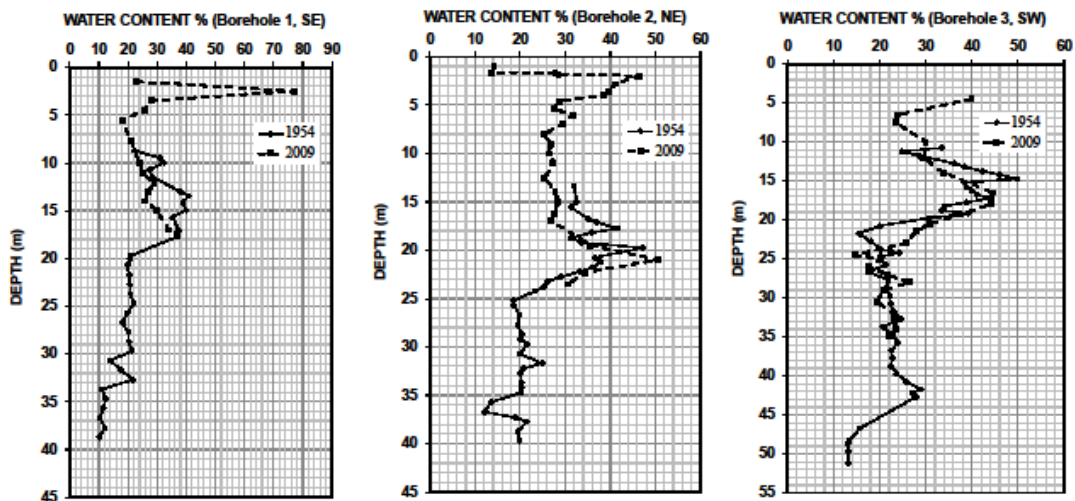
Soil properties were obtained in 1954 and 2009 and are combined in the following figures. The natural water content is presented in Fig. 7 and the plasticity index in Fig. 8. Fig. 7 indicates that there is no clear trend in the evolution of the water content with time and that the largest water contents occur in the layer of silty sand with peat at a depth about 3-5 meters and in the varved clay at the depth of 15-20 meters. Fig. 8 indicates that the varved clay at a depth of 15-20 meters exhibits the highest plasticity.

Figure 7. Variation of natural water content versus depth at different locations.

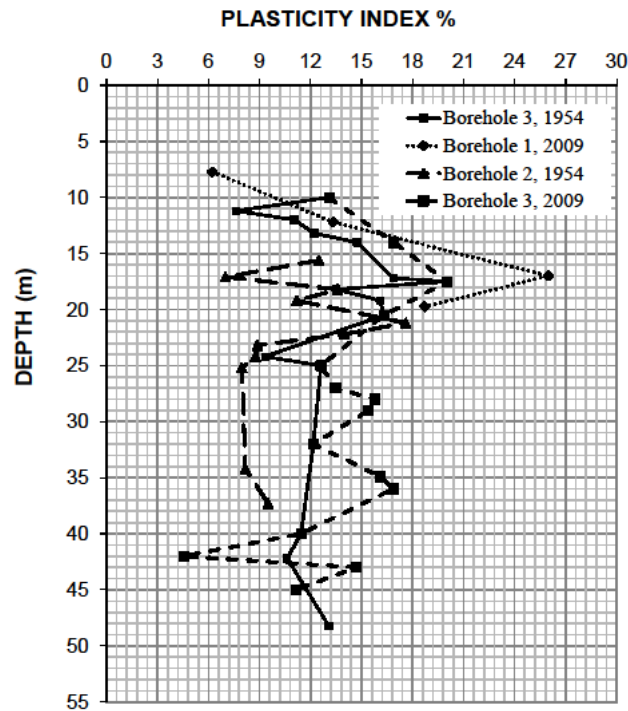
Figure 8. Variation of plasticity index versus depth at different locations.

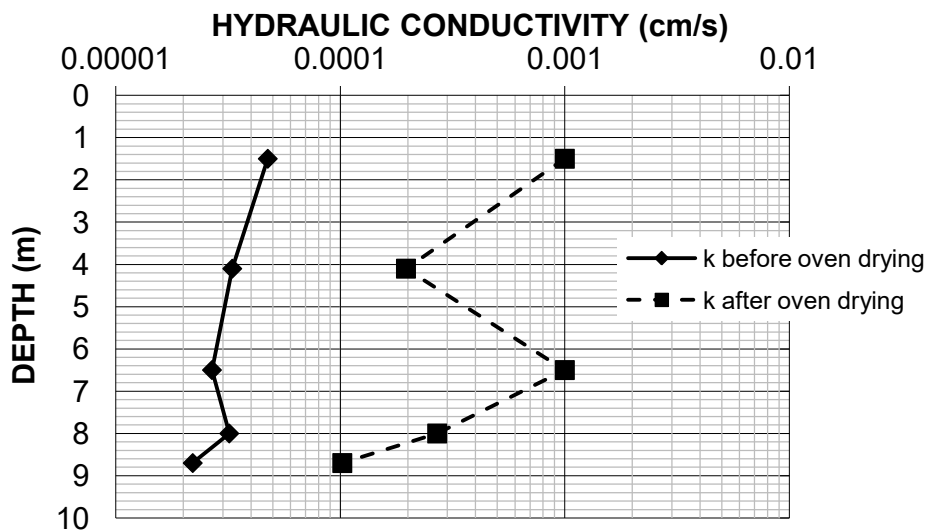
Falling head permeameter tests were performed in 2009 on the silty sand samples (Fig. 9) and indicated relatively low hydraulic conductivity varying from 1.1×10^{-5} to 6.8×10^{-5} cm/sec. These low values are likely due to the presence of organic matter clogging the pore space in the sand (Dashko et al. 2015, 2016). Permeability tests were also performed on the silty sand after oven drying the samples at 105°C ; the permeability of the dry silty sand increased to 1×10^{-3} to 1×10^{-4} cm/sec (Fig. 9). This likely occurred because the drying process burnt some of the organic matter thereby increasing the size of the pores.

Figure 9 - Hydraulic conductivity of sand vs. depth before and after oven drying.

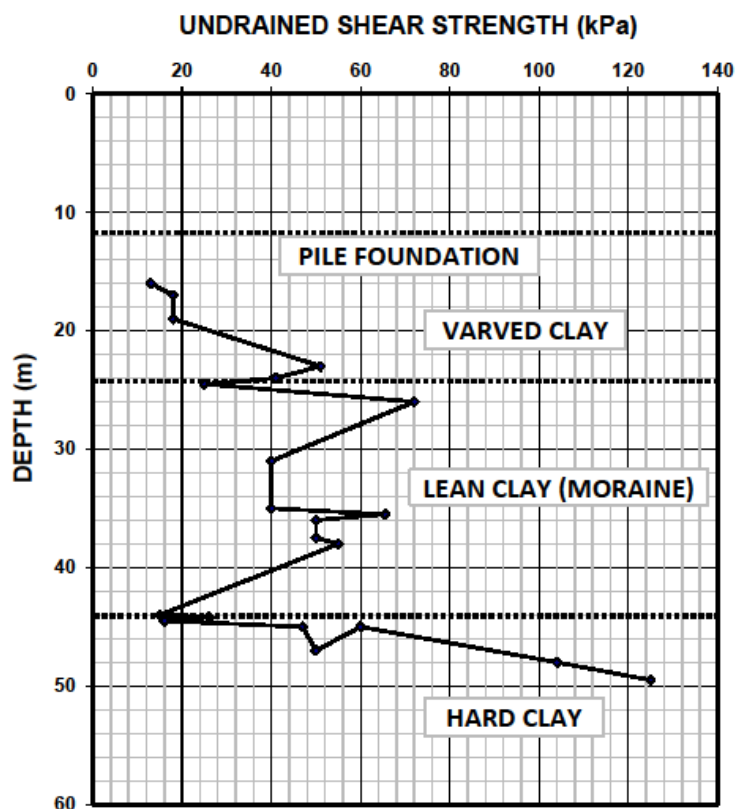
The shear strength properties, cohesion and angle of internal friction, available from the archives of 1954 are limited to direct shear test results (Table 3). In 2009, unconsolidated undrained triaxial tests were performed. The undrained shear strength (s_u) vs. depth profile obtained from these tests is shown in Fig. 10. Figs. 11 and 12 show the deviator stress vs. normal strain for some of the tests; the samples failed mostly in general deformation mode (barrelling) rather than along a single plane of failure. As indicated by the stress strain curves, the varved lacustrine clay underlying the pile foundation is very soft with s_u values between 18 and 20 kPa. The glacial clayey soil below the varved clay is a bit stronger with values in the range of 25 to 72 kPa. The Vendian clay below that glacial soil has s_u values which vary with depth from 18 kPa at the top of the layer to 125 kPa at depth. This significant variation could be due to the micro-fissures present in the upper zone of that clay layer which weaken the global strength.

Figure 10. S_u profile versus depth.

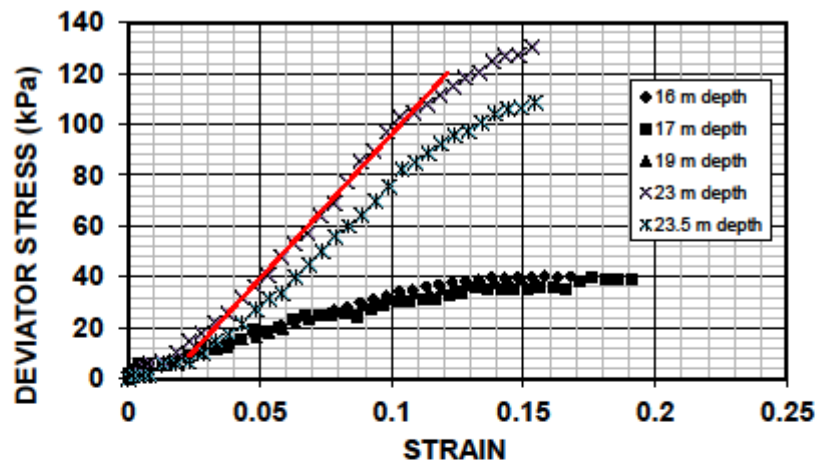
Figure 11. Deviator stress – normal strain curves from UU triaxial tests on varved clay.

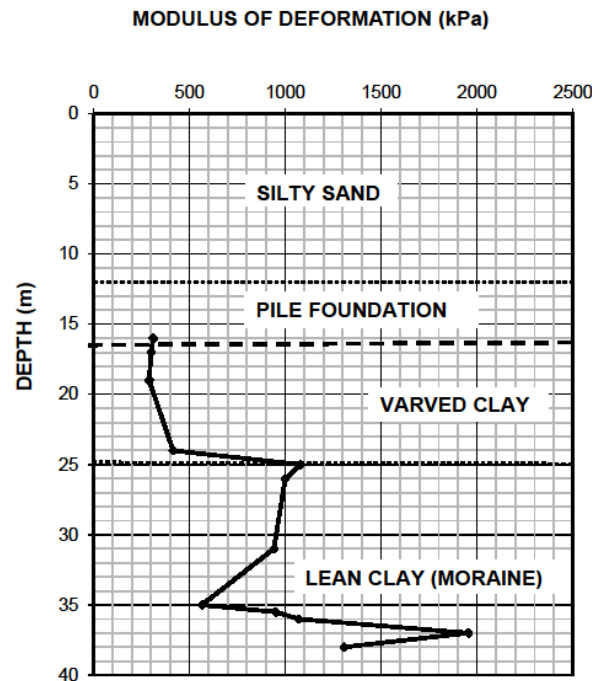
Values for the modulus of deformation of the soil were calculated from the triaxial test results. They are presented in Table 4 while Fig. 13 shows the modulus profile versus depth. The modulus E was obtained as the slope of the initial linear part of the deviator stress vs strain curve. The red lines on Fig. 11 and 12 show examples of how the linear part was selected. The modulus equation is:

becomes much lower in the glacial lake clayey soil with values between 290 to 1000 kPa, and then increases slightly in the moraine from 415 to 2000 kPa. Additional soil properties are shown in Table 4.

Figure 13. Undrained soil modulus versus depth.

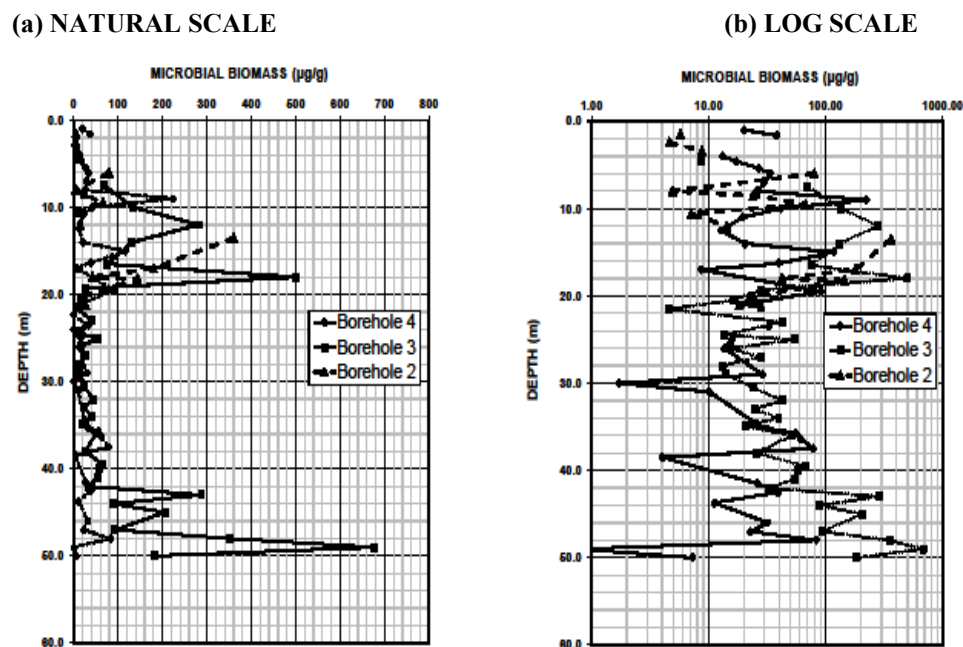
for some St. Petersburg soils by Dashko and Shidlovskaya (2015). The microbial mass and biofilms create slippery substances which coat the particle contacts and facilitate the movement of particles with respect to each other (lower modulus of deformation and lower strength) and clog the pores (lower permeability) (Dashko et al. 2013a, 2015). Indeed, for example, hydrogen sulfide (H_2S) as a metabolic product of sulfate-reducing bacteria in anaerobic state and bivalent iron (Fe^{2+}) leads to the generation of hydrotroilite $FeS \cdot nH_2O$ in the form of black and dark grey powder that was observed in all soil samples below the groundwater level. Fig. 14 shows the MM distribution through the soil profile. The peaks of MM at 20 m and 50 m depth correspond to the lacustrine varved clay (up to 500 micrograms per gram) and to the Vendian clay (up to almost 700 microgram per gram).

Figure 14. MM in soil vs. depth (2009 data): (a) natural scale, (b) decimal log scale.

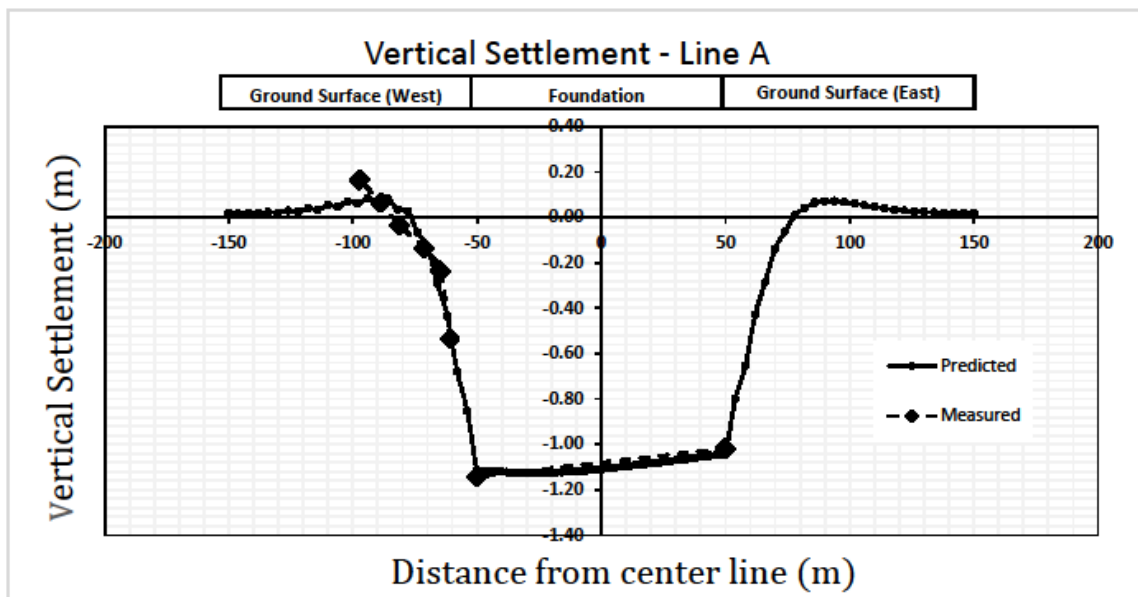
Fig. 18 shows the settlement of the Cathedral along the centerline East-West axis for the case that matches the measured total settlement of 1 m. A tilt is observed due to the uneven depth of the pile foundation; indeed, the Cathedral does not settle evenly due to the different lengths of piles in the foundation (Fig. 19) and the calculated difference in elevation between the eastern most point and the western most point of the Cathedral is 0.16 m. A parametric study was also conducted to investigate the influence of the structural parameters on the results. Fig. 20 shows the impact of the modulus of the foundation material on the bending of the foundation mat and associated distortion of the structure leading to increased cracking. Additional results of the analysis including ground surface settlement profiles, contours of vertical settlement with depth, and stress distribution in the soil mass can be found in Mohammadrajabi et al. (2015).

Figure 18. Ground surface settlement around and under the Cathedral.

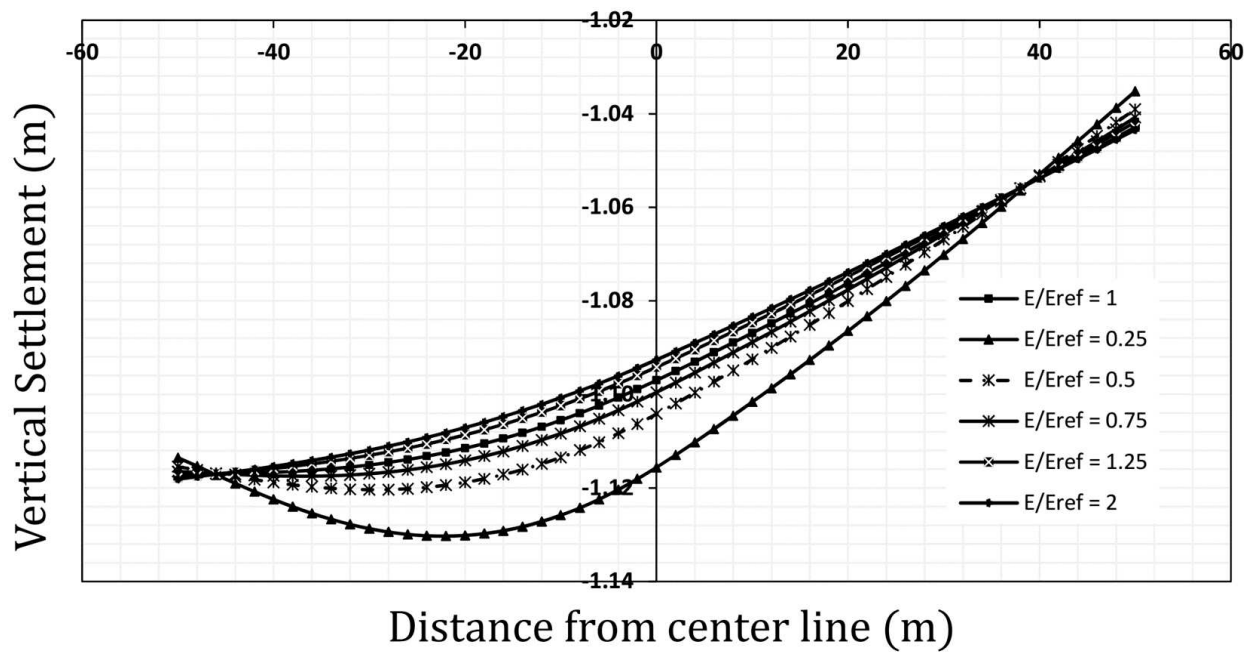
Figure 20. Bending of the mat foundation for different assumed moduli of the stone mat foundation ($E_{ref} = 20$ GPa).
