# Geobarrier System for Protection Against Rainfall-induced Slope Failure

Reference: Rahardjo, H., Satvanaga, A., Gofar, N., Leong, E.C., Kew, J.H., Wang, C.L. and Wong, J.L.H. (2019). Geobarrier System for Protection Against Rainfall-induced Slope Failure. *International Journal of Geoengineering Case Histories*, Vol.5, Issue 1, p. 26 - 42. doi: 10.4417/IJGCH-05-01-03

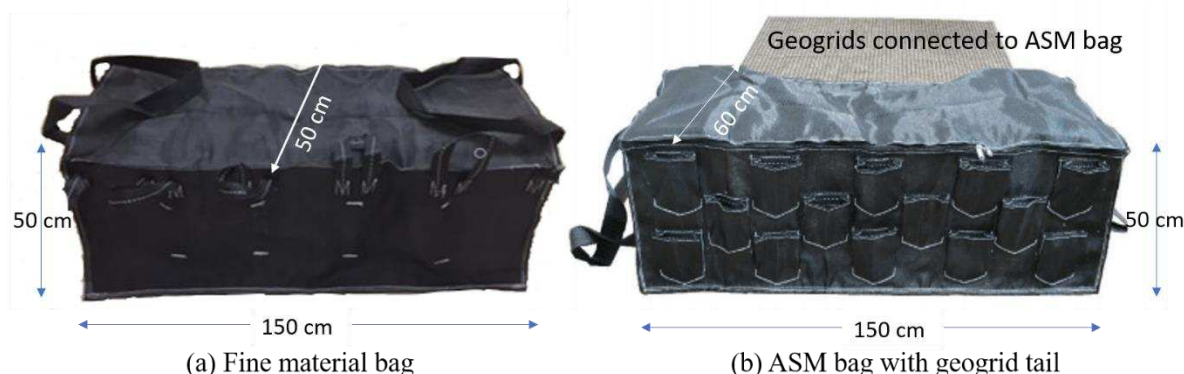
Figure 2 shows the geobags used for fine-grained material and ASM. The dimension of ASM geobag is 0.6 m width  $\times$  0.5 m height  $\times$  1.5 m length while the dimension of the geobag for the fine-grained material is 0.5 m width  $\times$  0.5 m height  $\times$  1.5 m length. The ASM bag is supported by specially designed pockets for planting different types of plants. The ASM bag is also connected to geogrids used as a reinforcing element. The bi-axial geogrids should be made from high-quality polyester yarn fibres with high tensile strength with a design life of 120 years and a tensile strength of 12 kN/m @ 2% strain and 30 kN/m @ 5% strain.

Figure 2. Geotextile bags for fine material and ASM.
