# Electrical Resistivity at Internal Erosion Locations in Levees

**ABSTRACT:** Internal erosion through or beneath levees frequently occurs during flood events, resulting in sand boils. Determining the extent of damage from the seepage channels that caused the sand boils remains difficult, and many sand boils are simply monitored in subsequent floods. There is a need for a nondestructive methodology to map the voids caused by seepage channels so that needed repairs can be identified prior to the next flood. The objective of this study is to identify the electrical response of internal erosion pathways with electrical resistivity tomography (ERT). A case study using ERT on the Hager Slough Levee, which has experienced sand boils since the 1990s, is presented. Three ERT surveys were conducted along the levee in an area of apparent damage (i.e., crown settlement and sand boils) and where nearby boring logs were available. Laboratory resistivity tests provide support for the field ERT interpretations. The results indicate that ERT may be used to identify zones of damage within and beneath a levee. If used in practice, ERT has the potential to improve remediation of levees by identifyi

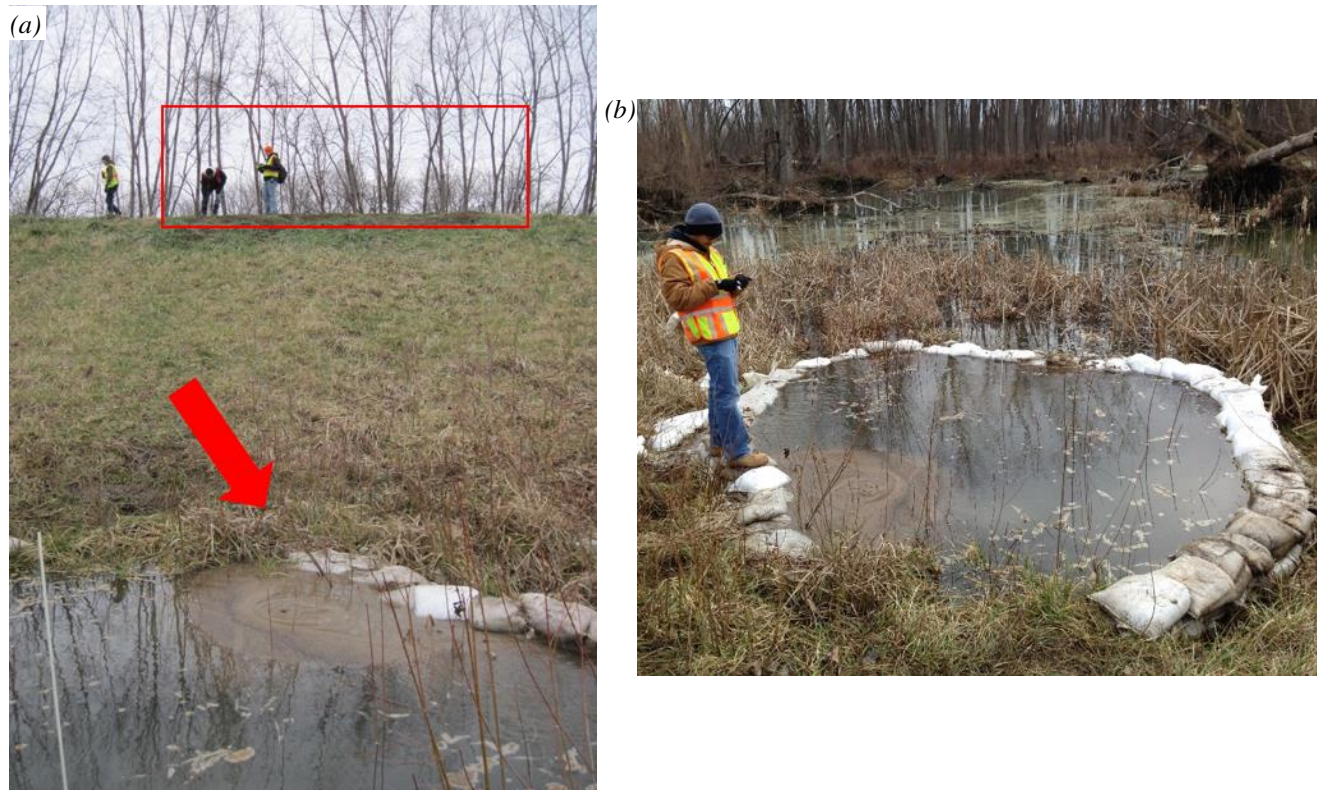
Figure 5. December 2015 flood reconnaissance: (a) settlement of crown with active sand boil at toe of levee, (b) active sand boil with sand bag ring (Rutherford et al. 2016).

Settlement of the levee crown occurred in several locations during the 2015 flooding which required repair (repair images not available). Subsidence of the levee crown in these locations was observed to be adjacent to sand bag rings (Figure 5), suggesting that the subsidence was due to material loss. The objective of the geophysical investigation described in this study was to evaluate if ERT can be used as an imaging technique to detect zones of material loss within the levee. Such a system would enable improvement of remediation methodologies following flood events where sand boils occur. ERT may also be used to evaluate if a levee is damaged internally despite the lack of external physical evidence (e.g., sand boils). Following this introduction are a brief background on ERT and the research methodology. The ability of ERT to identify material removal has been investigated by performing a series of ERT surveys and supported with soil borings and a laboratory electrical resistivity measurement of the material in the sand boils. A discussion of the field and laboratory results is presented, including limitations of this case history, followed by conclusions and recommendations.
