# Forensic Analysis of Levee Failures: The Breitenhagen Case

**ABSTRACT:** Forensic analysis of past failures is valuable to improve our understanding of levee behavior. In this article a new systematic approach of forensic analysis for levee failures is proposed and applied to the Breitenhagen levee breach that occurred along the river Saale in Germany in 2013. The purpose of this study is to identify the cause of the breach based on the proposed approach, even though limited data is available. Based on the information prior, during and after the breach of the levee, a slope stability model is developed for the entire event. First, results from this model are obtained based on the expected values of the uncertain parameters and the best estimates of the situation. Uncertainty of the model is included in the calculation subsequently by defining possible failure scenarios. The most likely failure scenarios are derived from the data and included into the model so that it is possible to eliminate or validate all possible causes by means of a sensitivity calculation. It is concluded that the levee breach is likely caused by locally weak soil conditions, unexpected high water pressures

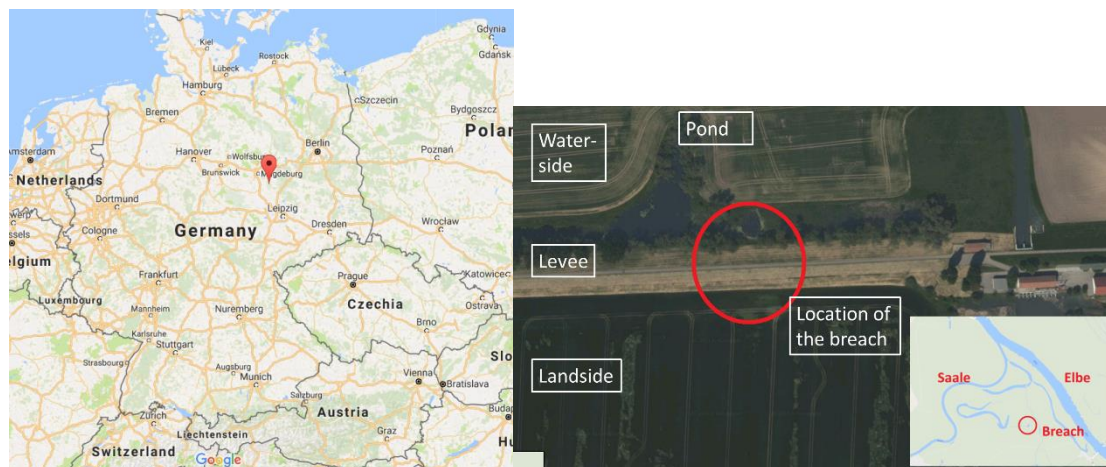
Figure 2. Overview of the location of the breach (GeoBasis-DE/BKG, 2009).

The data collected prior to the breach provide an indication of the condition of the levee prior to the breach. The overview photo shows a pond in front of the levee possibly caused by an earlier breach (Figure 2). This indicates the possibility of a direct connection between the outside water level and the aquifer below the levee. The photos show a row of trees at the riverside toe of the levee which might influence the conductivity of the levee due to the intrusion of the roots inside the levee, or might indicate the presence of a more conductive layer inside the levee (Figure 2). The slope of the levee is very steep (about 1:2.1 vertical to horizontal) with a gradient that exceeds the friction angle of most soil types. The slope at the landside is prone to instability (Figure 5).

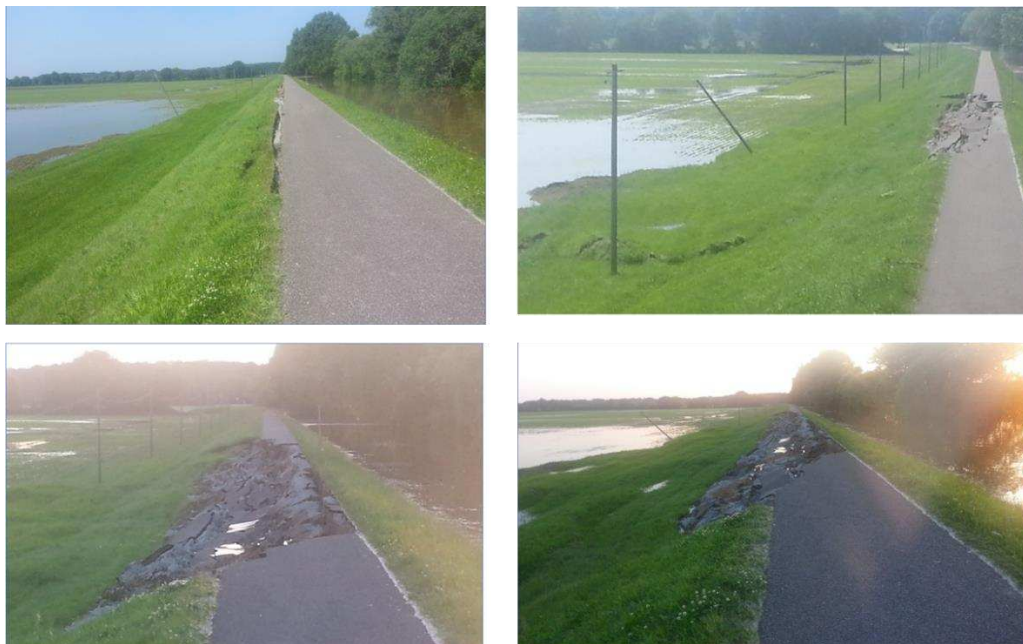
Photo data were collected during the breaching process as well, showing recognizable indications of the levee failure. The indicators were used to identify the deformations and the geometry of the slip circle (Figure 6). Also, ponding due to possible seepage of water at the landside is shown. Possible high water pressures in the aquifer may cause seepage and saturation of the soil at the landside of the levee.

*Figure 6. Photo series over time (upper left: 08.06.2013–10:37, initial break at the edge of the slope, upper right: 08.06.2013–14:10, horizontal shifts, bulge of the toe, lower left: 08.06.2013–20:51 continuing failure, lower right, 08.06.2013–20:55, continuing failure with the visual predictors (Grubert, 2013). Riverside of the levee is on the right for all photos.*

On the left side of the picture an electricity pole is recognized which seems to tilt over time, until it is almost completely horizontal (Figure 6). Also the slip circle is expanding until the road is completely damaged indicating an increasing deformation over time. The initial failure is considered to have weakened the levee to such a level that the levee lost all its retaining capacity.

Introducing undrained soil behavior for the clay, scenario D, results in FoS between 1.66 and 1.28. The slip circle of the actual failure (Figure 6) and the calculated slip circle (for example with the use of Bishop with undrained soil behavior and Spencer with drained soil behavior) differ in geometry. The slip circle of the Spencer method seems to show more realistic geometry of slip circle than the Uplift Van method and Bishop’s method in case of low effective soil pressures at the interface between sand and clay (Figure 14).
