# Geotechnical Effects and a 6-Year Outlook of the 2012 Hurricane Sandy in the Eastern United States

**ABSTRACT:** Hurricane Sandy was the deadliest and most destructive event of the 2012 Atlantic hurricane season. It originated as a storm off the coast of West Africa that turned into a tropical wave in the southwestern Caribbean Sea, and then into a hurricane that moved slowly north along the United States East Coast. Numerous regional coastal communities and urban centers in New Jersey (NJ) and the New York City (NYC) metropolitan area experienced widespread flooding, extreme winds, and heavy damage that disrupted daily life and business in Lower Manhattan, the world's financial capital. Consequences with great geotechnical engineering interest include: (i) modification of the regional coastal geomorphology due to storm surge, with the birth of new inlets, erosion, scour of soil at the shorelines; (ii) damage in coastal communities that revealed the vulnerability of residential building foundations not designed according to modern flood protection standards; and (iii) interruption of service of buried structures and below ground infrastructure due to flood damage to non-structur

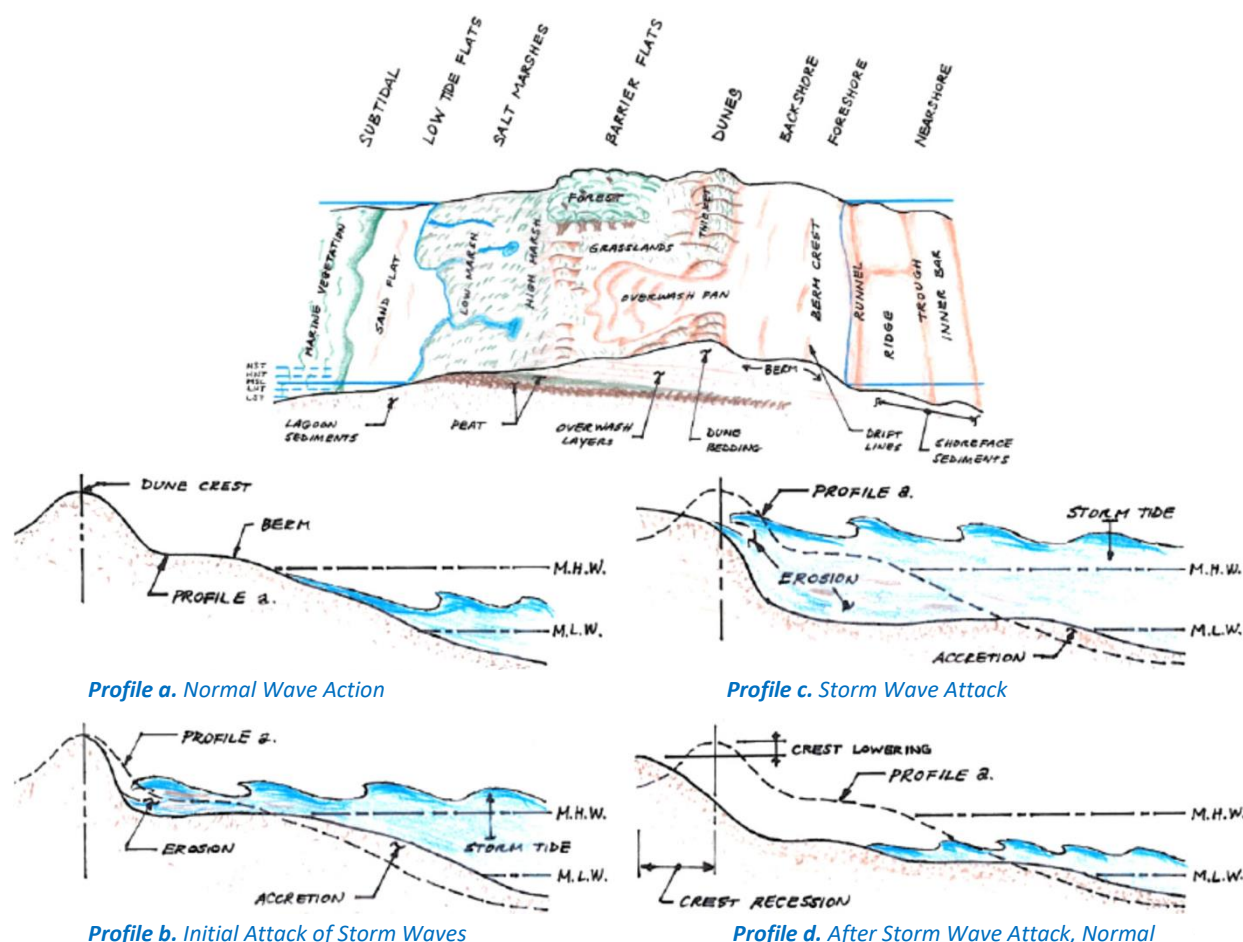
Figure 4. Barrier environments (top) and beach profile changes (bottom) in response to a coastal storm (Refs: A. Dyer from Leatherman, S.P., 1979; Godfrey, 1976; and U.S. Army Corps of Engineers, 1974).

Along the NJ shore, coastal hydrodynamics depend on local bathymetry, barrier islands, and shoreline structures. The coast is divided roughly into three zones of different wave climatology (Psuty & Ofiara, 2002), with most of the waves arriving directly onshore from the southeast in Ocean County. The south counties Atlantic and Cape May are exposed to waves from the east-northeast, while the north county Monmouth has no barriers, yet it is protected from waves by New England and Long Island. This indicates that local features have great effects on the hydrodynamics and sediment transport (USDA, 1989), with the combination of fetch and tides being key in producing record-flooding levels.

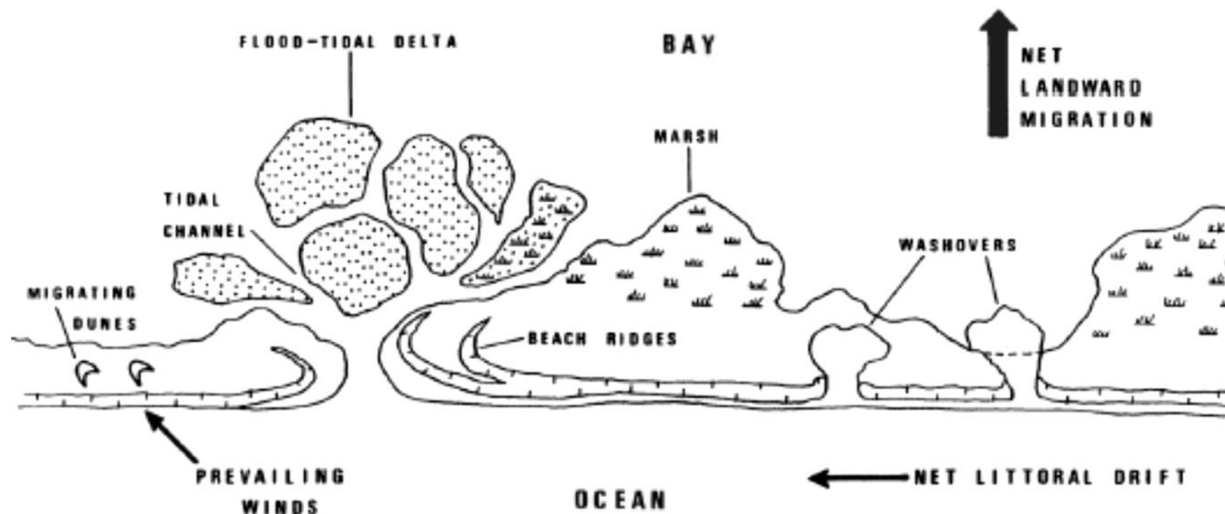
Figure 5. Geologic processes that build up a barrier island, allowing landward migration with sea level rise (Johnson, 1982).

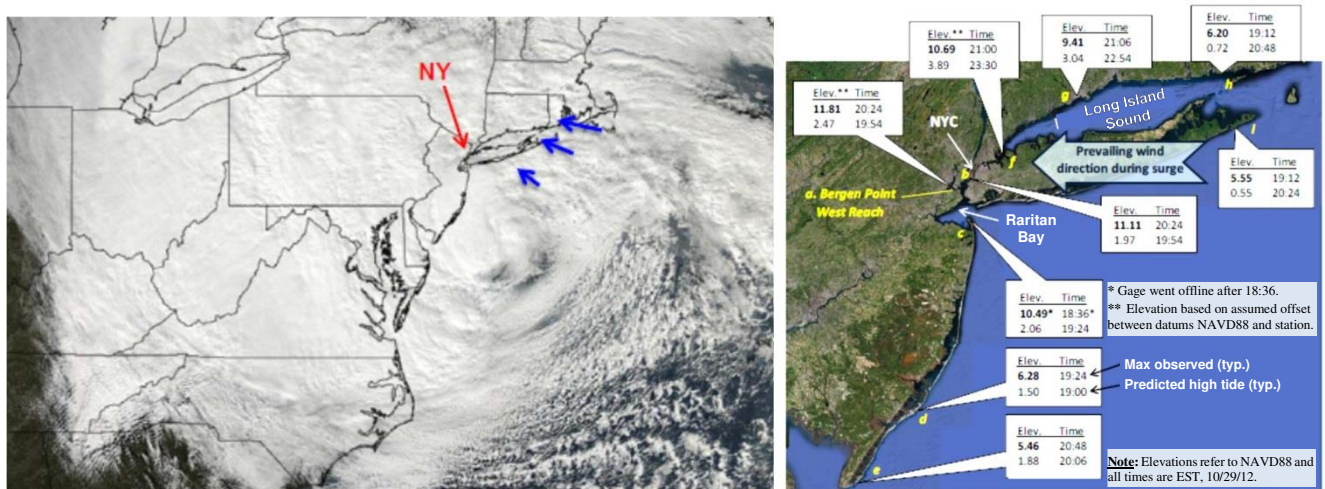
Figure 6. Hurricane Sandy's circulation on 10/29/12 at 2:20 pm EDT; blue arrows show wind direction close to landfall in southern NJ (left; [nasa.gov/hurricanes/h2012/Sandy](http://nasa.gov/hurricanes/h2012/Sandy)). Observed and predicted tide from NOAA stations (right).

Figure 6 depicts the wind direction, fetch, coastline shape, and normal tidal cycle. The counterclockwise wind currents caused an eastern high velocity wind direction over LI and NYC. This pattern was verified by the GEER team's observation that many of the thousands of fallen trees in LI fell to the west. The following factors contributed to an increase of the surge:

- The westward direction of the winds created a long fetch distance from the east towards Raritan Bay and LI Sound.
- The “constricted” shape of both the Raritan Bay and LI Sound narrowing to the west caused the surge height to increase as it moved into those areas due to a “funneling” effect.
- The slow storm movement resulted in the maximum surge being superimposed above the astronomical high tide.

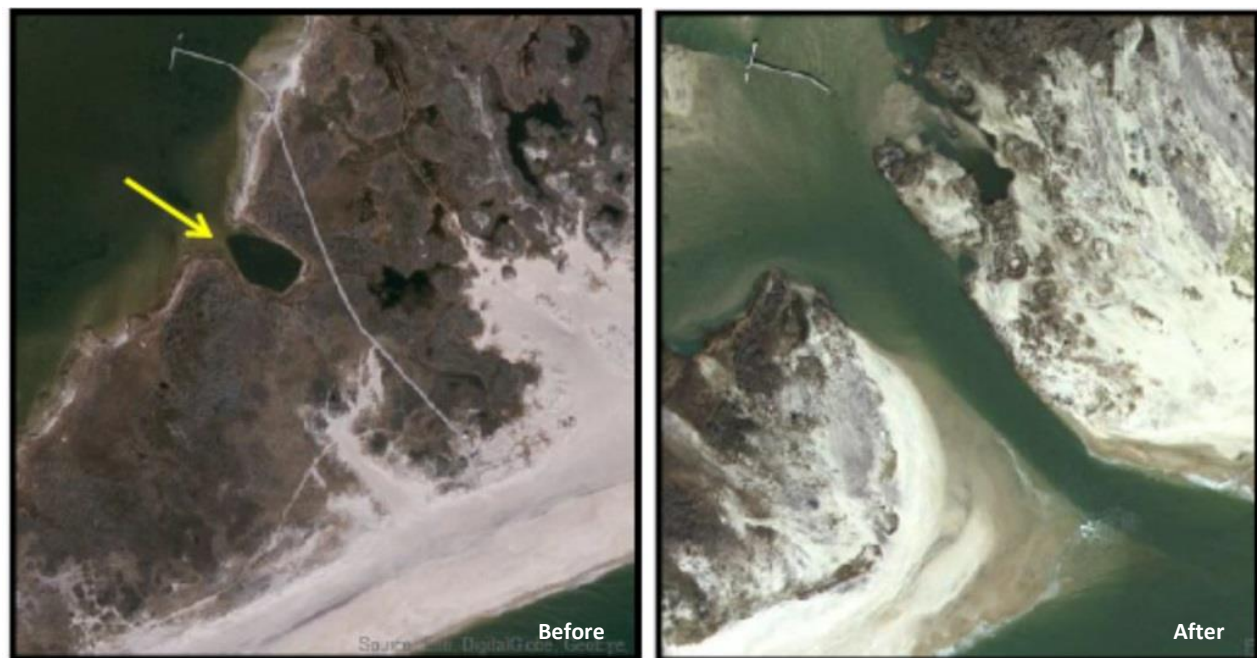
Figure 7. Fire Island, LI: New inlet with narrowing point by embayment in yellow arrow (Ref: [tmappsevents.esri.com/](http://tmappsevents.esri.com/)).

The storm surge significantly modified the coastal NY/NJ geomorphology, with the birth of new inlets and severe erosion and scour of soil on the shorelines (Fig. 7). While devastating in their path, these effects were largely consistent with predictions.

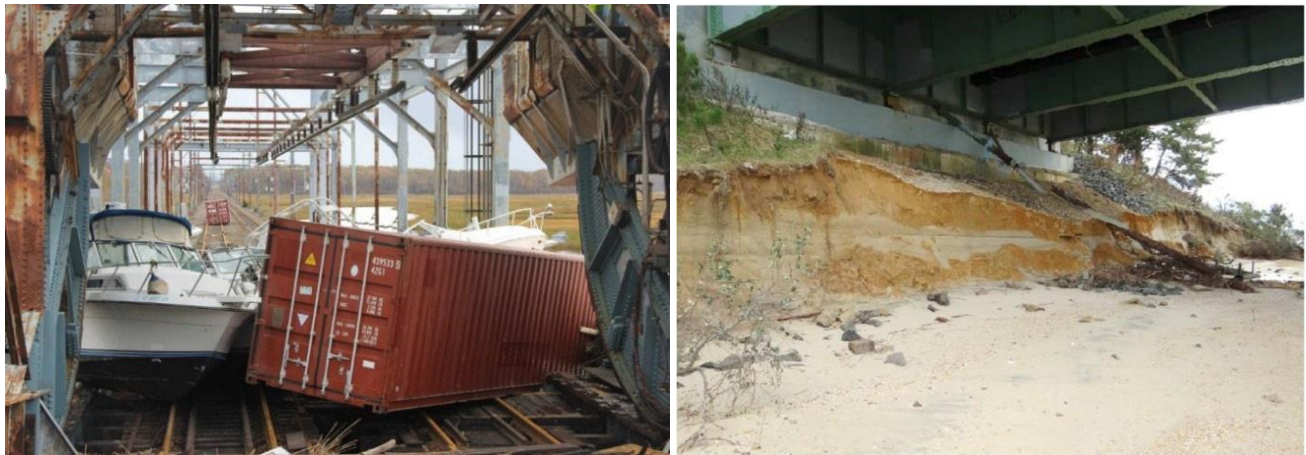
Figure 8. Morgan Drawbridge (left; NJ Transit) and Rt. 72 abutment erosion, looking south-east (right; NJDoT).

GEER observations of seven NJ bridges (NJ 35 - Cheesequake/Manasquan River Drawbridges; Railroad Drawbridge - Manasquan River; NJ 70 - Metedeconk River; NJ 37 - Mathis/Stamley Tunney; NJ 528 - Mantoloking; NJ 72 - Henderson Memorial) and data by the NJ Department of Transportation, Transit Authority, and Ocean County Engineering suggest that bridges remained mostly serviceable immediately or soon after the storm. Two primary themes of damage were identified: (i) flooding effects to drawbridges (e.g., Morgan Drawbridge, Fig. 8) and their electrical systems, and (ii) soil erosion at approaches and abutments (often supported on structures formed by fill within a perimeter soldier pile wall) in several bridges, averaging at 1.5 m (5 ft) of soil removal (e.g., Fig. 8: Rt. 72 Bridge, Fig. 9: Mathis Bridge). The exception was the Mantoloking Bridge that was unserviceable for a long period due to undermining of its abutments and approaches. Figs. 10 and 11 show large floating debris, including houses, that destroyed the T-wall, forcing the coping and sidewalk to cantilever out by about 3 m (10 ft).

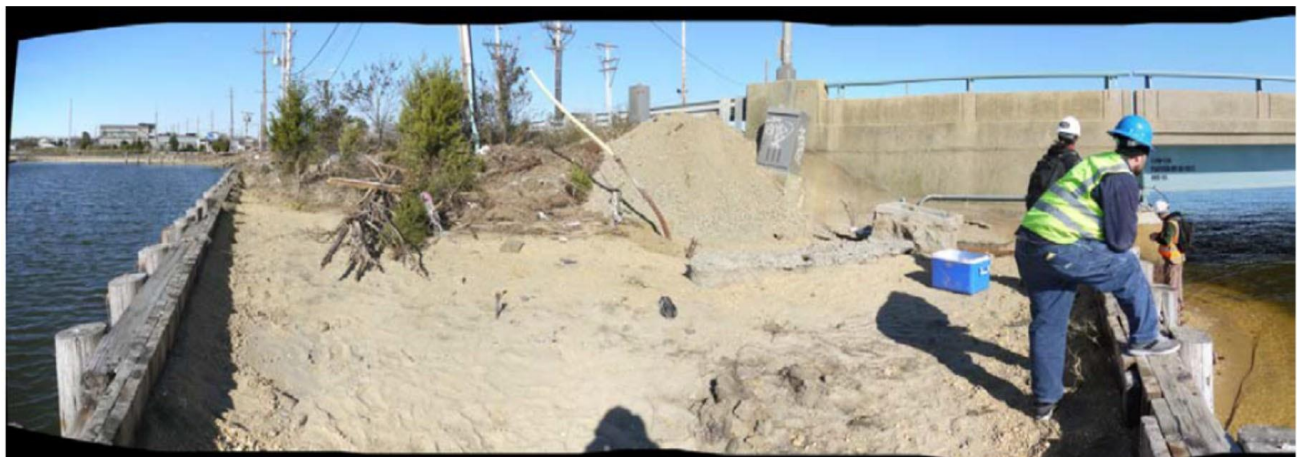
Figure 9. Erosion at Mathis Bridge southwest abutment (eastbound Rt37) ( $39.949350^{\circ}\text{N}$ ,  $74.113902^{\circ}\text{W}$ ; GEER 2014).

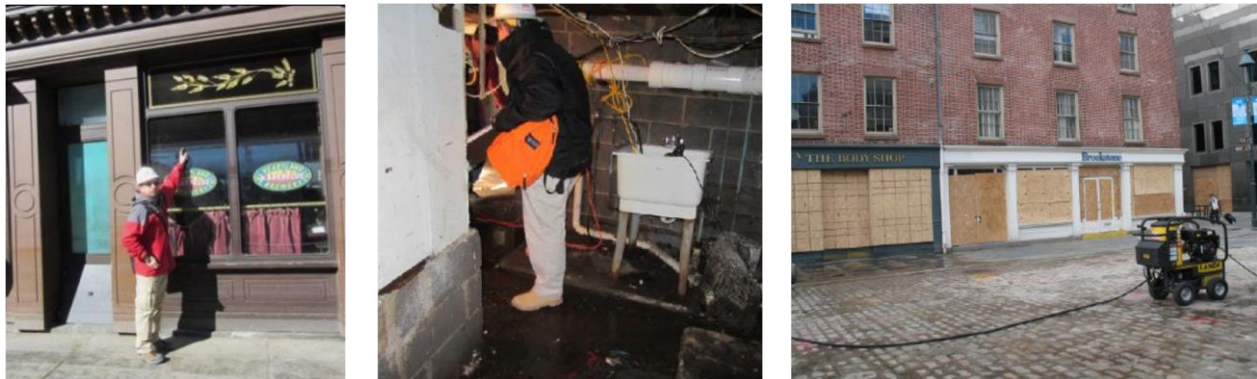
Figure 12. South Street Seaport (40.706685°N, 74.003554°W), 11/4/12: High water line on window of a restaurant (left); typical flooded basement (middle); flood damage (right). (GEER Report, 2014).

Damage in the dense urban NYC area of lower Manhattan was primarily related to flood inundation. High water marks and evidence of flood damage to approximately 1.2-2.1 m (4-7 ft) above street level were observed throughout low-lying neighborhoods (e.g., South Street Seaport) and water front areas (Fig. 12). Below-grade subway stations, tunnels, parking garages, and excavations experienced widespread flooding. While access to many of these locations was restricted to the GEER team due to ongoing recovery work, evidence of flood inundation was visible from the surface, e.g. at the Battery Park underpass and Bellevue Hospital. Based on reports in the days and months following the storm, the flooded tunnels included the Brooklyn Battery, Holland, and Queens-Midtown highway tunnels, the PATH rapid transit tunnels, NJ Transit / Amtrak / LI Railroad Hudson and East River rail, and seven subway tunnels. Several subway stations and open excavations were flooded, including South Ferry, which flooded to the ceiling, as well as an excavation at the World Trade Center site (Figs. 13-14).

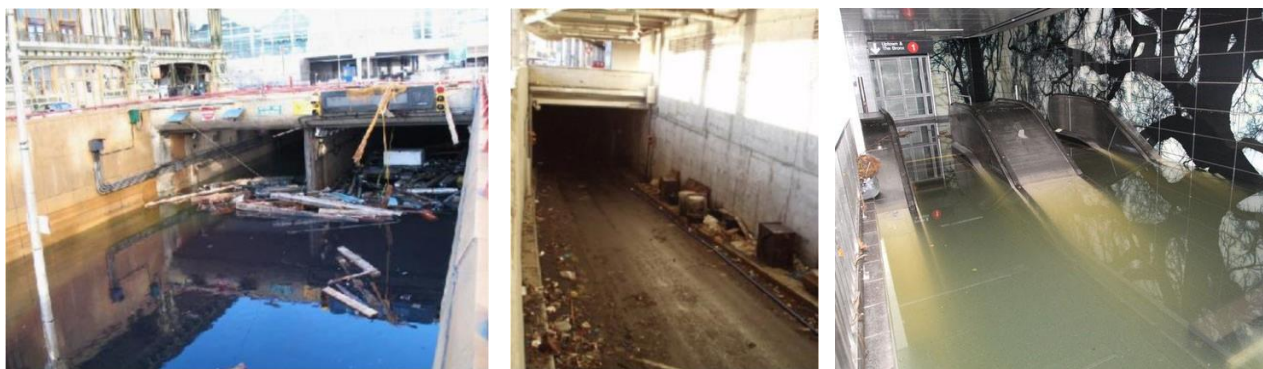
Figure 13. Flooded Battery Park underpass (40.701600°N, 74.011742°W) on 11/4/12 (left, by GEER 11/3/12); E30<sup>th</sup> St. (40.739830°N, 73.973263°W) Bellevue Hospital (middle, by GEER 11/3/12); South Ferry station (right, by MTA 10/30/12).

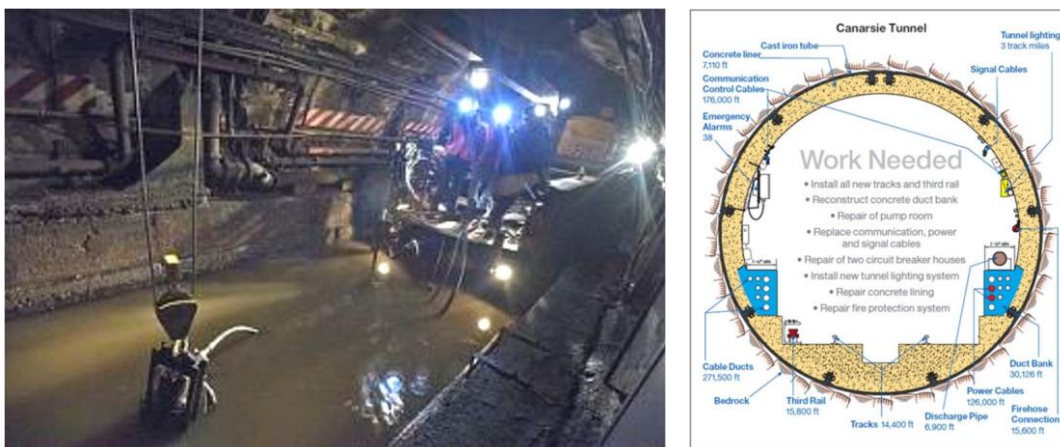
Figure 15. Canarsie tube of [L] line: damage from Sandy (left) and work needed to repair it (right) (MTA, 2017).

While most tunnels experienced minimal structural damage, utilities and ventilation systems were severely damaged and required lengthy repairs. Indicatively, the [R] Montague St. subway and the World Trade Center PATH tunnels were out of service for 2-3 months. The R line was taken out of service again in 2013 for lingering flood damage repairs. The Canarsie Tube of the [L] subway line was inundated with 265,000 m<sup>3</sup> (7M gallons) of saltwater that caused corrosion of cabling, circuit breakers, and disabling of power/track equipment. The duct bank alongside the track, which provides walkway for emergency egress, sustained heavy damage and exhibited a partial collapse. With an initial 15-month shutdown plan, a complete overhaul is still necessary today, in 2020 (Fig. 15), as the L line is critical with a large portion of its daily 400,000 riders travelling to 14<sup>th</sup> Street stations, some of which are not easily reached by other lines. The Queens [A] Rockaway subway line was out of service for nearly seven months due to two major washouts at the earth embankment crossing Jamaica Bay, which exposed the old Long Island Rail Road (LIRR) infrastructure (Fig. 16).

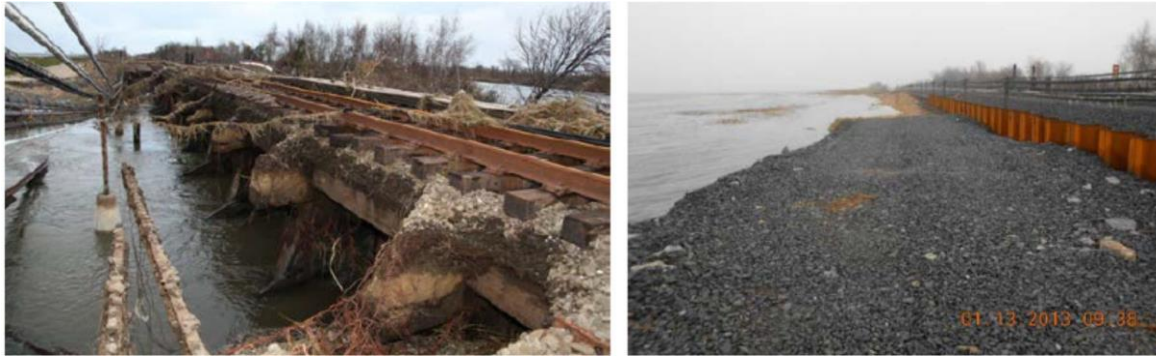
Figure 16. Earth embankment washouts in Queens, along Rockaway subway [A] line after Sandy with old LIRR infrastructure exposed (left) and post mitigation work (right). Photos by Khinda, ed. (2013).

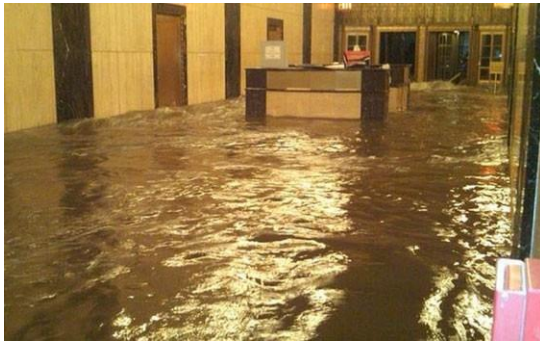
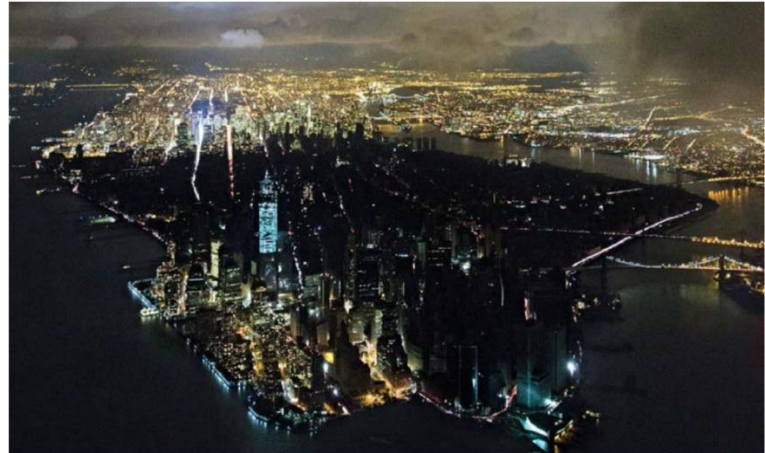
*Figure 17. Flooded lobby of the Verizon building (left, Photo by Governor A. Cuomo); Power outage south of 34<sup>th</sup> St., 10/29/12 in Lower Manhattan which lasted for four days (right, Photo by I. Baan, NY Magazine).*

The storm surge exceeded predictions and caused unprecedented damage to the infrastructure of Consolidated Edison (Con Ed), which supplies electricity to nearly all of NYC's 3M customers (representing 8.3M people and 250,000 businesses) and provides 41% of the city's natural gas service. Precautionary measures were taken, including sand bags and "aqua dams" (polyethylene berms filled with water) at substations and vaults, pre-emptive de-energizing of equipment, isolation of 26 steam main segments, and the pre-emptive shutdown of the East River generating station and the Brooklyn Navy Yard co-generation steam plants. Still, the East River, E13<sup>th</sup> St., and Seaport substations were flooded, resulting in the loss of almost a third of NYC's

generating capacity south of 34<sup>th</sup> St. for four days, thus causing severe delays to the recovery effort and the restart of subways (Fig. 17).

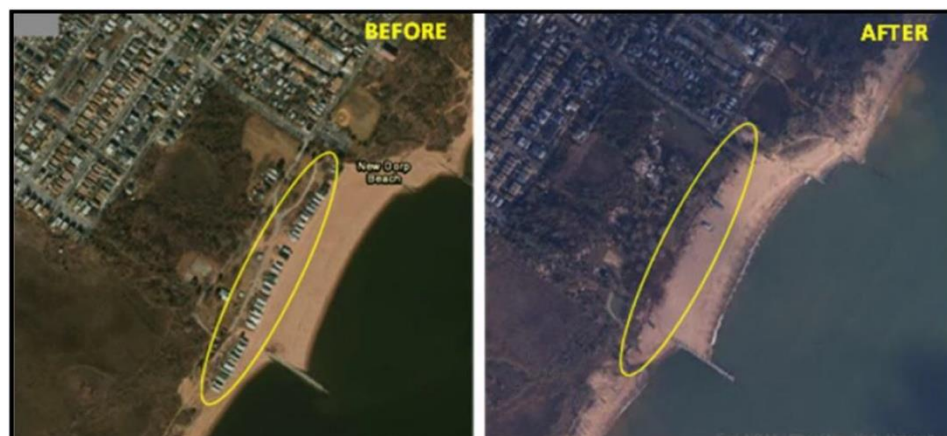
*Figure 18. Aerial photographs from New Dorp Beach, SI, before and after Sandy. Row of houses completely removed and debris moved inland. (Images from [tmappsevents.esri.com/website/swipe\\_sandy/](http://tmappsevents.esri.com/website/swipe_sandy/)).*

Storm surge, flooding, and erosion impacted residential housing and municipal infrastructure foundations in coastal areas investigated by the GEER team (Fig. 3). Destruction of wood-frame houses in Staten Island (SI) was common, as observed based on the "before" and "after" aerial photos of a row of houses (Fig. 18), which were completely removed by the storm. This area is underlain by glacial outwash sands, often overlain by man-made fill. Most of the structural/foundation failures occurred in dwellings built prior to 1938, typically developed as summer residences in areas with direct exposure to open ocean, constructed less robustly than modern, permanent-residence, homes (Eschenasy, 2013). Moving inland, dunes, and vegetated strips had a positive effect in reducing the damage.

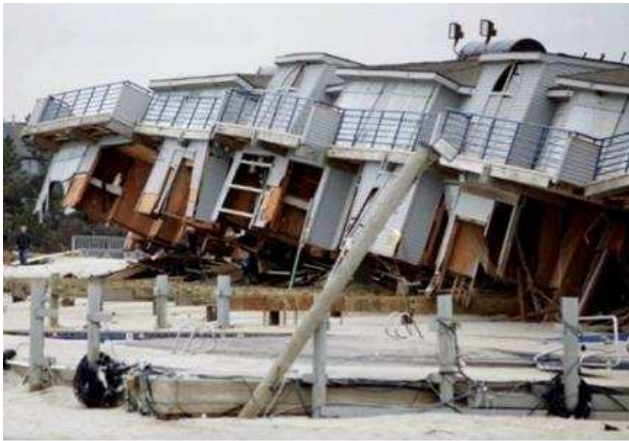
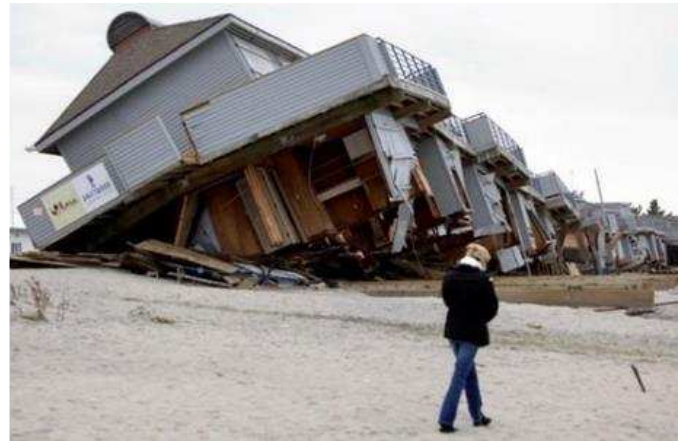
Figure 19. Sea Bright, NJ, beach cabana (40.350086°N, 73.972954°W) pulled off its base (Photo by AP/Wenig; 11/19/12).

A common damage pattern among wood frame houses was the pulling off their foundation due to inadequate anchorage (e.g., Sea Bright, NJ, Fig. 19). These house were subject to flotation, which not only causes distress, but removes dead load from foundations, making them more susceptible to breakage. Particularly, Concrete Masonry Unit (CMU) wall foundations and piers performed poorly, and were found buckled, broken, or completely removed, causing tilt, dislocation, or collapse of the superstructure (Fig. 19). In Sea Gate, Brooklyn, a concrete beachfront retaining wall foundation was undermined by erosion and subsequently broke, while the soil behind the wall was washed out (Fig. 20). In Breezy Point and Roxbury, Queens, two-story wood-frame homes, on CMU block wall and pier foundations, sustained major structural damage, including being pulled off their partially or completely destroyed foundations (Fig. 20). On the other hand, foundations of high-rise residential buildings (typically piles) generally performed well.

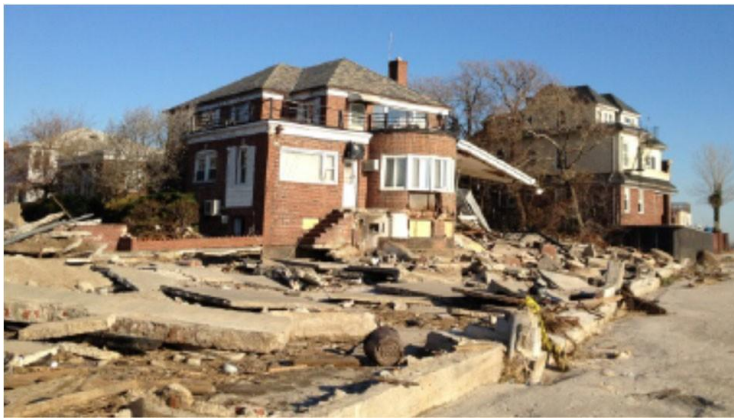
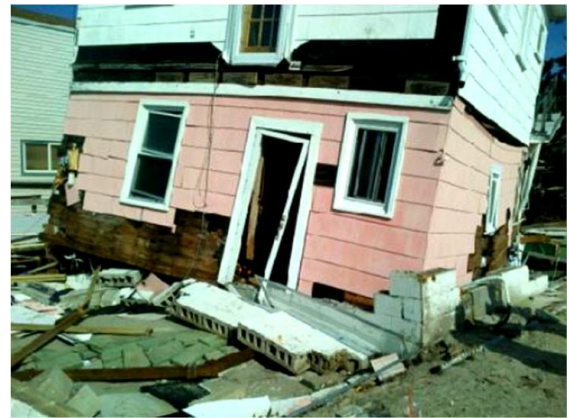
Figure 20. Undermining of beachfront retaining wall and loss of retained soil, Sea Gate, Brooklyn (left, 11/9/12); Destroyed CMU wall foundation, Breezy Point, Queens (right, 11/12/12). Photos by NYCDob (GEER, 2014).

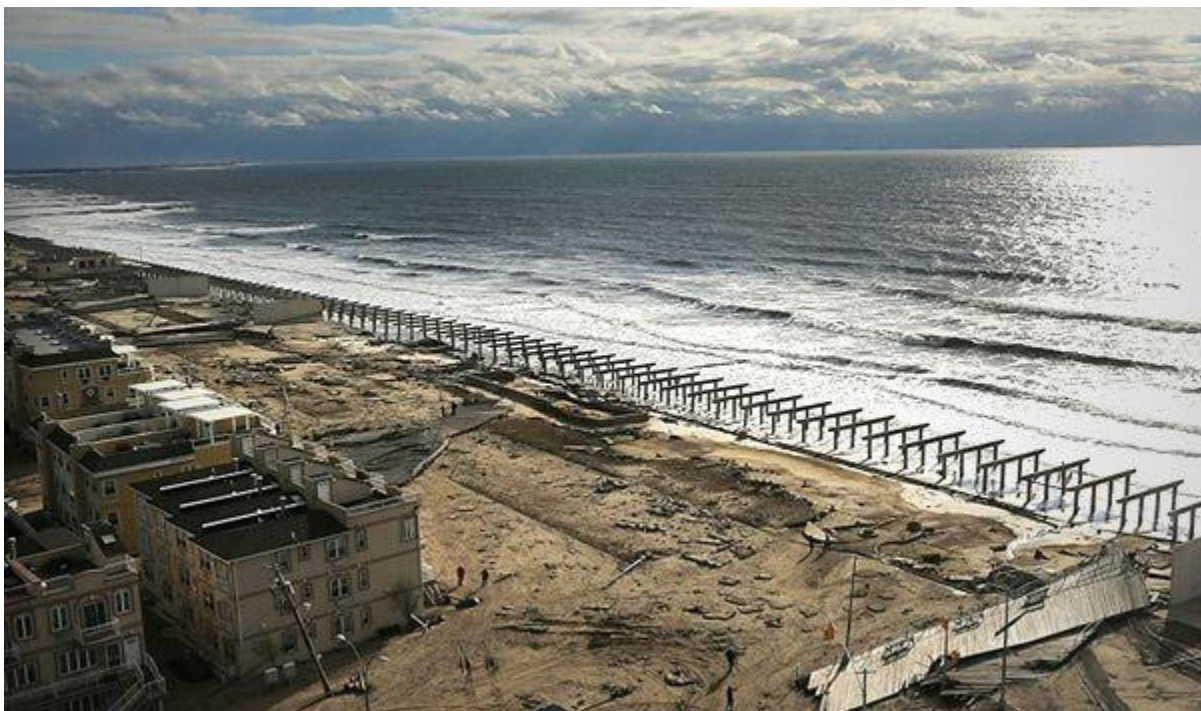
*Figure 22. Damage to Boardwalk at Rockaway Beach, Queens (40.583445°N, 73.81553°W). Photo by cnbc.*

concrete pile-supported wooden boardwalks, and some homes are separated from the beach by concrete or sheet pile retaining walls. In Rockaways, Queens, the boardwalk had been lifted off its piers and damaged or destroyed over its entire length, with debris carried up to 60 m (~200 ft) inland (Fig. 22).

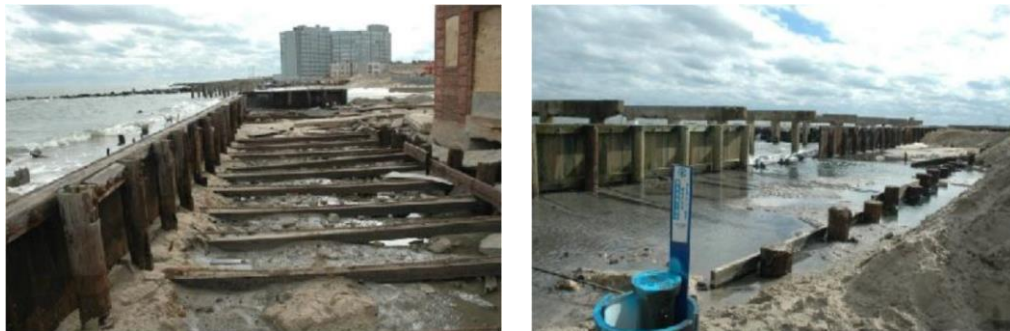
*Figure 25. Bulkhead in Atlantic City, NJ: backfill soil washed away, exposing severely corroded tie rods (GEER, 2014).*

along a section of the shore in Atlantic City, NJ, were breached.. The breaches were attributed to the destruction and washing away of the timber facing . The surge and water washing through the breaches exposed the tierods and anchors (Fig. 25).

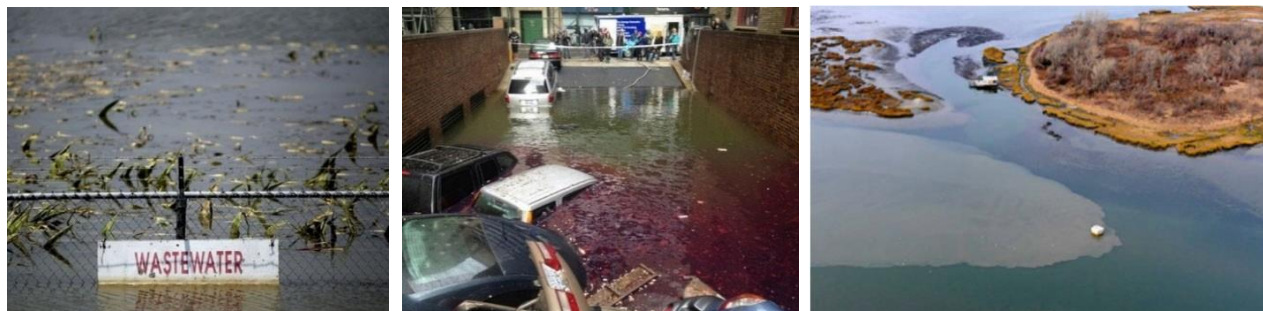
Figure 26. Untreated waste spilled in NY Harbor (left, photo Getty/Tama) and buried cars (middle, photo Bloomberg/Korby). Overflow from Bay Park Sewage Treatment Plant, East Rockaway (right, photo by D. Kuntz; Kenward et al., 2013).

to shut down or divert sewage into waterways due to power outages and flooding (e.g., Fig. 26 shows untreated waste spilled in the LI South Shore Estuary from the Bay Park Sewage Plant in East Rockaway). GEER visited the WWTP that processes waste water from Yonkers. Founded on filled land along the east bank of the Hudson River, it experienced one of the largest overflows with 4.5M m<sup>3</sup> (1.2B gallons). The river frontage has a rip-rap revetment at the south and a steel seawall (Fig. 27) about 1.5 m (5 ft) higher than the north rip-rap. Normally, the plant handles daily 360 m<sup>3</sup> (95M gallons) of waste water; during in Hurricane Irene in 2011, it processed 1,150 m<sup>3</sup> (300M gallons). After Sandy, loss of gravity flow caused more than 2.8 m (9 ft) of tail water and therefore flooding of below-grade areas (Fig. 27), something that damaged equipment including boilers, the alarm system, pipes, and motors.

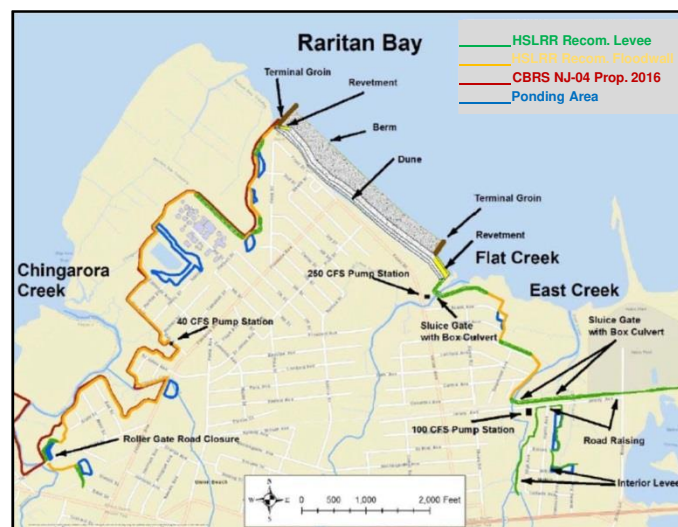
Figure 29. Union Beach plan overview from U.S. Army Corps of Engineering Limited Reevaluation Report (USACE, 2017).

The NJ State issued a report five years after Sandy with: (i) a record of damage and response; (ii) an agency-by-agency response/recovery playbook applicable to other states exposed to hurricanes; and (iii) rebuild measures co-funded by FEMA, the Departments of Interior and Housing and Urban Development (HUD), and Federal Highway Administration (FHWA), such as: Sea Bright wall, Mantoloking and Brick sheet piling, Belmar Lake Como discharge, Brigantine pump stations, Little Ferry tide gate, and Wildwood/Stone Harbor storm water/flood control. The Union Beach project in Raritan Bay (Fig. 29) would rebuild beaches and dunes and restore 100,000 m<sup>2</sup> (25 acres) of degraded wetlands to better absorb flood waters, with levees, flood walls, tide gates, and pump stations.

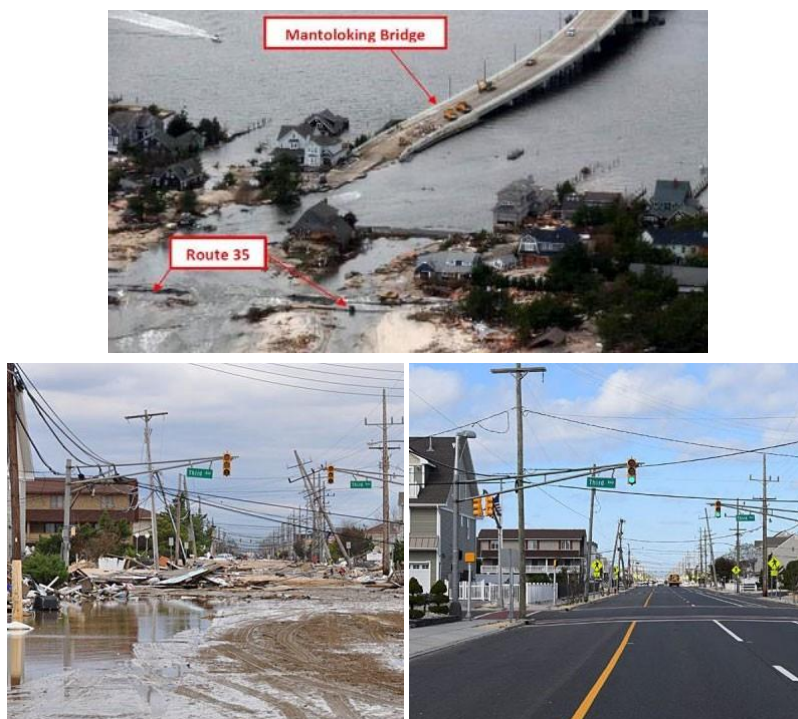
Figure 30. Rt 35 during Sandy (top); before/after photos at 3<sup>rd</sup> Ave, Ortley Beach (bottom, C. Raia, Toms River Township).

An example of a completed project is the \$340M Rt35 Reconstruction, which was a severely-damaged coastal emergency evacuation route that has since been rebuilt with state-of-the-art road construction and a thorough storm water drainage system (Fig. 30).

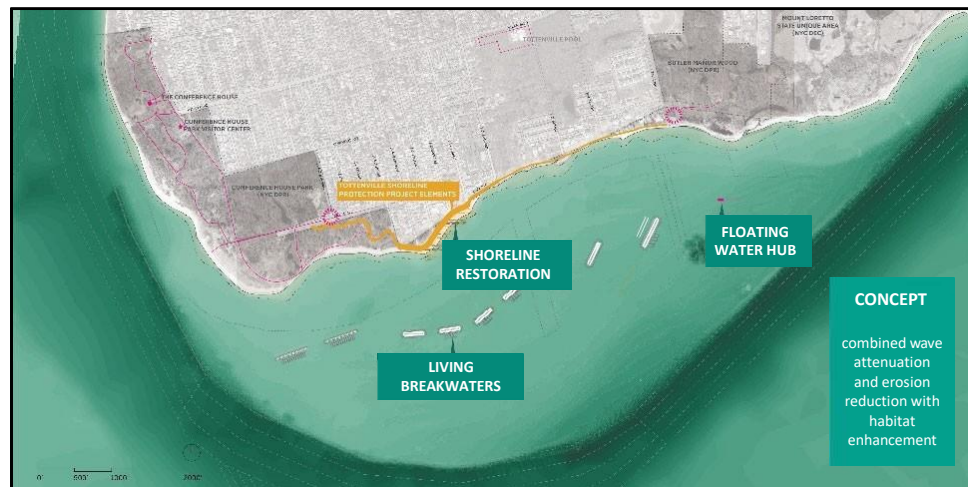
Figure 34. Living Breakwaters system: combined wave attenuation and erosion reduction with habitat enhancement.

added to the shoreline will protect vulnerable beaches, while breakwaters work to accrete beach elsewhere (Fig. 34). Similarly, in NJ, Rebuild by Design includes several projects, such as: (i) CDBG (\$380M) projects to be completed by 2022; (ii) Hudson River (\$230M) communities and critical infrastructure flood-resistance structures (e.g., N. Hudson Sewerage Authority); and (iii) protection of Meadowlands (\$150M) Little Ferry, Moonachie, Carlstadt, Teterboro, and S. Hackensack.

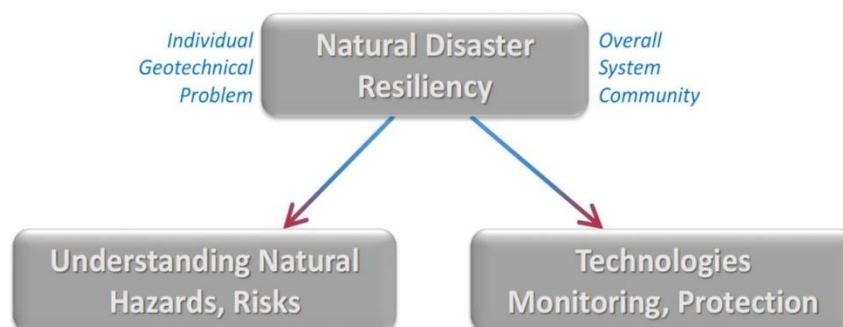
Figure 36. Framework for resilient-based design (Nikolaou et al., 2017).

and risk-based engineering framework which considers life cycle costs is needed to address both new infrastructure components and the (often aged) legacy components. A design framework as shown conceptually in Fig. 36 can address both the individual component as well as the overall system needs, while planning for cascading hazards (Nikolaou et al., 2017). The GEER-organized efforts and presentation of data highlighted key flaws, demonstrating to stakeholders and the public that geotechnical engineers should be involved early in the decision-making process after major events such as Hurricane Sandy.
