## A Constructability Problem in a Deep Shoring System

Reference: Köpüklü H., Ekli O., Akçakal Ö., Durgunoğlu H. T. (2021). A Constructability Problem in a Deep Shoring System. International Journal of Geoengineering Case Histories, Volume 6, Issue 1, pp. 53-66, doi: 10.4417/IJGCH-06-01-03

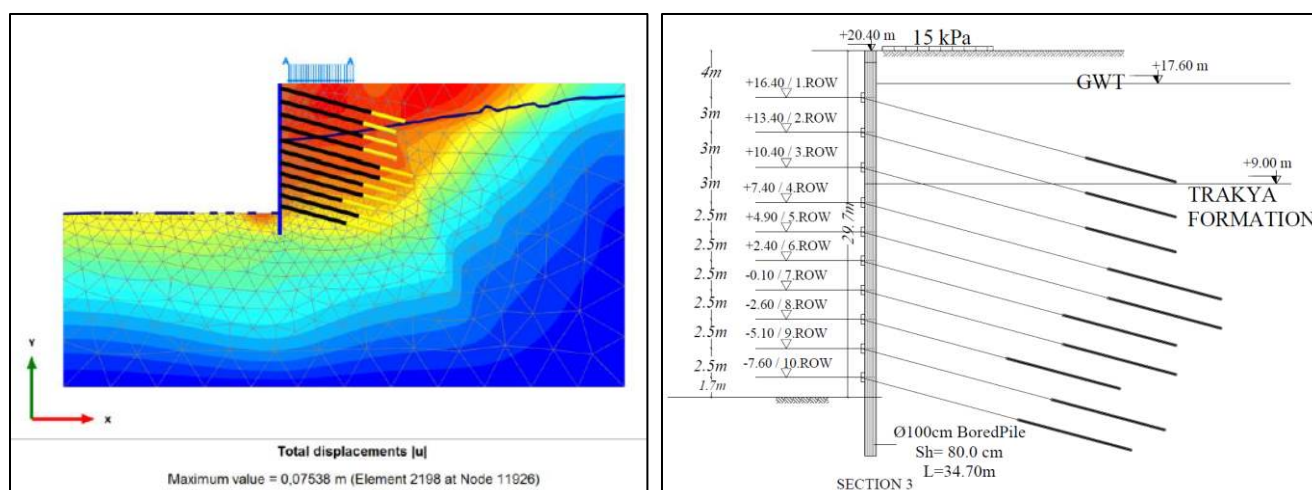
Figure 7. Section View of the Retaining System.

Three types of anchors were used for the calculations. Type 1 has 4.0m-20.0m free length, 8.0m grout length, at a 15° angle from the horizontal placed with 3.20m spacing in alluvial units. The other two are located in the rock unit. The first has 20.0m free length, 8.0m grout length, at a 15° angle from the horizontal (Type 2) placed with 1.6m spacing. The second has 17.0m-22.0m free length, 10.0m grout length, at a 15° angle from the horizontal (Type 3) placed with 1.6m spacing. Ten (10) levels of prestressed anchor rows are considered in the analysis.
