# The Multi-Purpose Bottom Plug for the Galataport Project

**Salvatore Miranda**, Technical Manager, TREVI Turkey, Istanbul (Turkey); email: [smiranda@trevispa.com](mailto:smiranda@trevispa.com)

**ABSTRACT:** *The paper describes an innovative geotechnical engineering solution that was provided by TREVI for the renovation project at Galataport in Istanbul, Turkey. Among other interesting geotechnical works included in the project, this paper also presents the design considerations and construction of the multi-purpose bottom plug (MPBP). This original geotechnical engineering solution was employed for a three-basement excavation in Karaköy and consists of a combination of seepage control, ground improvement, and load bearing elements, which were executed with double-fluid jet grouting, pseudo-elliptical jet grouting, and permanent micropiles, respectively. The paper describes each step of the design, execution, and the preliminary and final testing phases. Moreover, it highlights the importance of employing cutting-edge technologies used in deep foundation geo-construction and state-of-the-art electronic control devices, along with expertise, to obtain the desired results for thi

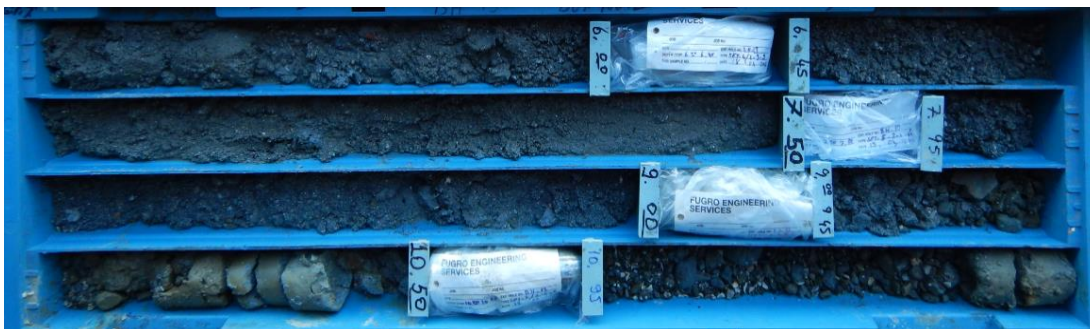
Figure 6. Loose-to-medium dense silty SAND.

The thick fill layer is underlain by a layer of very loose silty sand that is about 5 m to 10 m thick. The bedrock is a very strong, very fractured Greywacke (UCS = 100 to 150 MPa), with the top 10 m to 15 m thickness being very weathered, as shown in Figure 7. The bedrock is located at a depth between 35 m and 45 m below the existing ground level, which is deeper than the geotechnical activities involved in this area; therefore, all structures were executed within the man-made fill and the underlying marine sand layer. The thick fill/sand layer contains a small amount of fine material and is classified as loose-to-very-loose (SPT N-values = 0 to 15 blow/0.3 m,  $q_c = 0.5$  to 3.0 MPa), with a high liquefaction risk. The permeability of this layer was assessed to be in the range of  $10^{-4}$  m/s.

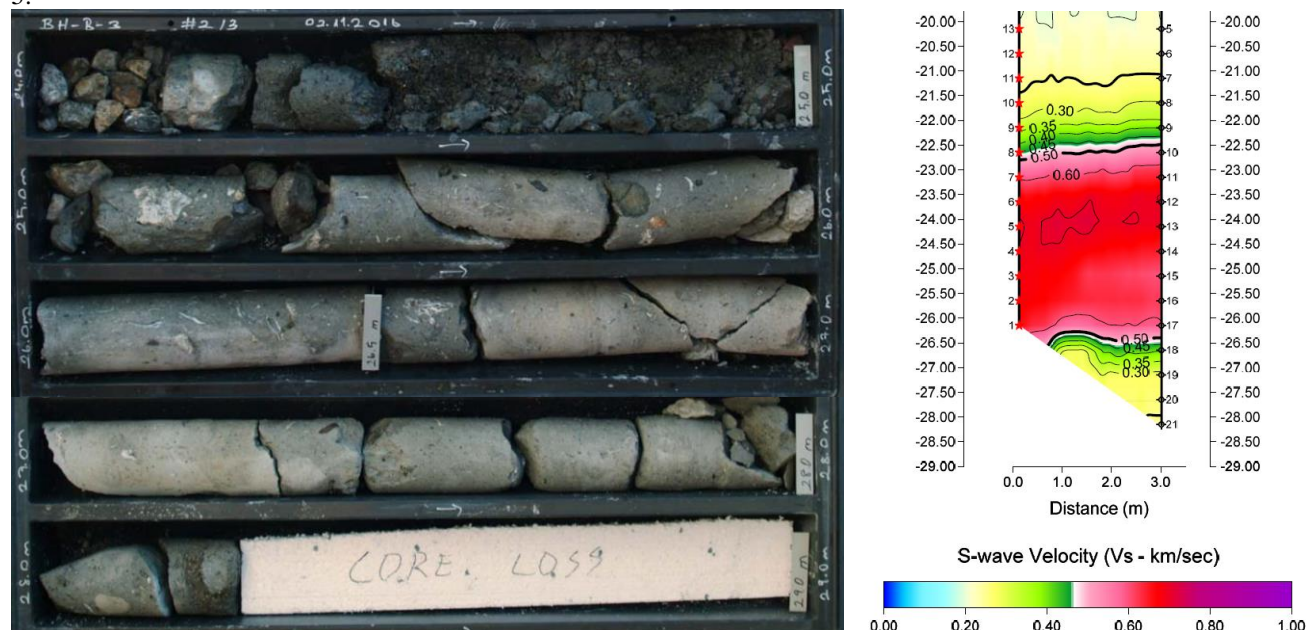
Figure 25. Core box photos of coring BH-B-3 between 24 and 29 m depth. Measured  $V_s$  across overlapping columns.

Several cracks were visible on the extracted core, which could be due to the coring effects but could be also related to the overlapping of two different jet grouting columns.

group of six overlapping columns (B-JG-3 to 8) at the design depth of bottom plug. Two continuous corings were executed in the overlapping zones and one seismic crosshole tomography line was also conducted across the columns to verify the presence and quality of the overlapping. Pictures of one coring (BH-B-3) and measured values of shear wave velocity ( $V_s$ ) can be found in Figure 25. The results of the seismic crosshole tomography executed on the overlapping columns show a full overlapping and continuity in the block of treated soil without relevant defects. The median measured value of  $V_s$  was 640 m/s.
