## 40 Years of Full-Scale Infrastructure Testing at a National Geotechnical Experimentation Site: Sand Site.

**ABSTRACT:** A site at the Texas A&M University RELIS campus near College Station, Texas, was dedicated to full-scale infrastructure testing in 1978. It was designated as a National Geotechnical Experimentation Site by NSF and FHWA in 1992. The site is made of 15 m of medium dense silty sand, within which most experiments took place, underlain by a deep layer of clay shale. The water table is approximately 7.5 m deep. Over the last 40 years, many full-scale instrumented experiments on infrastructure elements have been conducted at that site. The main projects include a box culvert within an embankment, spread footings of various sizes, drilled shafts with intentional construction defects, an anchored top down retaining wall, a top down deep-soil-mixing retaining wall, post grouted drilled shafts, vibro-driven steel piles, a drilled shaft embedded in an MSE wall and pushing on it, a tractor trailer truck crashing against a barrier on top of an MSE wall, a single unit truck crashing against a row of in line piles, and erosion in-situ tests. This paper describes each one of t

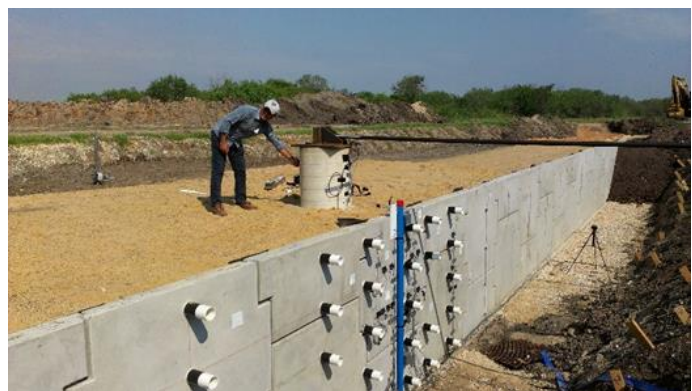
Figure 30. Construction of the MSE wall.
