# Asynchronous Mobilization of Shear Resistance in Slope Failures

**ABSTRACT:** *This paper focuses on the case study of the 2014 embankment failure at the Mount Polley TSF in Canada to study deformation-controlled mechanisms of instability leading to the asynchronous mobilization of shear strength and causing progressive failure. Three such mechanisms were identified in this failure: strain-weakening, the delayed mobilization of shear strength in the shell owing to stiffness incompatibility, and a reduction of mobilized shear resistance in the extending regions of the slide due to loss of confinement. Changes associated with these mechanisms were identified in the numerical analysis to help diagnose the impending collapse. These are: the emergence in the strain-weakening unit of a substantive area on the brink of strain-weakening, the depletion of reserve strengths in the foundation materials, and the extension of the unit above the strain-weakening zone owing to differential shear displacements within and outside the failure zone. Safety factor calculations do not adequately capture the stability of the Mount Polley embankment in the year preceding its collapse, and limit equili

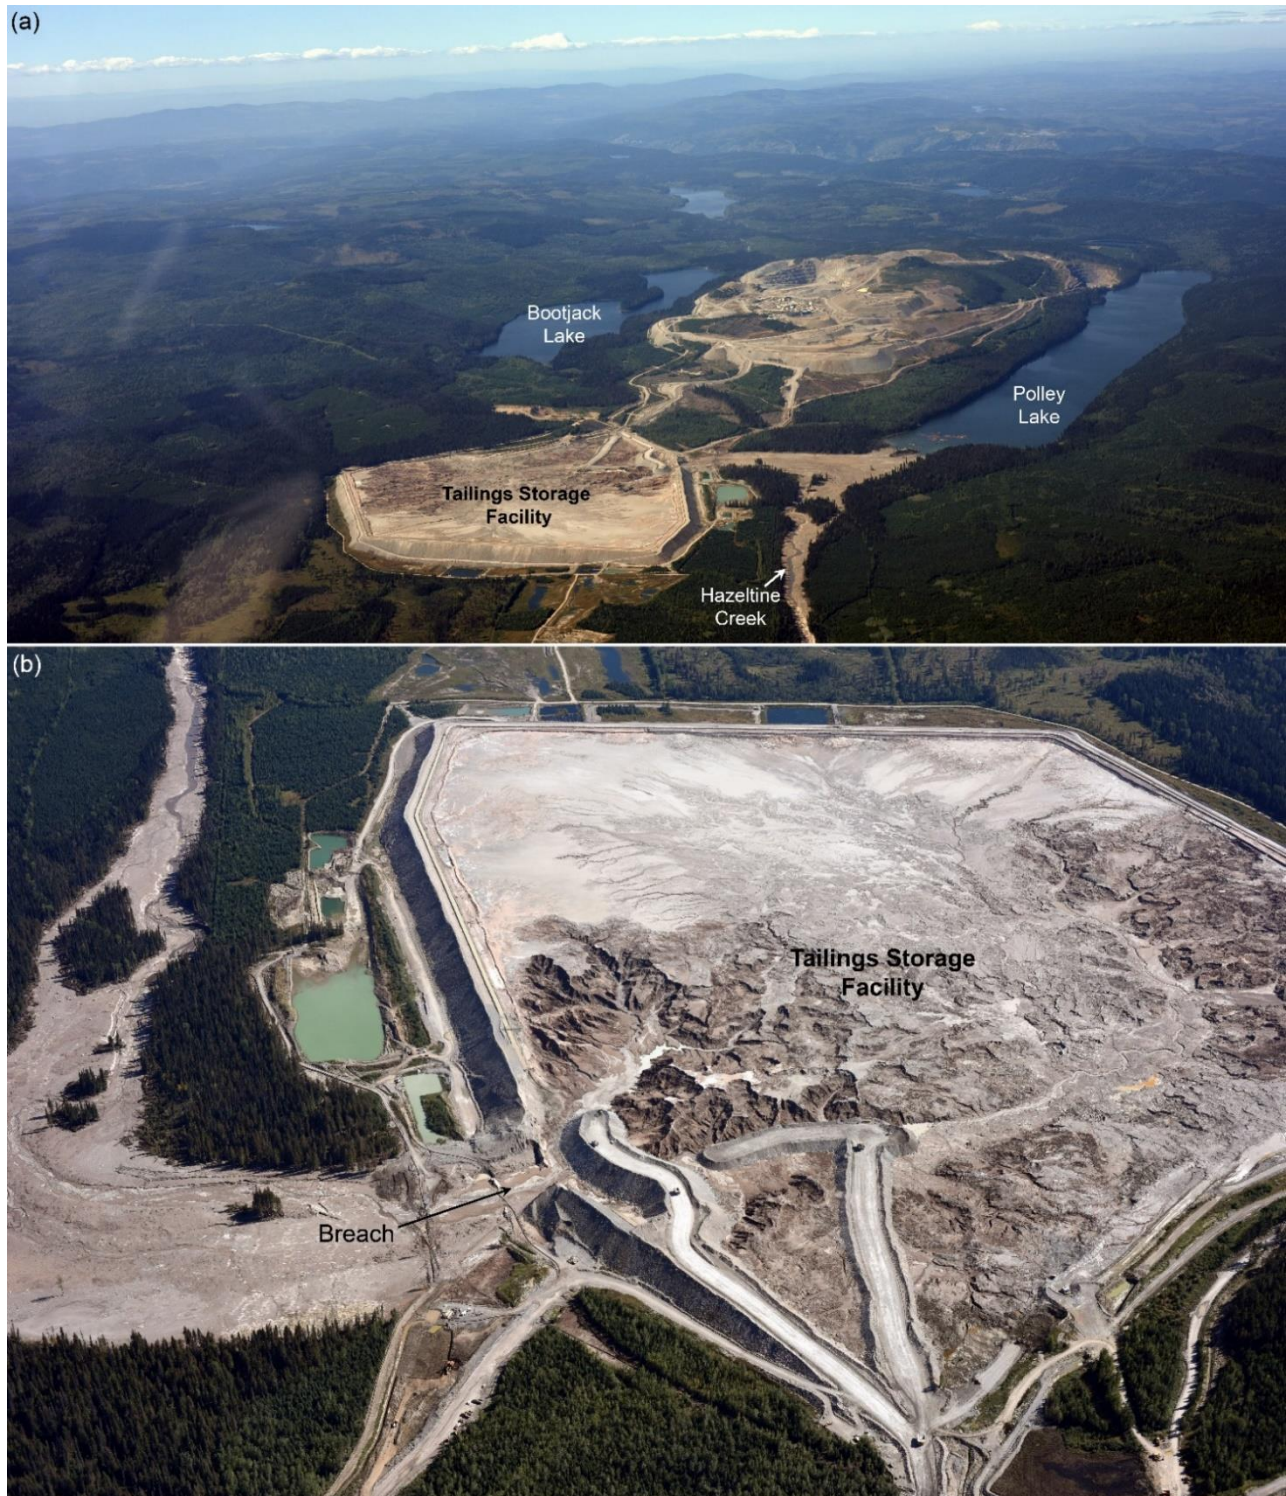
*Figure 1. (a) Aerial diagonal view of the Polley Mine looking NNW; (b) Aerial diagonal view of the Mount Polley TSF, looking SSW. Photography courtesy of Jamie Heath, [therrasaurus.ca](http://therrasaurus.ca), taken 09/05/2014, reproduced with permission, altered to add labels and enhance contrast/tonne.*

Mount Polley mine is a gold and copper mining operation managed by the MPMC. It is located in the Cariboo Region of British Columbia, Canada at the approximate coordinates 52°33'N 121°38'W. The mine is situated on glaciated terrain and is surrounded by pristine boreal forest along with a system of glacial lakes and creeks (Zabolotnii 2020, p. 75; Fig. 1).

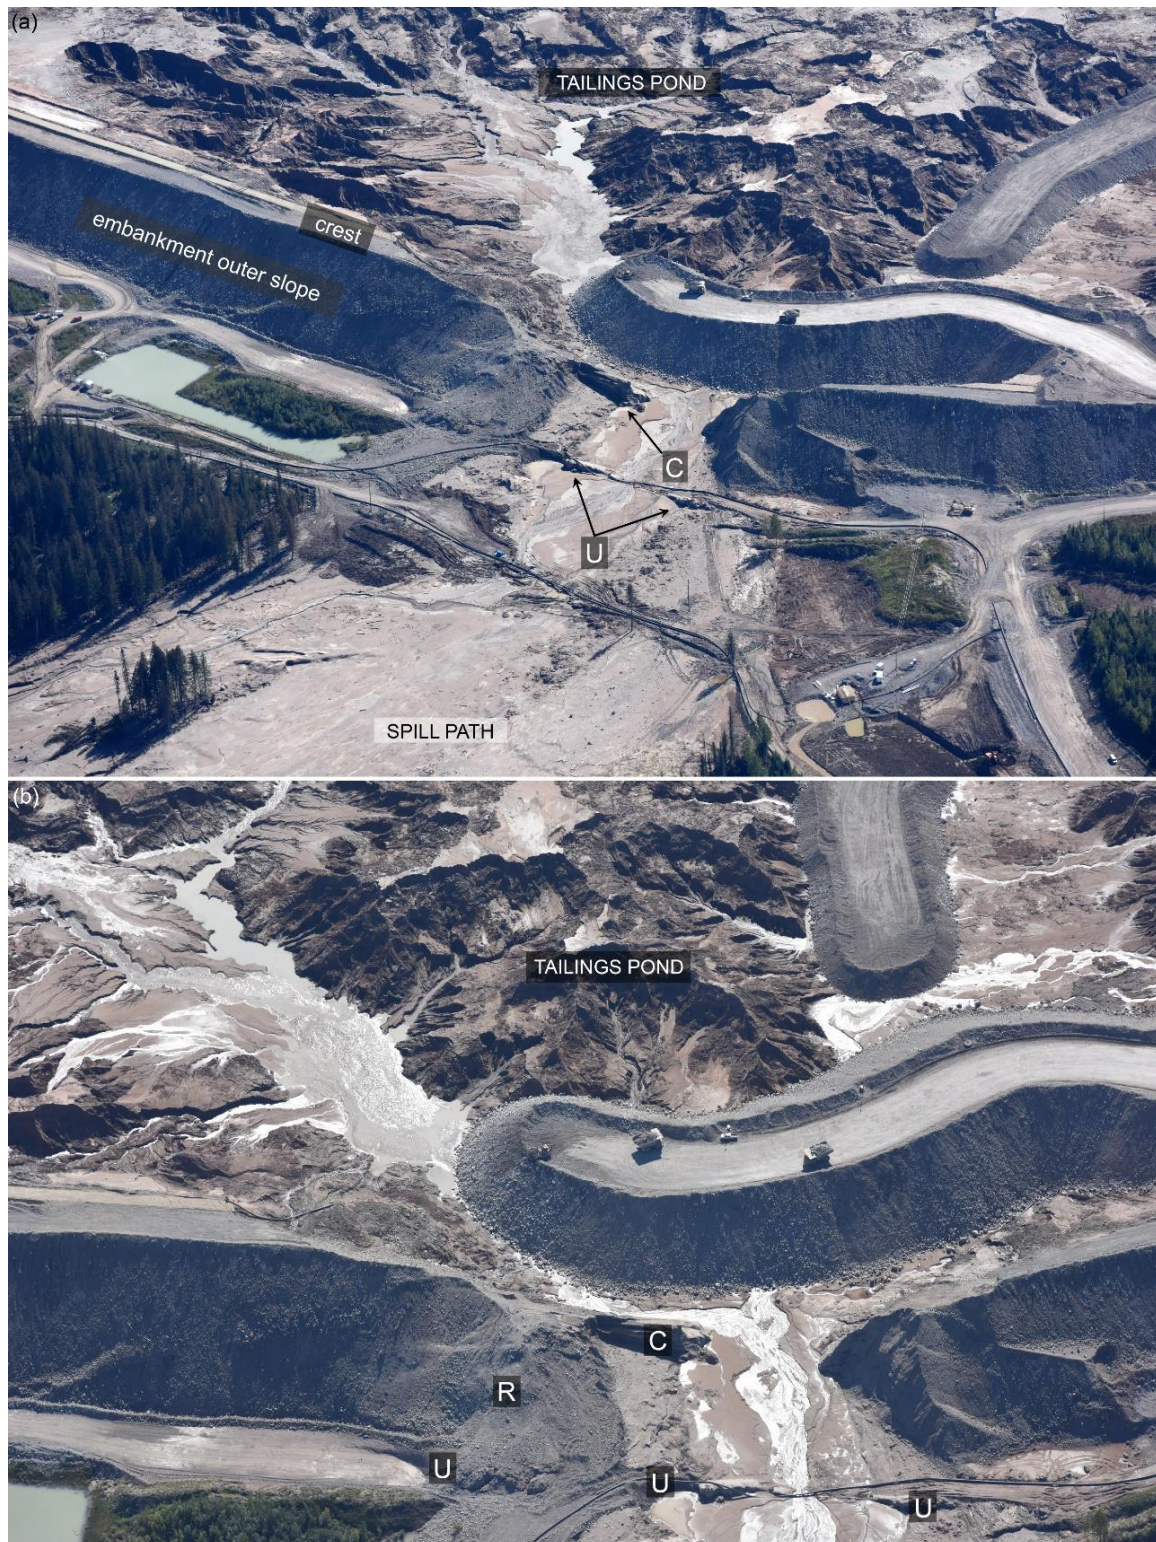
Figure 4. (a) Aerial diagonal view of the breach and spill path areas; (b) Aerial diagonal close-up of the breach location. Labels: C – core remnant, R – rockfill at the east boundary of the slide, U – uplift at the toe of the slide. Photography courtesy of Jamie Heath of terrasaurus.ca, taken 09/05/2014, reproduced with permission, altered to add labels.

Above the slide base, the geometry of the slip was irregular. Extensive ground cracking, shear zones (IRP 2015, Fig. 5.1.7), and sheared remnants of core (Fig. 4, feature C) delineated the extent of the slide in the upstream region roughly along the dam centerline and just few meters upstream of the Upper GLU's upstream edge. The failure zone was restricted to a width  $\sim 100\text{m}$  at ground level, widening to  $\leq 150\text{m}$  at crest level. The broad (200-250m) slip surface in the Upper GLU did not clearly propagate into the embankment; however, the rockfill in the shell zone flanking the breach is seen to have undergone significant deformation (Fig. 4, feature R). This material's lower deformation modulus and resulting stress-strain incompatibility with the rest of the structure was inferred both from the large deformations at failure but also from a documented history of poor compaction and low confinement stresses.
