Liquefaction Ejecta Case Histories for 2010-11 Canterbury Earthquakes

Reference: Mijic, Z., Bray, J. D., and van Ballegooy, S. (2022). Liquefaction Ejecta Case Histories for 2010-11 Canterbury Earthquakes. *International Journal of Geotechnical Engineering Case Histories*, Volume 6, Issue 3, pp. 73-93, doi: 10.4417/IJGCH-06-03-04

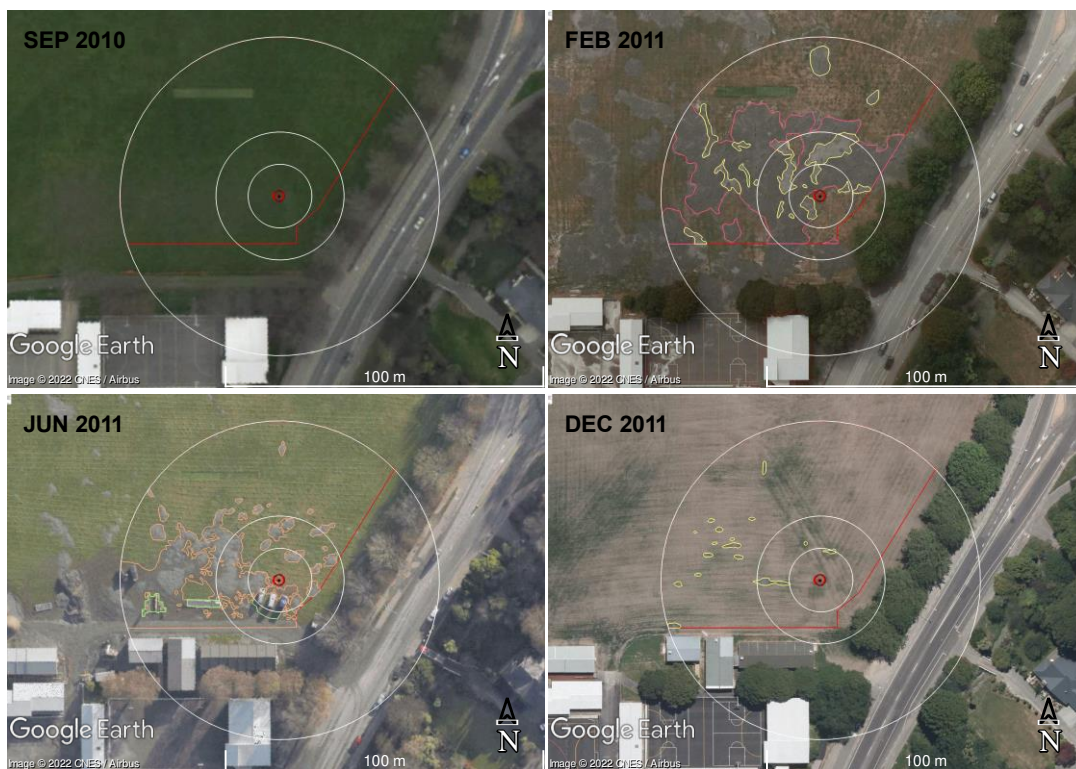
Figure 6. Aerial photographs acquired for Shirley Intermediate School in Sep 2010, Feb 2011, Jun 2011, and Dec 2011 (CGD, 2012a) with ejecta outlines for the 10-, 20-, and 50-m buffers.

The aerial photographs in Figure 6 were used to estimate the occurrence of ejecta and to measure the area of ejecta coverage within the assessment area (the red outline). The absence of ejecta is evident for the Sep 2010 earthquake. For the Feb 2011 earthquake, ejecta occurred across the site in a pattern of interconnected soil deposits originating from different fissures and forming irregularly shaped ejecta blankets rather than in a pattern of individual conically shaped soil boils. Different shades of gray of the ejecta were interpreted as different ejecta thicknesses. The light gray ejecta outlined in yellow were classified

as thin ejecta, while the dark gray ejecta outlined in pink were classified as thick ejecta. The total areas of the outlined thick ejecta layers and the outlined thin ejecta layers ($A_{E,thick}$ and $A_{E,thin}$, respectively) were measured in Google Earth Pro. The $A_{E,thick}$ and $A_{E,thin}$ values for the 10-m buffer are summarized in Table 2. In the absence of ground photographs, the height range for the thick and thin ejecta layers ($H_{E,thick}$ and $H_{E,thin}$, respectively) was estimated based on the typical height of similar-looking ejecta for the neighboring area and observations made by people (Table 2). Finally, the volume of ejecta was estimated using Eq. 1 and was divided by the total assessment area, A_T , to obtain the areal ejecta-induced free-field settlement, S_{E,P_areal} (Table 3), while the localized ejecta-induced settlement, $S_{E,P_localized}$ (Table 3) was obtained by dividing the total volume of ejecta within A_T by the coverage area of ejecta, A_E . Figure 6 also shows the presence of ejecta for the Jun 2011 earthquake. However, ejecta appeared to be partially cleaned from the site. To account for this uncertainty, the height of ejecta was provided as a wider range, while assuming ejecta covered the portion of the site in light brown color. The area for the Jun 2011 earthquake reported in Table 2 corresponds to the area outlined in orange and within the 10-m buffer. Also, cars, shadows, and construction equipment obscured a portion of the assessment area in the Jun 2011 aerial photograph, resulting in that portion of the site being excluded from the analysis. For the Dec 2011 earthquake, only minor ejecta (outlined in yellow in Figure 6) were present.

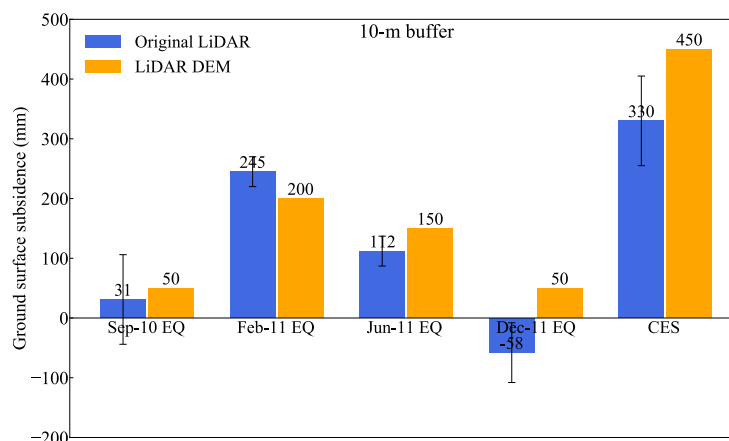
Figure 9. Comparison between the ground surface subsidence determined using the individual LiDAR elevation points and the ground surface subsidence estimated using the LiDAR DEMs.
