# Practical Design, Numerical Analysis, and Site Monitoring for Huge Arching Effect during Massive Excavation of Undercut Slope in Open-Pit Mine

**ABSTRACT:** *This paper reviews a successful case history where applications of numerical predictions for a massive excavation were undertaken for both Class A and Class B predictions. Forming a stable arch across the pit of an open-pit mine is beneficial to the design of an undercut slope. However, predicting the maximum stable undercut width under which the slope does not collapse is a challenging problem in geotechnical engineering. Slope undercutting techniques originally developed for 1g physical and centrifuge models were realized in practice for a full-scale design at the Mae Moh mine, one of the large coal open-pit mines in Southeast Asia, during the period of 2011 - 2017. Numerical analyses, along with in-situ measurements for data assimilation, were applied to test the novel design concept before and during the surface excavation. At the initial stage of excavating the undercut slope, the mine was studied in terms of forming an arch, by conducting a field experiment of a partial undercutting in Area 4.1, which was of monumenta

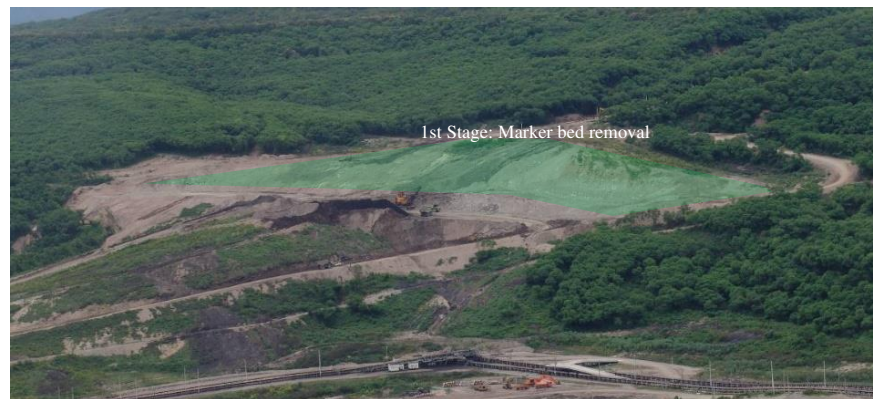
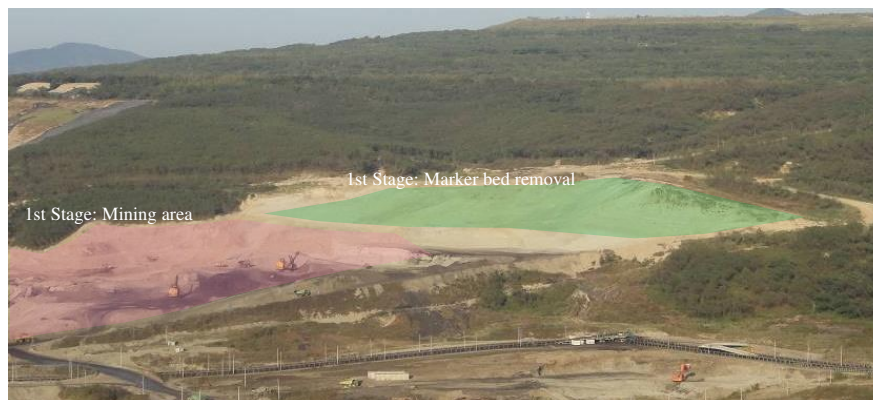
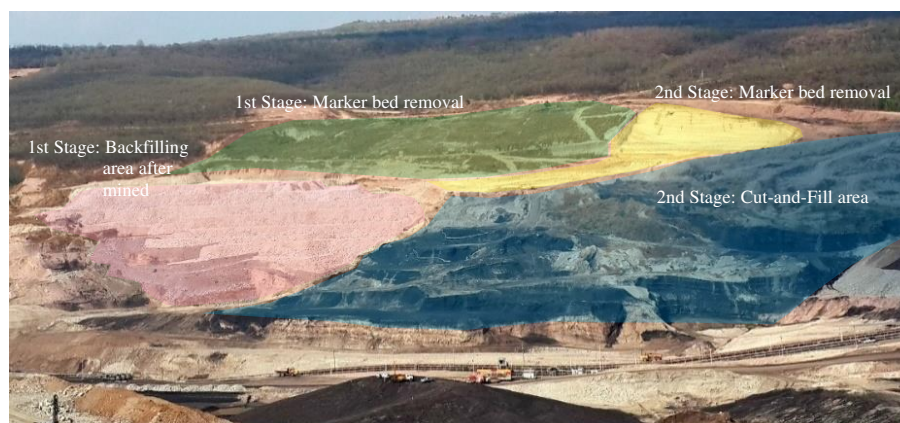
*Figure 12. Photographs of the 1<sup>st</sup> Stage in Area 4.1.*

The undercutting in Area 4.1 was periodically photographed for archival purposes; some of the photographs are presented in Figure 12. The mine equipment was moved to Area 4.1 and the site preparation began in April 2011. Three months later, in July 2011, the Marker bed was ready to be excavated; by August 2011, it had been totally removed. The undercutting of the northern part of Area 4.1 began in August and reached an elevation of 170 msl by January 2012. The undercut span was approximately 80 m. The undercutting continued and reached an elevation of 137 msl by April 2012. The undercut width was approximately 90 m. Between May and June 2012, the backfill, comprising 30,000 cubic meters, was placed from an elevation of 115-192 msl. The undercut width was then shortened to 30 m. The undercutting was restarted and continued in the southern direction in August 2012. The 1<sup>st</sup> Stage was completed in May 2014. Finally, the undercut width had been extended to approximately 100 m by the end of the 1<sup>st</sup> Stage.

(a) Access road and Marker bed removal in 1<sup>st</sup> Stage (as of August 2011)

(b) Mining elev 170 m in 1<sup>st</sup> Stage (as of January 2012)

(c) Marker bed removal and 2<sup>nd</sup> Stage preparation in 1<sup>st</sup> Stage (as of April 2014)

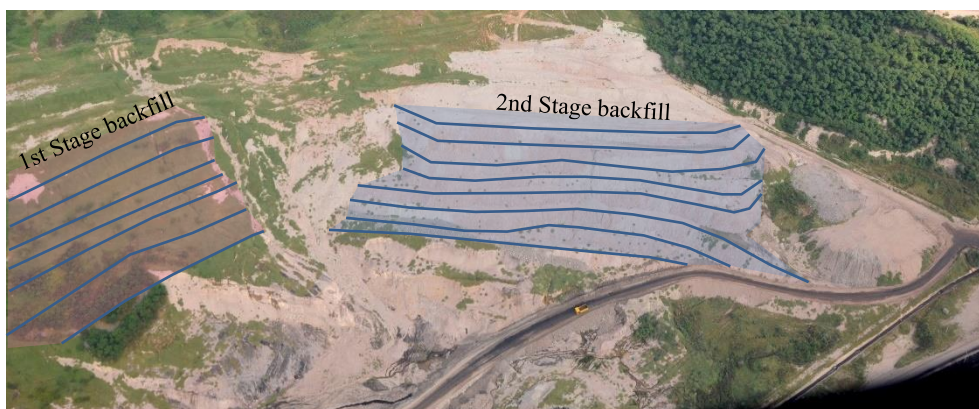
Figure 13. Sequential excavation of the 2<sup>nd</sup> Stage in Area 4.1.

The mining sequence of the 2<sup>nd</sup> Stage is depicted in Figures 13(a) to 13(c). In Figure 13, the daylighted G1 interface and the normal faults in Area 4.1 are represented by green and red lines, respectively. The 2<sup>nd</sup> Stage was launched by mining the interburden and coal from an elevation of 104-192 msl during the period of 2014 to 2016. At the beginning of 2017, the backfilling of the 2<sup>nd</sup> Stage began and was completed in October 2017. The undercut face could not be fully backfilled and supported, as presented in Figure 13(c), because of the working space constraints. Consequently, the G1 interface (green line) was still daylighted on the undercut slope face for a length of 190 m.

(a) At the beginning of 2<sup>nd</sup> Stage

(b) Mining elev 192–104 m

(c) Backfilling elev 104–192 m

(d) Aerial view at end of 2<sup>nd</sup> Stage (as of October 2017)
