## Segmental Retaining Wall Reinforced with Geogrids, in New Hospital Works (Salamanca, Spain)

**ABSTRACT:** *The construction of a new hospital, located by the river Tormes in the Spanish city of Salamanca, involved the expansion of roads and the construction of a new way of access to the complex, as well as a large retaining wall to bridge the gap between them and the river level. The project original solution was in situ foundations and precast concrete walls. However, at both ends of the alignment of Transición Española Avenue, there were several construction constraints (such as the existence of rainwater chambers for discharging into the river, a large-diameter drainage pipe at the back of the walls, communications, and gas services). The need to maintain steady access to the old hospital in service during the COVID-19 pandemic was furthermore required. The wall was founded on fills with low bearing capacity in other sections. Finally, a reinforced segmental retaining wall (SRW) was adopted as the optimum choice. It consists of concrete block (segmental) facing with a high-quality fill reinforced backfill, reinforced with polyester (PET) geogrids. The facing required a varia

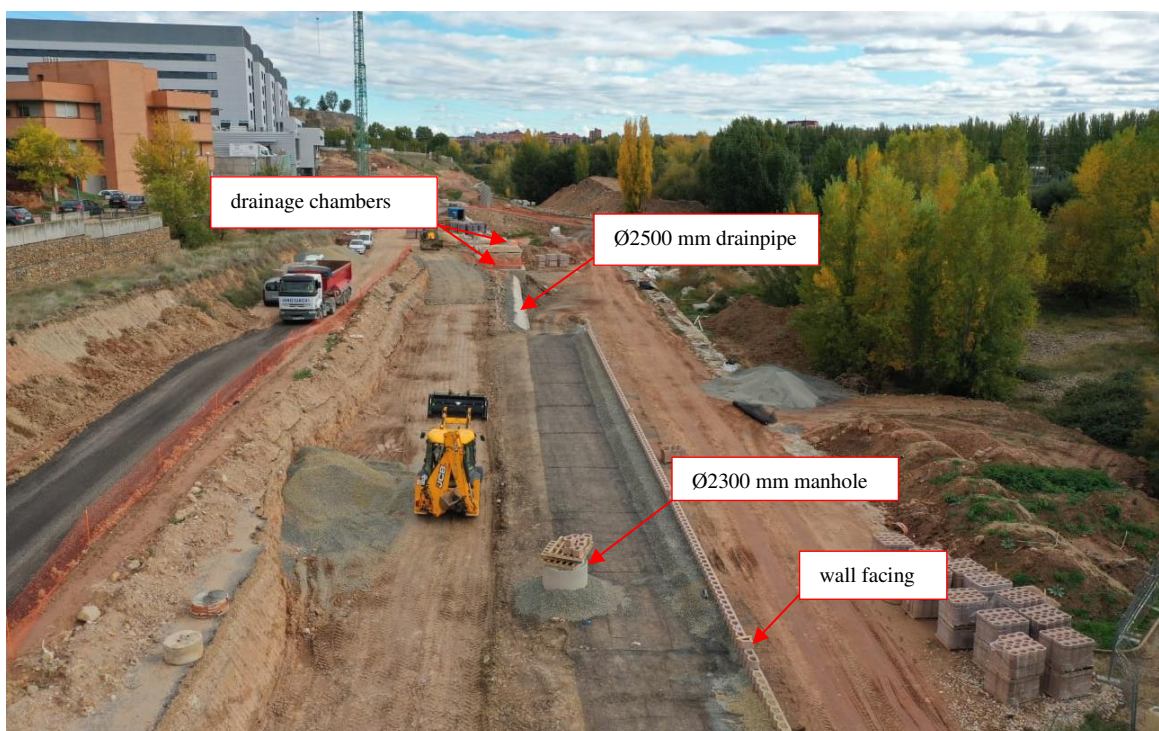
Figure 3. Wall 1 under construction (Orbe Técnicas y Medioambiente).

The last of the challenges was the geometric encounter with the existing prefabricated vertical wall. It was solved thanks to the professionalism and skill on the installers' part, bearing in mind that a face angle of the exposed face is required to make a smooth transition from 80° to 90° with steps at both at the foundation base and at the top of the blocks by varying the horizontal set back of each course. The installation company's engineers carried out a geometric fit using CAD, which was later redefined on site and each course was checked with precision.
