# Liquefaction and Non-liquefaction Cases from the Mataquito Bridge, Chile, after the $M_w$ 8.8 (2010) and $M_w$ 6.6 (2019) Earthquakes

**ABSTRACT:** This paper describes field investigations and soil foundation performance of the Mataquito Bridge with respect to the 2010  $M_w$  8.8 and 2019  $M_w$  6.6 Chilean earthquakes. The Mataquito Bridge was constructed at the site prior to both earthquakes using a pile foundation designed against liquefaction and lateral spreading. The foundation system performed correctly during both earthquakes, and in the case of the 2010 event it withstood surface manifestation of liquefaction and lateral spreading loads. Different liquefaction severity indices are used to assess the liquefaction hazard with data from in-situ measurements. This paper provides a collection of data (Vs, CPT, SPT) for liquefaction and non-liquefaction cases at the same site under two different levels of shaking, and valuable case history data for future triggering and severity index models. Lateral displacements are also calculated and compared with those observed on the field after the 2010 earthquake.

Reference: Moffat, R., and Moss, R. (2022). Liquefaction and Non-li

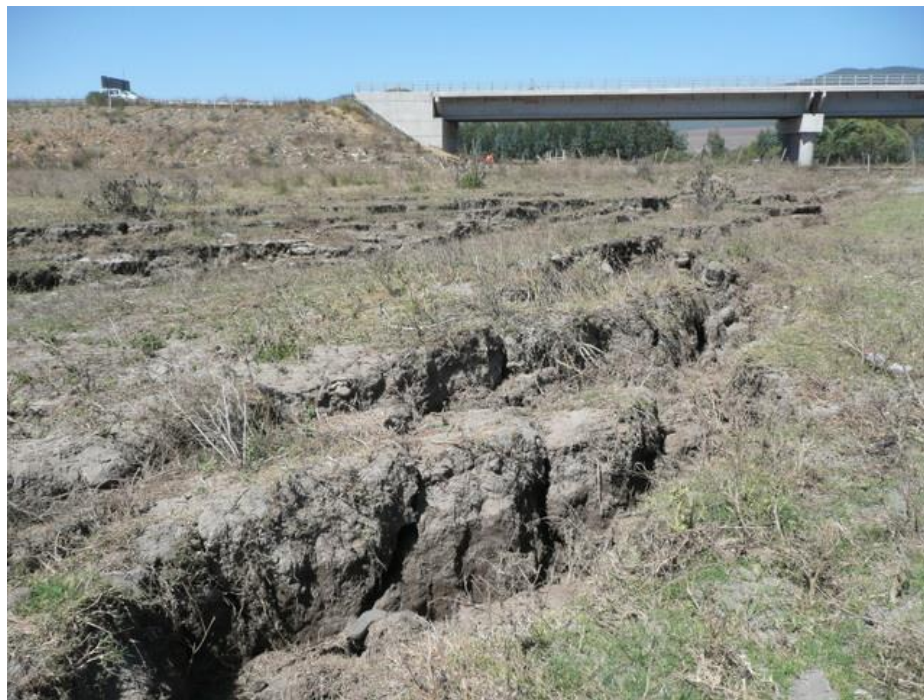
Figure 3. Lateral spreading at the north side of the bridge. Cracking showing roughly 0.6 m of vertical and 0.8 m of lateral displacement toward the river (Bray et al., 2010).

Reconnaissance of the bridge found large lateral spreads towards the river at the north and south abutments in adjacent fields and directly below the bridge deck. Figures 3, 4, and 5 show photos of the settlement and lateral spreading (with sand boils) on the north and south sides of the bridge. Lateral spreading on the south side appeared to be confined to the border of the river, with deformations decreasing rapidly around 20 m from the river's edge to the south. On the north side, due to the relatively flat topography, it was observed to extend up to 250 m from the river's edge. Evidence of settlement was observed on the approach embankment and the rows of piers. Cracking of the asphalt on the north side was also observed along a distance of 200 m from the river's edge along the road.

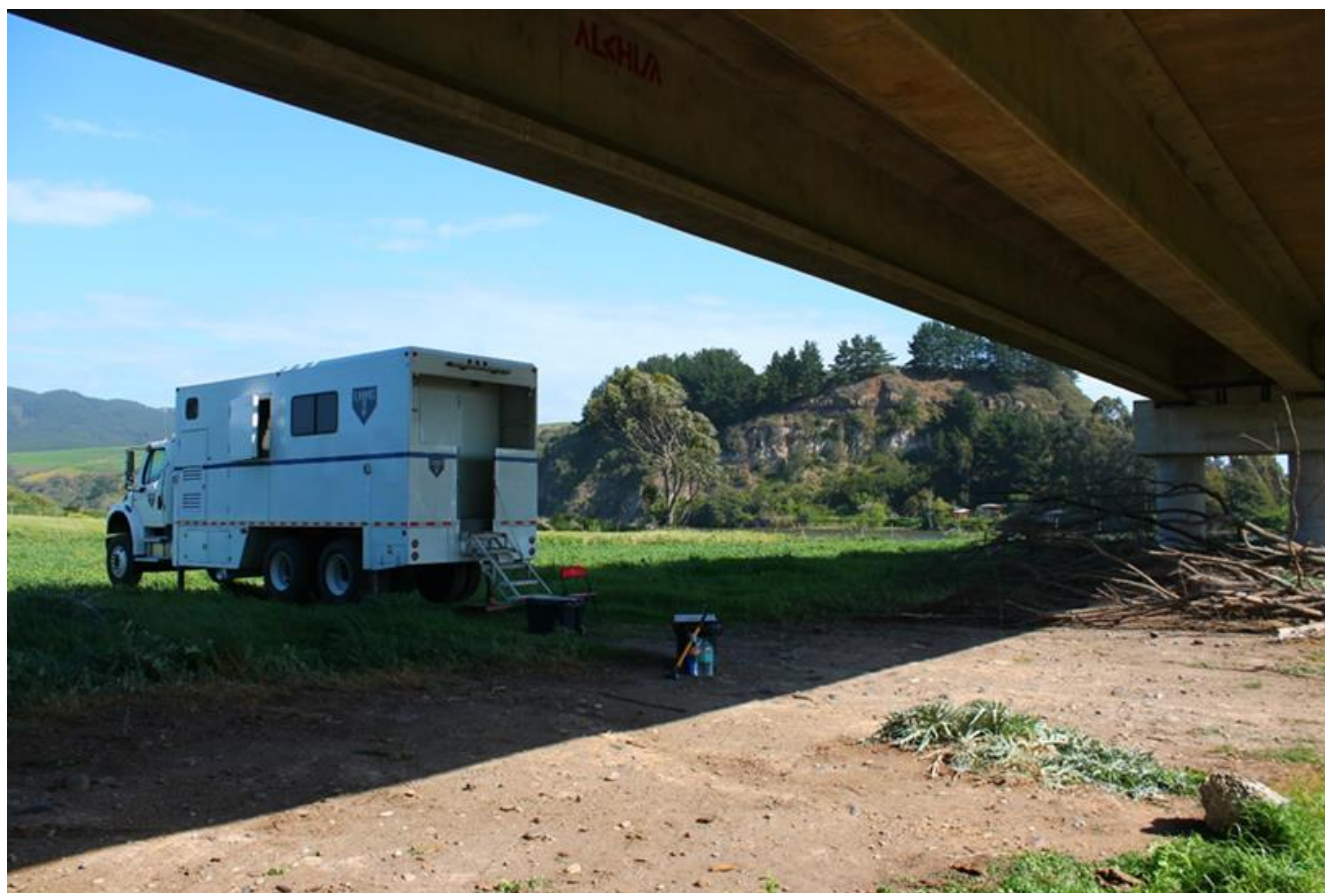
*Figure 6. Photo of the north side after the 2019 earthquake (October 17<sup>th</sup>, 2019). The CPT truck is shown here doing subsurface testing.*

This earthquake did not generate any major reported damage of consideration, as would be common in a seismic country like Chile. The site was visited before and after this earthquake by the authors. There was no evidence of liquefaction or changes on the surface. Figure 6 shows a photo of the north site during repeat CPT soundings after the 2019 earthquake.
