A geocomposite barrier for hydrocarbon containment in the Arctic

Bathurst, R. J., Rowe, R. K., Zeeb, B., Reimer, K. (2006), *A geocomposite barrier for hydrocarbon containment in the Arctic,* International Journal of Geoengineering Case histories, http://casehistories.geoengineer.org , Vol.1, Issue 1, p.18-34.

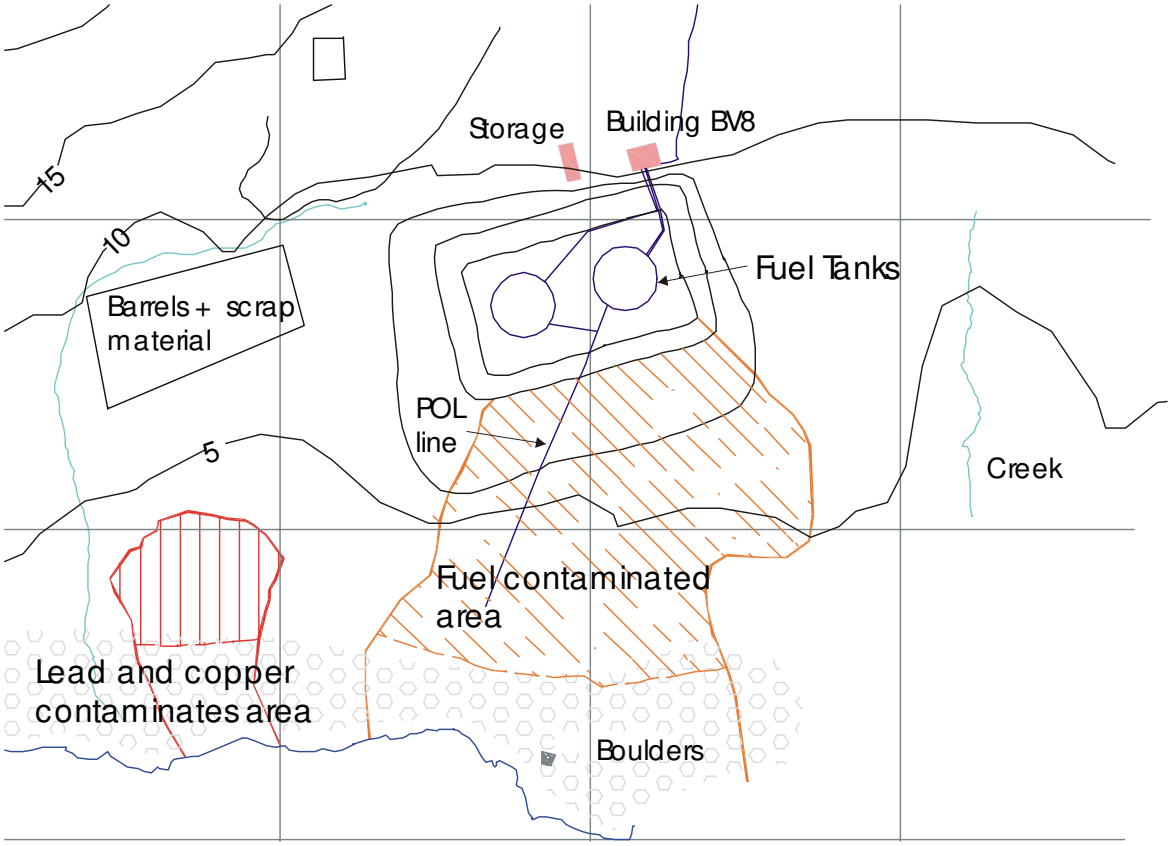
Figure 3. Plan view of fuel contaminated area.

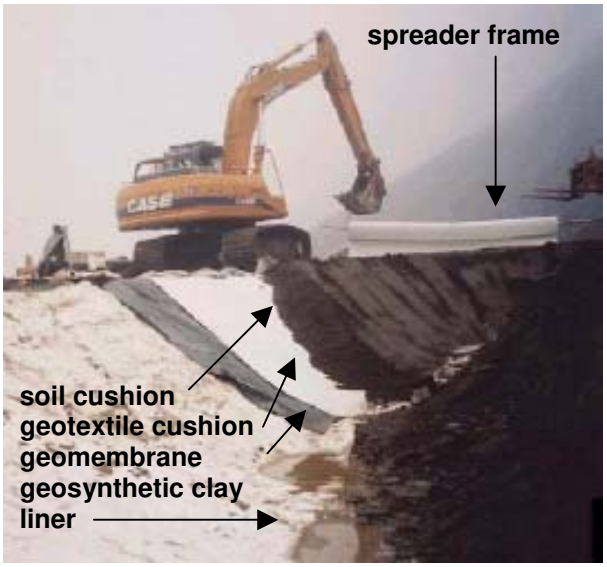
Figure 8. Photograph showing installation and arrangement of liner system components.

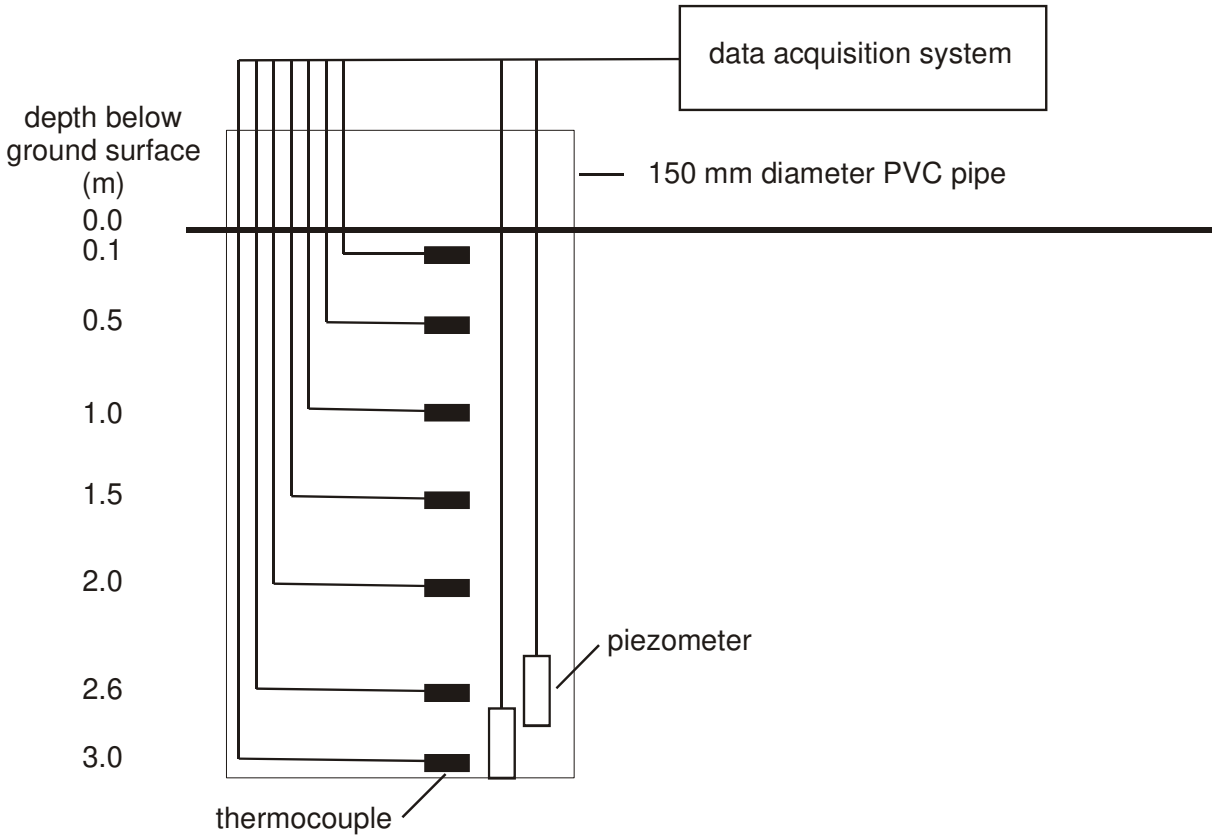
In order to assess the thermal and groundwater regimes at the site, 16 thermocouples and 6 piezometers were installed in three 150 mm-diameter PVC pipes extending to the bottom of the trench excavation. Two pipes were installed immediately upstream of the barrier system and one immediately downstream. The pipes were placed while the excavation was open. An example installation is illustrated in Figure 11. The data acquisition system (Campbell Scientific) was specially designed for harsh environments and consists of a memory module that can be swapped out at intervals and the data downloaded. The module can store up to one year of data. A battery supply connected to a solar panel is used to power the system.

Figure 11. Example thermocouple and piezometer installation (Pipe 1 – upstream of geocomposite barrier).

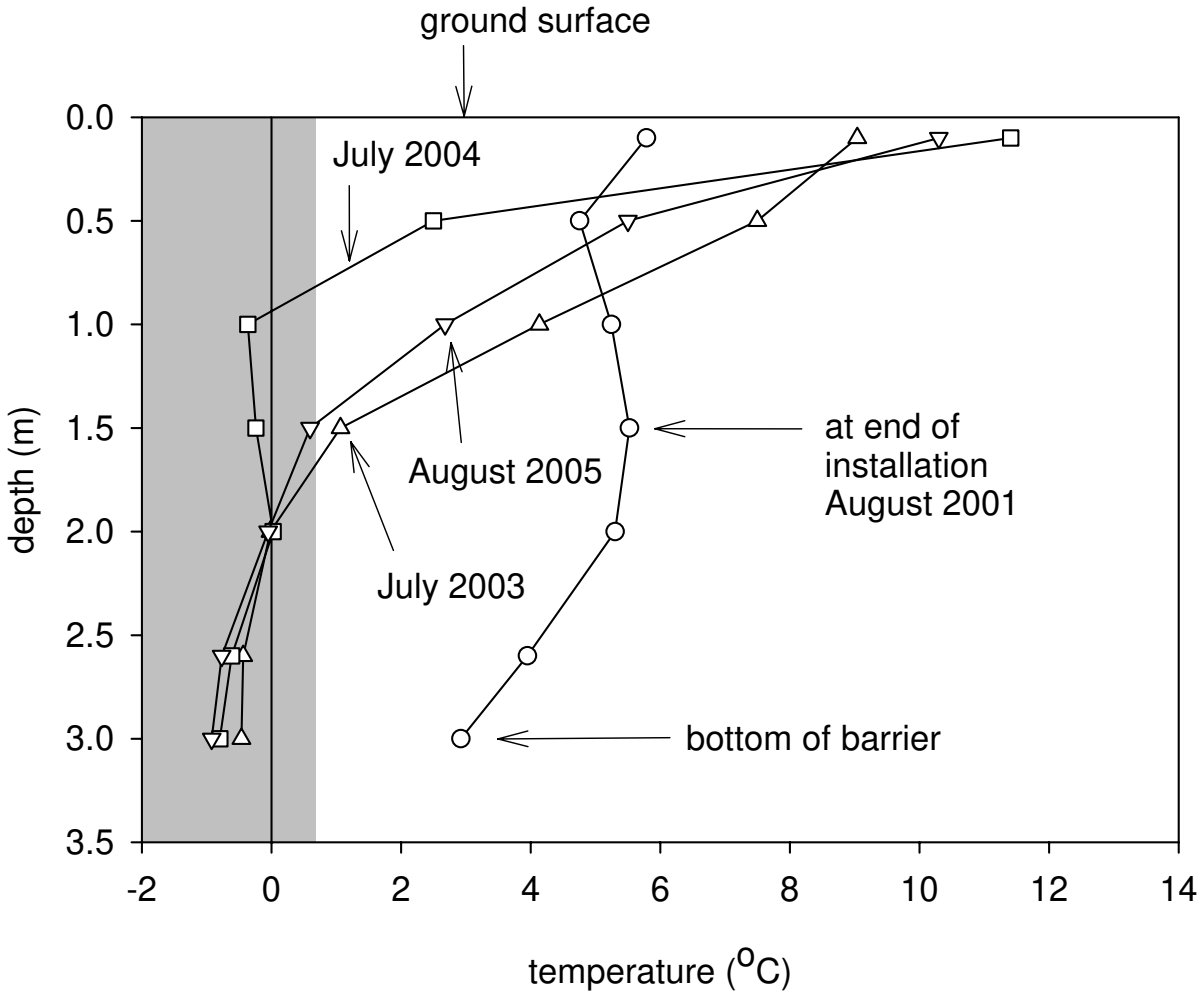
Figure 13. Temperature profiles at location of barrier system corresponding to times of maximum recorded surface temperature.
