Seismological and geotechnical aspects of the M_w=6.3 l'Aquila earthquake in central Italy on 6 April 2009

ABSTRACT: *The L'Aquila earthquake occurred on April 6 2009 at 03:32:39 local time. The earthquake (M_w=6.3) was located in the central Italy region of Abruzzo. Much of the damage occurred in the capital city of L'Aquila, a city of approximate population 73000, although many small villages in the surrounding region of the middle Aterno river valley were also significantly damaged. In the weeks following the earthquake, the Geo-Engineering Extreme Events Reconnaissance (GEER) international team, comprised of members from different European countries and the U.S., was assembled to provide post-earthquake field reconnaissance. The GEER team focused on the geological, seismological, and geotechnical engineering aspects of the event. We describe the principal seismological findings related to this earthquake including moment tensors of the main shock and two triggered events, the aftershock pattern and its variation with time, tectonic deformations associated with the main shock, surface fault rupture, and the inferred fault rupture plane. We describe damage patterns on a village-

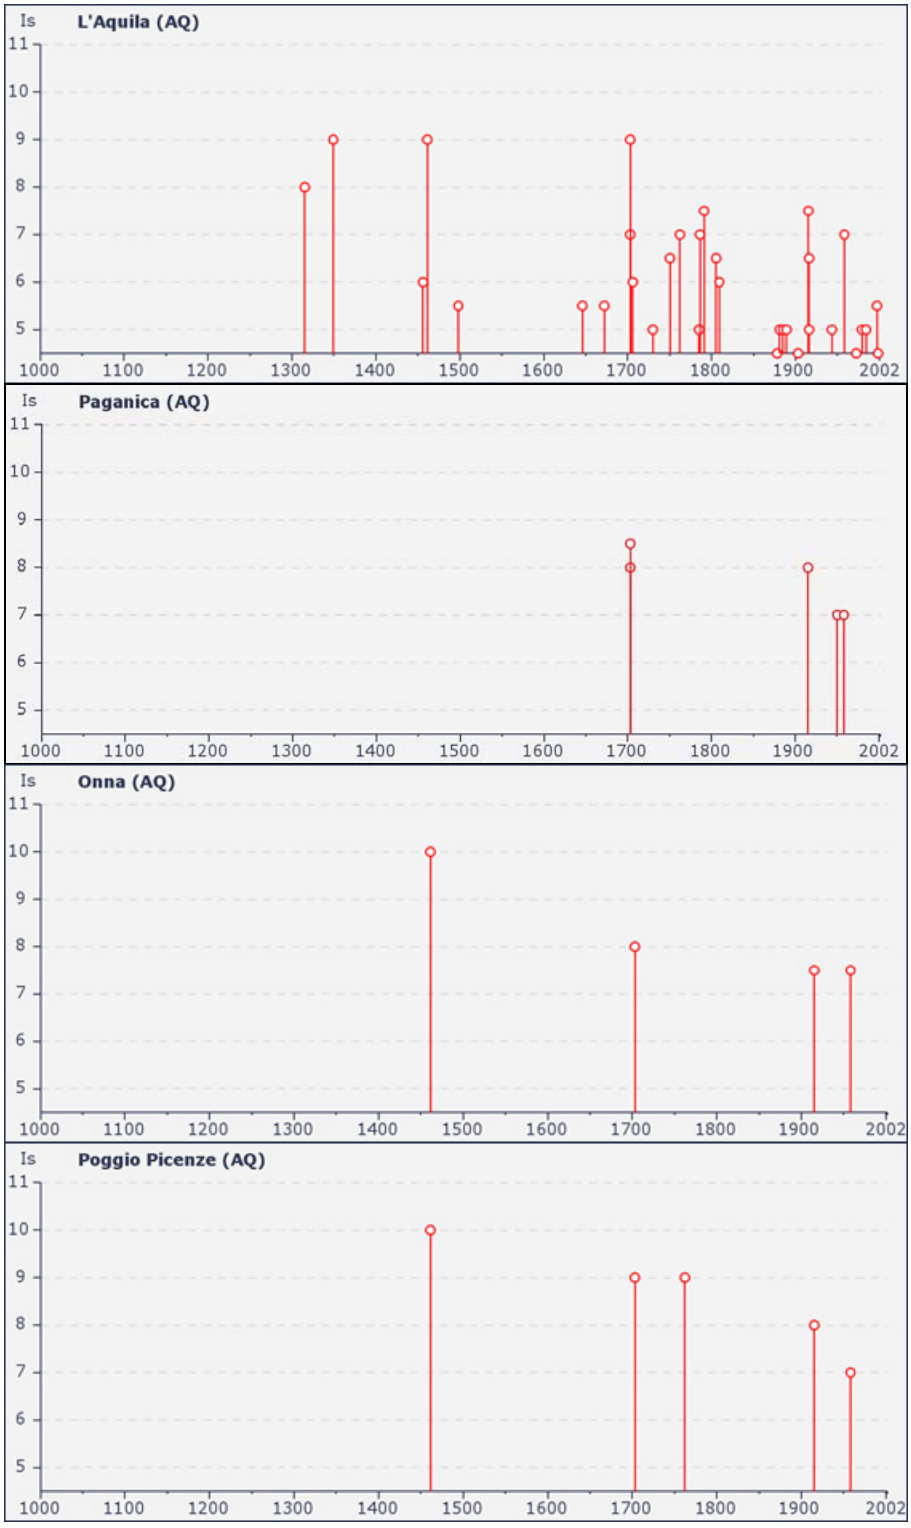
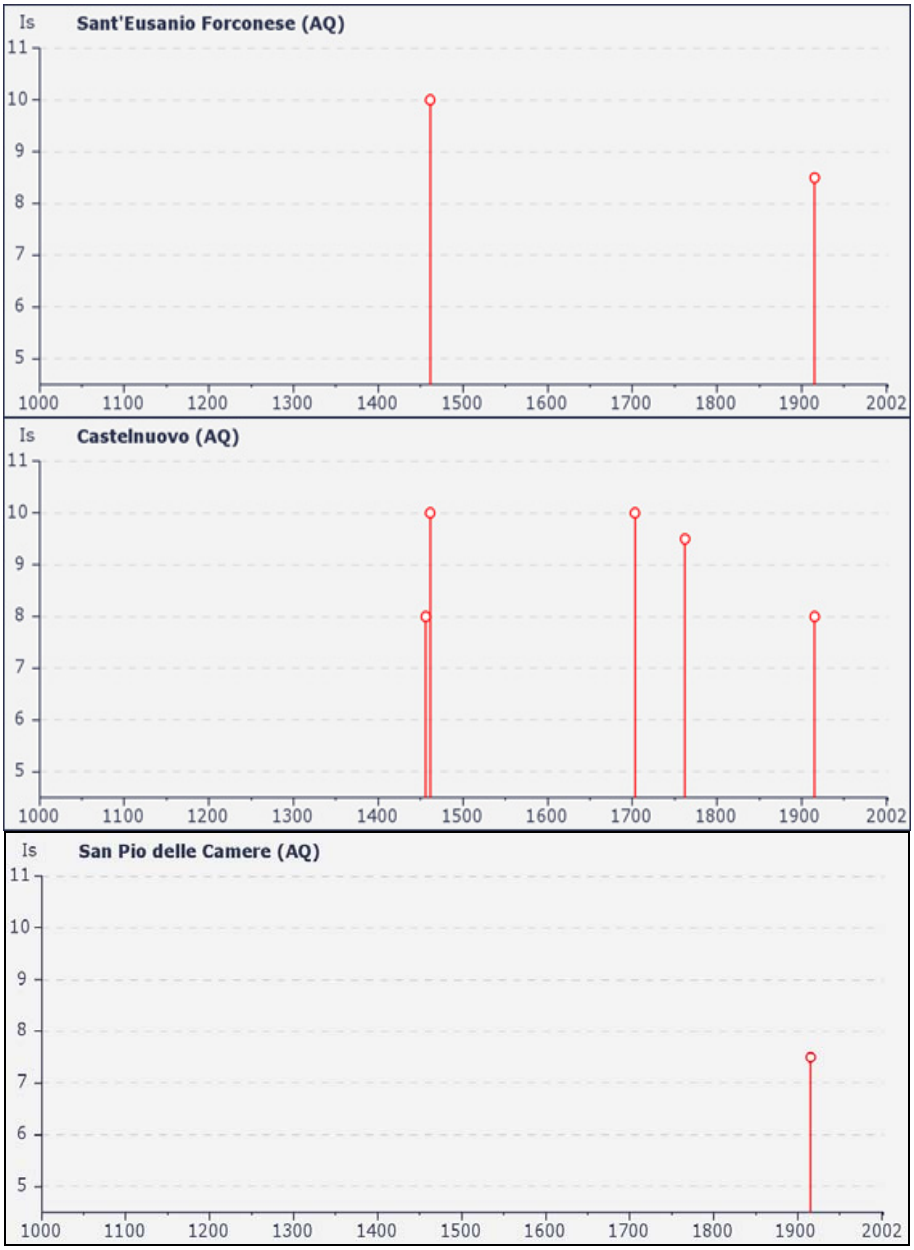
The information contained in the historical documents make it possible to compile a seismic history for each Italian region, in the form of a graph with years on the abscissa and macroseismic intensity (MCS) on the ordinate. Figure 20 shows macroseismic histories of several locations affected by the April 6 earthquake. The various macroseismic histories indicate particularly strong intensities during the earthquake of 1461 especially in Onna and Castelnuovo, which were also significantly damaged by the 2009 sequence. Using these graphs one can compare intensities experienced at various inhabited village centers for the same earthquake. It is notable, for example, that there is a paucity of historical information for the inhabited center of San Pio delle Camere, located near the relatively well-documented inhabited center of Castelnuovo, because the two sites experienced very different damage patterns during the recent earthquake. In fact,

although the two towns are characterized by very similar construction types with “poor” stonework and masonry buildings, San Pio delle Camere (Intensity MCS=V-VI) consistently has much less damage than Castelnuovo (Intensity MCS=IX-X). These different damage levels likely result from variations in local seismic response, primarily due to the lithostratigraphic characteristics of the subsoil in the two areas (details presented in the subsequent section on Damage Patterns).

Figure 20. Seismic history of several inhabited centers that were affected by the earthquake of April 6, 2009 (http://emidius.mi.ingv.it/DBMI04/; Stucchi et. al., 2007).

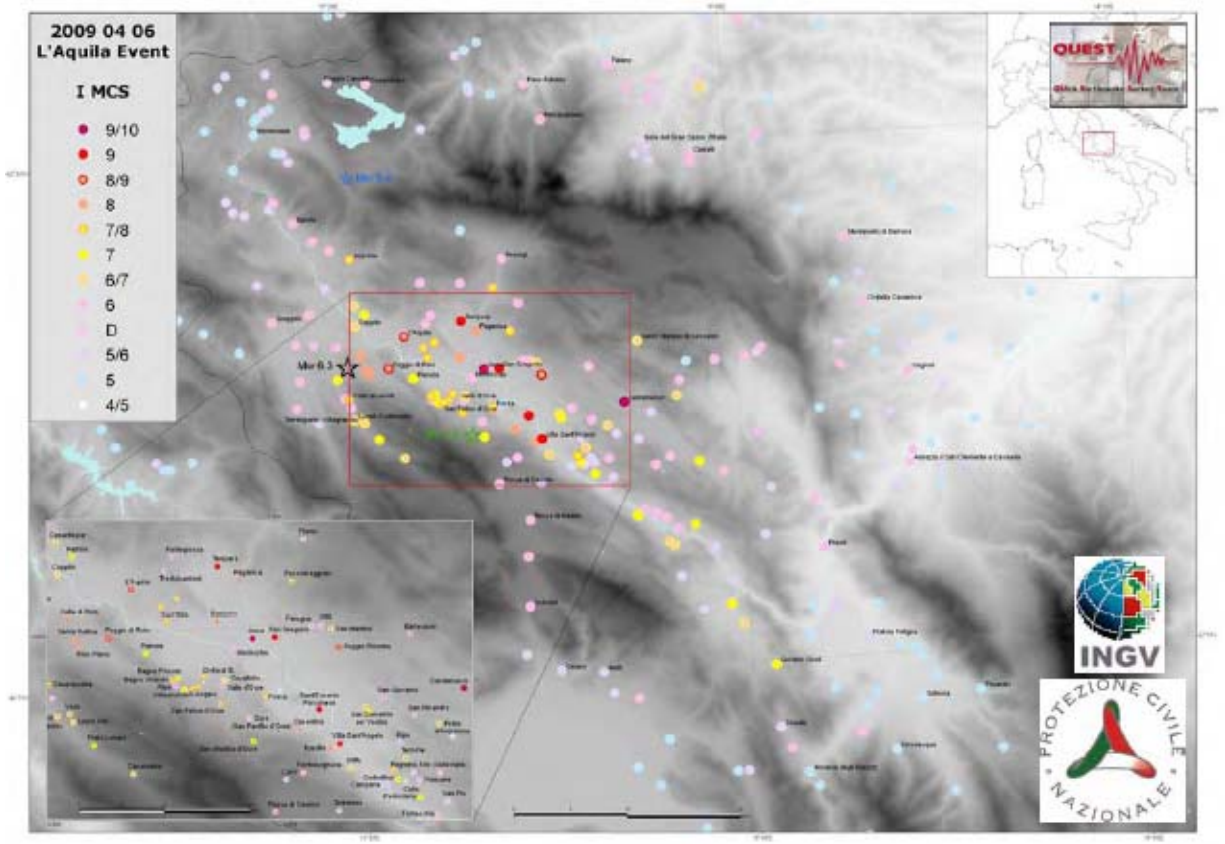
The map shows an asymmetric distribution of damage with respect to the earthquake's epicenter. Damage is limited north and west of the epicenter (black star), with macroseismic intensities no higher than VI MCS. Conversely in the area southeast of L'Aquila, the intensities reach IX-X MCS within an elongated area of high intensity and damage. Macroseismic intensities ≥ VI (MCS) attributed to some villages are reported in Table 2. Also the value V-VI (MCS) for San Pio delle Camere is indicated. Additional macroseismic data, not reported in Table 2, is still being withheld because it is in the process of being made official.

Figure 21. Result of the QUEST macroseismic survey (http://www.mi.ingv.it/eq/090406/quest.html) for the April 6, 2009 earthquake. The black rectangle indicates the macroseismic box, or the expression of the source fault for this earthquake, based on the distribution of macroseismic intensities.

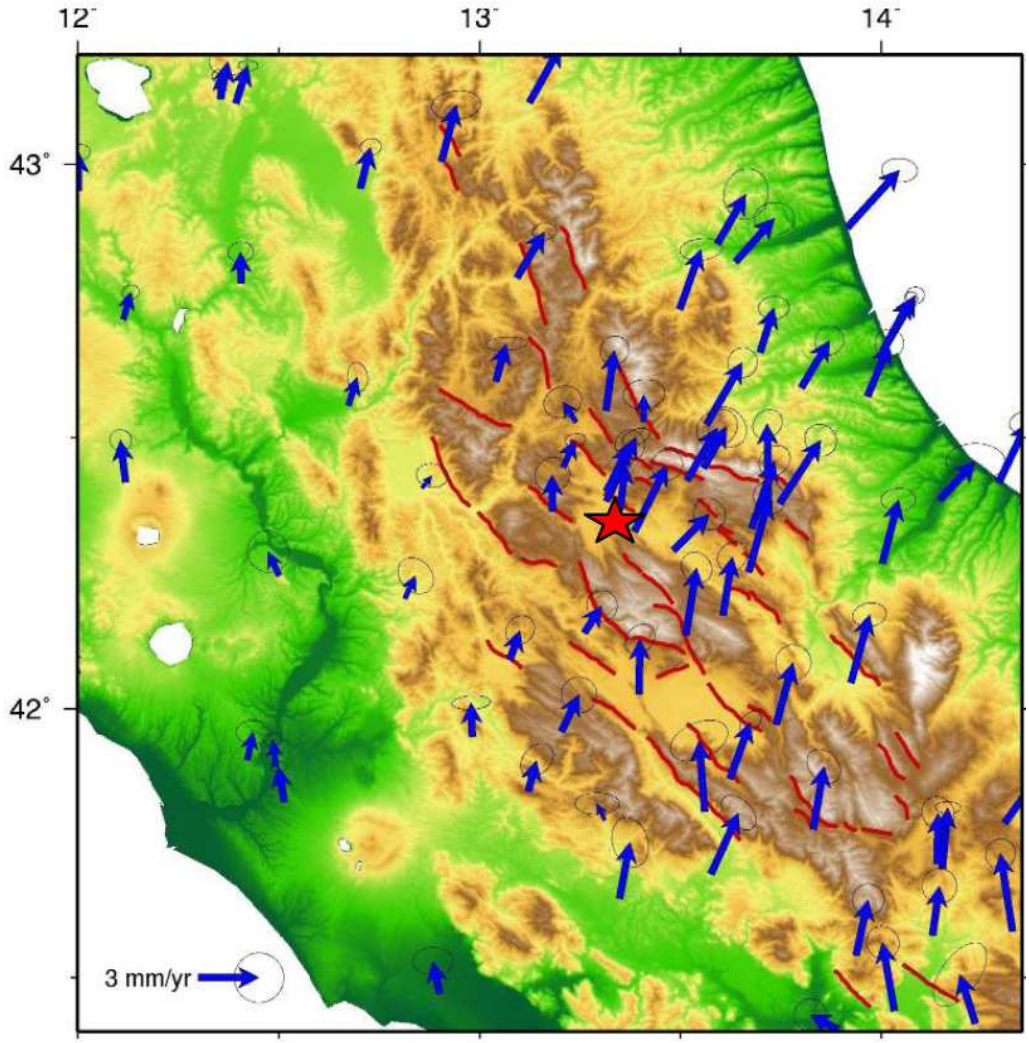
The INGV maintains a GPS network for monitoring crustal deformation associated with both tectonic strain and deformations associated with the numerous active volcanoes within Italy. This network is maintained within the "Rete Integrata Nazionale GPS (RING)" program operated by INGV and integrated with the Central Appennines GPS network resulting in over 100 permanent and non-permanent GPS stations distributed throughout the region (http://ring.gm.ingv.it/). Information related to the sites and instrument clusters and processing methods are available at the referenced web site. Of the stations maintained within RING, 74 are currently located in central Italy and help define the annual deformation rates relative to a stable Eurasian plate (http://ring.gm.ingv.it/velocityfield.php). Figure 22 shows the pre-earthquake GPS velocity field in the region surrounding L'Aquila based on data acquired between 2000 and 2008 (D'Agostino, 2009). This figure shows that the highest interseismic displacement rates are located in the central Apennines and reach magnitudes between 4 mm to 5 mm per year and generally directed in a North, North-East direction. To the Southwest of the April 6, 2009 epicenter, the displacement rates decrease to approximately 1 mm indicating extension strains across the Apennines. A counter-clockwise rotation is observed for the eastern side of the Apennines while a clockwise rotation is observed to the

western side of the Apennines with respect to a rotation pole located in Pianura Padana (http://ring.gm.ingv.it/velocityfield.php). These deformations indicate that in addition to extension, relative lateral deformations must also be accommodated across the Apennine fault systems giving rise to oblique slip on many of the structures in this region. This deformation characteristic was discussed by Galadini and Galli (2000) based on mapped fault patterns in the upper Aterno valley fault system. This is the fault system that was actived by the April 6, 2009 earthquake.

Figure 22. Annual deformation rates in central Italy determined from GPS data acquired from the RING GPS Network (Modified from D'Agostino, 2009).

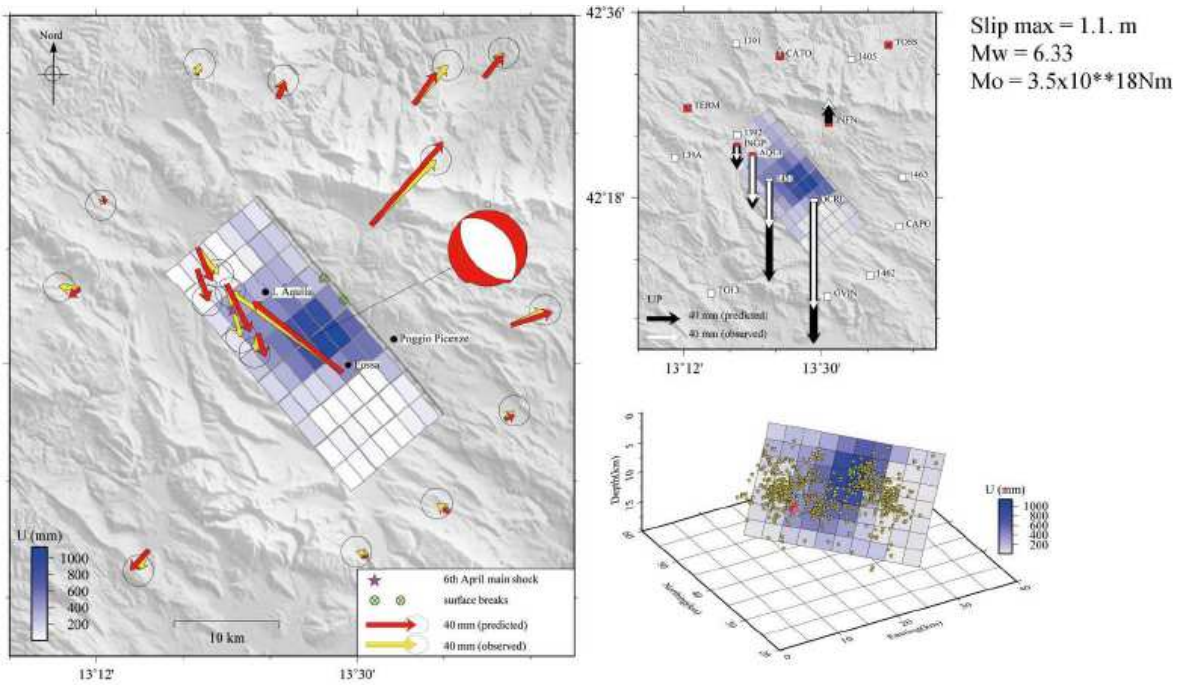
The GPS data was processed in the days following the earthquake to determine the co-seismic displacement field associated with this event. The displacements in the epicentral region between April 5 and April 9 are shown in Figure 23 (D'Agostino, 2009). Additional information is available in Anzidei et al. (2009). The post-earthquake GPS measurements taken on April 6, 7 and 8, 2009, when compared with the data gathered on April 5 and, for a few stations, with measurements taken the previous year, demonstrate "instantaneous" earth surface deformations associated with this earthquake (Figure 23, vectors in yellow). The horizontal movements indicate an area in extension with rotation of displacement vectors within the area of maximum deformation, due to the rebound effect in the NW-SE direction of the area subjected to a SW-NE traction. The vertical movements tend to increase as they move from the city of L'Aquila towards the southeast. The preliminary best fit of the inversion of these data was obtained using movements along a fault plane running NW-SE with normal displacement in a SW direction, which generates an earthquake of M_w=6.3 with maximum co-seismic slip of 1.1 m. The location of the fault plain is constrained near Paganica, where co-seismic fractures of the ground were mapped (EMERGEO Working Group, 2009).

Figure 23. GPS data inversion: on the left horizontal predicted (red) and observed (yellow) displacements, on the right vertical movements and proposed fault plane solution (Modified from D'Agostino, 2009).

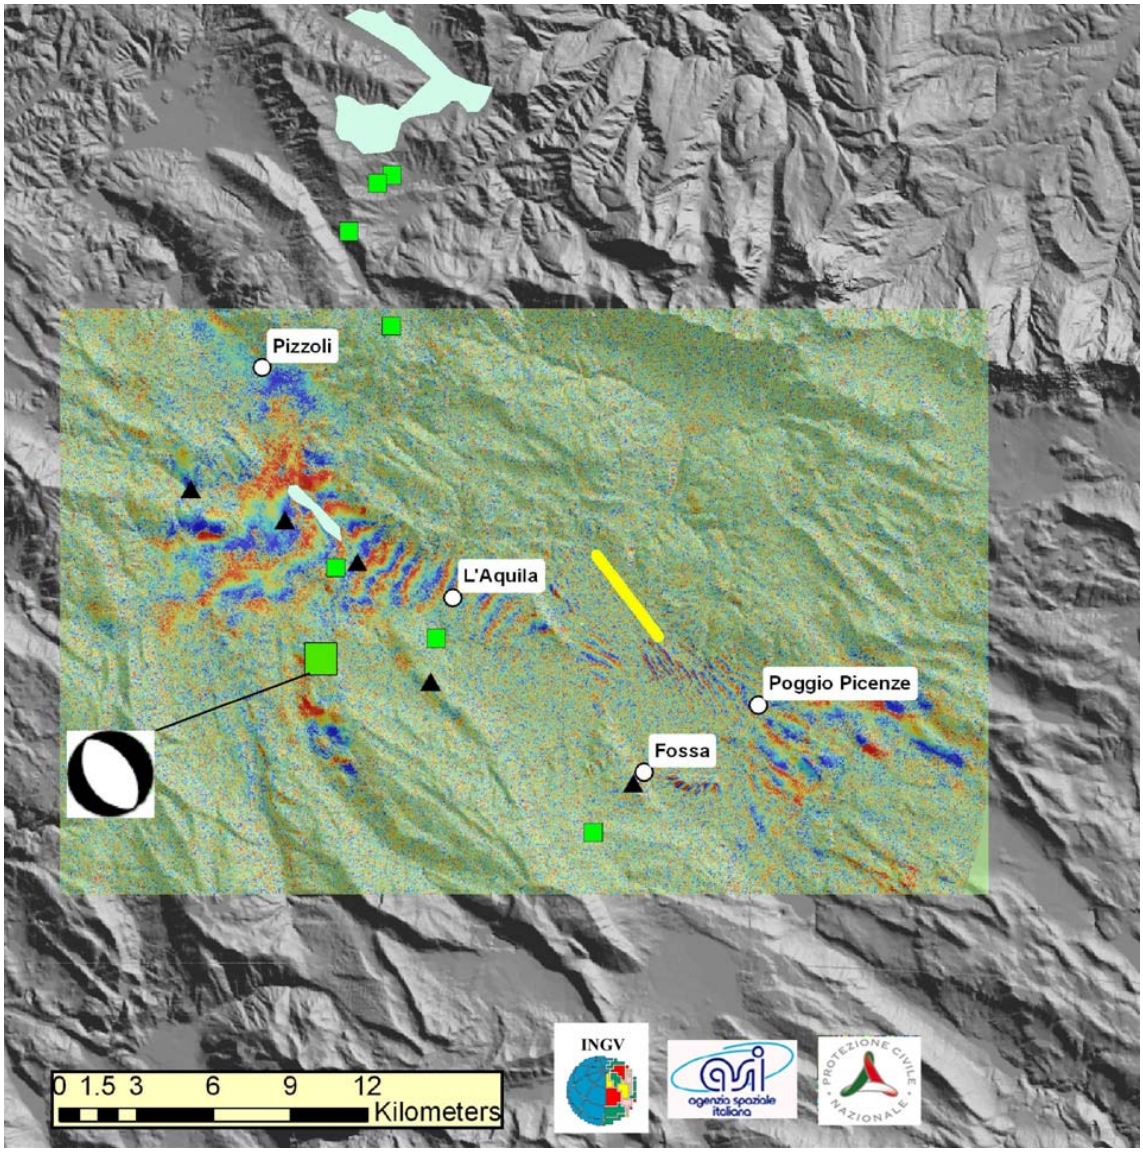
The interferometric analysis is insightful regarding the co-seismic effects of this earthquake. Our primary discussion is based on the work of Salvi et al. (2009), who present the data and detailed analyses. The first interferometric analysis available to the scientific community was developed from the COSMO-SkyMed constellation using images from the February 19 and April 9. This image was processed by INGV researchers and the ISA and was utilized for assisting in the initial field reconnaissance. Figure 24 shows the first interferogram, the epicenter for the M_w= 6.3 main shock (large square) and events with a $M_w \geq$ 5.0 (small squares) and the location of ground failures (yellow line). This image shows that the initial surface deformations were concentrated to the north of the main event epicenter and along a line running from L'Aquila past Poggio Picenze. The surface deformation (fringes) are well constrained within different lineaments developed in the surrounding region. Some of these lineaments correspond to identified faults while others do not. Changes in the primary orientation of the fringes can also be observed to change across different lineaments.

Figure 24. Interferogram developed from Cosmo-SkyMed images taken on 19 February and 9 April. The M_w= 6.3 main event is identified by the large square and focal mechanism. The $M_w \geq$ 5.0 events are marked by the small squares. The yellow line indicates the area of observed ground failures (EMERGEO Working Group, 2009).

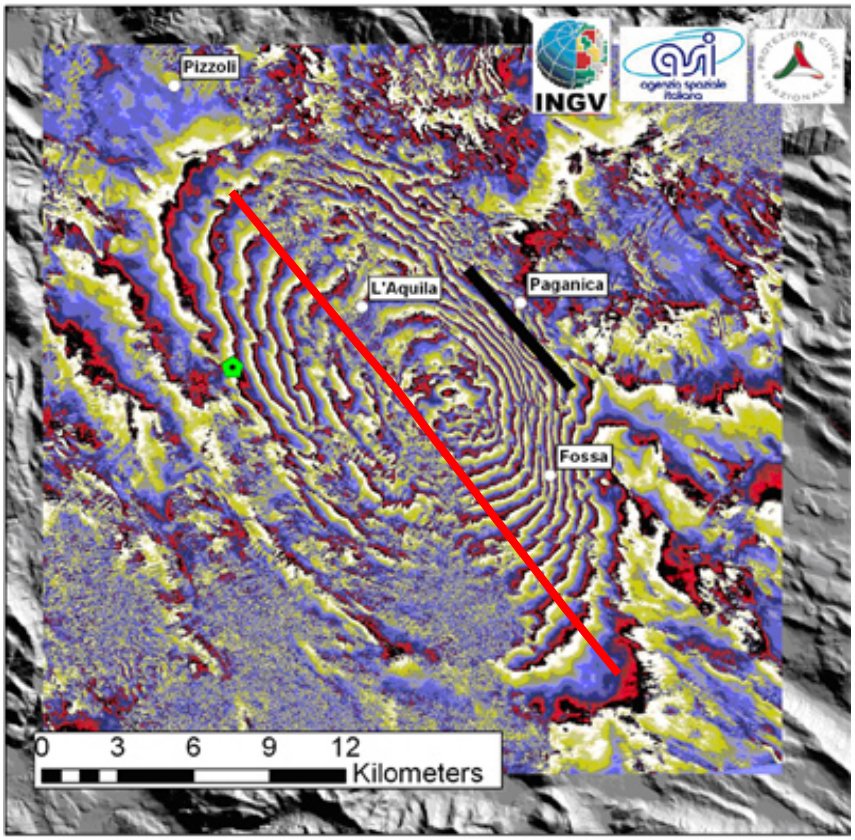
Figure 25 presents one of these analyses showing the interferometric fringes that were created using images downloaded from ENVISAT and COSMO-SkyMed, the earth observation satellite system developed by the Italian space agency Agenzia Spaziale Italiana in cooperation with the Italian Ministry of Defense. Images of the area affected by the earthquake, which were gathered beginning on April 6 by COSMO-SkyMED, were analyzed with the interferometric technique DInSAR (Differential Interferometry Synthetic Aperture Radar). This technique involves taking images from the same geographic area, using the same view angles at different times, for measuring with specific algorithms, the deformations produced on the ground surfaces (http://www.asi.it/it/news/la_faglia_del_terremoto_individuata_grazie_ai_dati_di_cosmoskymed). In Figure 25 each concentric fringe quantifies 1.5 cm of co-seismic vertical deformation. In the same figure, Salvi et al. (2009) also show the trace of the alignment of ground fractures that were observed near the inhabited center of Paganica (EMERGEO Working Group, 2009). The following observations can be made:

2. The area of maximum negative vertical deformation does not coincide with the outcrop area of the Paganica fault (see black line segment in Figure 25), which several researchers have hypothesized as having generated this earthquake. Rather, the zone of maximum deformation is located about 3-4 km southwest of this tectonic element, a hypothesis supported by the band of fractures observed on the ground (EMERGEO Working Group, 2009). The maximum vertical displacements of the observed fractures are on the order of 10-12 cm;

5. The interferometric fringes show variations in trend at various points and along several lines associated with active tectonic elements (Pettino Fault, just to the Northwest of L'Aquila and Bazzano-Fossa Fault, between L'Aquila and Paganica) that also had a co-seismic displacement of modest extent. In particular, Figure 25 shows a discontinuity in the interferometric fringes (indicated by the red line) that would correspond to the antithetic Bazzano-Fossa Fault.

Figure 25. Interferometric fringes of co-seismic displacements (modified from Salvi et al., 2009). The black line indicates the alignment of ground failures associated to the Paganica Fault. The discontinuity marked by the red line corresponds to the antithetic Bazzano-Fossa Fault.

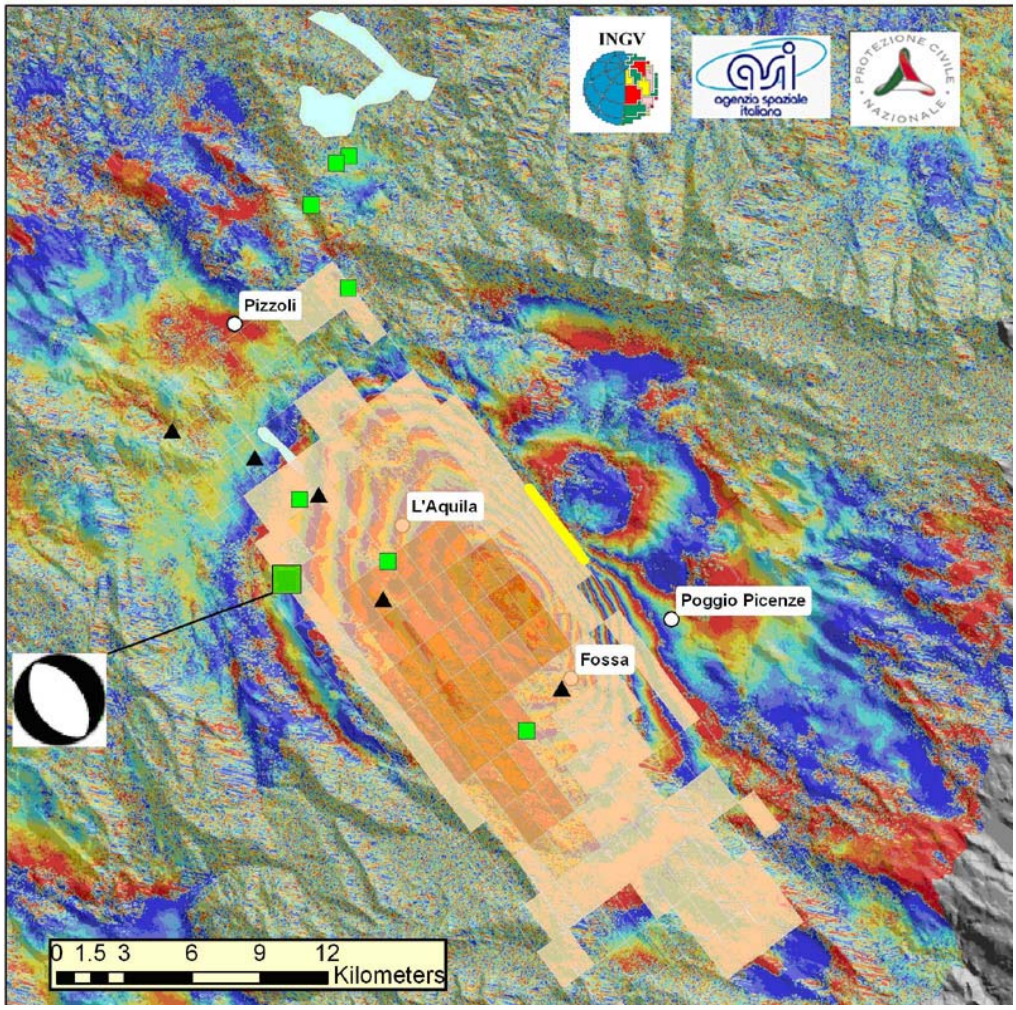
6. The preliminary inversion models of co-seismic movement (Figure 26) show that the Paganica Fault would have a limited slip on the surface. This is supported by field observations at several places along the alignment of co-seismic ground fractures, which noted maximum displacements no greater than 10-12 cm, compared to a maximum slip of about 1 m on the fault at depth.

Figure 26. Fault plane solution by InSAR data inversion (Salvi et al., 2009). The yellow line indicates the alignment of ground failures associated to the Paganica Fault. The maximum slip modeling corresponds to the surface area with maximum vertical displacement. Near the surface, along the Paganica Fault, the vertical displacement is very small.

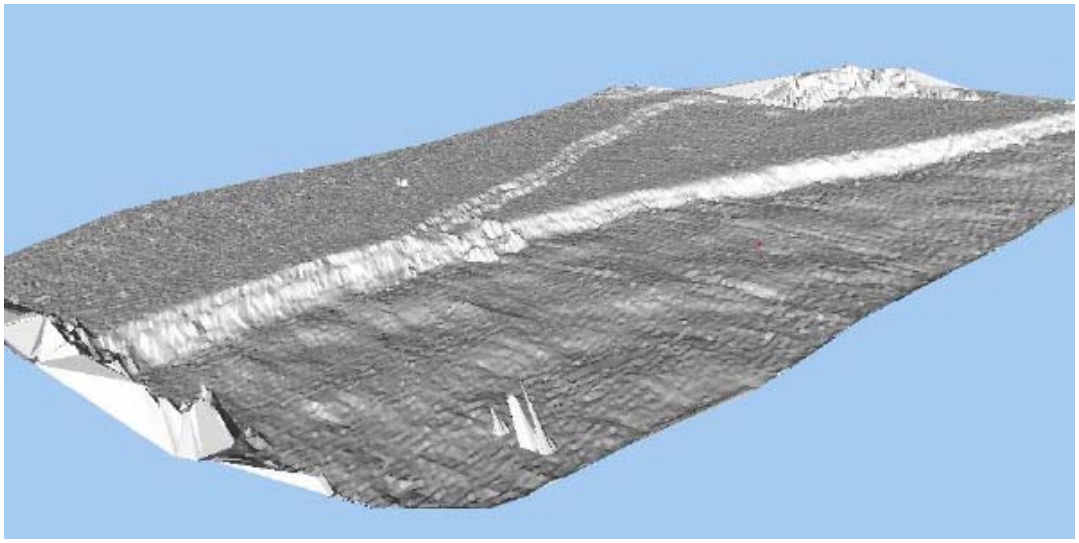
Additional observations by Ken McCaffrey, Max Wilkinson (University of Durham), Richard Phillips (University of Edinburgh), Gerald Roberts (University of London), and Alessandro Michetti (University of Insubria (personal communication with G. Roberts, 2009) in the Paganica area are strongly suggestive of surface rupture (see also Walters et al., 2009). Figure 34 shows the results of a lidar scan that indicates clear normal slip. The feature shown in the image has a strike and position that aligns with the Paganica fault. The length of the feature is approximately 3-4 km, and the amount of slip is approximately 10 cm.

Figure 34. Lidar scan of normal faulting along Paganica fault (courtesy of G. Roberts, personal communication, 2009).

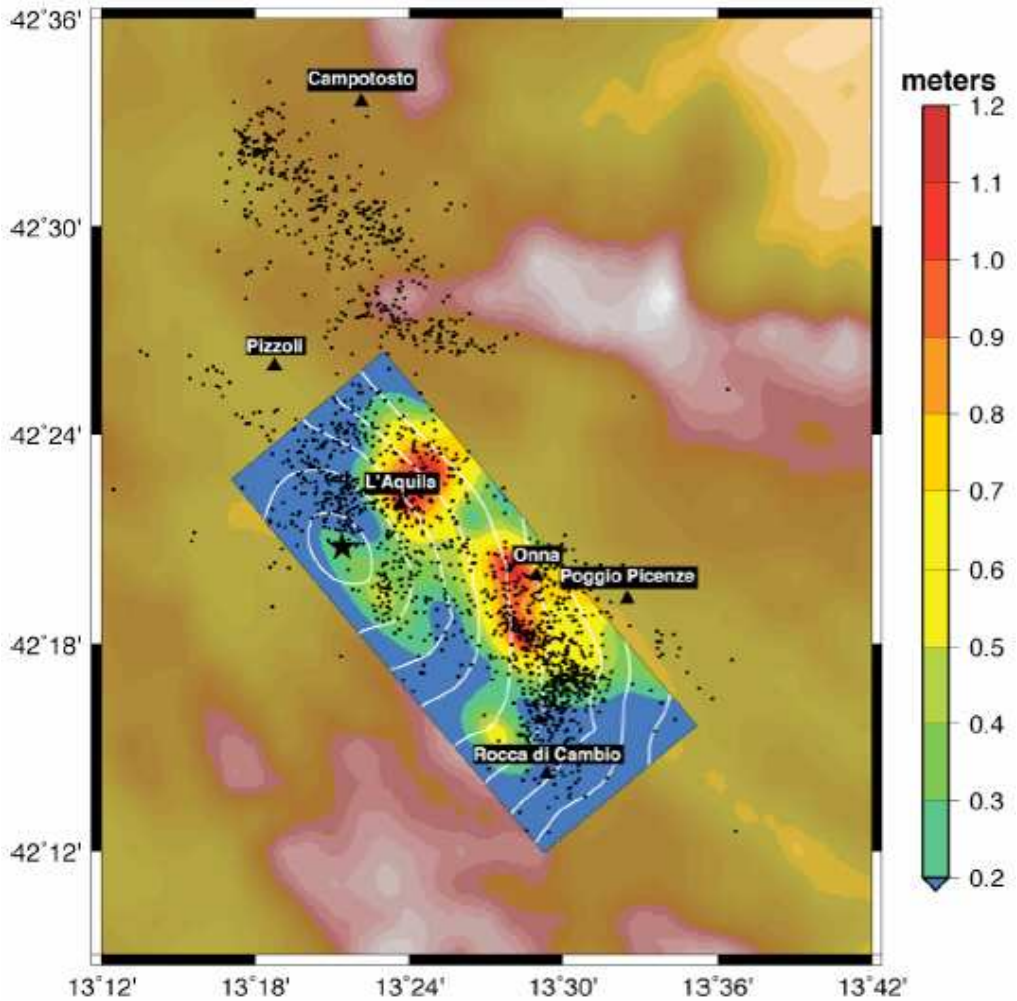
Figure 35. Inverted rupture model projected on the Earth surface. Colors on the fault plane indicate the slip distribution. White contours represent the position of the propagating rupture at 1 s interval. Black dots are the recorded aftershocks (from Piatanesi and Cirella, 2009).

Using nonlinear inversion of the accelerometer and GPS data in order to model the rupture process that occurred on the presumed rupture surface that generated the April 6 earthquake, Figure 35 shows the projection of the proposed fault surface, whose characteristics are reported in Table 3 (Piatanesi and Cirella, 2009).

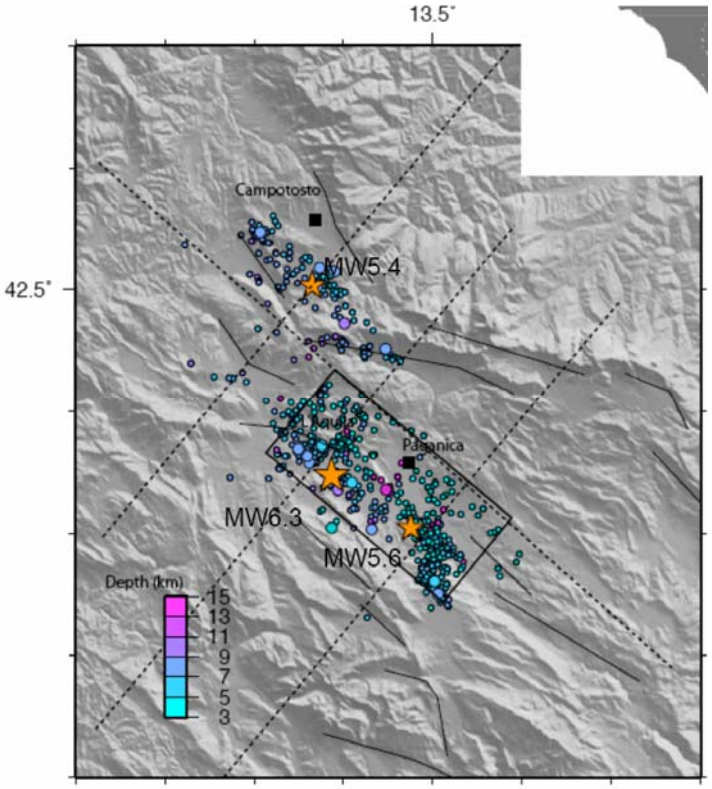
After this preliminary elaboration (originally available two weeks following the April 6 earthquake), additional fault plane solutions have been inverted using different data. Two such inversion results are reported in Figures 36 and 37, respectively by Chiarabba et al. (2009) and Atzori et al. (2009a, 2009b). These solutions have strikes smaller than one given in Table 3. The different source planes have an area approximately between 250 and 280 km^2.

Figure 36. Proposed source plane (black box) for the April 6 earthquake by inversion using seismological data of about 700 events of 6000 recorded by INGV National Seismic Network. The strike is about 130°. Reproduced from Chiarabba et al. (2009).

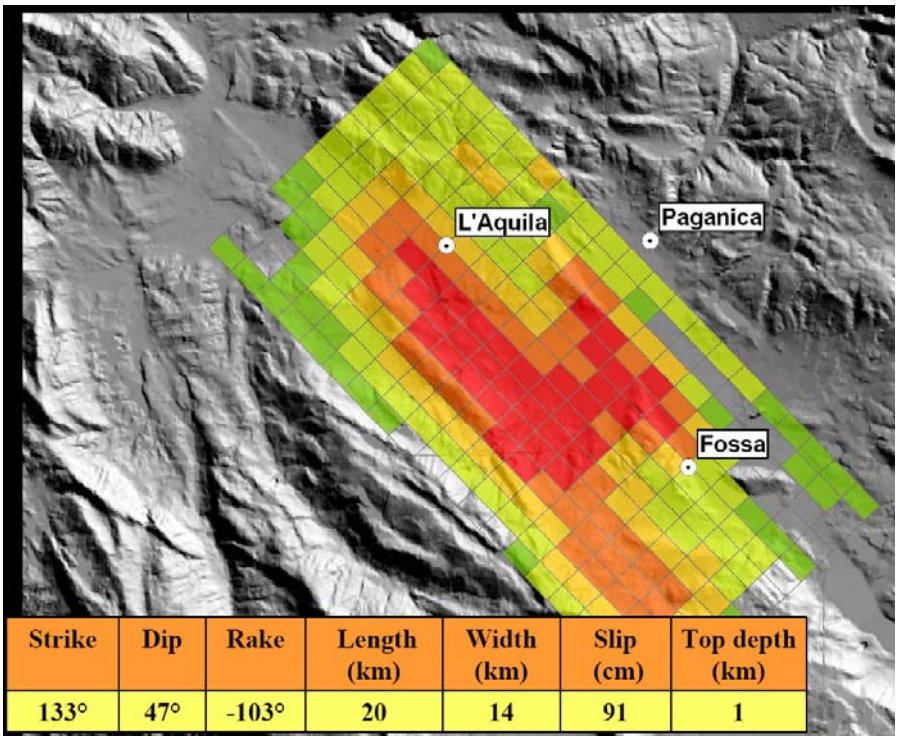
Strike	Dip	Rake	Length (km)	Width (km)	Slip (cm)	Top depth (km)
133°	47°	-103°	20	14	91	1

Figure 37. Distribution of the slip movements on the source area for the April 6 earthquake by linear inversion of SAR and GPS displacements up to the April 12. Table shows source plane dimensions. Figure from Atzori et al. (2009a,b).

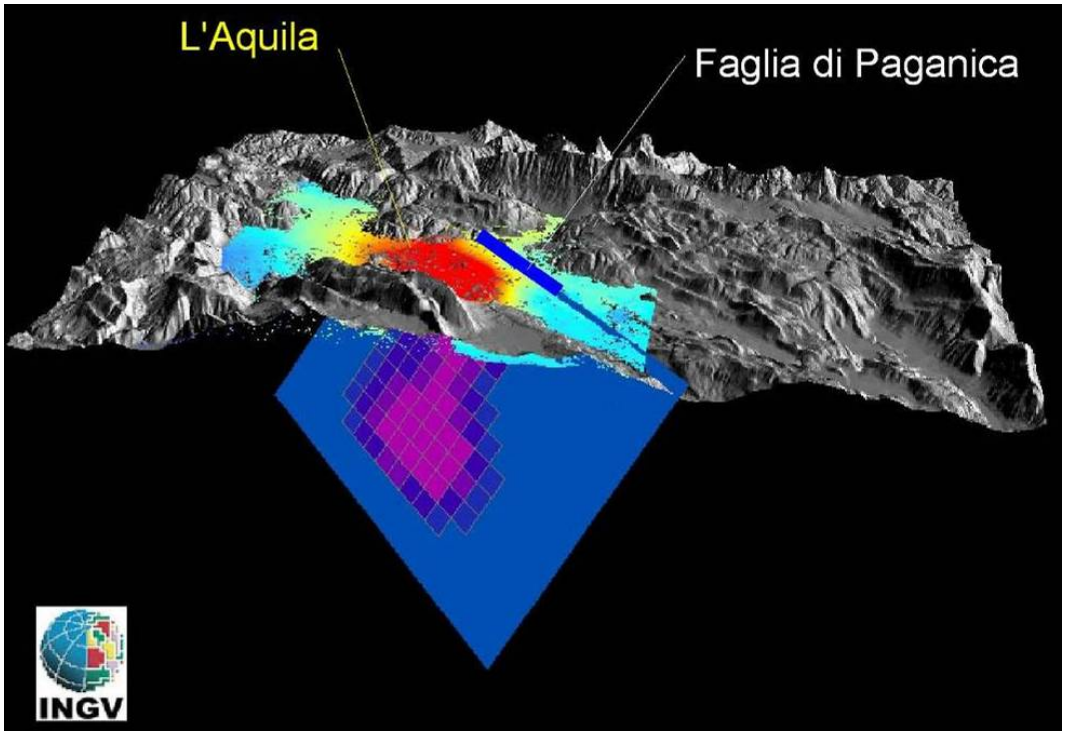
Figure 38. Fault plane solution by InSAR data inversion, corresponding to the theory of a seismogenic and capable Paganica fault (Salvi et al., 2009). The results of displacement modeling are shown on the fault plane.

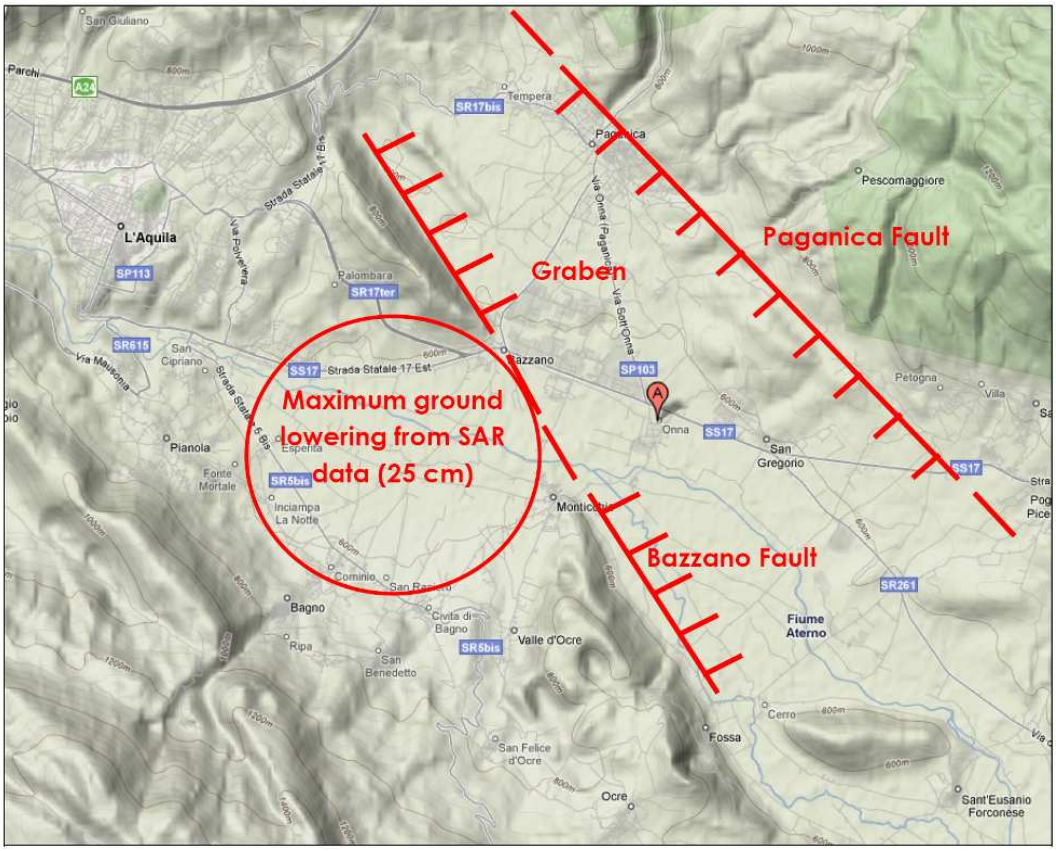
In addition to the two hypotheses currently in discussion, there are other considerations that warrant discussion. The Paganica Fault (which dips to the southwest) and the Bazzano-Fossa Fault (which is antithetic to the Paganica Fault, dipping towards the northeast) have produced the graben where Onna is situated (Figure 39). This area, which suffered strong damage with maximum macroseismic intensity IX-X MCS within Onna, likely experienced an incidental concentration and entrapment of seismic energy inside the graben filled with Quaternary sediments, which are in strong velocity contrast with the rigid substrate composed of Meso-Cenozoic deposits (limestones and marls).

Figure 39. Relationship between Paganica and Bazzano active faults and topography.

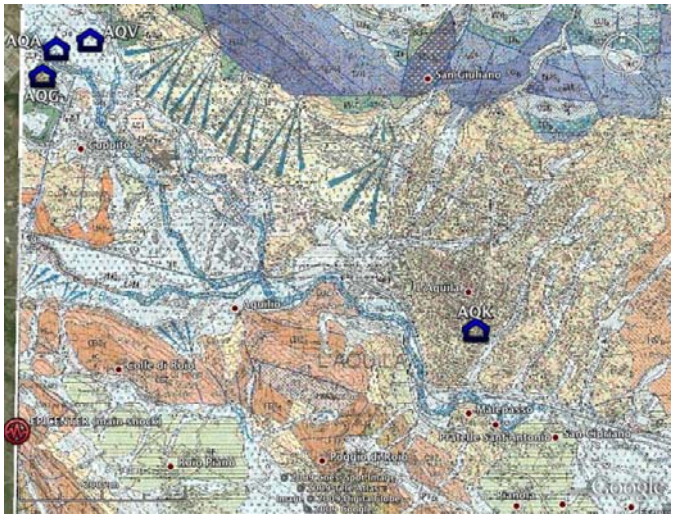
The L'Aquila main event of April 6, 2009 was recorded by 56 digital strong motion instruments, 14 of which are in the Abruzzo region as shown in Figure 40a. Figure 40b shows the locations of four instruments located on the hanging wall of the fault near L'Aquila, three NW of the city in an array with one reference rock station (AQG) and two stations on recent alluvium (AQA, AQV) and one instrument near the city center on Pleistocene material (AQK). An additional instrument known as the Moro station recorded the mainshock (AQM), although this data was not released as of this writing. The other 42 instruments that recorded the mainshock are generally located in portions of the Apennines NW and SE of the source region, as shown in Figure 41. These instruments are part of the Italian Accelerometric Network (RAN - Rete Accelerometrica Italliana) that is owned and maintained by Italian Department of Civil Protection (DPC). The entire network is comprised of 388 accelerometers, 199 analogue and 269 digital, distributed across Italy. All stations listed in Table 4 have digital accelerometers, principally Altus Etna and K2 devices with 24-bit A/D converters. It is possible that additional analogue instruments recorded the earthquake and that data from those instruments will become available at a later date.

Figure 40.(A) Locations of accelerometers in Abruzzo region that recorded the 6 April 2009 main shock. Fault plane surface shown in yellow.

(B) Location of instruments on hanging wall near L'Aquila overlayed on 1:50000 scale geology map.

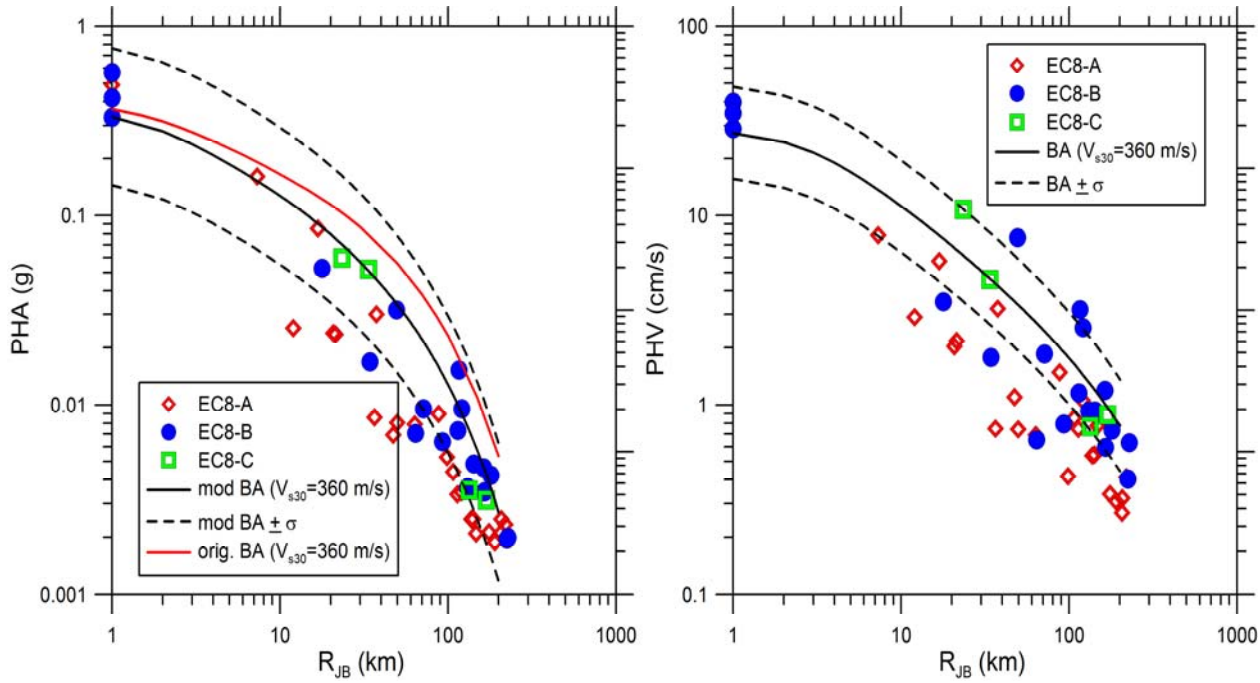
Figure 42 shows geometric mean PHA and PHV, as computed using the GMRotI50 parameter (Boore et al., 2006), as a function of R_{jb} for EC8 subsoil classes A (rock), B (weathered rock and stiff soil), and C (medium-stiff soils). Four stations (AQA, AQK, AQG, AQV) are on the hanging wall and hence have R_{jb}=0. Those are plotted at R_{jb}=1 km in the figure. Also shown in Figure 42 are medians (μ) and medians ± one standard deviation (σ) for the Boore and Atkinson (BA) 2008 GMPE as modified for faster attenuation in Italy by Scasserra et al. (2009b) for PHA (no modification for PHV). The BA GMPE was plotted for V_{s30}=360 m/s. The red curve in the figure is the original BA 2008 median. Note that the modification for faster distance attenuation better captures the data trends.

Figure 42. Variation of orientation-independent geometric mean (GMRotI50) PHA and geometric mean PHV with R_{jb} for EC8 site categories A, B, and C.

Data for EC8 categories A and B are numerous and allow approximate inference of site effects. At large distance (R_{jb} > ~50 km) B sites appear to be higher-amplitude than A sites, whereas the difference is not distinguishable for the relatively few stations at closer distance (R_{jb} < ~30 km). These apparent trends will be evaluated through statistical analysis in subsequent work.

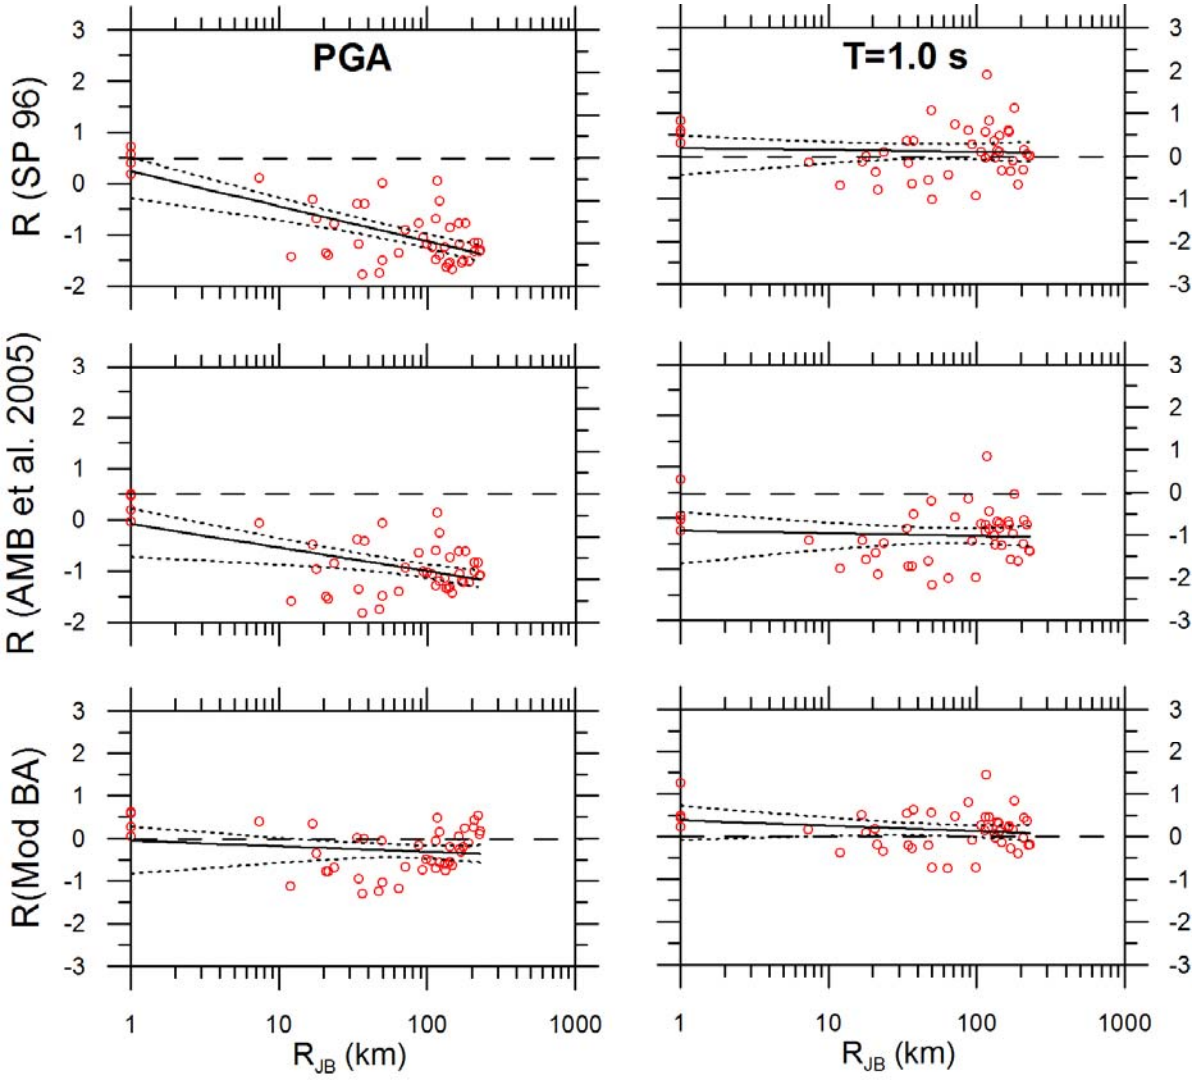
where $(IM_i)_{rec}$ = value of ground motion intensity measure from recording i and $(IM_i)_{GMPE}$ = median value of that same IM from a ground motion prediction equation. The intensity measures used here are PHA and S_a at 0.2, 0.5, 1.0, and 2.0 sec. We used the BA GMPE as modified by Scasserra et al. (2009b) for T ≤ 1.0 sec, the Sabetta and Pugliese (1996) GMPE, and the Ambrasseys et al. (2005) GMPE. Results of those calculations are shown in Figure 43 for the IMs of PGA and 1.0 sec S_a.

The results shown in Figure 43 indicate that the distance attenuation for the modified BA relation is consistent with the data, as indicated by the nearly horizontal trend lines. The other GMPEs have what appears to be a significantly non-

horizontal trend line for PHA, suggesting that the actual distance attenuation is faster than that predicted by the models. These trends will be more formally evaluated in subsequent work.

Figure 43. Residuals of intensity measures from recorded ground motions (GMRotI50) relative to predictions of the modified Sabetta and Pugliese (SP) (1996) GMPE, the Ambrasseys et al. (AMB) (2005) GMPE, and the modified BA GMPE (Scasserra et al., 2009b). Log-linear trend line shown with 95% confidence limits.

Although nearly horizontal, the modified BA trend line is not at zero ordinate. This indicates a systematic bias of the model relative to the data. Since this event is well recorded, this bias is nearly equal to an event term as would be calculated from a mixed-effects regression (e.g., Abrahamson and Youngs, 1992). Non-zero event terms are typical; what is of interest is to see if the event terms for the L'Aquila mainshock are consistent with event-to-event scatter as observed from previous earthquakes. This is typically represented by event term dispersion τ. Figure 44 shows the L'Aquila mainshock event terms at the aforementioned periods along with the $\pm \tau$ model from the modified BA GMPE (the τ terms are identidical in the original and modified GMPEs). The L'Aquila event terms are seen to be unusually low at short periods but nearly zero at longer periods.

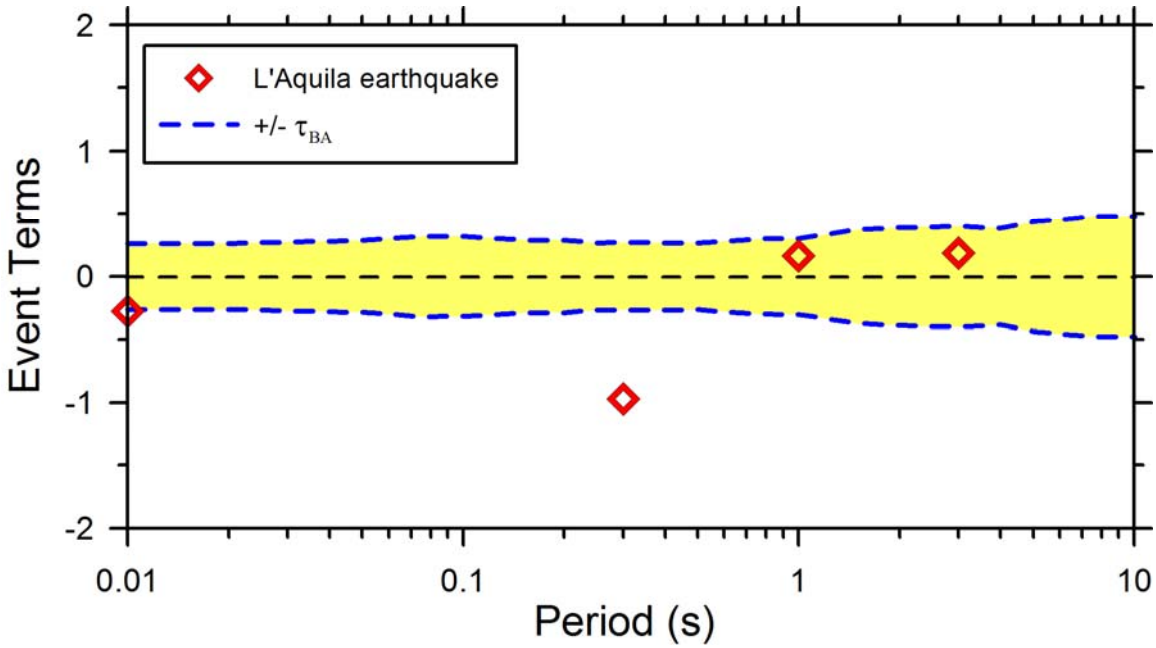
Figure 44. L'Aquila earthquake event terms versus standard deviation of event terms (τ) from the BA (2008) GMPE.
