Seismological and geotechnical aspects of the M_w=6.3 l'Aquila earthquake in central Italy on 6 April 2009

ABSTRACT: *The L'Aquila earthquake occurred on April 6 2009 at 03:32:39 local time. The earthquake (M_w=6.3) was located in the central Italy region of Abruzzo. Much of the damage occurred in the capital city of L'Aquila, a city of approximate population 73000, although many small villages in the surrounding region of the middle Aterno river valley were also significantly damaged. In the weeks following the earthquake, the Geo-Engineering Extreme Events Reconnaissance (GEER) international team, comprised of members from different European countries and the U.S., was assembled to provide post-earthquake field reconnaissance. The GEER team focused on the geological, seismological, and geotechnical engineering aspects of the event. We describe the principal seismological findings related to this earthquake including moment tensors of the main shock and two triggered events, the aftershock pattern and its variation with time, tectonic deformations associated with the main shock, surface fault rupture, and the inferred fault rupture plane. We describe damage patterns on a village-

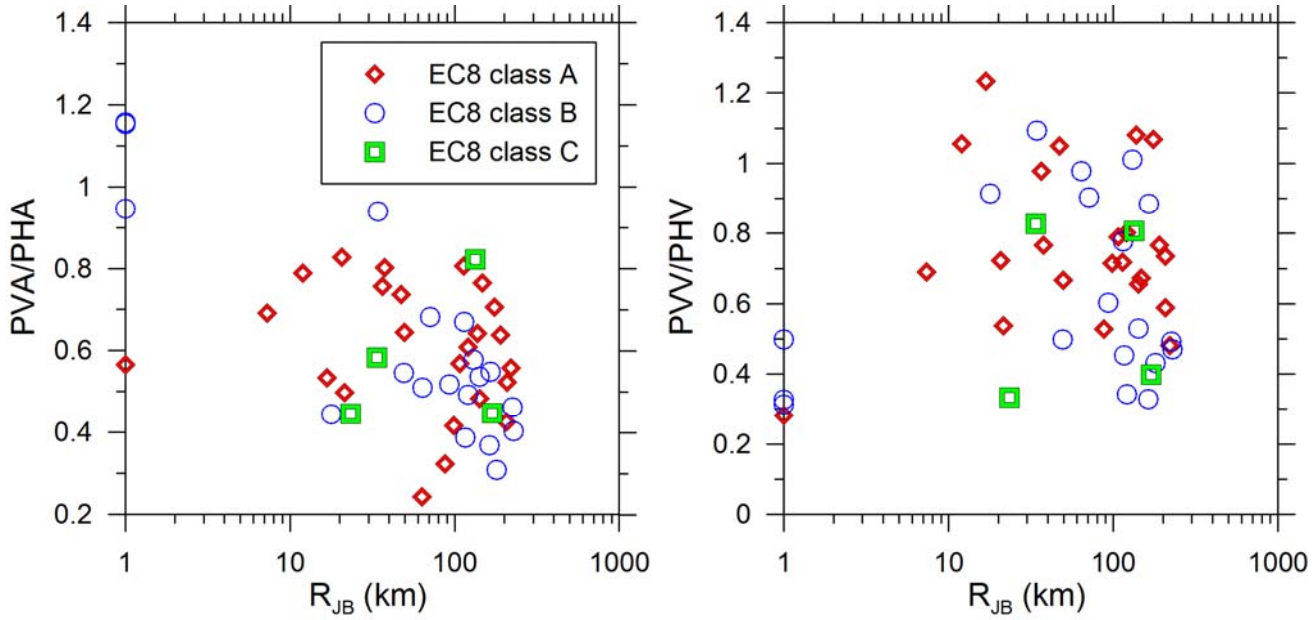
In Figure 45 we show V/H ratios for the mainshock peak accelerations and velocities, where H is taken as the geometric mean of the recorded motions. For peak acceleration, V/H is high in the near field and drops with distance in a manner consistent with empirical relationships (Bozorgnia and Campbell, 2004). For peak velocity, V/H increases with distance.

Figure 45. L'Aquila earthquake V/H ratios for peak acceleration and velocity.

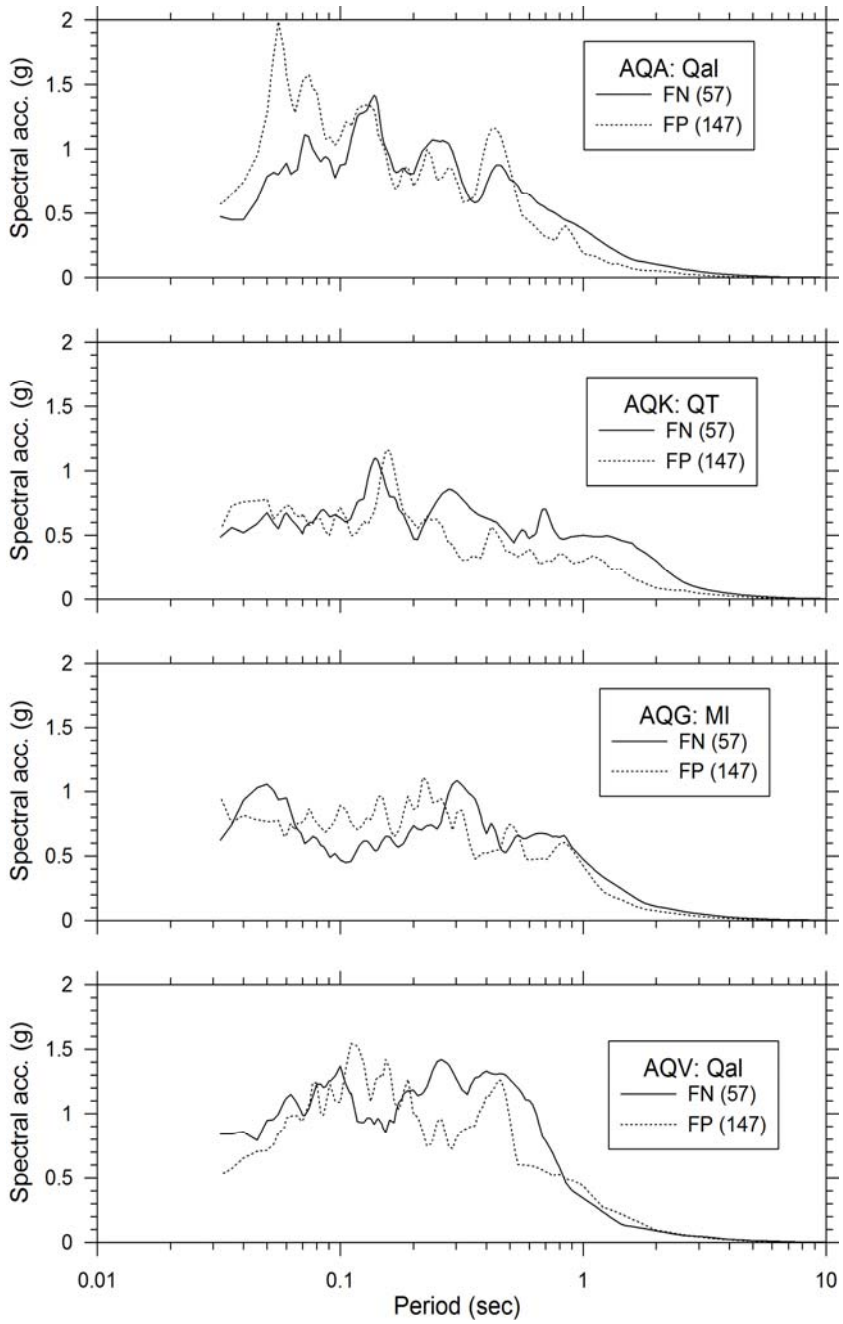
Figure 46 shows 5% damped pseudo-acceleration response spectra for four stations on the hanging wall of the fault. Before calculating spectra, the motions were rotated into fault normal and fault parallel directions, based on the 147 degree strike reported in the Earthquake setting and source characteristics section. The results are not suggestive of significant polarization of ground motion in the fault normal direction, which is an indicator of rupture directivity.

A notable feature of these motions is significant energy content at high frequencies for which motions in California have often saturated to the peak acceleration. In the 0.3-1.0 sec period range, the two motions from relative soft site conditions (AQA and AQV) appear to be relatively more energetic than those for firmer site conditions (AQG and AQK).

Figure 46. Pseudo acceleration response spectra (5% damping) for four motions recorded on hanging wall of fault.

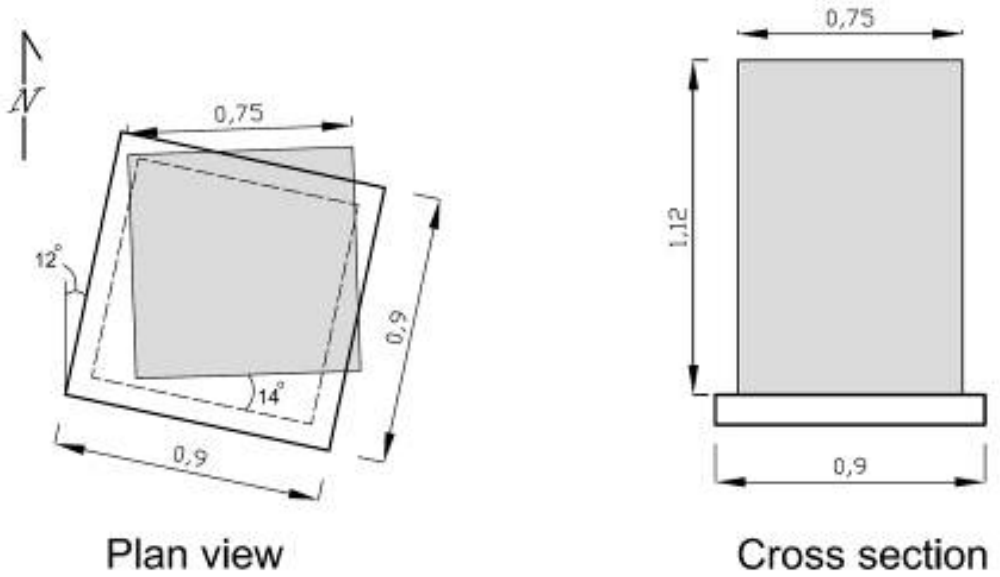
The monument consists of a block of porous stone with dimensions 0.75 m x 0.75 m x 1.12 m, sitting on a level stone pedestal made of similar material (Figure 47). As a result of the main shock, the block rotated about 14° counter-clockwise

(Figure 48) leading to a maximum sliding at the edge of the stone of approximately 20 cm. The final position of the block was almost aligned with NS direction. As the coefficient of friction is not less than 0.4, peak ground acceleration at the site may have been higher than 0.4g. More analysis is needed to back calculate additional ground motion parameters.

Figure 47. Rotated monument in Paganica.

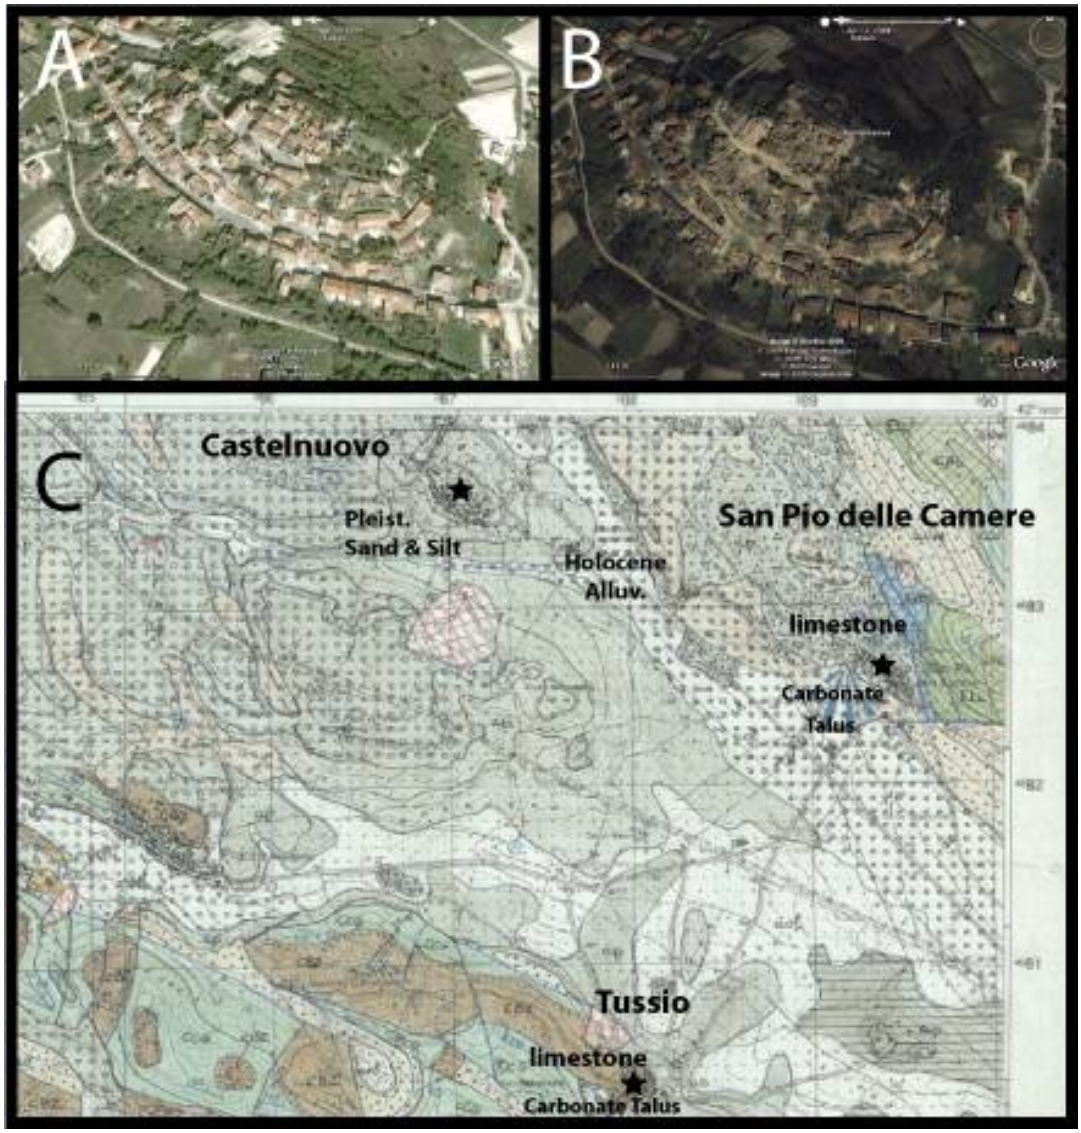
The village of Castelnuovo is located on a hilltop 10-70 m above the surrounding alluvial plain. The village (810-860 m elevation) is settled on an elliptical hill, consisting of fluvio-lacustrine deposits of lower to medium Pleistocene age. The village top is an eroded Pleistocene unit of weakly cemented sand with inter-collated gravel and conglomerate (Bosi and Bertini, 1970; Bertini et al., 1989). This unit lies on top of a soft erodable carbonate silt of the San Nicandro formation that was incised by the Aterno river during Pleistocene time. Holocene fluvial and alluvial deposits fill-in the topographic lows and surround the eastern and southern sides of the village (Figures 55 and 56). The site is located 5 km away from the surface projection of the fault plane depicted in Figure 35. During the reconnaissance, we observed outcrops of the weakly cemented sandstone near the top of the village in a sinkhole that formed among D5 collapsed structures. On the north side of the village at the base of the hill is an abandoned masonry ENEL seismograph station that was badly damaged during the earthquake (Figure 57).

The village consists of un-reinforced masonry structures 2-3 stories in height. Some of the structures were retrofitted with through-going iron bars. Shaking was strong enough to significantly damage (D2 or greater) almost the entire village, with most of the structures in the upper half of the hill either collapsed or teetering on collapse (D3-D5). Figure 58 shows a D2 structure near the base of the village, where the D4-D5 Ratio was approximately 25%. In this area most structures survived the event. Figure 59 shows a series of collapsed structures near the top of the hill, where the D4-D5 ratio was 80-90%. Figure 60 shows a sinkhole apparently associated with erosion from a water pipe break at this same location near the top of the hill. The village of Castelnuovo was previously almost completely destroyed during the earthquake of 1461 (Rovida et al. 2009).

Figure 55. Castelnuovo village before the earthquake. (A) The village after the earthquake, (B) Geologic map of the eastern Aterno Valley region, (C) Geologic map of the region (Courtesy of INGV).

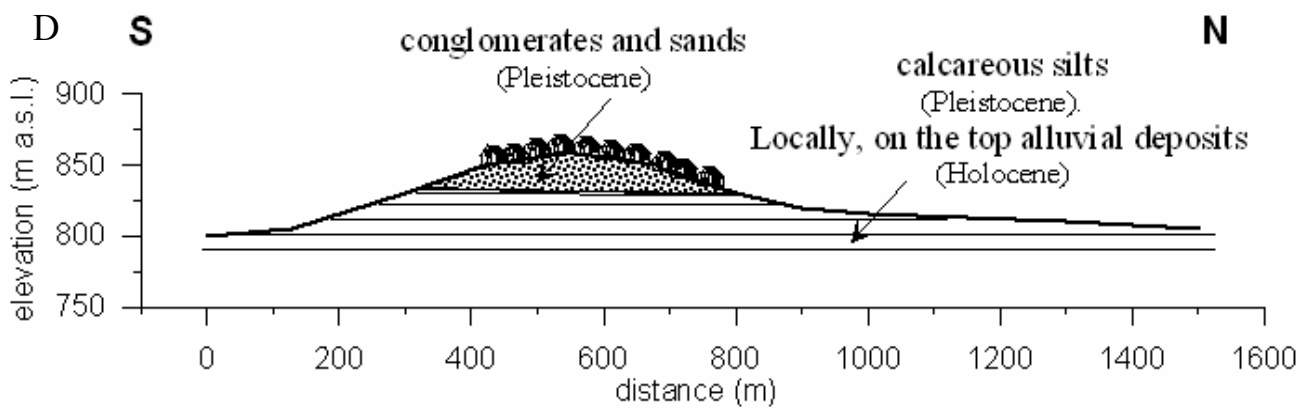
Figure 55. (D) Geologic section through the hill. Castelnuovo is built on Pleistocene sand and silt deposits, whereas nearby villages with the same building stock are located on Mesozoic carbonate Bedrock, and limestone talus.

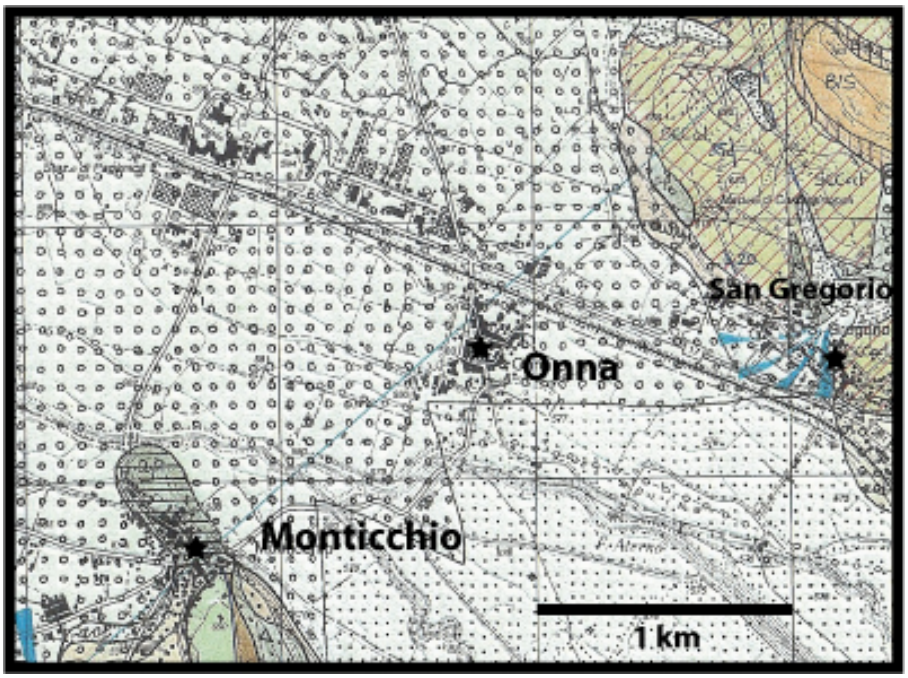
The hardest hit village near the city of L'Aquila was Onna (Figure 64), an old village on the floor of the Aterno valley built on Holocene calcareous alluvial and fluvial deposits of sand and gravel, and inter-bedded clay and silt, some more than 5 m thick (Figures 65 and 66). The village is in the valley thalweg on the left bank of the Aterno river. The village is similar to Castelnuovo in that it is composed mainly of 2-3 story unreinforced masonry structures, with a minority of retrofitted structures. Unlike Castelnuovo, this village has a small number of newer reinforced concrete residential structures (Figure 64). The village is on the hanging wall of the fault above a region of high slip (R_{jb}=0, see Figure 35) at an average elevation of 580 m elevation. Unreinforced masonry structures in Onna suffered a collapse (D5) rate of about 80% (Figure 67a). Reinforced concrete structures suffered minor or no damage. The intensity degree attributed by QUEST team was IX-X.

Figure 64. The village of Onna suffered D4—D5 damage in most of the unreinforced masonry structures. Reinforced concrete structures at the margins of the village performed well with only minor damage (D0-D2).

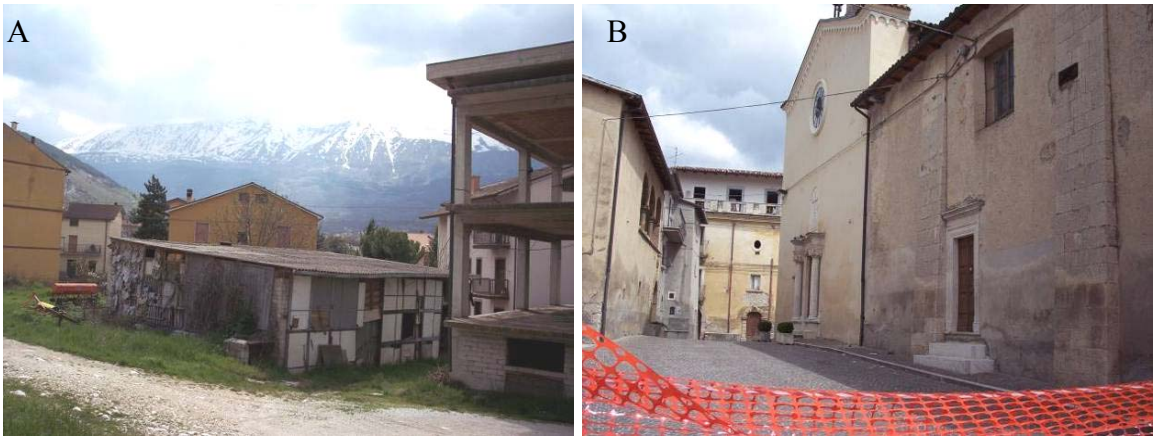
Figure 70. Monticchio. (A) D0 damage level on different building structures, (B) D0 damage on monumental masonry buildings.

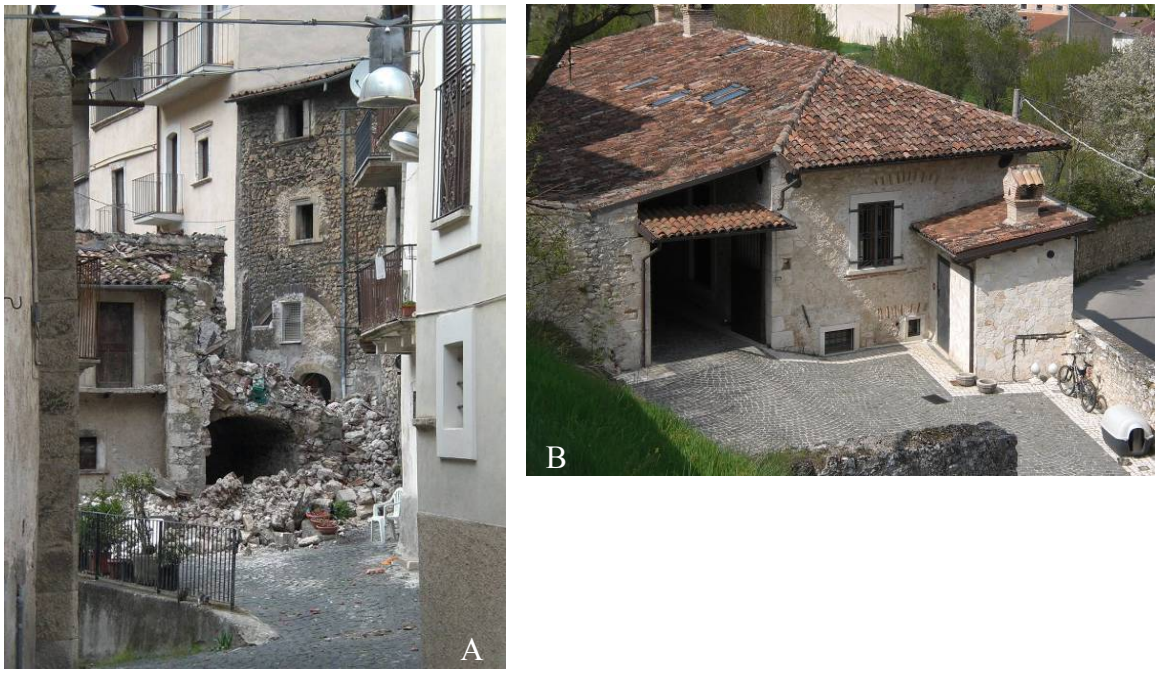
Figure 77. Fossa. (A) Collapse of masonry constructions in the historic center, (B) Sstrengthened masonry construction with no damage.

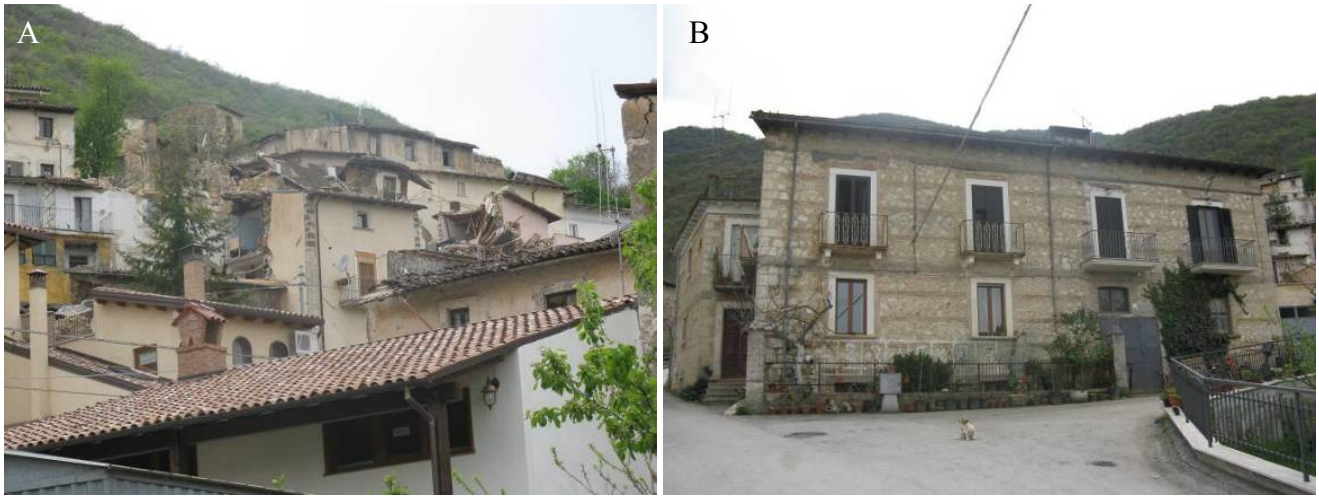
Figure 90. Tussillo. (A) View of the historic center with some collapsed masonry buildings on the background, (B) Masonry building at the entrance of the village showing no damage.

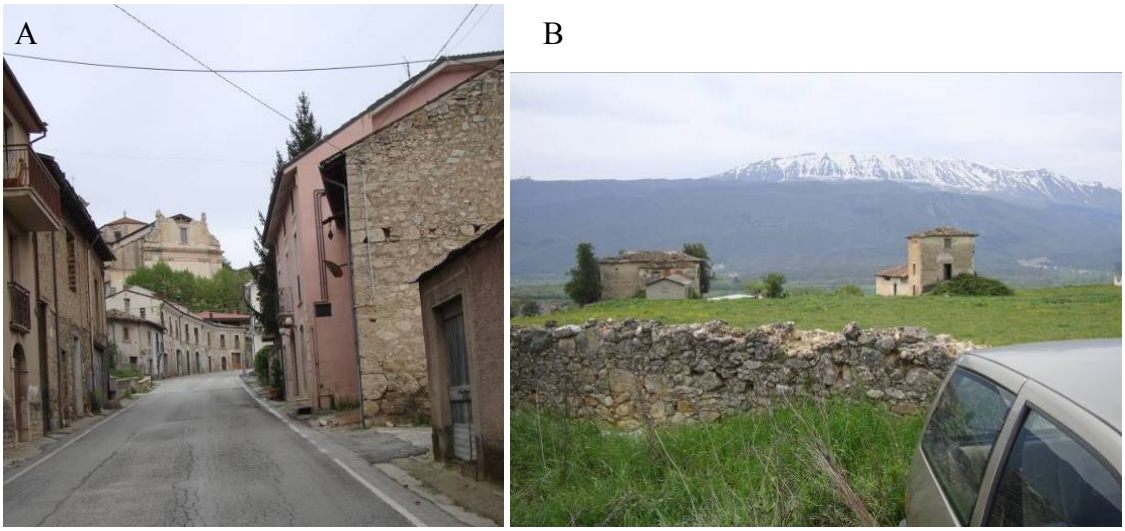
Figure 92. San Demetrio ne' Vestini (A) access road to the village showing mostly masonry buildings with no damage, (B) old masonry buildings with no damages.

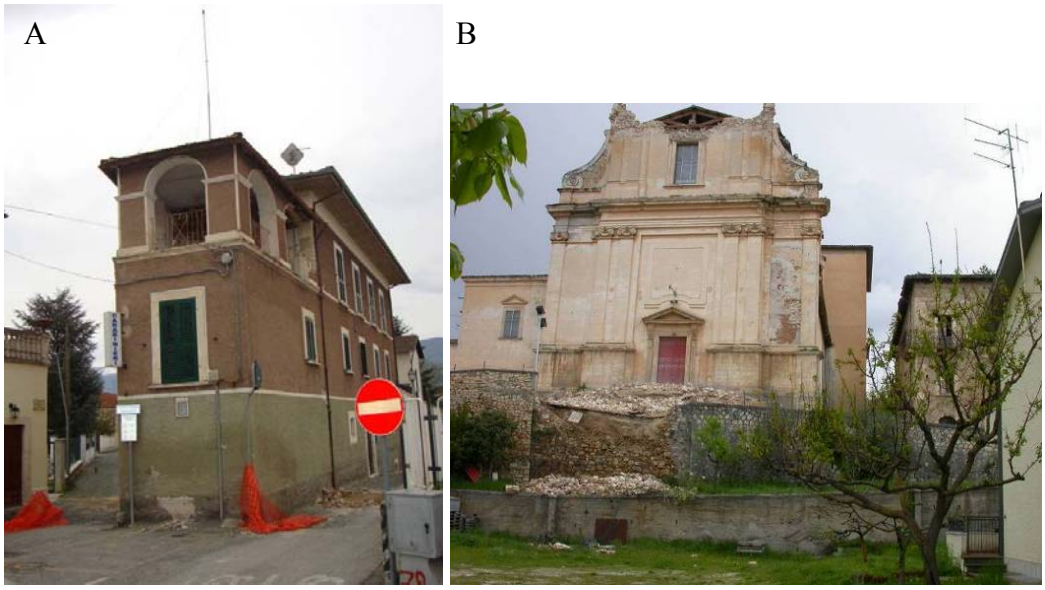
Figure 93. San Demetrio ne' Vestin. (A) "Caserma dei Carabinieri" with cracks (not evident in the picture) and falls from the highest story, (B) Partial collapse of the tympanum of the facade of the Madonna dei Raccomandati church.

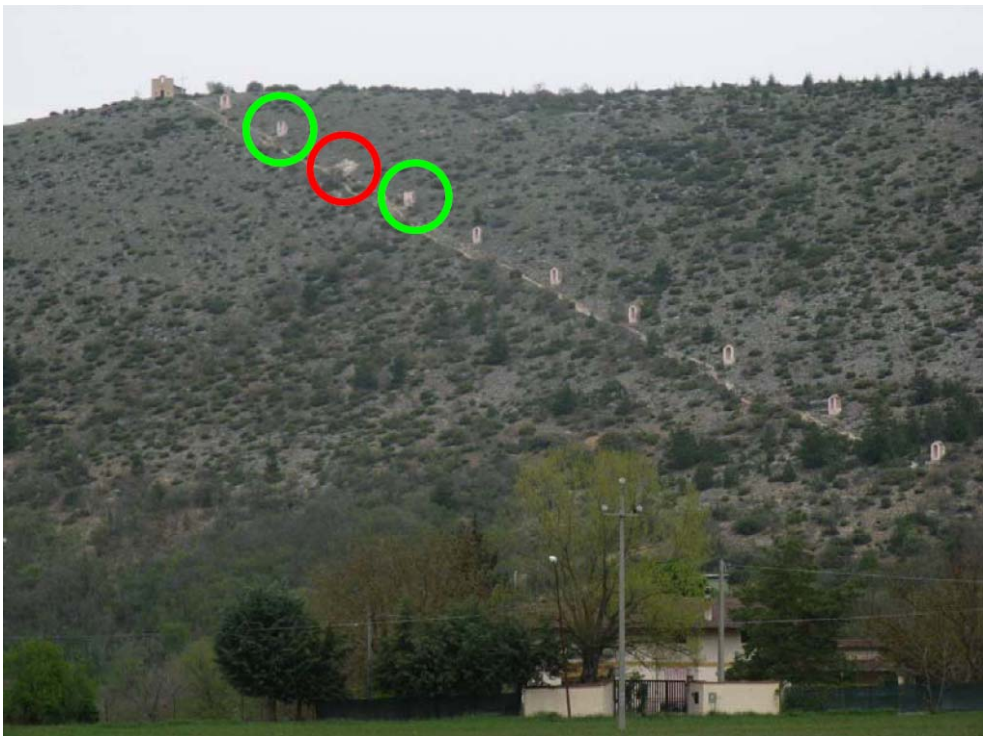
Figure 94. San Demetrio ne' Vestini: damages at the "Via Crucis" stations constructed along the slope.

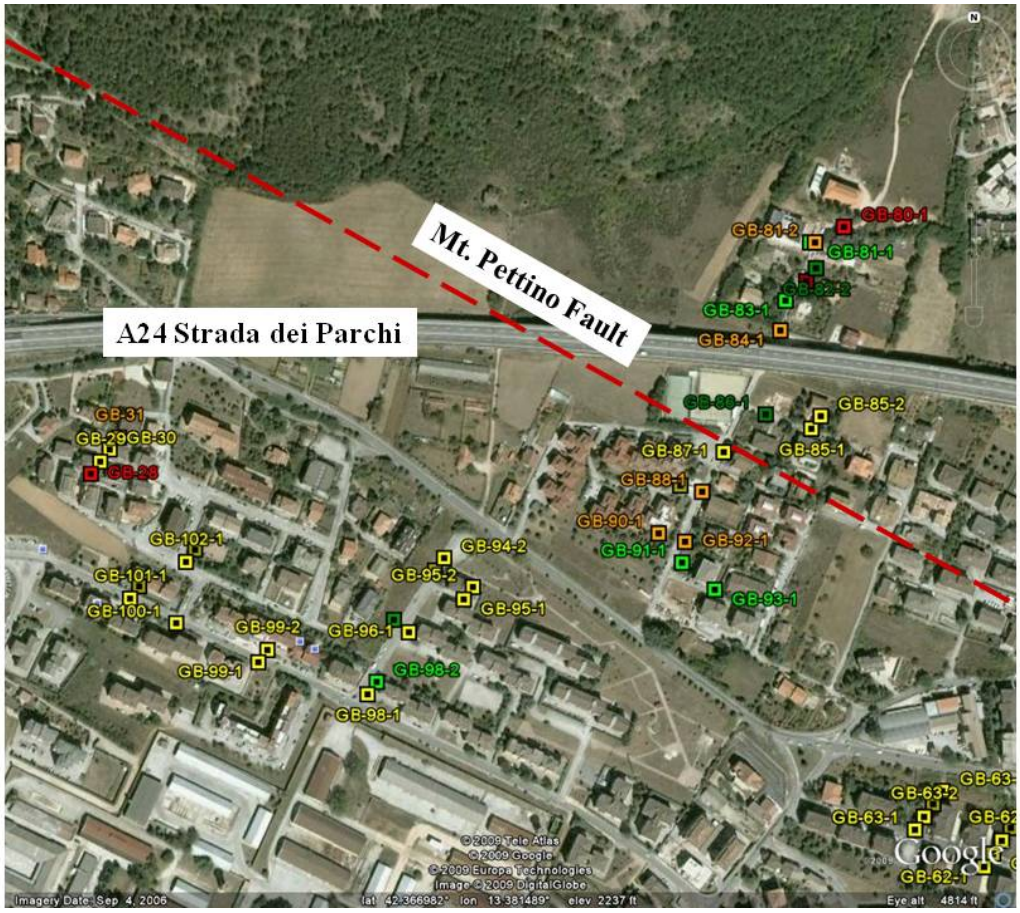
Figure 103. Zone (a) of the building damage survey along the Mt. Pettino Fault.

Figures 103 and 107 show close-up views of the mapped zones marked (a) to (e) in Figure 101. Zone (a) is the easternmost mapped area. The concentration of structures with damage level D3 is higher in this area than anywhere else along the Mt. Pettino Fault. Waypoints GB-80-1 and GB-82-1 are both masonry structures (Figure 104a and b). The first one is an older and abandoned building, while the second was a family residence (Figure 105). The remaining waypoints are reinforced concrete structures with masonry infill ranging between 2 and 5 stories. Of the five structures in this zone with damage classified at the D3 level, four are 3-stories, and the fifth is a 4-story building. An example of D3 damage (from the building at waypoint GB-88-1) is shown in Figure 105. Another area with a number of collapsed buildings is located in zone (a). These are all reinforced concrete structures, 3- to 4-story high in which the ground floor columns collapsed, causing it to pancake (Figure 106). Although high levels of damage are concentrated in this small area, similar buildings on adjacent streets show D2-level damage. Damage in zone (b) of the survey was generally lower, with only a few structures suffering D2 levels (Figure 107). Moving northwest, damage levels increase in zone (c), with a higher concentration of apartment buildings with minor structural damage (D3). Many of these buildings are actually the same design oriented differently. The area of collapsed buildings in zone (d) is isolated. Figure 107 shows in detail the location of the buildings in the damage cluster and Figures 108-110 show examples of damage in this area. The ground floor collapsed in the structures at waypoints GB-23-1 and GB-24-1. From conversations with the owners of units in the lightly damaged building, structures at waypoint GB-22-1 (D1) and GB-24-1 (D5) were built by the same construction company, but GB-

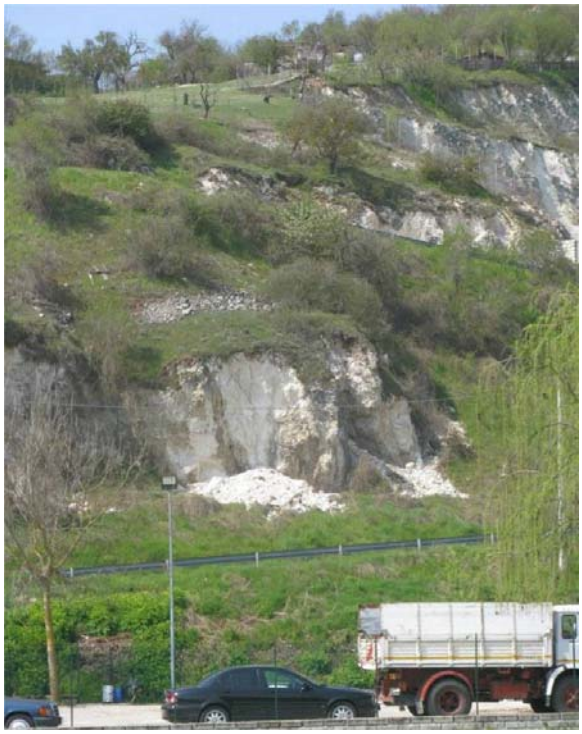
Cuts made into silty clayey colluvium also generally performed well, and only minor instances of shallow sloughing as shown in Figure 123 was observed. A larger failure affected a road cut excavated in breccias on the road from Barisciano to S. Stefano di Sessanio (Figure 124). Besides the collapsed material the presence of stepped ground surfaces with apparent tension cracks was observed behind the top of slope. Small slides and ravelling occurred also in pervasively jointed limestones (Scaglia formation) on the eastern flank of the hill of Bazzano, which overlooks the SS17 highway (Figure 125). Slides did not exceed few tens of m^3 but were widespread over the whole slope.

Figure 124. Slides and topples along the road from Barisciano to S.Stefano.(DC-11-1; 42.3349N, 13.5796E).

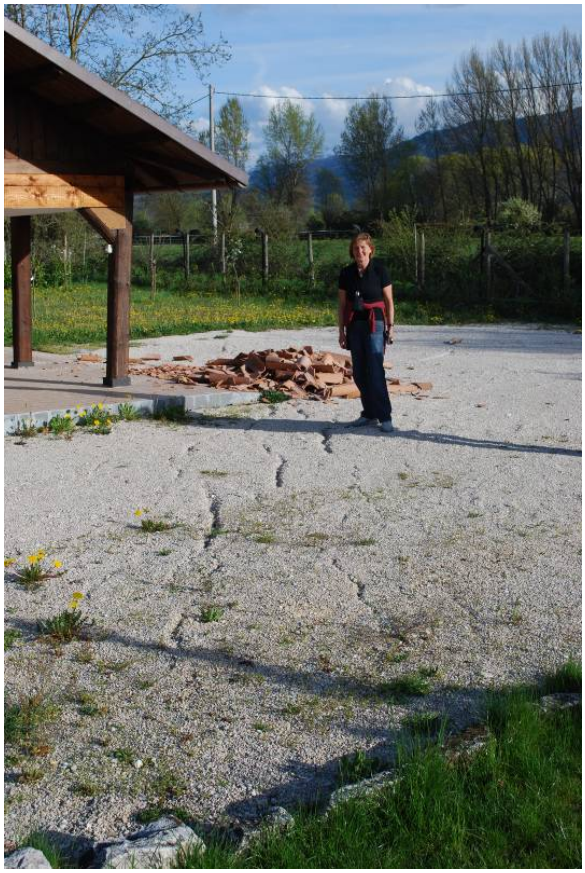
Figure 140. Ground fissures developed in alluvial floodplain directly south of central Onna and approximately 150 m from the Aterno River. Orientation of fissures is approximately parallel to the river (42.325N, 13.480E).

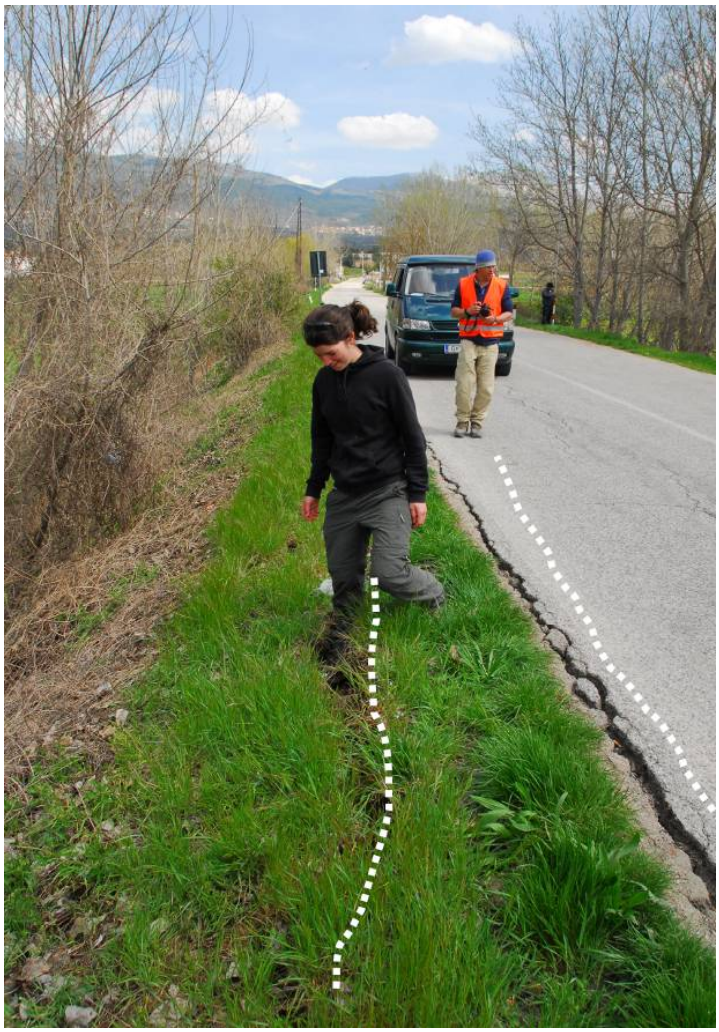
Figure 146. Approximately 15-20 cm lateral displacement of approach fill (42.325N, 13.463E).

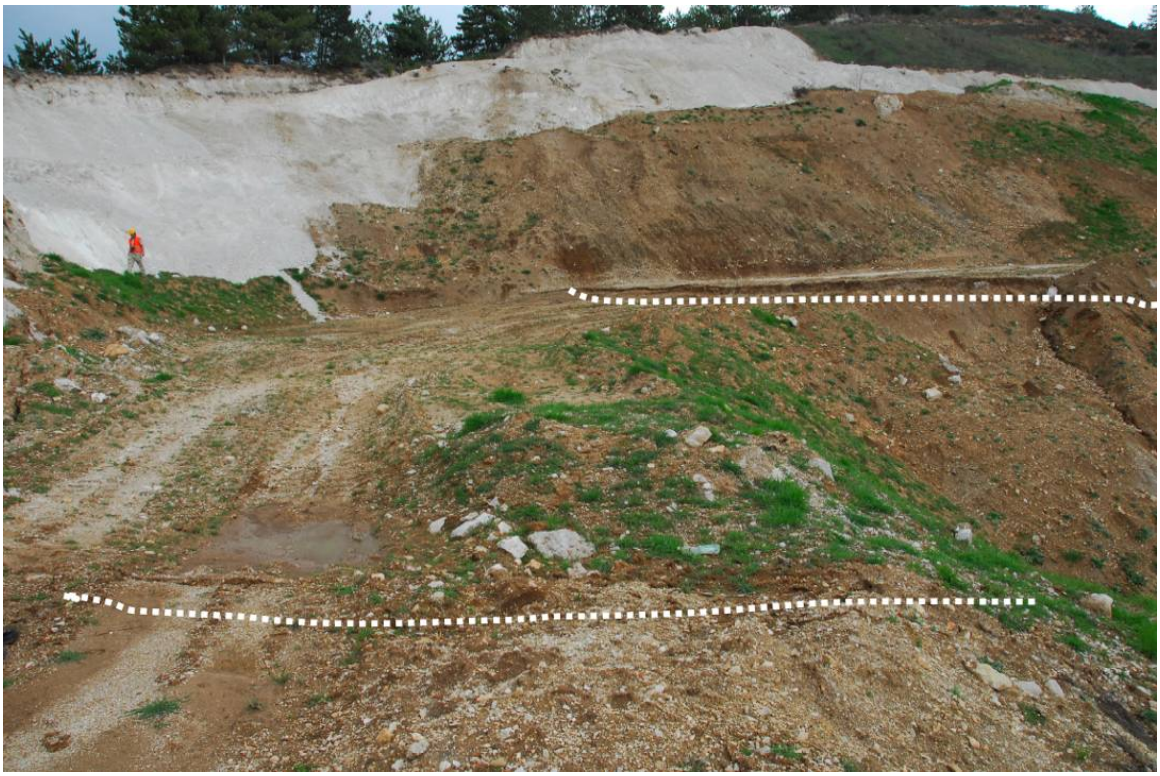
Figure 150. Graben structure (between lines) created by parallel down-dropped shears (42.435N, 13.330E).

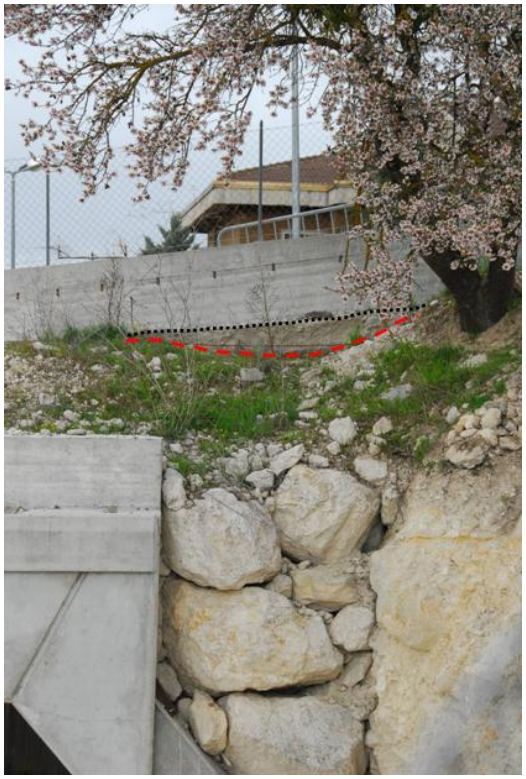
Figure 153. Settlement trough reaching 10 to 15 cm maximum, relative to the spanning parapet wall foundation (42.358N 13.415E).

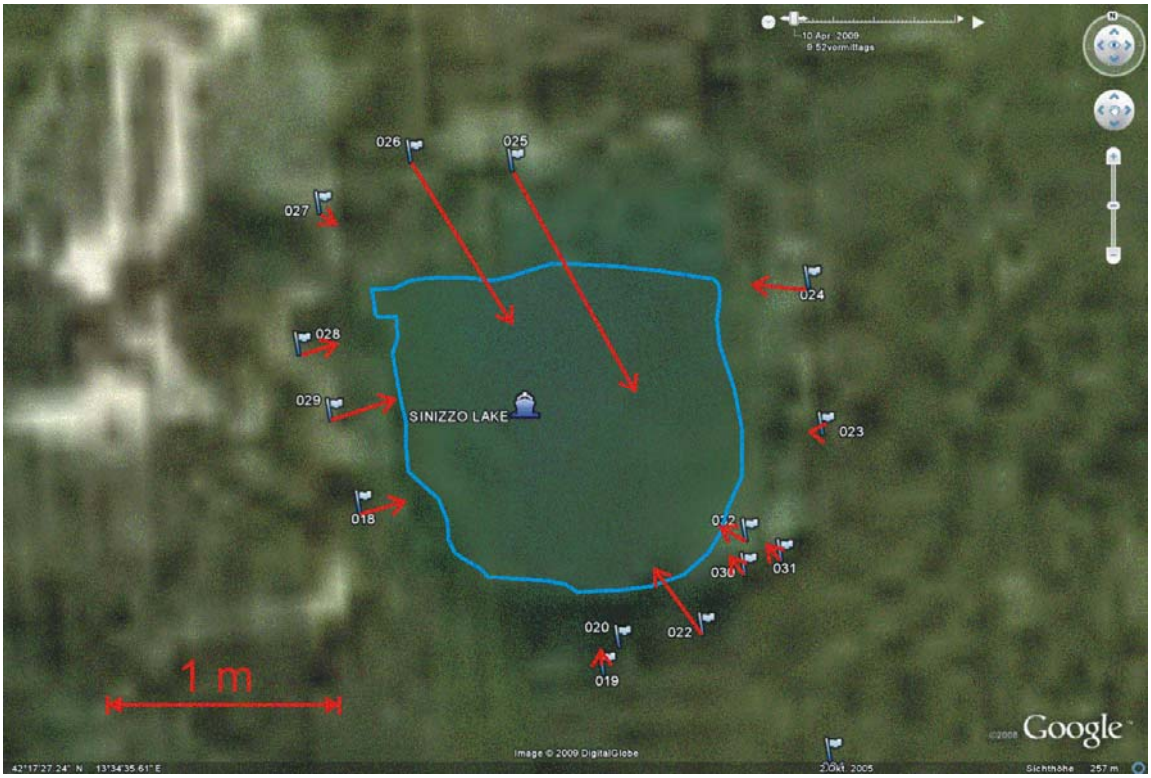
Figure 163. GPS way points indicating measurement locations around Lake Sinizzo. The red arrows indicate the orientation and maximum cumulative crack opening measured at each location.

Figure 163 plots the orientation and maximum cumulative crack opening distance for each measurement location superimposed on a Google Earth image of Lake Sinizzo. From this image it can be seen that the primary permanent displacements were towards the lake. However, the magnitude varies considerable with position around the lake.

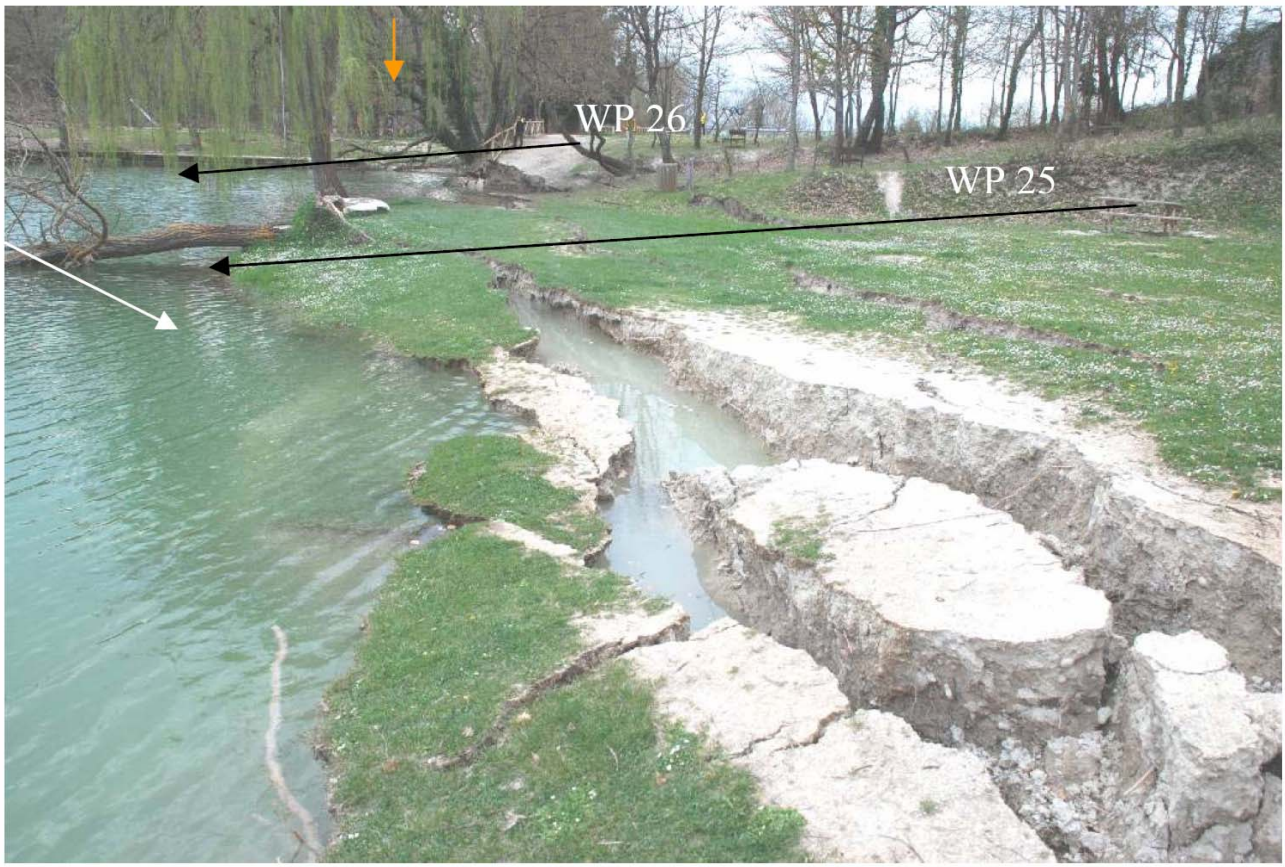
Figure 164. Blocks lying under the water (white arrow) were not included in the traverses (WP 25 and WP26). The orange arrow shows where the fence (and the slump below it) truncated the traverse at WP 27. (Photo E. Button).

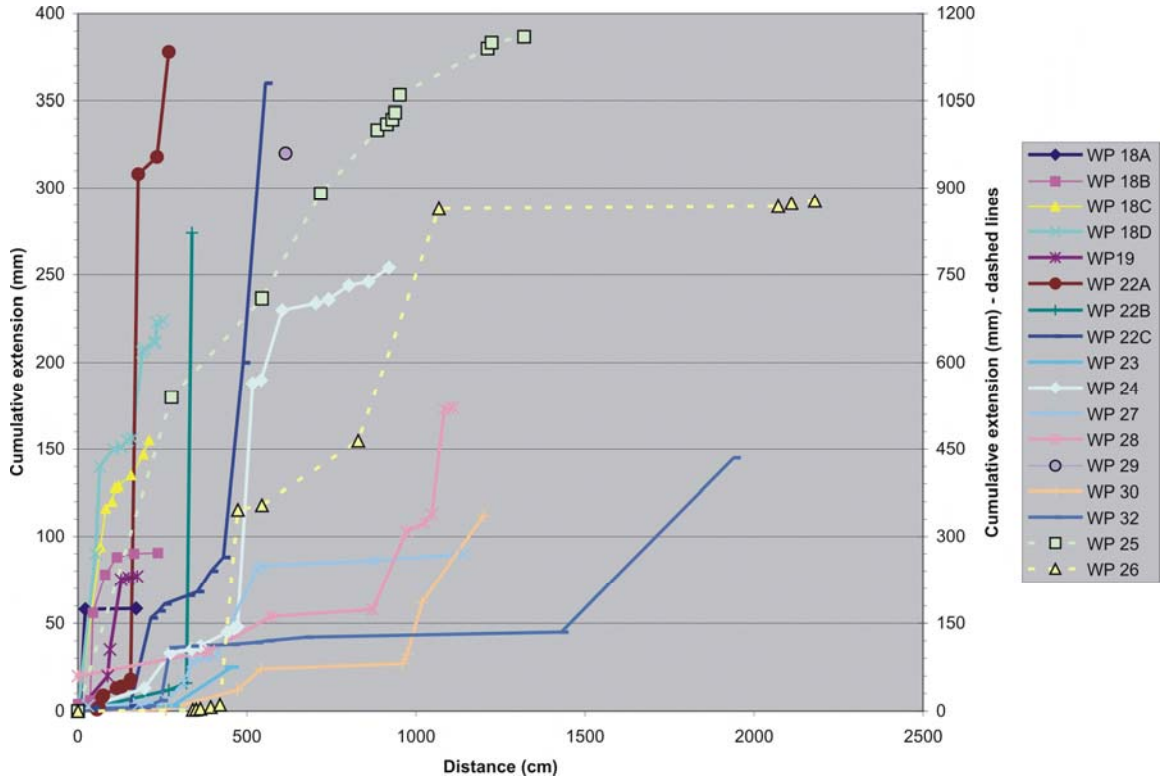
Figure 165 summarizes the cumulative crack opening for all of the traverses at Lake Sinizzo. The largest permanent displacements occurred on the north and south shores respectively. The traverses at WP 25 and WP 26 document two locations associated with the largest permanent displacements at Lake Sinizzo with cumulative extension of more than 1 m. The traverses at WP 22 document three locations along the largest scarp observed on the south shore.

Figure 165. Plot of the cumulative crack opening (extension) for all of the measurement locations. The data for WP 25 and WP 26 are plotted relative to the right axis (3X larger).

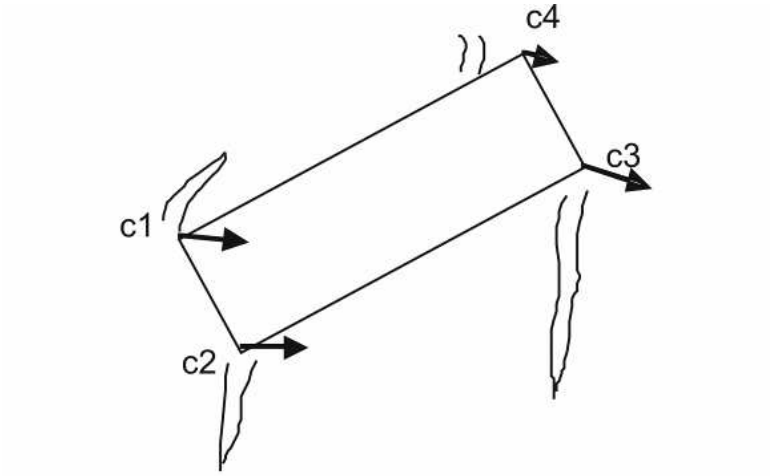
The measurements at WP 31 were associated with differential displacements occurring at a park bench bedded into the ground. Figure 166 shows a schematic diagram of the bench and the associated displacements. The features related to the bench displacement for C2 and C3 corners are shown in Figure 167.

Crack opening (mm)	Crack length (cm)
C1	60	40
C2	60	60
C3	42	90
C4	38	11 cm overthrust

Figure 166. Schematic diagram and magnitudes of the cracks associated with the park bench at WP 31.

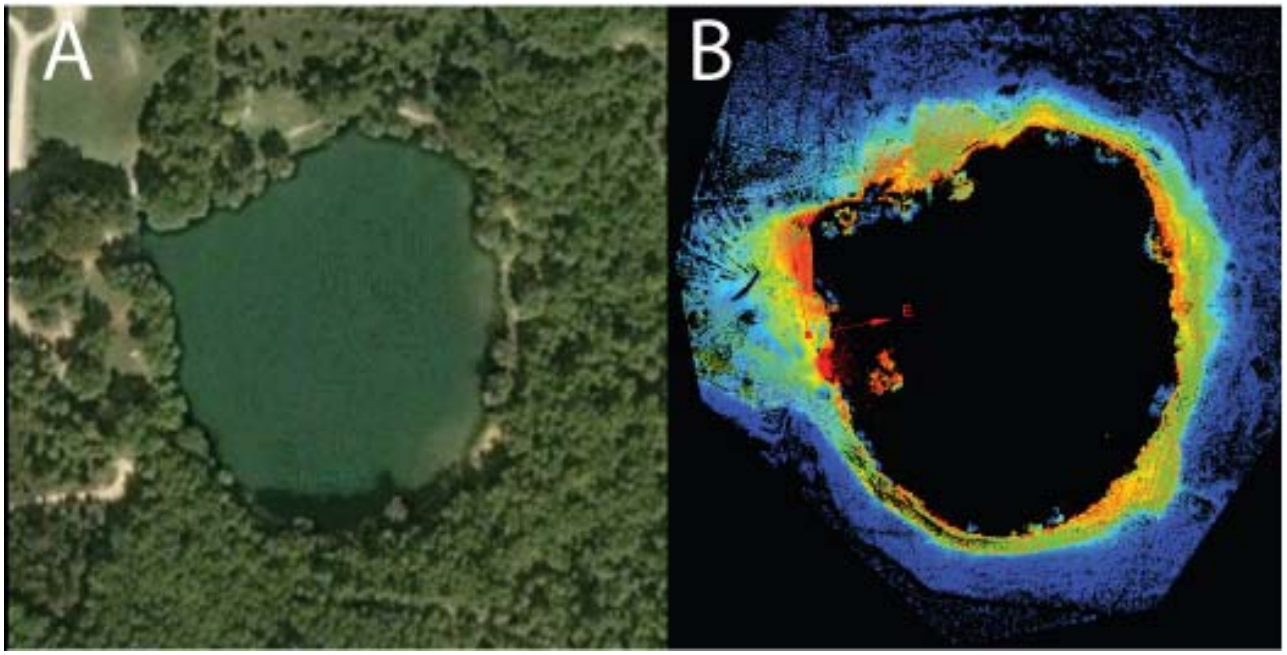
Ten scans were collected around the perimeter of the lake on April 15, 2009. The locations of the scans were irregular, with a higher density along portions of the lake margin that failed. Figure 169 shows a composite registered image of the 10 scans for the entire lake margin alongside the Google Earth image of the lake. Figure 170 shows high-resolution detail of the lake point cloud. The Google Earth image of Figure 169a was taken prior to the earthquake. The black central portion of the lidar image in Figures 169b and 170 is the surface of the lake water. The near infrared laser is unable to penetrate water, and therefore, all submerged portions of the lake are un-imaged. The images are colored from red to blue in a rainbow shade, with the red being the lowest typography and blue the highest topography. The point cloud data does not have vegetation removed through filtering and individual trees can be seen overhanging the lake water. On the left side of the image a clump of trees can be seen in the water, and are the vegetation of the displaced landslide block that entered the lake.

Figure 169. (A) Google Earth image of the lake taken prior to the earthquake, (B) Lidar point cloud image of the lake taken on April 15, 2009. The coloring in the lidar imagery ranges from red (lowest typography) to blue (highest typography).

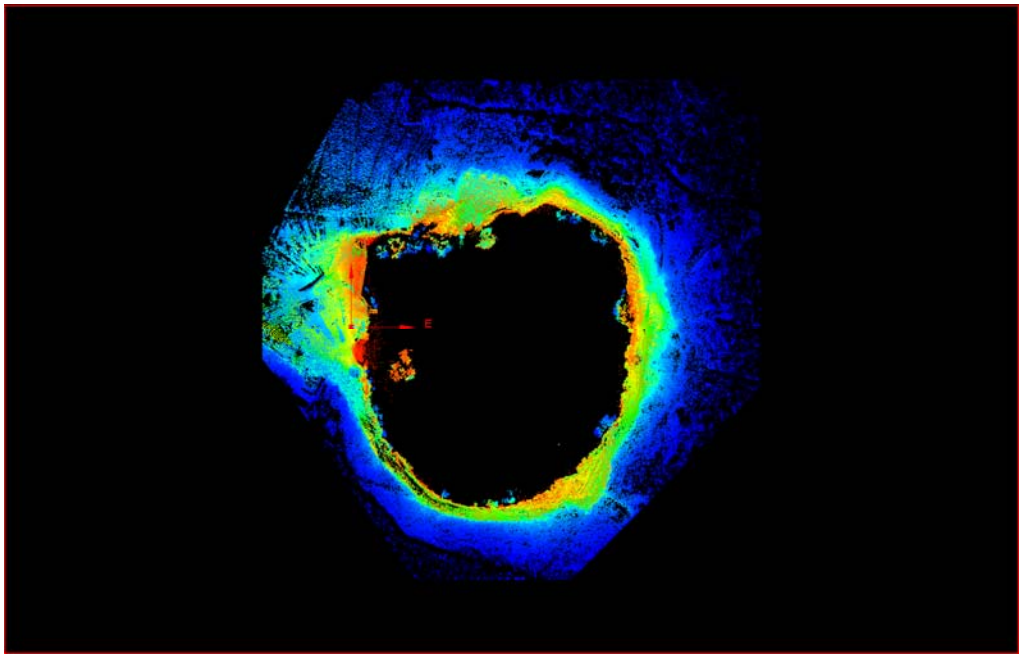
Figure 170. High-resolution detail of the lidar point cloud image of the lake taken on April 15, 2009.

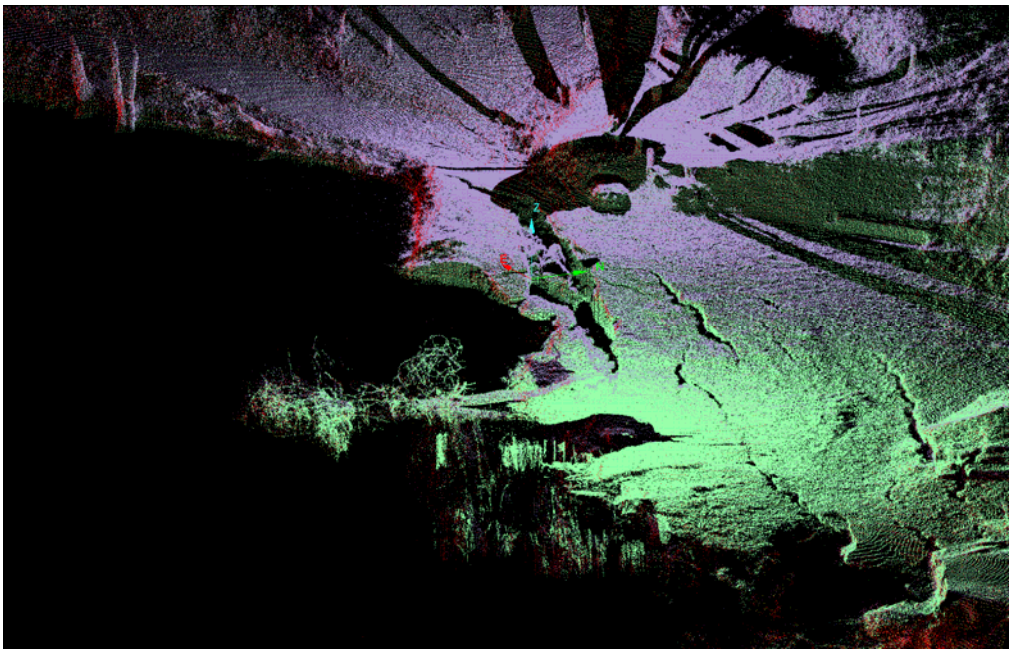
Figure 171. Detail of ground failure along the perimeter of Lake Sinizzo, captured in three of the overlapping scans (red, purple, and green).
