Seismological and geotechnical aspects of the M_w=6.3 l'Aquila earthquake in central Italy on 6 April 2009

ABSTRACT: *The L'Aquila earthquake occurred on April 6 2009 at 03:32:39 local time. The earthquake (M_w=6.3) was located in the central Italy region of Abruzzo. Much of the damage occurred in the capital city of L'Aquila, a city of approximate population 73000, although many small villages in the surrounding region of the middle Aterno river valley were also significantly damaged. In the weeks following the earthquake, the Geo-Engineering Extreme Events Reconnaissance (GEER) international team, comprised of members from different European countries and the U.S., was assembled to provide post-earthquake field reconnaissance. The GEER team focused on the geological, seismological, and geotechnical engineering aspects of the event. We describe the principal seismological findings related to this earthquake including moment tensors of the main shock and two triggered events, the aftershock pattern and its variation with time, tectonic deformations associated with the main shock, surface fault rupture, and the inferred fault rupture plane. We describe damage patterns on a village-

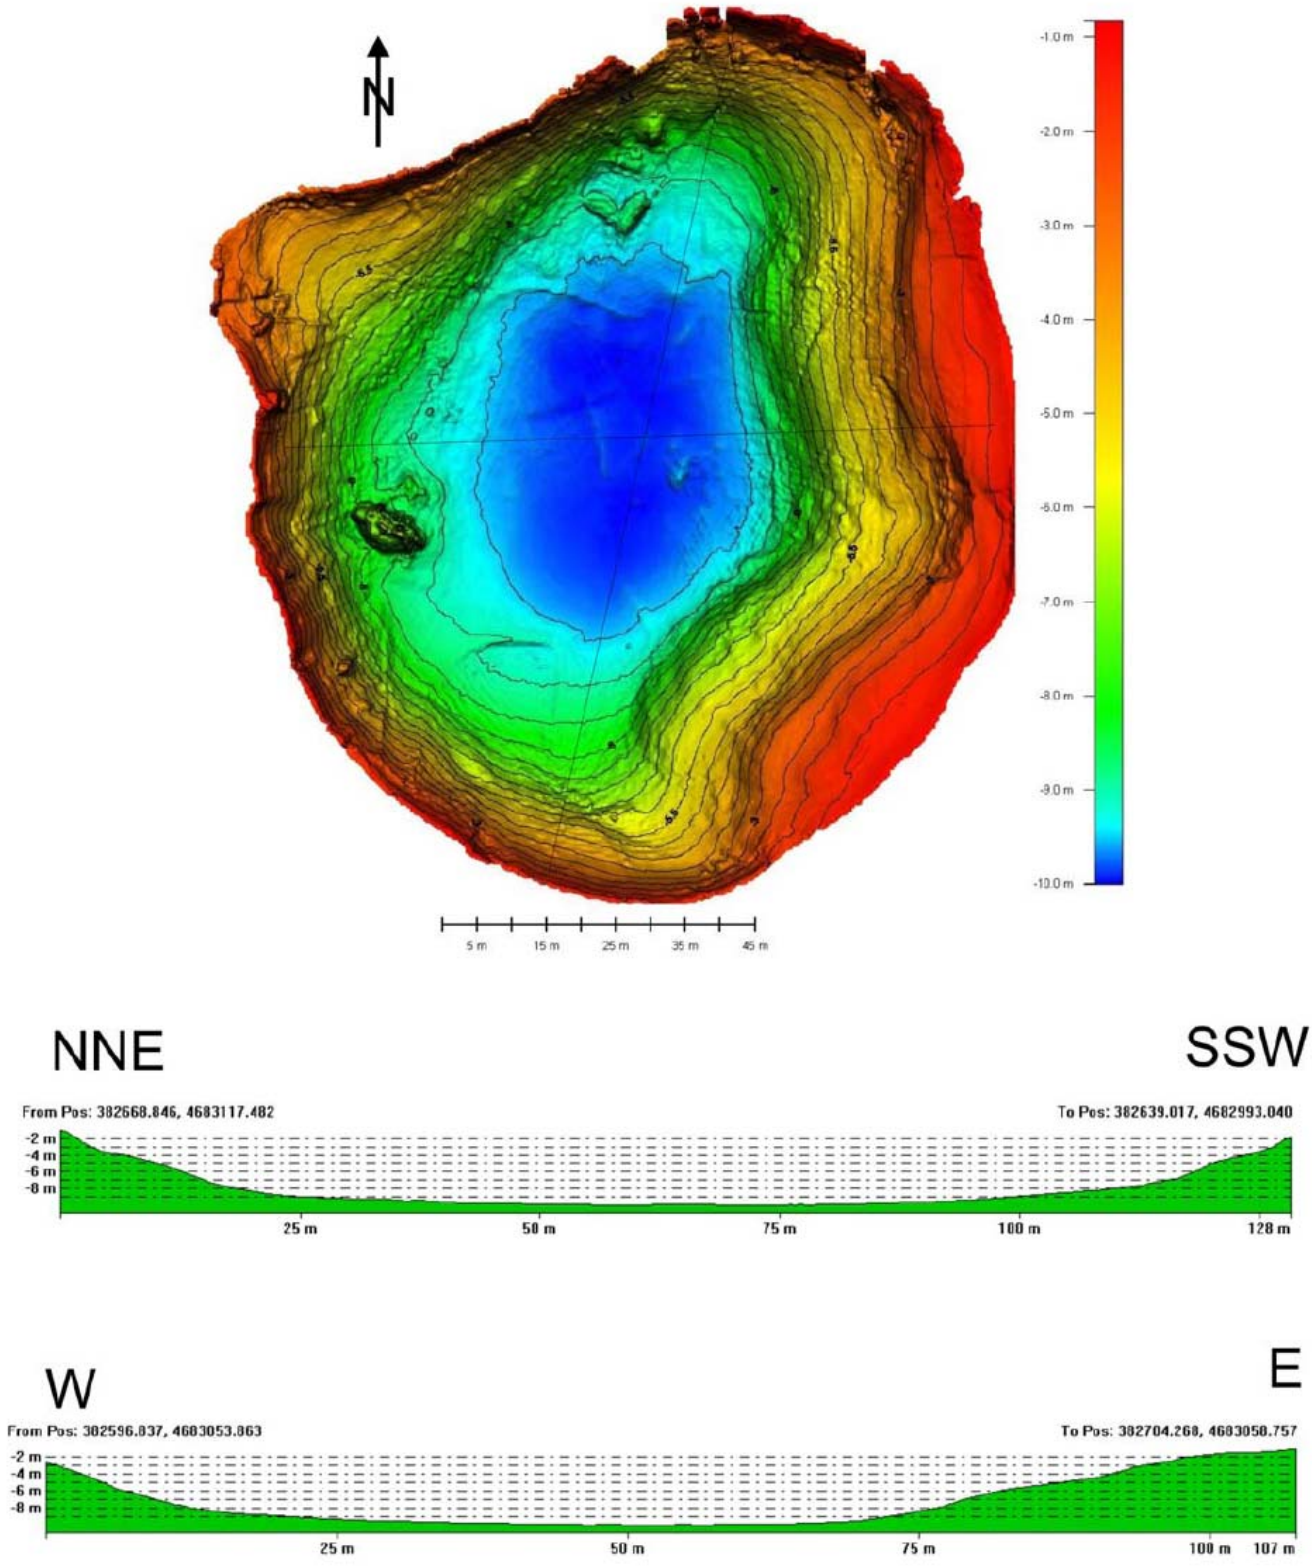
Figures 174 and 175 illustrate the main morphological features of the lake floor. Comparing the results to the 1984 single-beam bathymetry (Figure 175) indicates no significant differences in the general lake-floor configuration and relative depth distribution. The most relevant feature is an incipient instability denoted by an irregular morphological step (1 to 20/25 cm high) possibly locally evolving into a crack with an overall concave shape in plan-view, developing for about 120 m along the eastern side of the lake between -1.5 and -7.5 m. Some of these features may be underwater continuations of the cracks observed at lake banks. The western side of the lake seems to be affected by a shallow creep or decortication of the sediment cover. Also the multibeam data clearly show the area of detachment and accumulation of the "fallen trees" (Figure 160). The sliding block induced deformation of the lacustrine sediments during transportation towards the lake bottom.

Figure 174. Lake Sinizzo bathymetric survey results including cross sections.

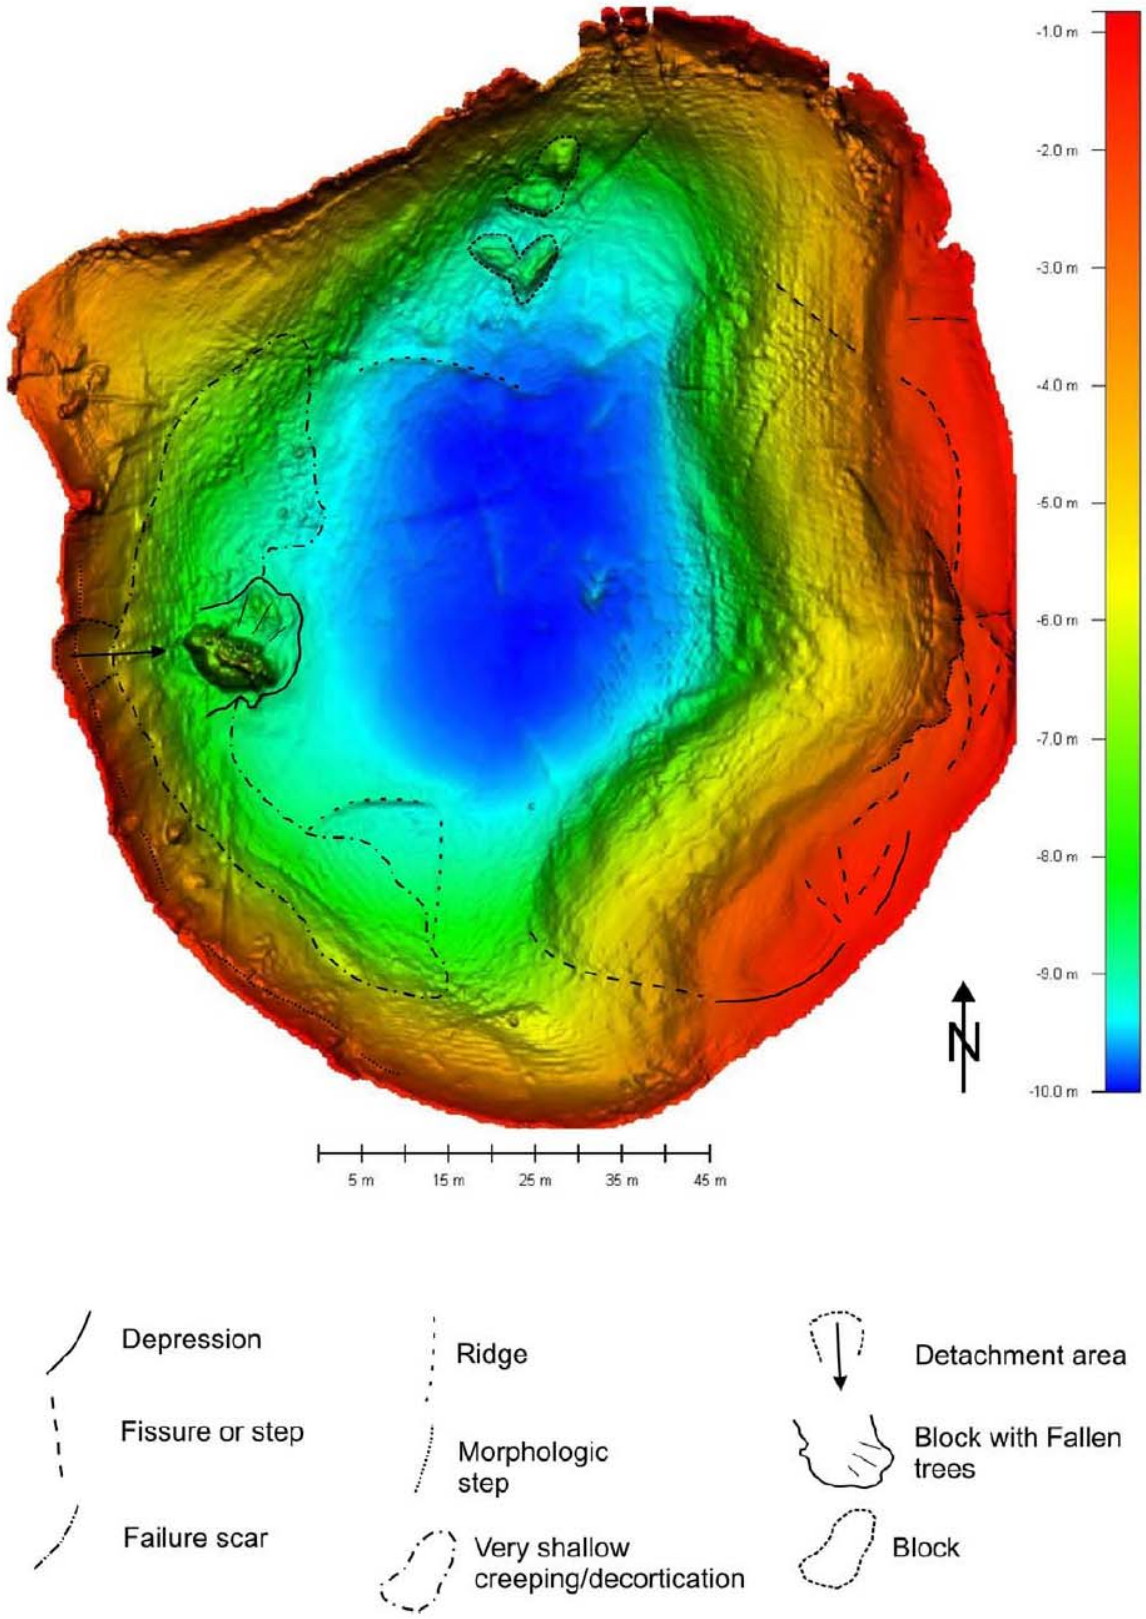
Figure 175. Lake Sinizzo bathymetric survey results marked with interpretive symbols.

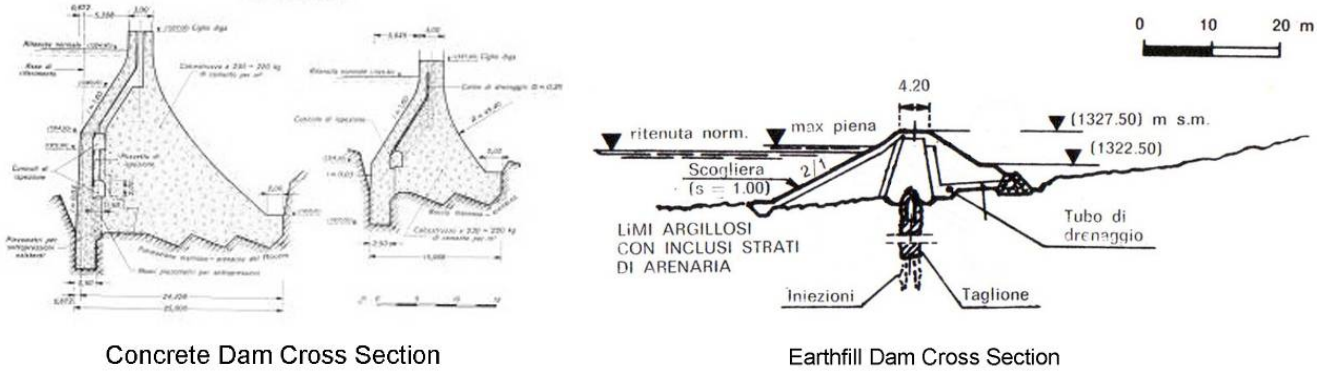
Over most of its length "Sella Pedicate" dam is a concrete dam while at one of its extremities it is a zoned earthfill embankment with an clayey central core and a concrete foundation diaphragm. It is 25 m tall and 750 m long. Its construction dates from the 1950's. Figure 177 shows a plan view of the dam from Google Earth. The upstream face is very steep (possibly 5 horizontal to 1 vertical) and is shown in Figure 178. The downstream face has a much milder inclination. Following the main shock of April 6 2009, the water level was lowered by ENEL by approximately 2 m to reduce water pressure on the structure. The reduction in water level is evident in Figure 178. At the time of the earthquake the water depth behind the dam was about 25 m. No earthquake damage was observed in the dam (crest, slopes, abutments). In addition, no soil liquefaction with sand ejecta was observed along the shoreline in the vicinity of the reservoir.

Figure 177. Plan and cross sectional (concrete dam central portion, earthfill embankment end portion) views of Sella Pedicate (42.514954°N, 13.369194°E) dam and adjacent highway system.

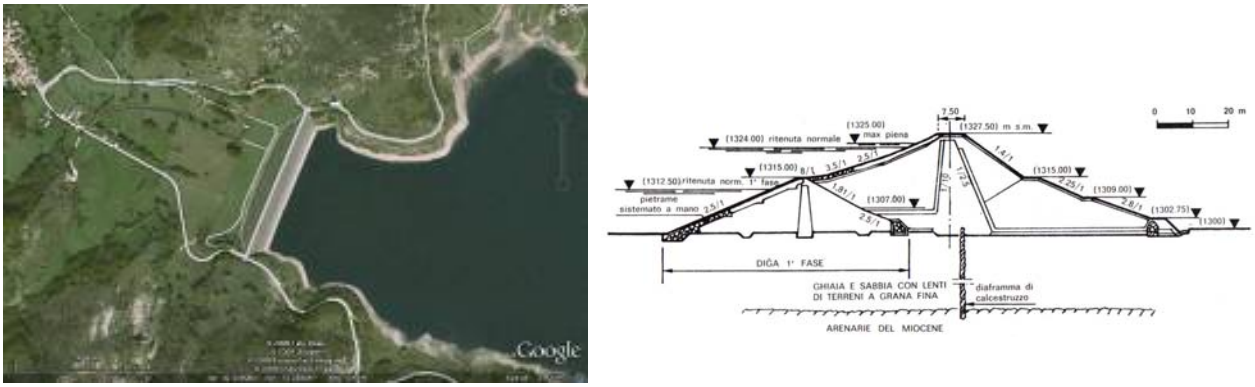
"Poggio Cancelli" is a zoned earth dam approximately 500 m length and 30 m in height. The inclination of the upstream face is about 3 horizontal to 1 vertical while that of the downstream face is approximately 1 horizontal to 1 vertical. No information as to instrumentation is currently available. At the time of the earthquake the freeboard was estimated to be about 20 m. Figure 182 and Figure 183 show the main embankment, which was found to have no visible damage from the earthquake. Moreover, no liquefaction was observed in the surrounding area.

Figure 182. Plan and cross sectional views of Poggio Cancelli dam (42.558380°N, 13.338944°E).
