Assessment of Stability Conditions of Ancient Underground Quarries using On-Site Monitoring and Numerical Modeling

Anna Maria Ferrero, *Professor, Dept. of Civil and Environmental Engineering and Architecture, University of Parma, Parma, Italy; e-mail: annamaria.ferrero@unipr.it*
Andrea Segalini, *Professor, Dept. of Civil and Environmental Engineering and Architecture, University of Parma, Parma, Italy; e-mail: andrea.segalini@unipr.it*

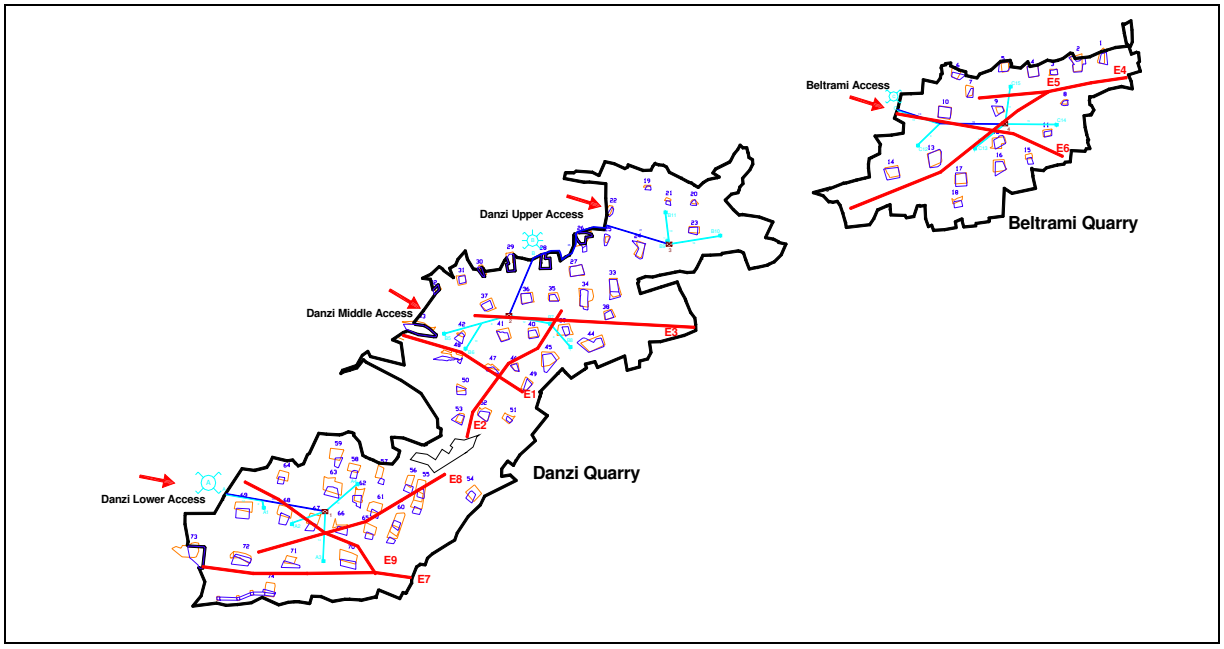
Figure 5. Map of quarries with their names, accesses and respective position. Base (green) and roof (blue) of pillars are numbered and outlined.

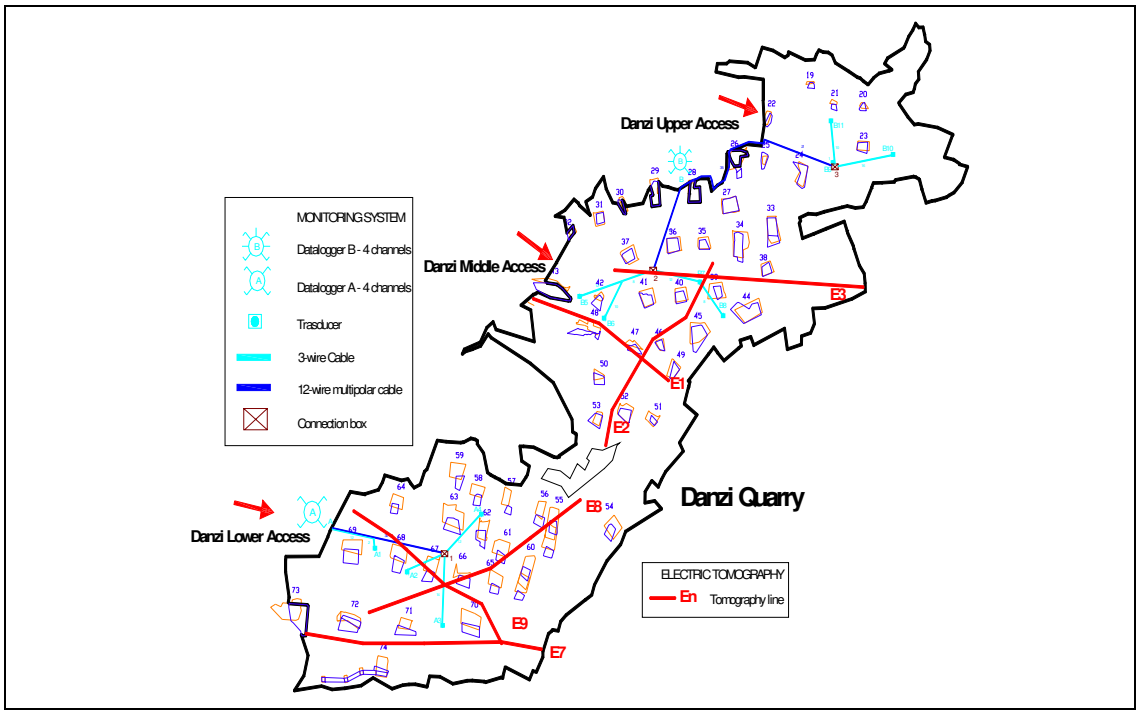
Figure 7. Map of Danzi quarry showing roofs of pillars (blue) and base (green), monitoring system and tomography lines.

Nine tests were performed on the pillars (see Figure 7 for location of the pillars) and the boundary walls by allowing the estimation of the acting state of stresses (see Table 6). These results were then used for the numerical model calibration.

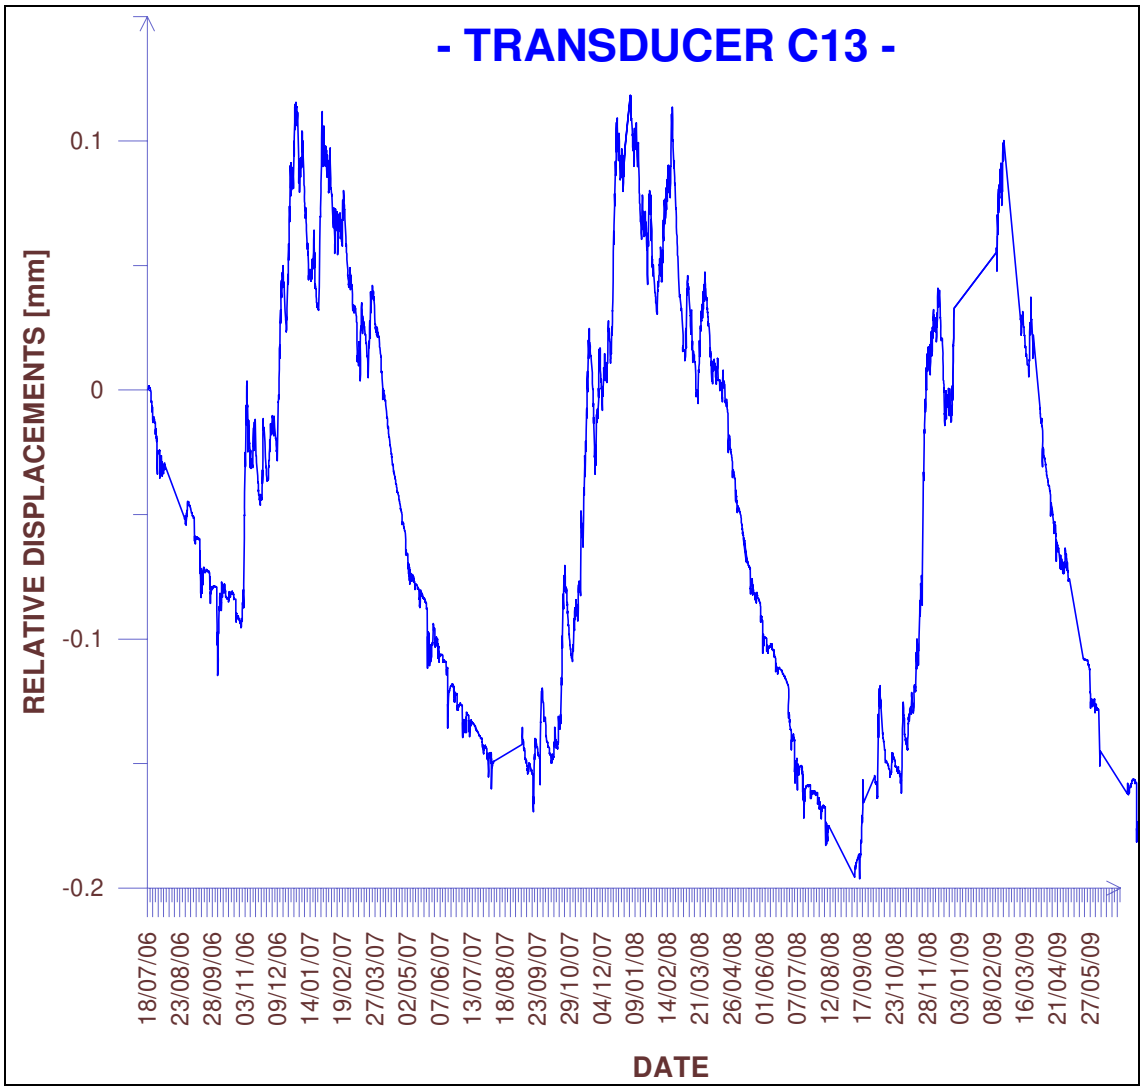
The design of the automatic monitoring system is based on the main observed discontinuity features, the installation of the monitoring devices and the initial data verification. The control system is still being refined. Throughout the entire observation period recorded displacements remained within a limit of 0.35 mm when closing and 0.40 mm when opening. During the closing period the average velocity of displacement was about 0.1 mm/month; immediately thereafter a period of opening occurred, displacing 0.75 mm with an average speed of 0.125 mm/month. After this, the displacement tendency switched back to closure, almost completely recovering the registered displacement. Such contractions could probably be explained by the increase in external temperature and the consequent thermal dilation of the rock mass. An example of the trend in the recorded data is reported in Figure 8. Based on the results obtained during the monitoring, the discontinuities appeared to be stable without any increase in aperture or shear displacement.

Figure 8.Readings from C13 transducer in period July 2006–May 2009.

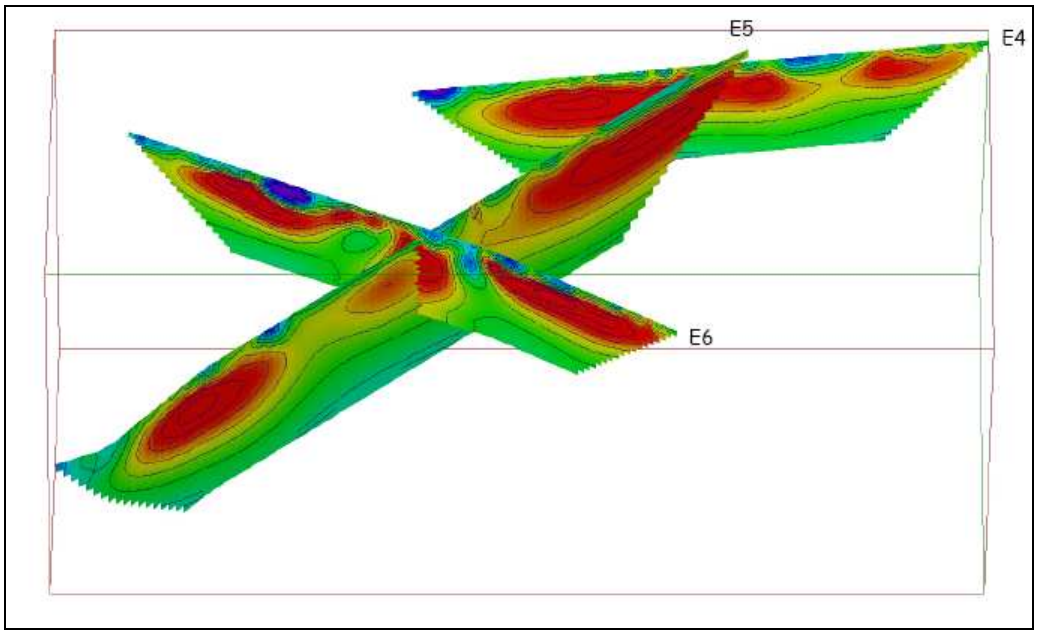
Figure 9. 3D tomographic section of quarry floor. See Figure 6 for positions of tomography lines.

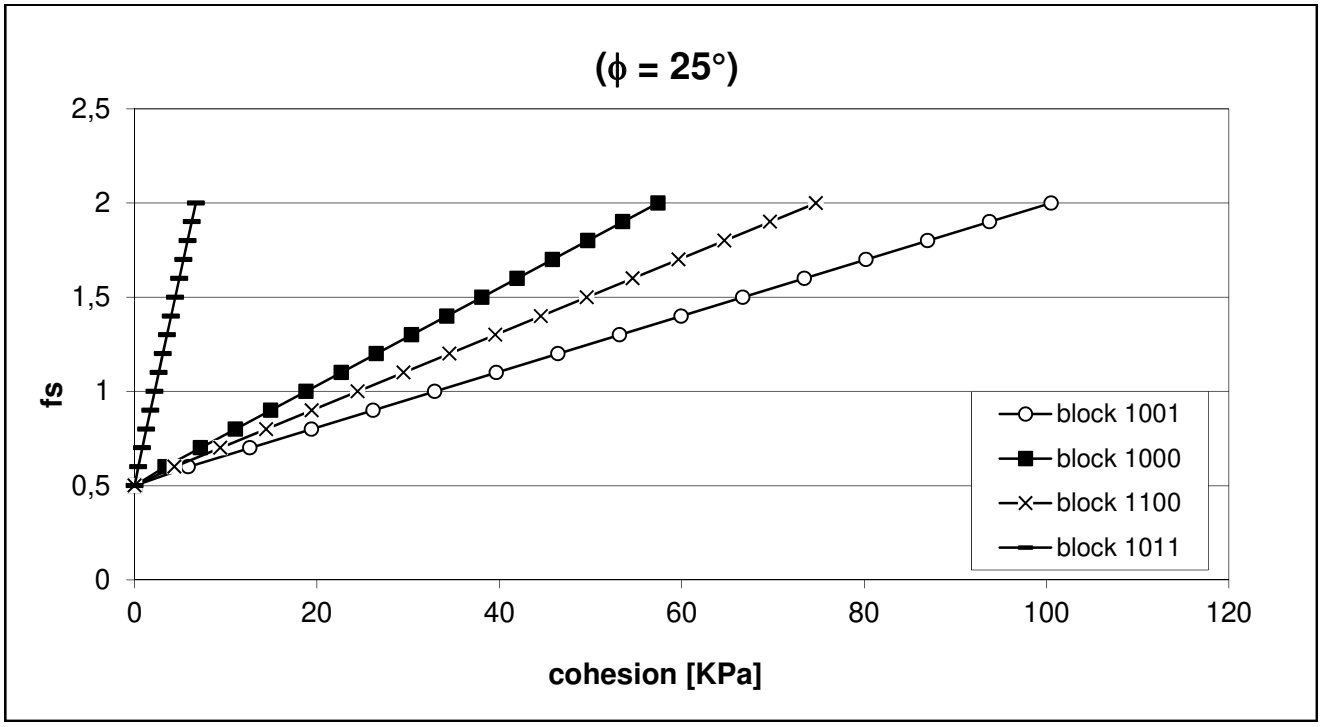
The parametric analysis of the discontinuity shear strength has also been considered. Laboratory tests on discontinuities have shown shear friction angles of 51° and 41°, respectively, for peak and residual condition. However, in situ observations have outlined the presence of non-fully persistent discontinuity and weathering due to karst actions. These two effects caused the authors to take the cohesion value (due to rock bridges) and the low friction angles (due to karstic action) into account. The results obtained on the central entrance indicated that for friction angles below 44.5°, instability occurs for all finite and removable blocks. For friction in the range of 30.3°–32.9°, the safety factor (SF) varies from 1–1.3 (see Figure 10).

Figure 10a. Variation of SF with cohesion (friction angle = 25°).

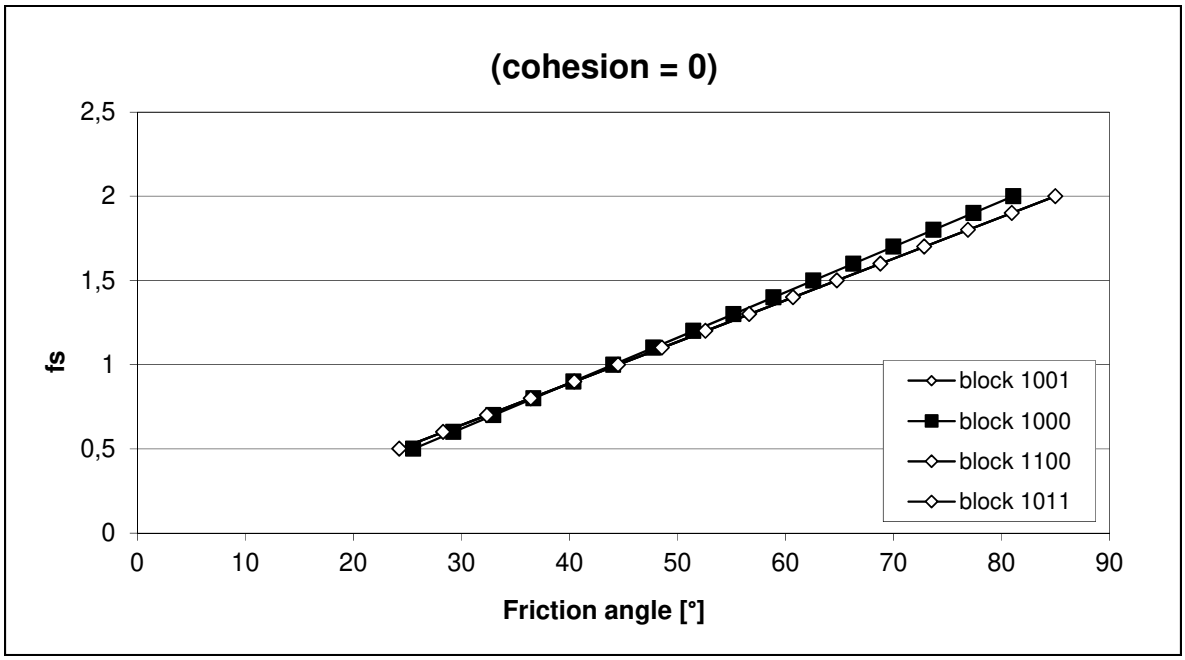
Figure 10b. Variation of safety factor (SF) with friction angle (cohesion = 0).

For friction angles above 56.6°, SF > 1.3. For the lower entrance, similar results have been obtained where instabilities occur at friction angles below 53.7°.All of the finite blocks are unstable at the upper entrance of the Danzi quarry. On the other hand, cohesion in the range of 20–30 kPa can guarantee stability for most blocks. Table 7 reports the results subdivided for each examined entrance area.

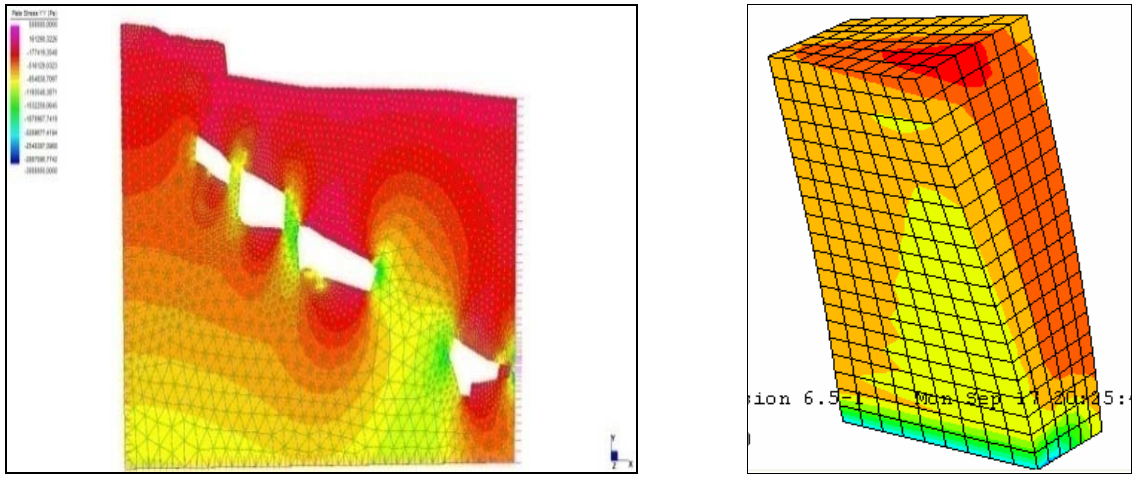
Figure 12. Vertical stresses: (a) 2D model of vertical section on pillar No. 23 (in center in (a)) modeled with Straus/ (G+D Computing, 1999) (see Figure 7 for pillar location on a map); (b) 3D model of pillar using ABAQUS code.

The FEM analysis on pillar 23 (see Figure 7) returned a value of approximately 2.22 MPa for vertical stress in the area where the flat jack test was performed, which fits well with the experimental results that indicate a vertical stress of 2.14 MPa. The same conceptual procedure has been used for all of the pillars and walls that were tested with the flat jack. The mechanical features of the rock mass after the calibration procedure are reported in Table 9.

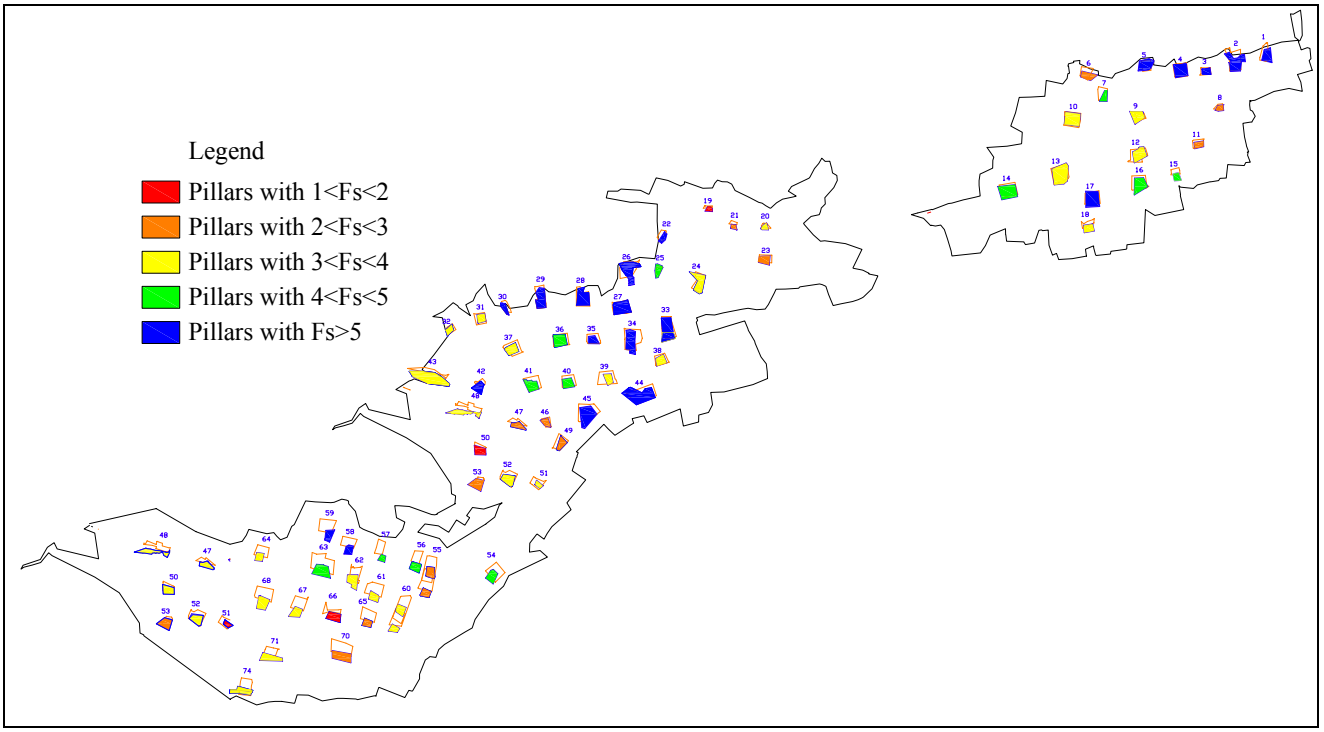
Figure 13. Quarry map reporting SF range for each pillar.

Table 11 reports a few values of the SF that were computed in pillars where flat jack measurements were performed. The comparison between the measured vertical stresses (from the flat jack tests) and the averaged computed vertical stresses (from the numerical model) indicates how the flat jack measurement are not reliable when, such in this case, the single pillar is subjected to flexural compression.

Figure 13 shows the SF computation for each pillar in the entire quarry. This graphical representation has been used to identify an optimal route for visitors in light of the stability of the various pillars.

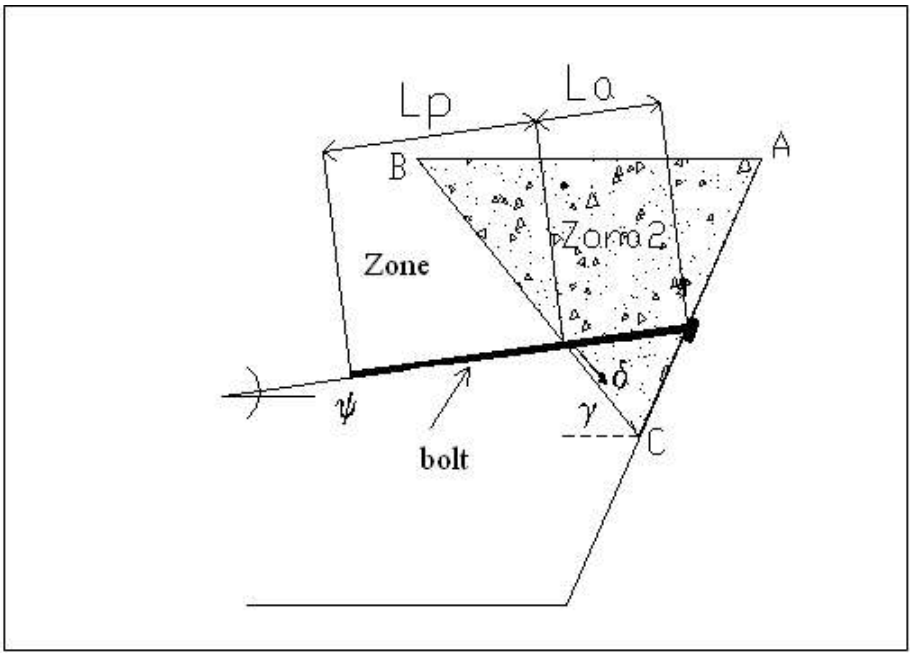
Figure 14. Scheme of interaction between rock mass and bolt; La: length of bolt in unstable zone (zone 1); Lp: length of bolt in stable zone (zone 2); δ: block displacement along sliding; ψ: dip of bolt from horizontal plane; γ: angle between sliding direction and horizontal plane.

Reinforcement design was carried out according to the block reinforcement procedure (BRP) (Oreste and Cravero, 2008). This method was developed for passive bolting dimensioning for rock block reinforcement. The method can be applied to blocks of small to medium dimensions that are possibly detaching from vertical walls or from roofs. The computation method considers the response of the bolt through the unstable block. The unknowns of the method are: axial forces and shear and flexural forces along the bolt caused by small displacements due to the unstable block. According to this procedure, the correct bolt can be obtained after a series of tests using a trial and error method which compares different bolting schemes. The factors of safety obtained in the different scenarios are compared until the required safety conditions are reached. Finally, the required stabilization force is determined.

The bolt chosen for this application is 3 m in length and the maximum bolt length inside the rock block computed by Rock3D is 1 m. The number of bolts changes for each block as a consequence of the dimensions of the block. The hole diameters are a consequence of the bolt type that is chosen. The properties of the bolt steel and of the cement mortar utilized for bolt installation are obtained from the commercial data.

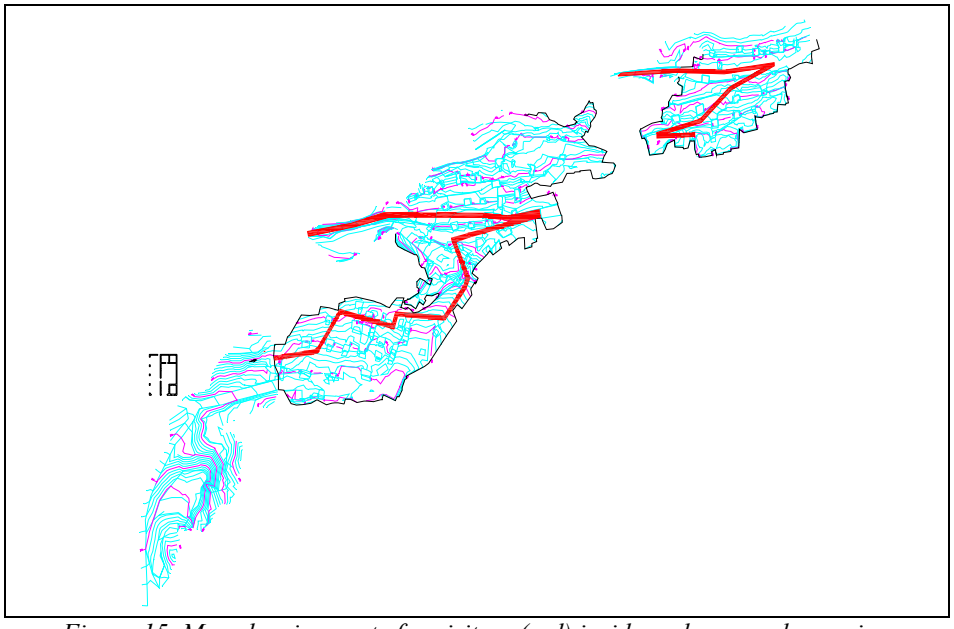
Figure 15. Map showing route for visitors (red) inside underground quarries.

The proposed route has been determined on the basis of historical and environmental interests. The hazard map, determined on the basis of results from the stability analysis, was superimposed over the proposed path to determine the reinforcement works needed in the different areas of the quarries.

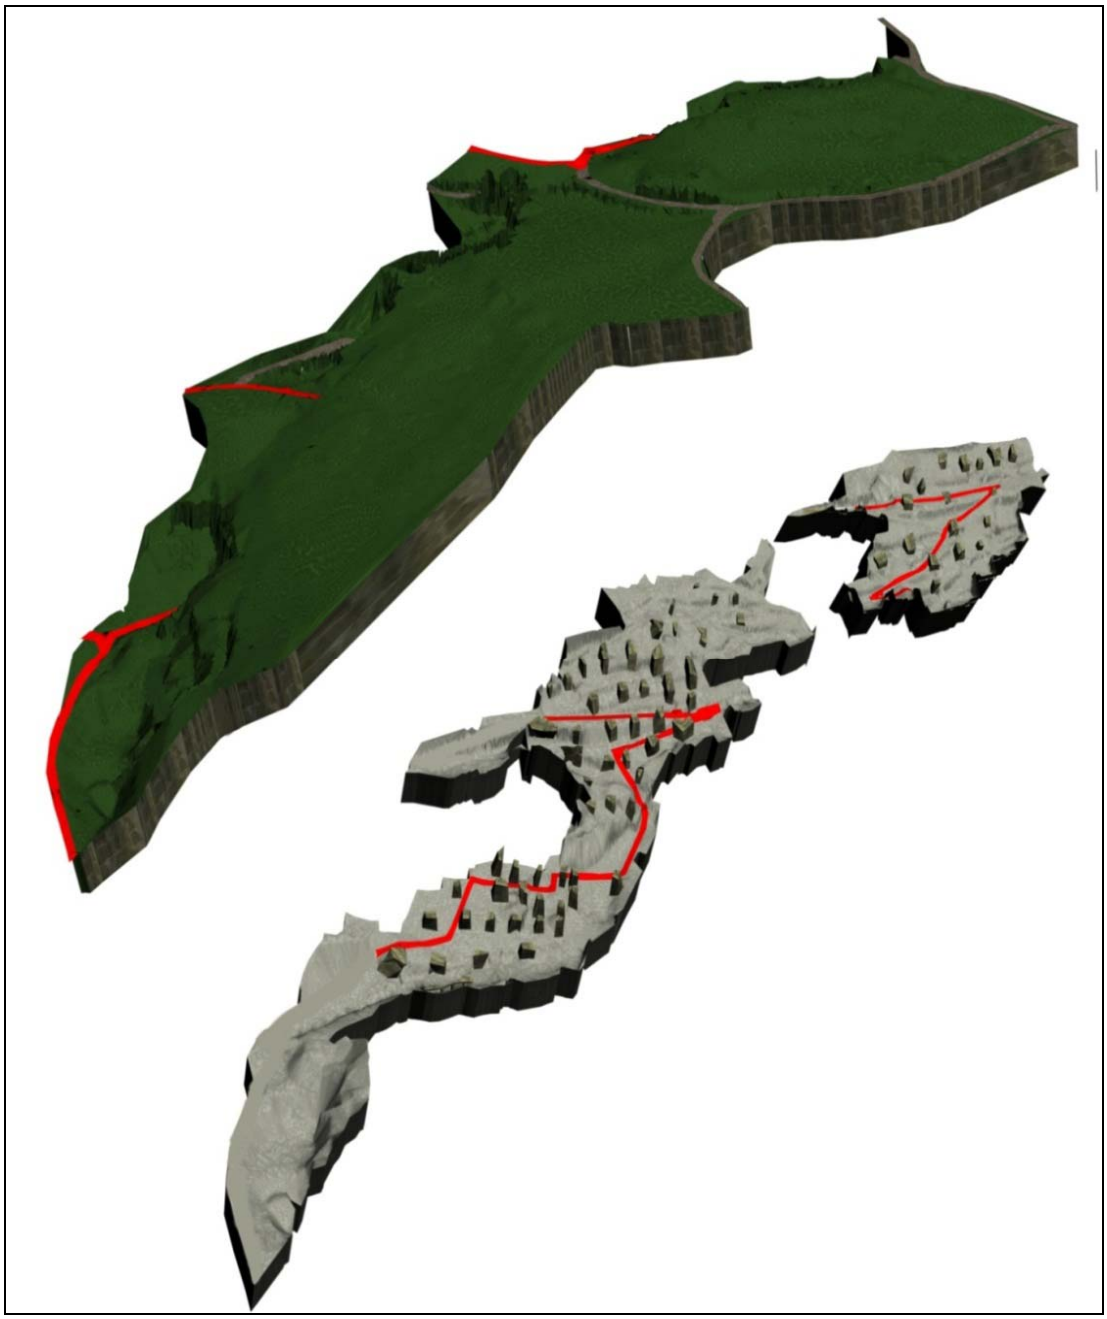
Figure 16. 3D rendering of route for visitors. External area (above) and underground path (below).
