Rockfall and Subsidence on Mumbai-Pune Expressway

Submitted: 14 October 2009; Published: 29 October 2010
Reference: Kumar, K., Prasad, P.S., Mathur, S., Kimothi, S., (2010). Rockfall and Subsidence on Mumbai -Pune Expressway. *International Journal of Geoengineering Case Histories*, http://casehistories.geoengineer.org, Vol. 2, Issue 1, p.24-39. doi: 10.4417/IJGCH-02-01-02.

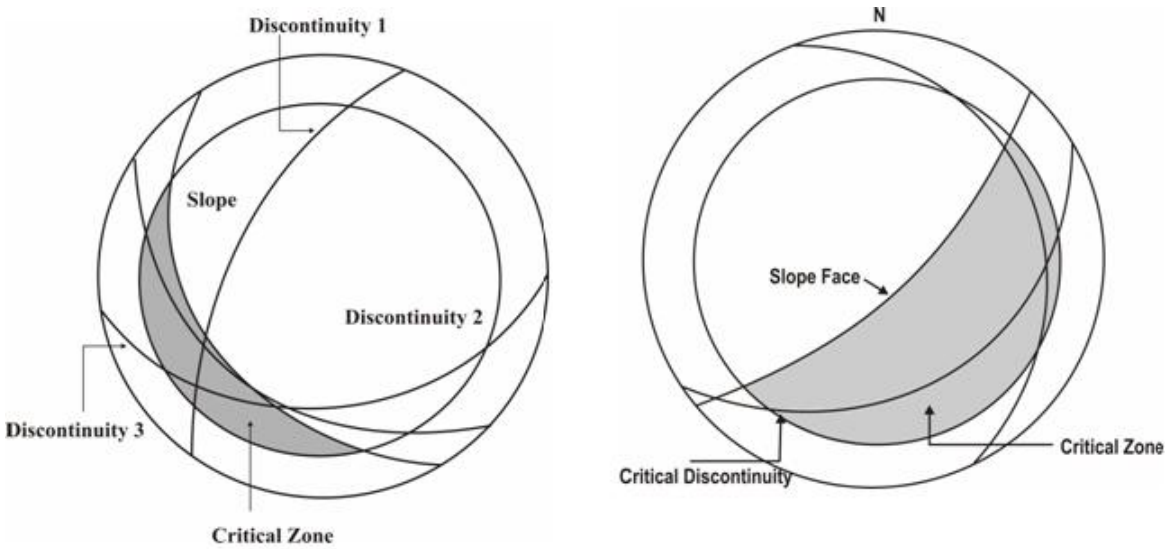
Figure 4. Markland test for planar failure on two sites showing critical zone for potential failure.

planes. The fractures on the rocks, which are normally confused with joints, have prominent attitudes. There are mainly three major joints, but one of the most prominent planes of weakness is the vertical joint (typical of basaltic layer, i.e. columnar joint). This prominent joint is repeated at regular intervals. The stereographic projection diagram, using the field data of joints, revealed the formation of a prominent wedge at the slope face. The vertical joints intersect to form wedges on the slope independently as well as when they intersect other steeply dipping fractures and other horizontal and subhorizontal fractures, as shown in Figure 4. In most cases, the plunge of the intersection of these two joint sets lies toward NNW in the direction of the slope. Additionally, the plunge of the intersection of the joints is more than the angle of the slope most of the time. The Markland Test was used to define the critical zone of planar and wedge failure in the stereographic projection. In the case of planar failure, the dip of the discontinuity exceeds the angle of friction of the rock; the discontinuity daylights in the slope face and dips less than the slope. In the case of wedge failure, the plunge of the line of intersection of two joints is considered (Figure 4) (Markland, 1972).

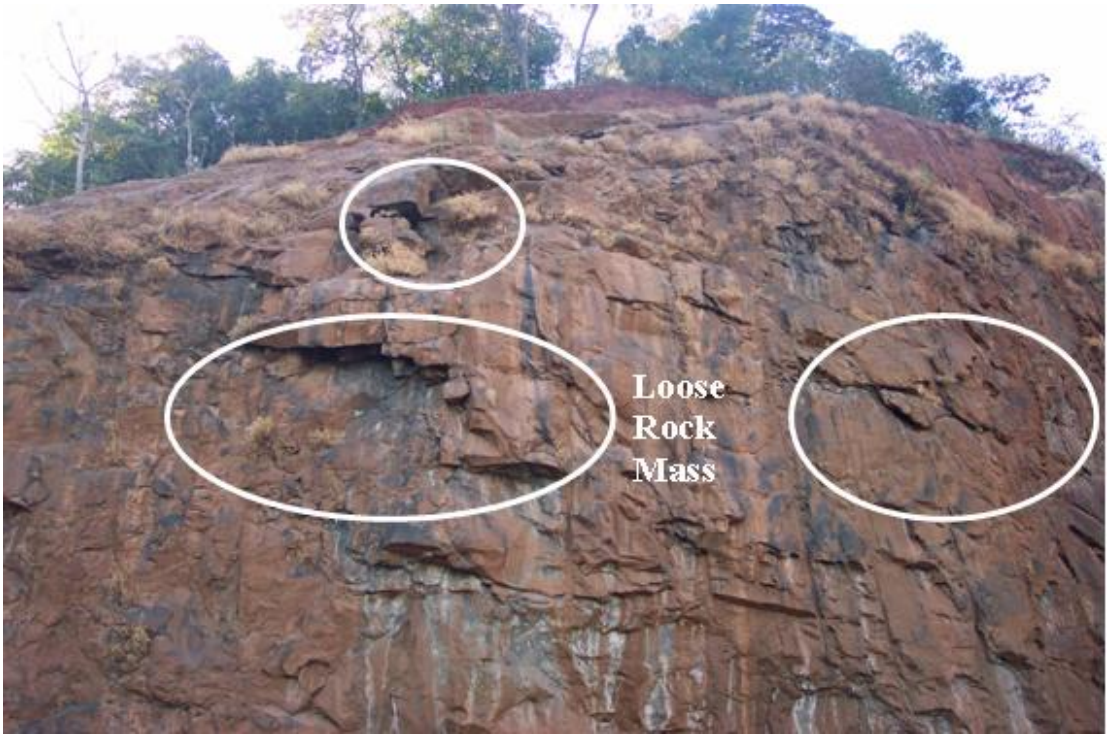
Figure 5. Vertical joints and formation of wedge along slope face.

Figure 6. Intersection of oblique and sub-horizontal fractures.

Figure 7. Significant water drainage during a monsoon.

Based on the investigations carried out, the primary causes of rockfall include vertical rock cutting and blasting, inadequate dressing of rock face after blasting, the intersection of the joints exposed on the face of the slope forming wedges, the presence of a prominent oblique joint/fracture between the two separate layers of basalt, a weak subhorizontal layer dividing two basaltic layers, showing on the face of the slope, a smooth joint surface or sheet joint of the top of the slope acting as a sliding surface through which most of the material slides down, a large amount of precipitation with high intensity, seepage of water into the weathered and weak layers that are exposed on the surface after the construction of the expressway, a high gradient of slope and a steep vertical cut.

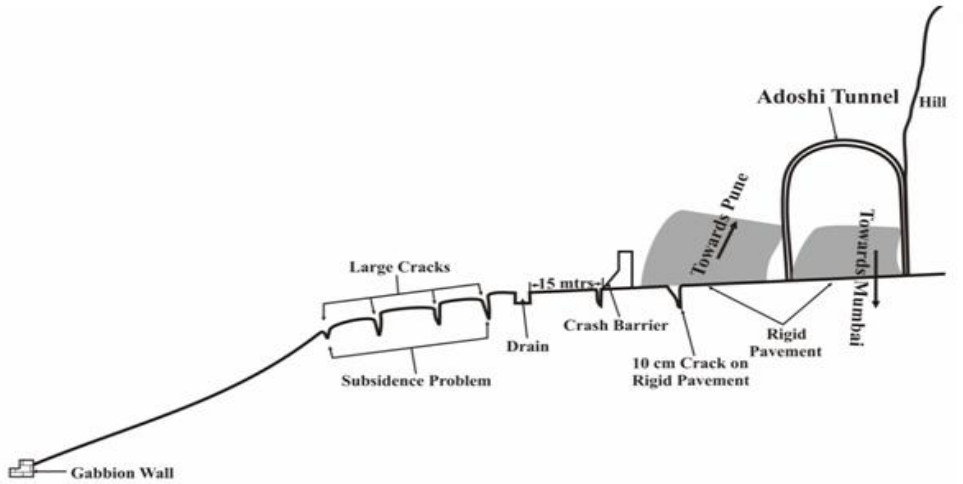
The subsidence portion (Figure 1) is located at km 41 on the downhill side of the expressway, adjacent to Adoshi tunnel (which extends for 500 m along the expressway). Figure 10 shows the schematic diagram of the subsidence problem on the expressway. The annual rainfall in this area is 200–300 cm, and the present drainage measures are not sufficient to drain this amount of water effectively. During the rainy season, water causes significant damage to this road at four locations in the form of a waterfall. One is in the curved portion, the second one is in between the curve and entrance of the tunnel, the third one is above the tunnel and the fourth one is after the tunnel exit. Pipe culverts were provided to help drain out the water on this stretch of the road, but the gradient of these culverts is not proper. However, it was observed that the internal diameter of the pipes varies from 1 to 1.2 m. In the pipe culvert, two pipe sections 1.0 m in internal diameter are provided, and the remaining pipes are 1.20 m in internal diameter. Two 1.0 m diameter pipe sections are installed in between the 1.20 m pipe sections. The joint between the 1.0 m diameter pipe and the 1.2 m diameter pipe is not proper, and the gap between the two pipes is 30 cm (Figure 11). Remaining pipes are also not joined properly. During periods of heavy rain, water seeps through the joints and saturates the surrounding soil mass, thereby causing cracking between lanes (i.e., flexible and rigid pavement). The runoff from the pipe culvert and cross drains is draining directly onto the embankment surface (Figure 12). The rainwater scours the embankment soil, thereby causing the instability of the embankment. After the exit of the Adoshi tunnel, the gradient of the drain is not proper. As a result, water may stagnate and seep into the pavement through the existing weep holes. The rigid pavement (on the outermost side lane) subsided by 5 to 6 cm, and subsidence also has occurred in between the joint of fast track lane (middle lane) and the truck lane. The average width of a crack is 5 cm and the average length of a crack is 85 m (Figure 13). The surface between the crash barrier and the rigid portion has been paved with bitumen. The flexible portion or shoulder (bituminous surface) has separated from the rigid pavement; the depth of the crack is 50 cm (Figure 14).

A crash barrier has been provided along the slope. Beyond the crash barrier, the average width of the embankment on the downhill extends downhill another 12 m. Drainage holes (Figure 15) are provided in the crash barrier at frequent intervals, but the holes are left open directly on the embankment surface. The considerable quantity of water passing through these drainage holes is causing saturation of the embankment fill beyond the parapet and is weakening the foundation of the crash barrier as well as the scouring below the crash barrier and pavement (Figure 16). A longitudinal drain is provided after a certain distance from the crash barrier on the embankment. From the crash barrier to the longitudinal drain, the surface is not lined and scouring was observed below the crash barrier. The crash barrier is also tilted, and below the crash barrier, the embankment slope has experienced scouring up to a depth of 1 m. The embankment has subsided by 2 to 3 m in steps, and each step has an average height of 1 m (Figure 17).

The height of the embankment ranges from 15 m to 35 m, and the embankment slope varies from 35^0 to 45^0. At the toe of the embankment, a 2-meter high gabion wall was constructed to support the slope. The gabion wall is bulging at some places, which indicates movement of the embankment slope. The gabion wall is also obstructing the flow of water coming from pipe culverts.

Figure 10. Schematic diagram showing subsidence problem on the Mumbai-Pune expressway.

- The broken culvert was repaired by providing uniform-sized pipe sections, and the joints were properly sealed.
- On the shoulder portion and below the crash barrier, the cracks were sealed with cement grouting and monitored for three years. The portion stabilized and no further cracks were observed in this area.
- After the crash barrier, the embankment was excavated up to 3 m and recompacted to 95% of maximum dry density and moisture content.
- Longitudinal and transverse drains were provided at frequent intervals.
- To prevent erosion and to stabilize the embankment, the slope has been protected with stone pitching/turffing.

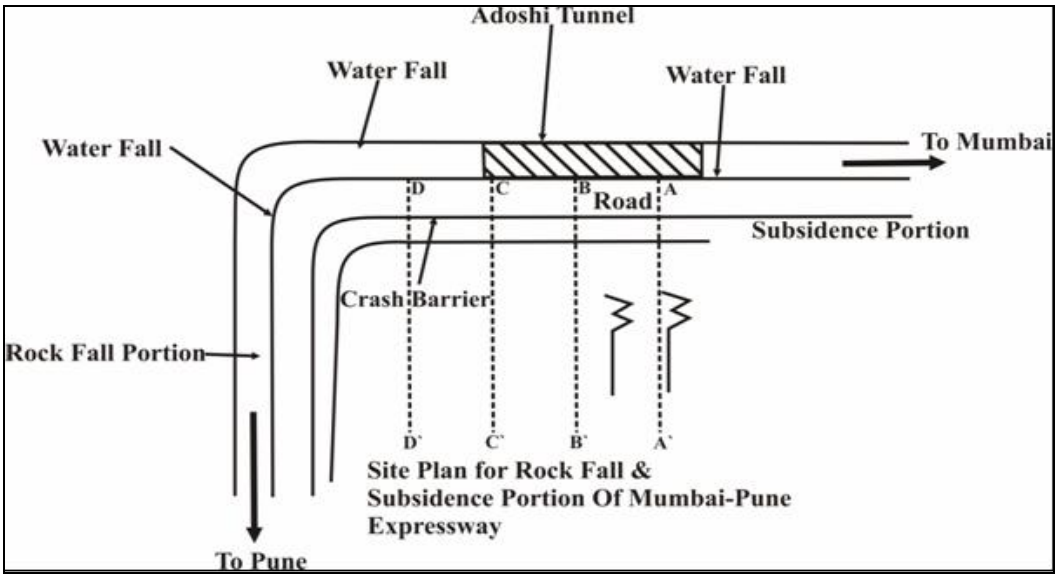
Figure 18. Location of crosss sections for stability analysis.

Soil samples were collected from the field. In-situ density of the embankment was measured using the core cutter method. The bulk density of the embankment is 17 kN/m^3. The shear strength parameters of the embankment soil are c'=3 kPa and φ'=30^0. The subsidence portion is around 500 m in length. The cross sections A – A, B – B, C – C and D – D were chosen for every 125 m as shown in Figure 18. Stability analysis of the embankment slope was analyzed by using GEO 4 software (Figure 19). The factor of safety of the embankment was analyzed using Bishop's and Peterson's methods. These results are presented in Table 1. The factor of safety at cross sections A – A and B – B is less than 1.25, which is considered critical by both the code of Indian standards and the US Army Corps of Engineers (IRC: 75, 1979 and EM 1110- 2-1902, 2003).

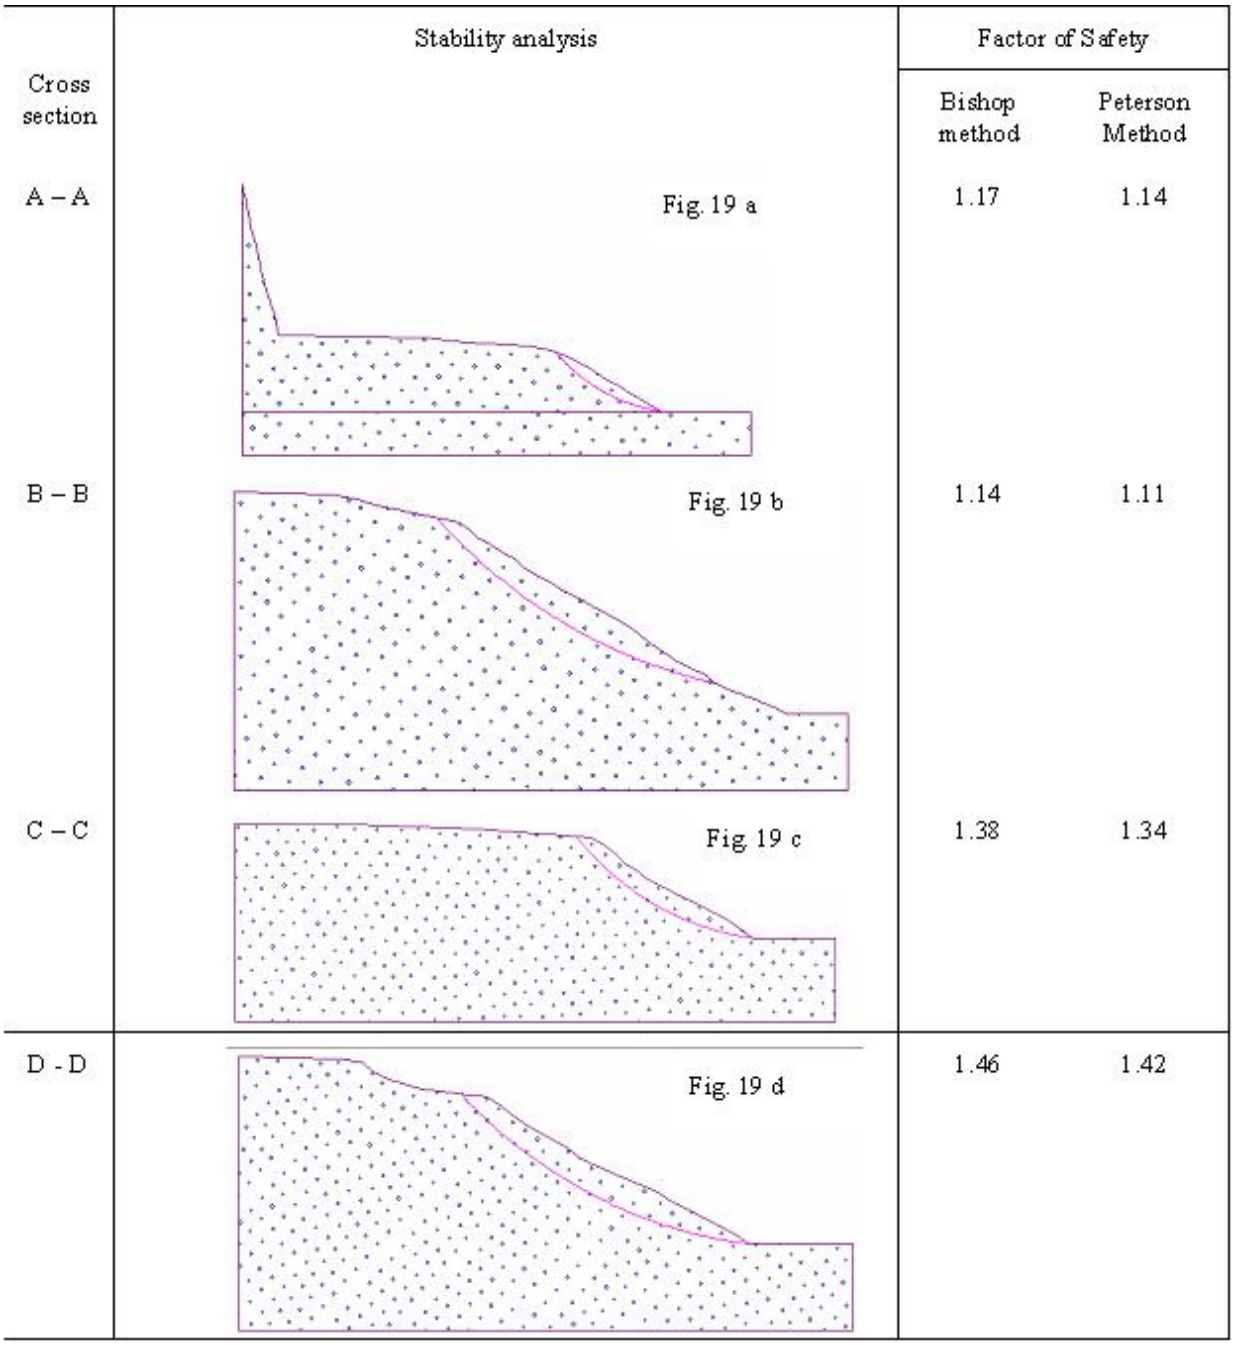
Figure19. Slope stability of subsidence portion.

S.No	Cross Section	Factor of Safety	
		Bishop Method	Peterson Method
1	A – A	1.17	1.14
2	B – B	1.14	1.11
3	C – C	1.38	1.34
4	D – D	1.46	1.42
