Mississippi River Levee Failures: June 2008 Flood

ABSTRACT: *During the spring and summer of 2008, record rainfall in the Midwest United States led to severe flooding as water overtopped the levees bordering the Mississippi River and its tributaries. The erosion associated with the overtopping resulted in levee breaches in many places. After the flooding, a field reconnaissance team was sent to collect time-sensitive data and provide a comprehensive overview of the performance of the levees during the flooding.*
Two locations where levee overtopping occurred are particularly interesting because of their differing site conditions and performance. This paper presents the levee overtopping case histories of the Winfield-Pin Oak site which was overtopped and severe erosion led to failure, and the Brevator site which was also overtopped but did not fail. Included are a hydrological investigation, documented site conditions, geotechnical soil properties, a soil erodibility analysis, and the documented levee vegetative cover. Levee performance is influenced by the flood conditions, the site conditions, and the soil properties. Both sites in this study experienced large levels and duratio

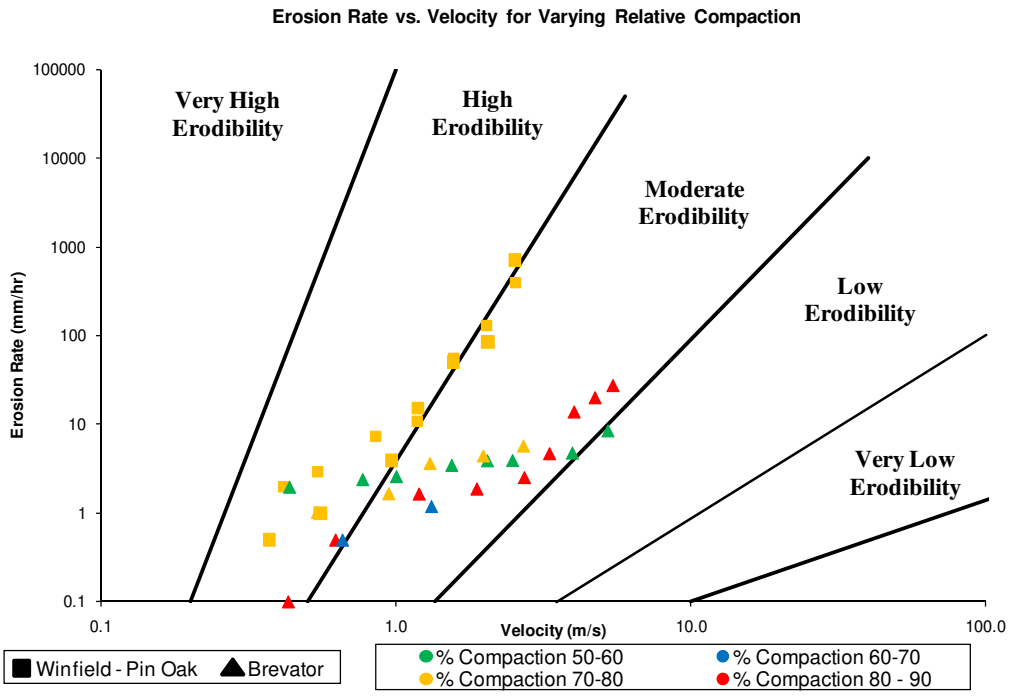
Figure 30. EFA comparison of % RC for the Winfield-Pin Oak and Brevator Sites.

According to USACE design manual EM 1110-2-1911, the minimum acceptable field density for levee design is usually established as 95 percent of the maximum dry density of the soil found using a test procedure utilizing the amount of energy set by the Standard Proctor Test. The values shown in Figure 31 are for Modified Proctor energy. Note that the ratio of compaction energy between the Modified Proctor and Standard Proctor is 4.5 causing the values shown to be lower than they would be if conducted using the Standard amount of energy. Several of the samples were taken at the surface and are expected to be at a lower compaction level so that grasses will root and spread.
