Quarry-Induced Slope Instability at a Broadcasting Transmission Plant near Valcava, Lombardia, Italy

***Monica Barbero**, Assistant professor, Politecnico di Torino (Torino, Italy); email: monica.barbero@polito.it*
***Fabrizio Barpi**, Assistant professor, Politecnico di Torino (Torino, Italy); email: fabrizio.barpi@polito.it*

Submitted: 21 April 2011; Published: 16 November 2011
Reference: Barbero, M., Barpi, F. (2011). *Quarry-Induced Slope Instability at a Broadcasting Transmission Plant Near Valcava, Lombardia, Italy.* International Journal of Geoengineering Case histories, http://casehistories.geoengineer.org, Vol.2, Issue 2, p.163-181. doi: 10.4417/IJGCH-02-02-04

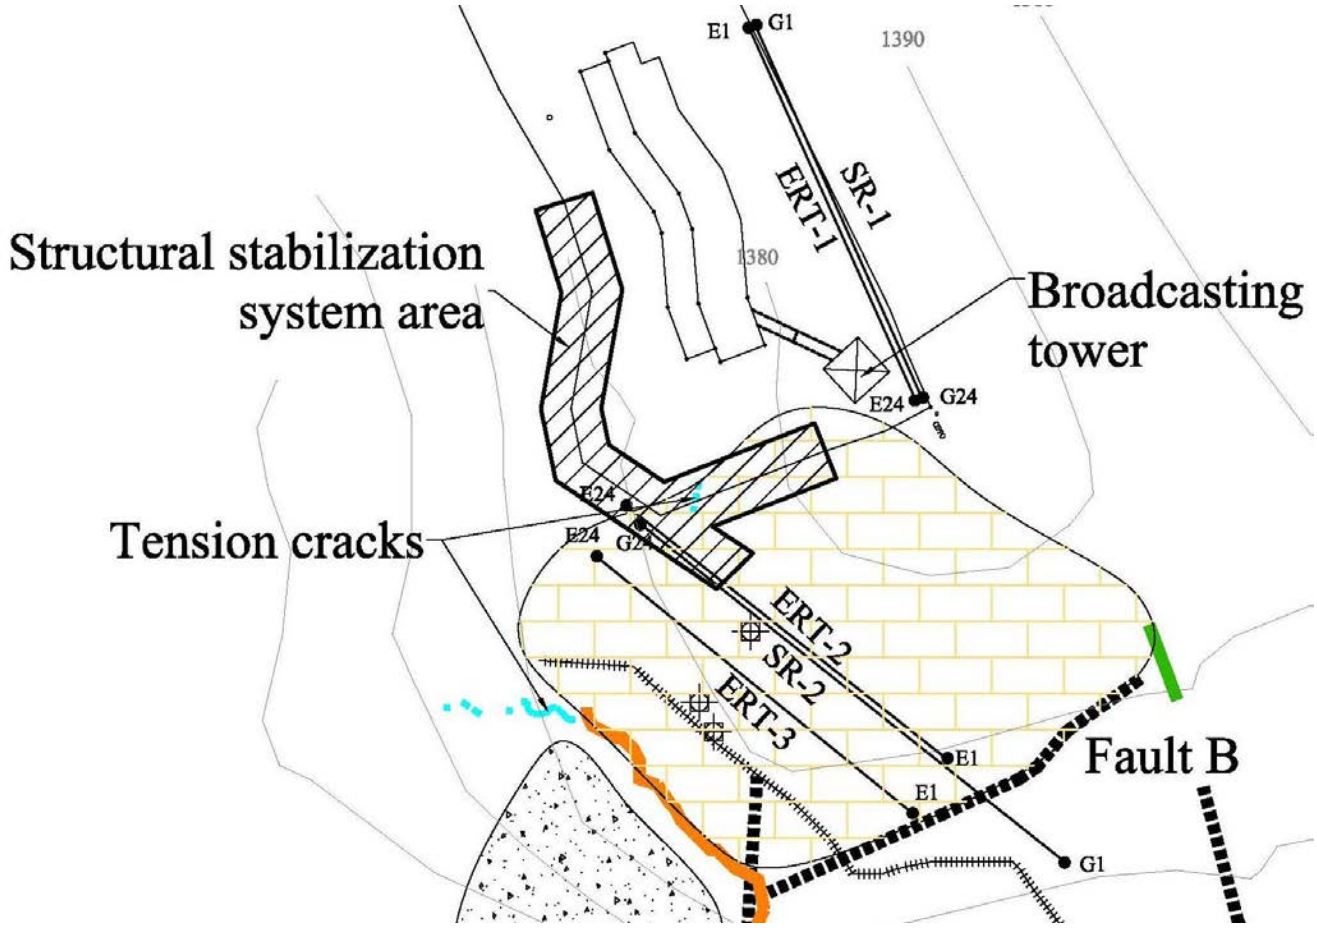
Figure 15. Map of the site with the location of the stabilization system.

In order to confine the strain effects of the stress release induced by the landslide, the broadcasting site has to be isolated from the unstable slope. For this purpose, a structural stabilization system in the warehouse square was suggested (Figure

15 and 17). It was conceived to be a bulkhead consisting of 27 m long micropiles reinforced with steel pipes, 139.7 mm of diameter and 10 mm thick. The micropiles are connected at their head level by a reinforced concrete beam. The bulkhead extends as shown in Figure 15 and is anchored in the head to the undamaged rock mass by means of 28 m long four strands steel anchors, at center distance of 3 m and with a down dipping of 25°. During the construction of the bulkhead, any karst cavities will be filled.
