Embankment Failure in Residual Soils at Nivsar, Ratnagiri

ABSTRACT: *The Nivsar Yard embankment was constructed by the Konkan Railways in 1994. Near the station building, the 22m high embankment runs parallel to the Kajali River for a stretch of about 100m. This stretch has experienced failure and settlement related problems since the record-breaking July 2005 rainfall. Corrective ground improvement measures were implemented immediately after the monsoon. However, these measures were inadequate because the failure surface reappeared during the following monsoon. The failure surface mirrored the shape and size of the failure observed in 2005. Since then after nearly every monsoon, the embankment has moved despite precautionary measures taken by the railway to arrest the movement. The hydrogeological and geotechnical properties which affect slope stability are first discussed. The stability of the embankment is then evaluated at 5 sections drawn along the slope. Two cases are considered. In the first case, the stability of the unreinforced slope is calculated. In the second case, calculations are done using the slope reinforced with soil nails and micropiles installed in 2005 and 20

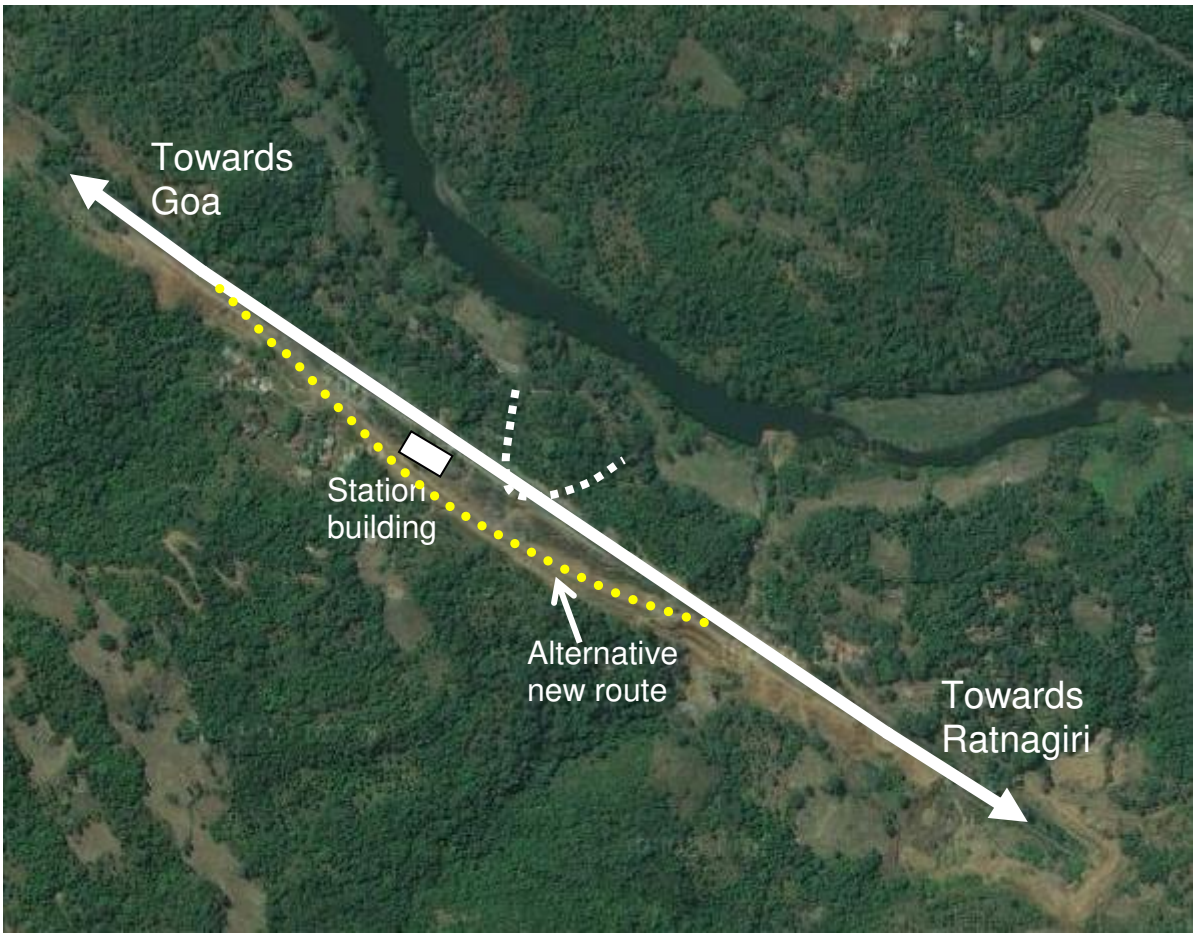
Figure 1. Nivsar Station in Ratnagiri District of Maharashtra (Source: Google earth). Note: The dashed line shows the approximate location of the embankment failure .

In 2010, the rail track was realigned to bypass the failure surface. This arrangement provided immediate relief to the rail-traffic. Figure 1 also shows the new alternate route used by the Konkan Railways. Since then, three other lines have been realigned to follow this alternate route. Irrespective of the above change in the rail alignment, Figure 3 also shows that the rate of settlement of the embankment has reduced since the 2009 monsoon. It is plausible to assume that the slump accumulated at the toe has reduced the gradient and hence affected the soil movement over this period (Figure 5). The site was re-investigated in 2010. The results of the re-investigation are part of this present study. The objective of this paper is to investigate the slope failure at Nivsar as recorded since the year 2005. Stability of the embankment before and after the ground improvement works is discussed. Railway loads from the old as well as the new rail alignment were used in the analysis. The critical failure circle for each case is shown to be affected by the geometry of the slope and the hydrogeological conditions at the site.

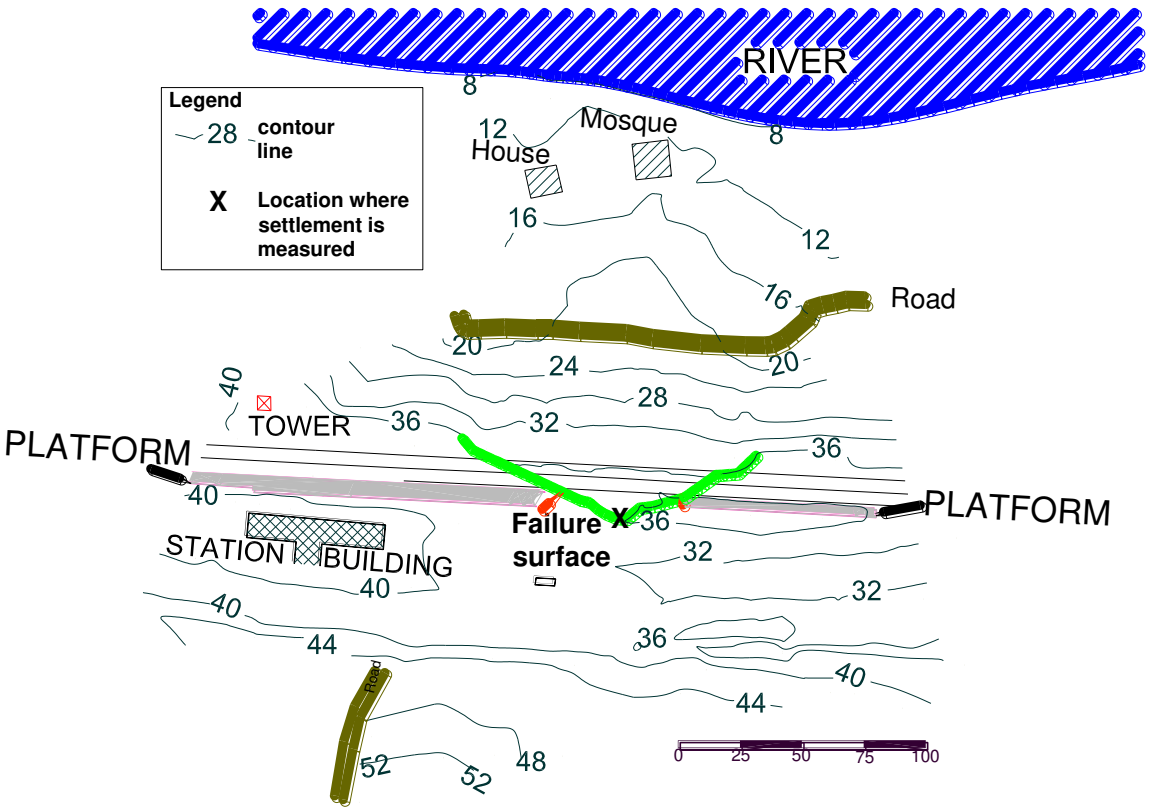
site until the year 2005. In that year, cracks in the embankment developed between chainage km 218.8 and 218.9 following record-breaking rainfall. Heavy rain occurred for 3 days between July 24th and 26th. Cracks opened up to 20mm width over a period of 15 to 20 days. During the same time, the slope settled by more than 150mm. The total settlement was about 550mm towards the end of the 2005 monsoon. At the end of this period, the cracks took shape of a parabola with its vertex close to the station platform. The parabola sloped downhill for about 100 to 120m towards the river. Figure 2 shows the extent of the slope failure observed in 2005.

Figure 2. Failure at Nivsar Yard Embankment

Soon after the observed failure, and when the 2005 monsoon was over, soil nails and micro-piles were installed to prevent further damage to the embankment. Table 1 shows details of the ground improvement works undertaken at the site in 2005. However, the 100mm wide and 130m long crack reappeared during the 2006 monsoon. As in the previous year, the crack encompassed all 3 railway lines, including the main line. The shape and size of the crack mirrored the shape and size observed following the 2005 monsoon. The embankment settled throughout the 2006 monsoon reaching a high value of 2930mm at the station platform.

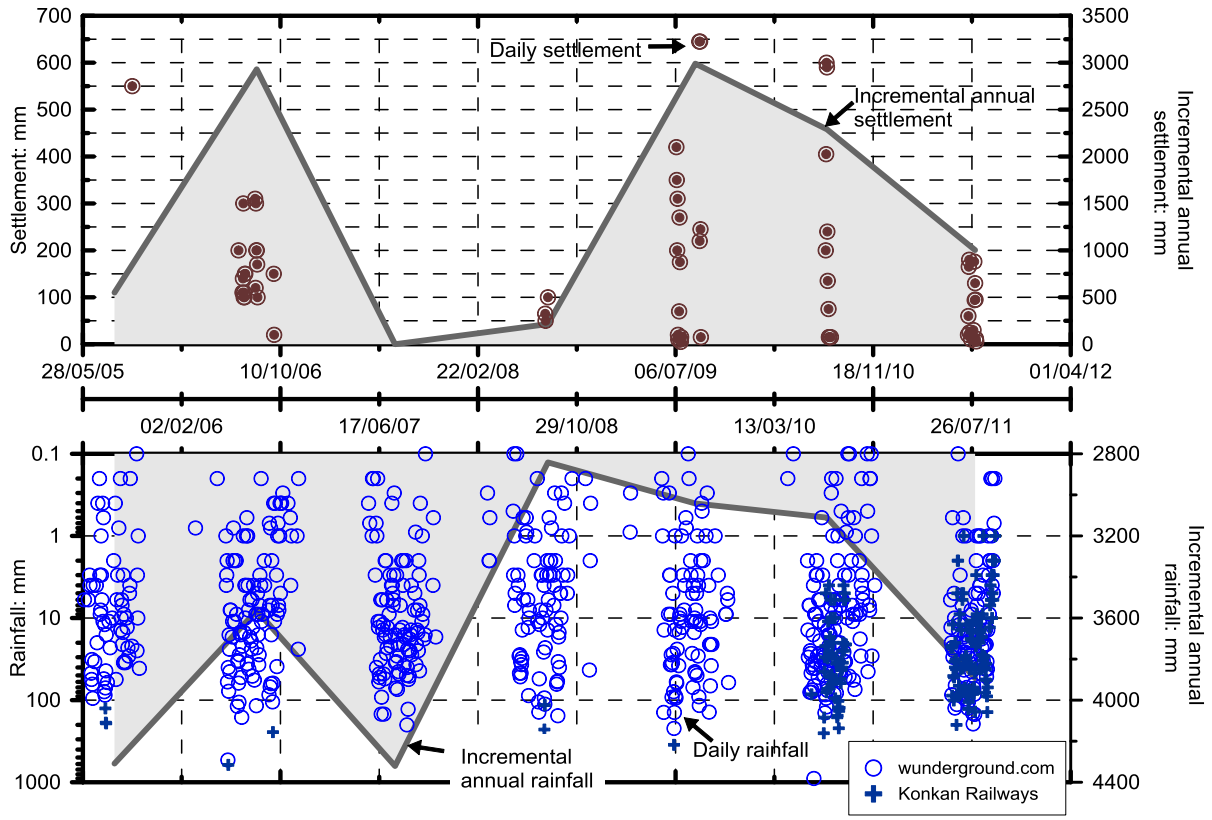
Figure 3 shows the recorded settlement of the embankment from the year 2005. The settlement was measured at top of the embankment near the station platform and its location is shown in Figure 2. Figure 3 also shows the record of rainfall in this region. The rainfall record was obtained from the web pages of http://www.wunderground.com/ and from the data maintained by Konkan Railways. A clear trend between the magnitude of rainfall and slope movement can be observed in Figure 3. For instance, rainfall of over 200mm per day was invariably followed by more than 100mm settlement every year except during the 2007 and 2008 monsoons. The embankment did not move during the 2007 monsoon. Movement occurred only after more than half of the 2008 monsoon was complete. It appears that the stabilisation work completed before the onset of the 2007 monsoon was insufficient and effective only for a year, before losing effectiveness during the 2008 monsoon. It is likely that the slip planes redeveloped along the original failure surface during the 2008 ground failure. All effects of the soil improvement vanished before the onset of the 2009 monsoon, resulting in rapid movement of the embankment towards the river. The failure cracks that developed in 2009 are shown in Figures 4a-c. Figures 4a and b show the top few meters of the micro-piles that were exposed because of the steady soil-flow down the hill, and Figure 4c shows the transverse cracks observed along the road.

Figure 3. Settlement and rainfall record at Nivsar Yard Embankment.

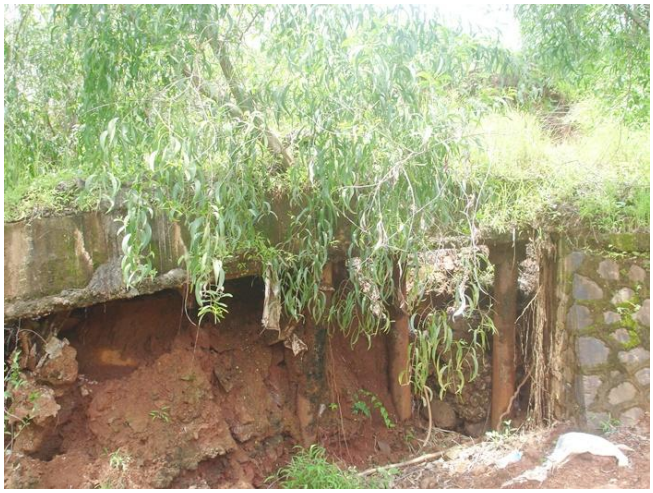
Figures 4a-c. Failure of micropiles and curtain grouting: (a) and (b) Exposed pile foundation; and (c) Location of transverse cracks along the road (curtain grouting was conducted around this location).

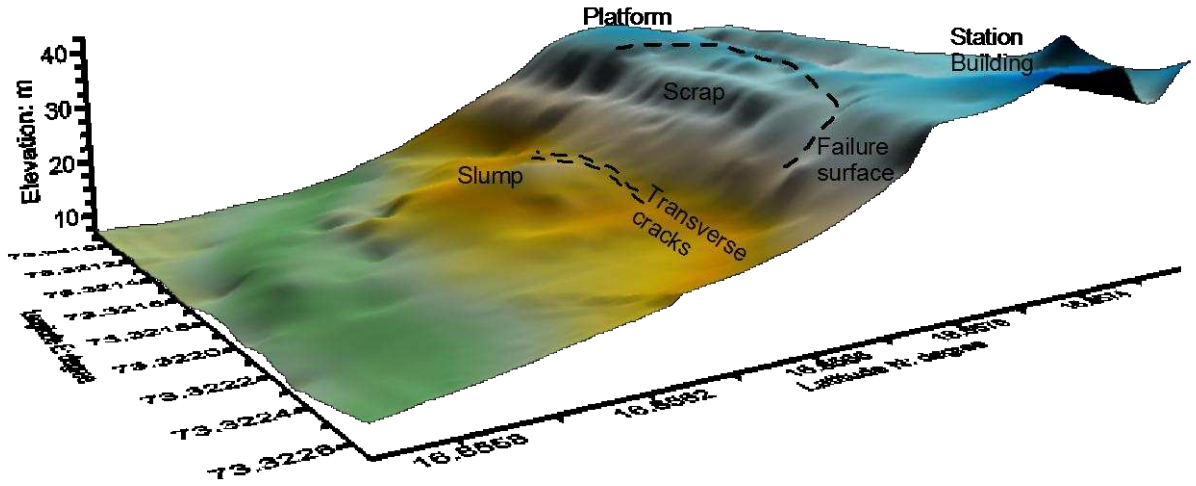
Figure 5 shows the map of the failure surface at the Nivsar Yard Station. In the figure, the latitudes and longitudes were obtained from the local coordinates using the WGS84 method (Chen and Hill 2005). The location of the slump, transverse cracks, and the failure surface are marked in the figure. The position of the transverse cracks was obtained by superimposing the observations made in Figure 4c onto Figure 5. All of the above, and the location of slope-reversal and scarp shown by the tilted trees and the cracked brick walls in Figure 6, suggest that they are parts of a landslide event.

Figure 5. Three dimensional view of the failure surface at Nivsar Yard Station.

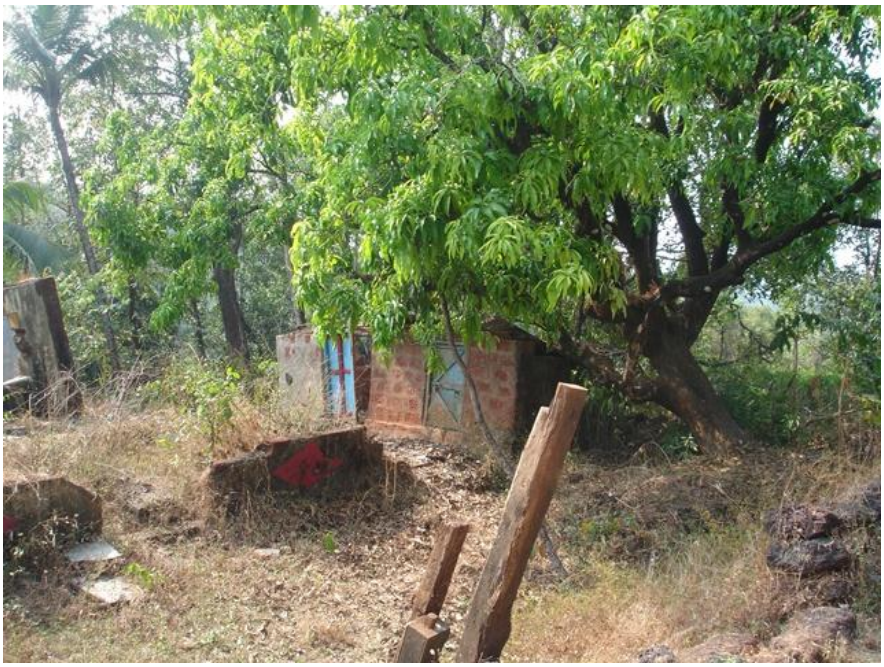
Figure 6. Tilted trees and cracked brick walls observed along the slope.

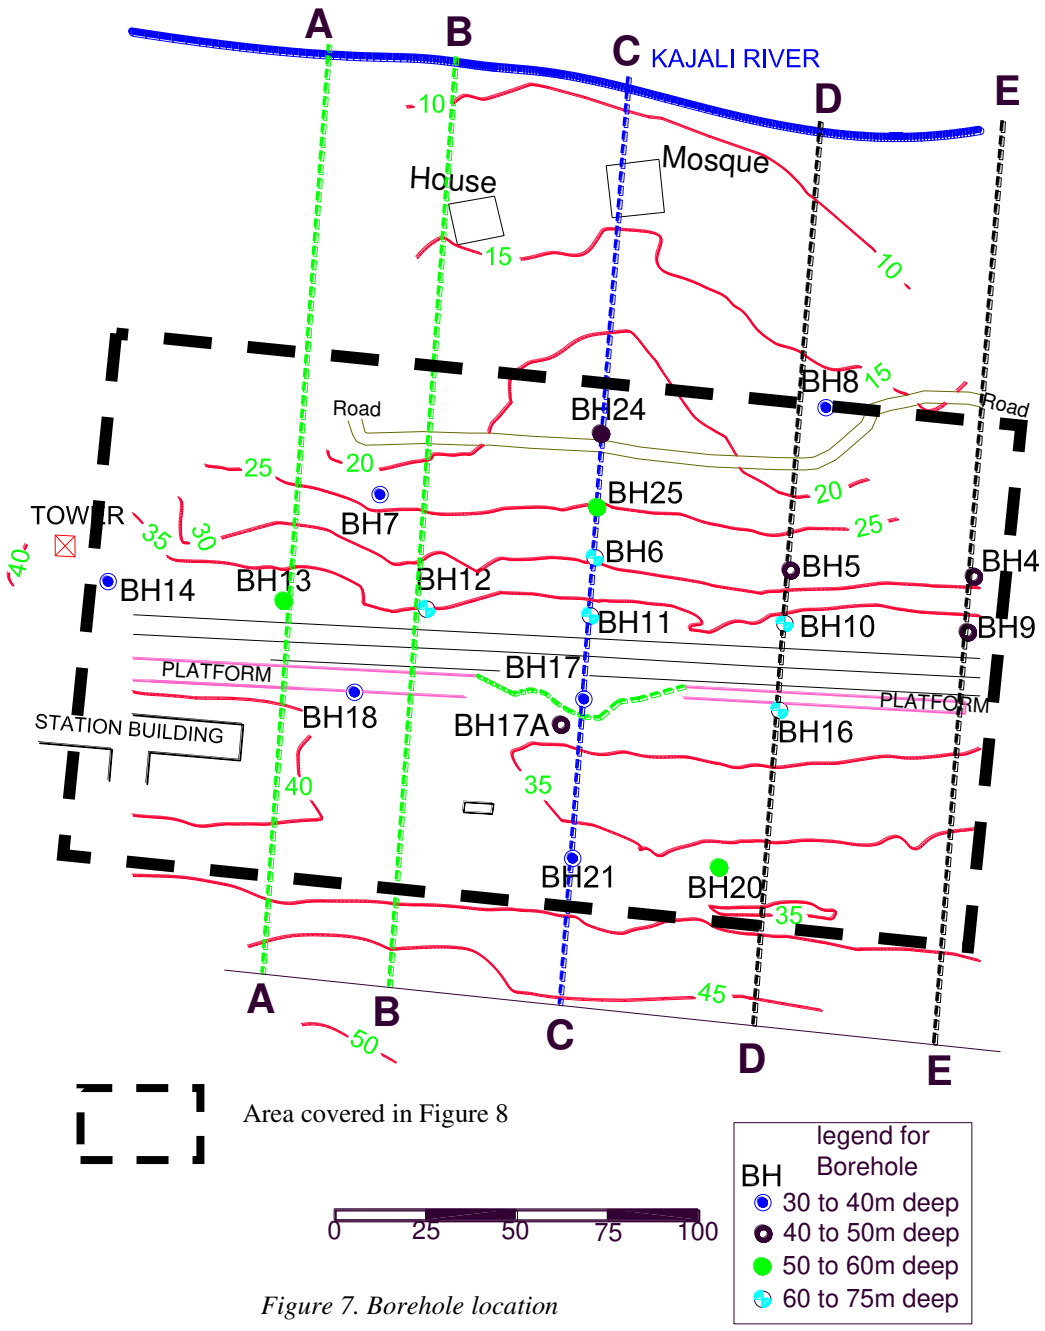
Figure 7. Borehole location

Geotechnical data was collected from 19 boreholes drilled at the top and bottom of the embankment. These boreholes were drilled in the year 2010. Figure 7 shows the location of the boreholes. All boreholes, except for BH-20 and BH-21, were

drilled at the location of the failure. These two boreholes were located near the new alignment. Boreholes BH17 and 17A were drilled adjacent to the vertex of the failure surface; while care was taken to drill all other boreholes through the undisturbed zone. Many boreholes were of 50m depth. However, some boreholes were drilled deeper to over 60m depth at locations where the rock mass was highly fractured. Table 3 summarises the thicknesses of the soil and rock layers in each borehole. Using the data presented in the table, the 3-dimensional cross-section of the subsurface profile shown in Figure 8 was developed. A brief description of the layers in this profile is presented below. This description follows the order in which the layers were encountered in the boreholes.

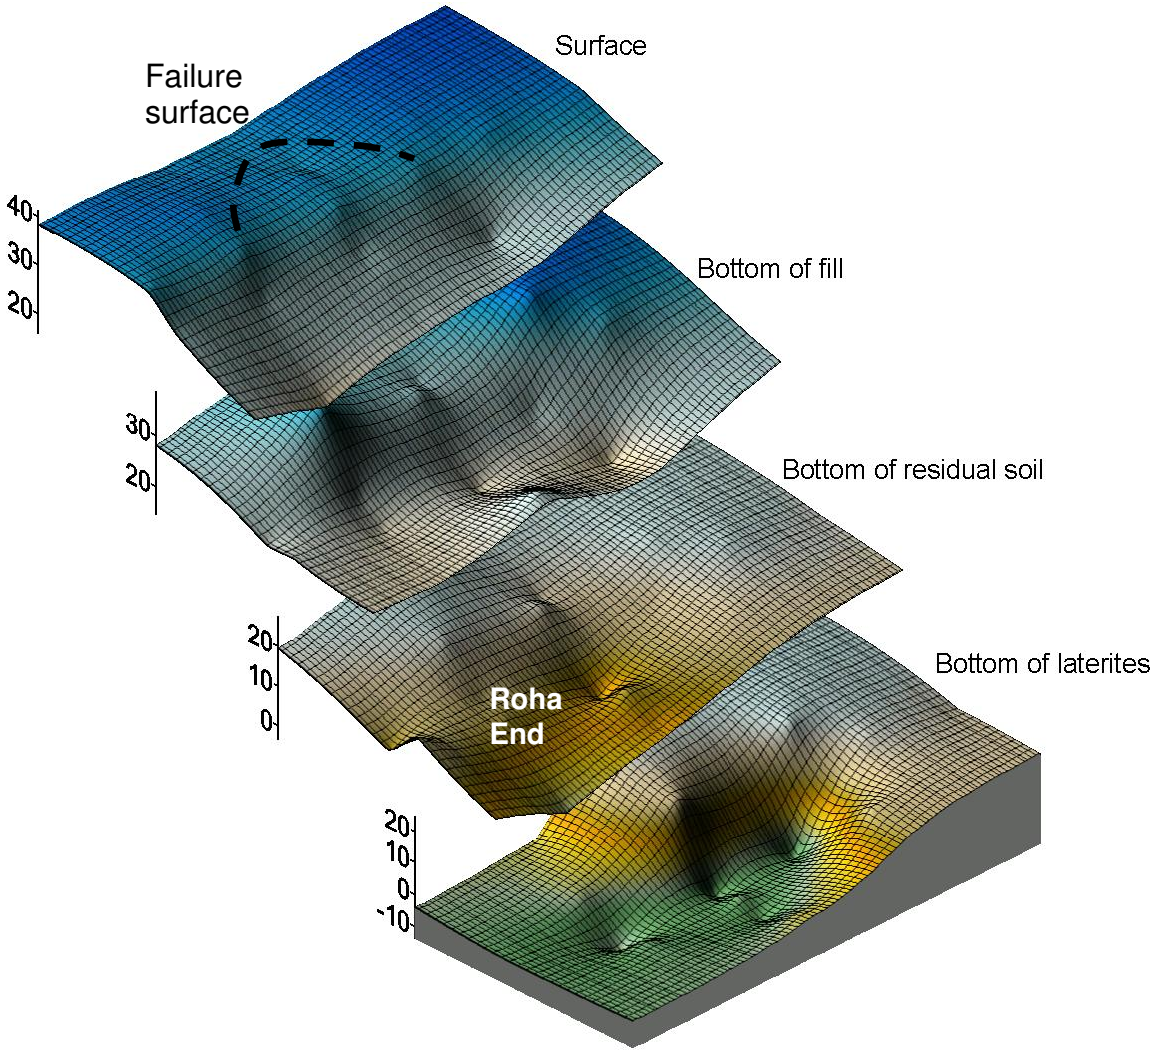
Figure 8. Three dimensional cross-sections of the soil and rock layers

Fill: Fill consisted of reddish brown silty clay and clayey sand. The clay matrix was frequently filled with coarse gravel and cobbles, which made this topmost-soil-layer firm to stiff. The fill was classified as medium to dense at locations where the sand and gravel proportions were in majority. The thickness of the fill was in between 13.5 to 15m in boreholes drilled close to the rail line at top of the hill. The thickness of the fill was surprisingly only 9m in borehole BH-17 drilled near the vertex of the failure surface. Apparently, the slip along the failure surface had caused the fill thickness to reduce at this location. The fill gradually narrowed towards the top flat end of the hilltop. Likewise, boreholes BH-7, BH-8, BH-24 and BH-24 indicate that the fill tapered off downhill at the road level. Figure 8 shows that the fill is bowl-shaped with its edges fused to the edges of the section. From Figure 8, it is interesting to note that the shape of the failure surface mimics the shape of the fill.

Basalt bedrock: Basalt bedrock was logged from 13m to 49.5m below ground surface. As shown in Figure 8, the top surface of the basalt was undulating which provided a strong grip to the above laterites. The bedrock was weathered at the top with fractures at many locations. The depth from which the quality of the basalt improved to slightly/moderately weathered is shown in Table 3. The UCS of the bedrock was in between 200 kN/m^2 and 124 MN/m^2. Table 3 also shows the termination depth in each borehole.

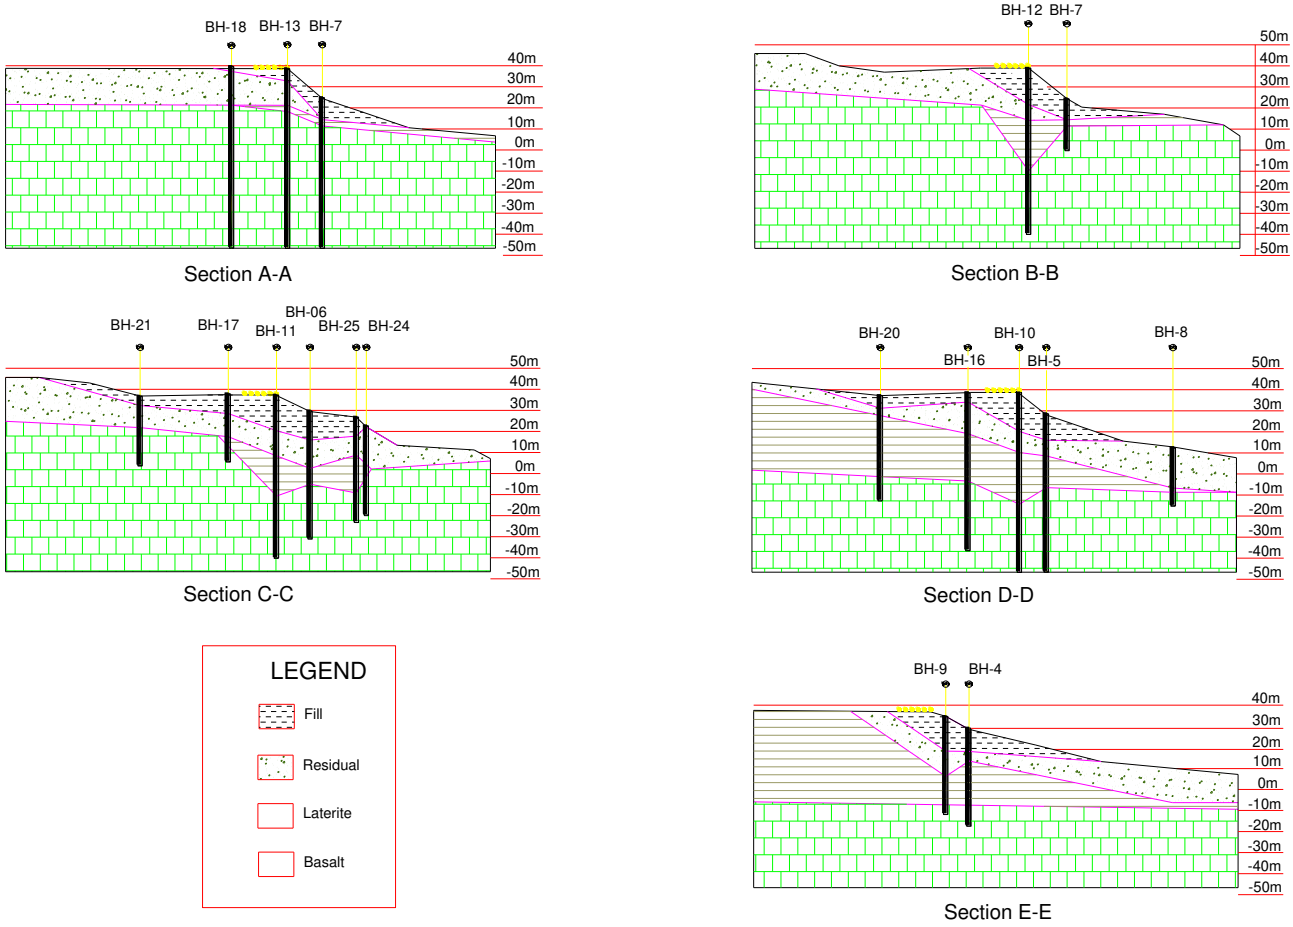
Figure 9. Subsurface profile at the site. Location of sections A-A to E-E are as per Figure 7.

Using the borehole data, five cross-sections were drawn to interpret the subsurface profile of the site. The five sections are marked as A-A to E-E in Figure 7 and are shown in Figure 9. Sections B-B to D-D were chosen to represent the edges and centre of the failure zone. Laterites were nearly absent in section A-A and had the maximum presence in section D-D. The average geotechnical properties at each section are shown in Table 4. The material properties in Table 4 were obtained from the field and laboratory testing programme monitored jointly by Konkan Railways and IIT Bombay. Direct shear tests were conducted to obtain c' and ϕ'. Unconsolidated undrained (UU) triaxial tests were conducted to obtain c_u. The secant Young's modulus, E, of selected samples was obtained from stress-strain curves on UU samples confined with 50 to 200 kN/m^2 mean stress. Unconfined compression tests were conducted to obtain the c_u of laterites and basalt.

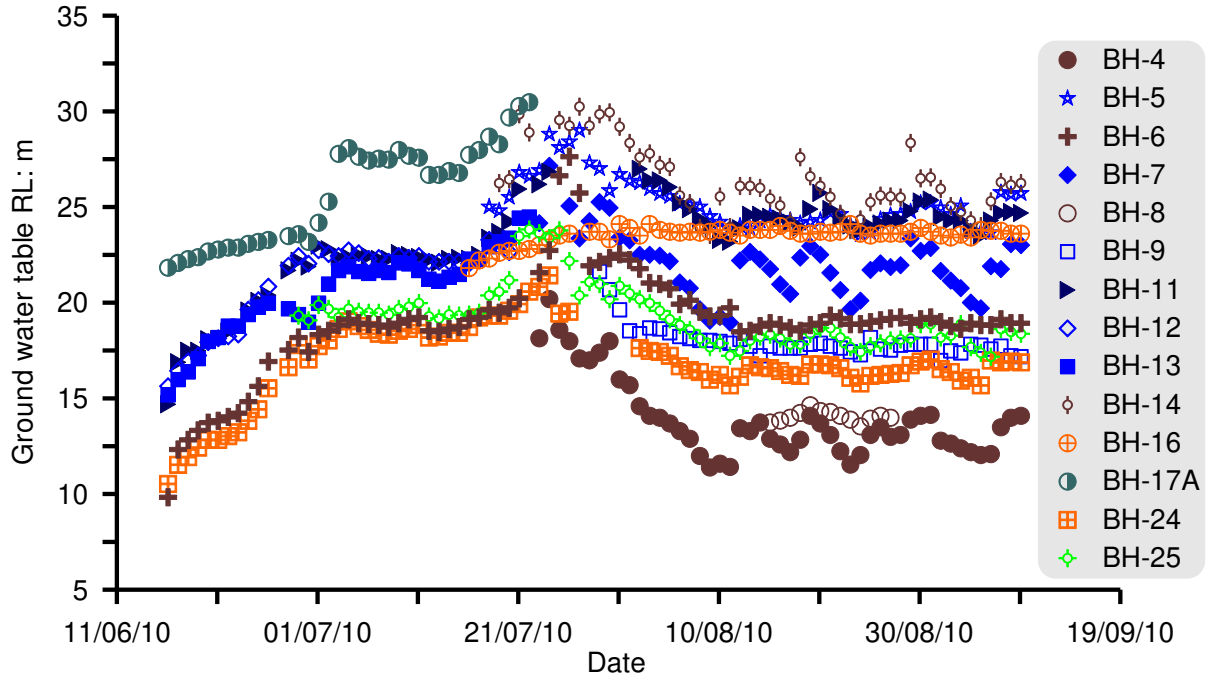
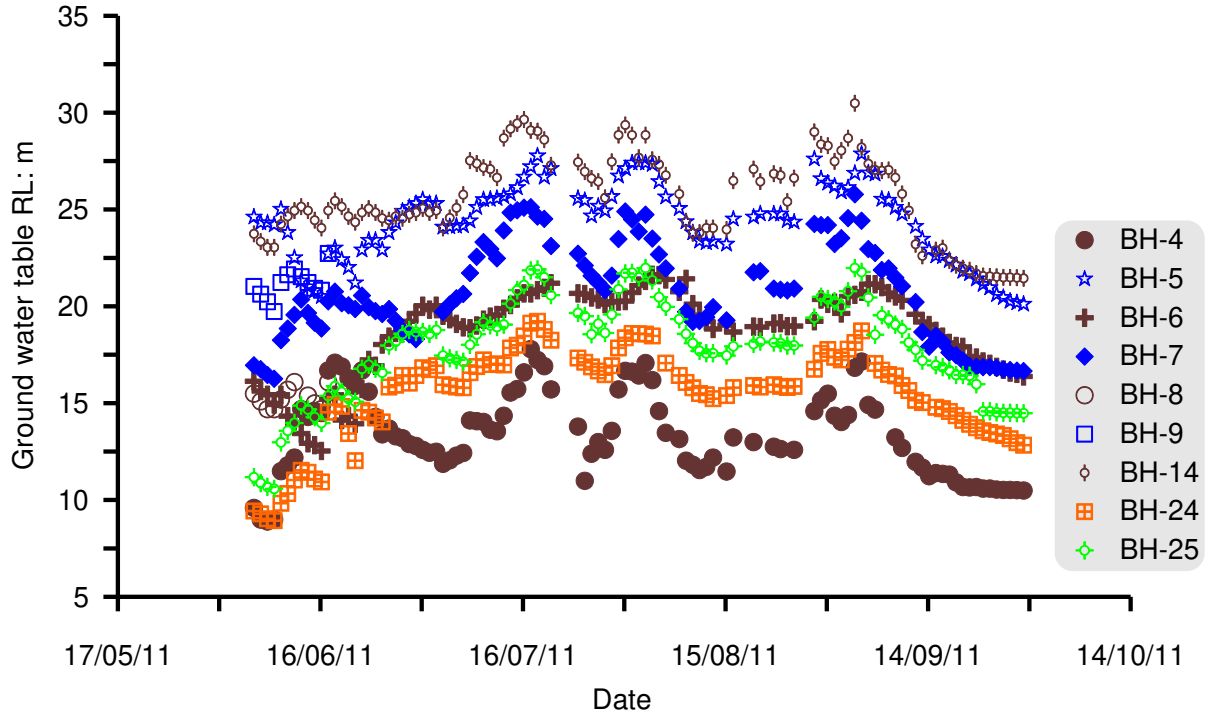
Standpipes were installed in the boreholes after the completion of the drilling. Ground water depths were occasionally recorded in these standpipes for about two years. Figures 10a and 10b show the water table recorded in 2010 and 2011, respectively. The slope movement during the 2010 and 2011 monsoons, sheared-off some of the standpipes. As a result a complete record of ground water data is not available over the monitoring period at these locations. The maximum and minimum water table depths are summarised in Table 5. A few observations may be made from Figures 10a-b and Table 5. First, the water table changed from 12.5m to 20m over the monitoring period in boreholes which were drilled along the centre-line of the failure surface. This variation in the water level possibly created a large pressure gradient. Second, the seasonal variation in the water level was more than 9m in boreholes drilled within the failure zone. There was significant variation in the water level even outside the failure surface. For example, the pressure head difference between boreholes BH-7 and BH-12 was more than 17m although the boreholes were only about 35m apart. Inevitably, these large pressure head difference caused large groundwater flow and significant seepage forces.

Figures 10a-b. Water table in standpipes: (a) In 2010; and (b) In 2011.

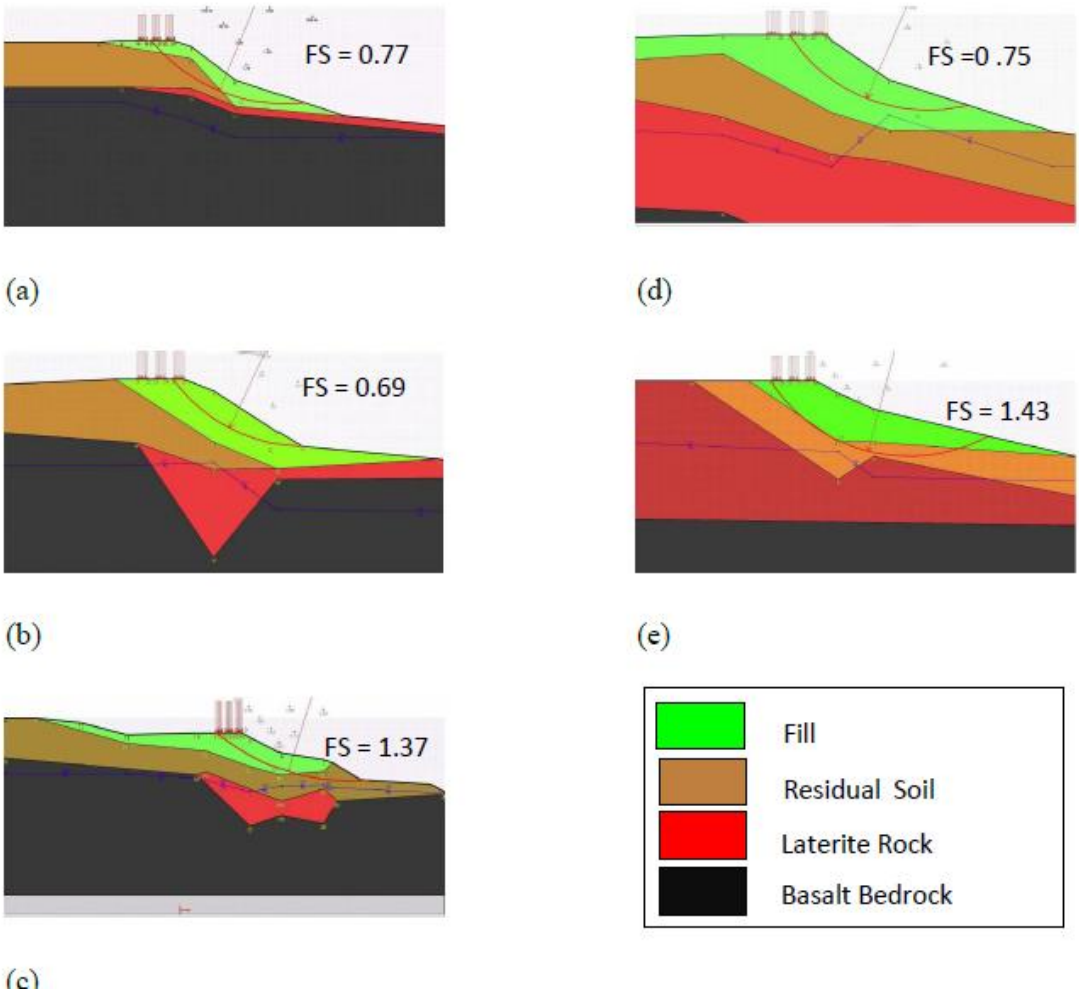
Figures 11a-e show the minimum safety factor and the location of the critical circle in sections A-A to E-E for the dry season. It is surprising to note that the minimum safety factor in 3 out of 4 sections is less than one, despite the fact that the slope was known to be stable and did not show any distress during the dry season. These sections are A-A, B-B and D-D in the figures. Figures 11a to 11e also show that the ground water level is below the critical failure circle in all 4 cases. Therefore, even if it is argued that the hydrological conditions which led to the 2005 failure and those measured in 2010 and 2011 may not be the same, it is unlikely that the position of the water table could influence the stability of the slope during the dry season.

Figures 11a-e. Safety factor during dry season with original parameters for section: (a) A-A; (b) B-B; (c) C-C; (d) D-D;and (e) E-E.

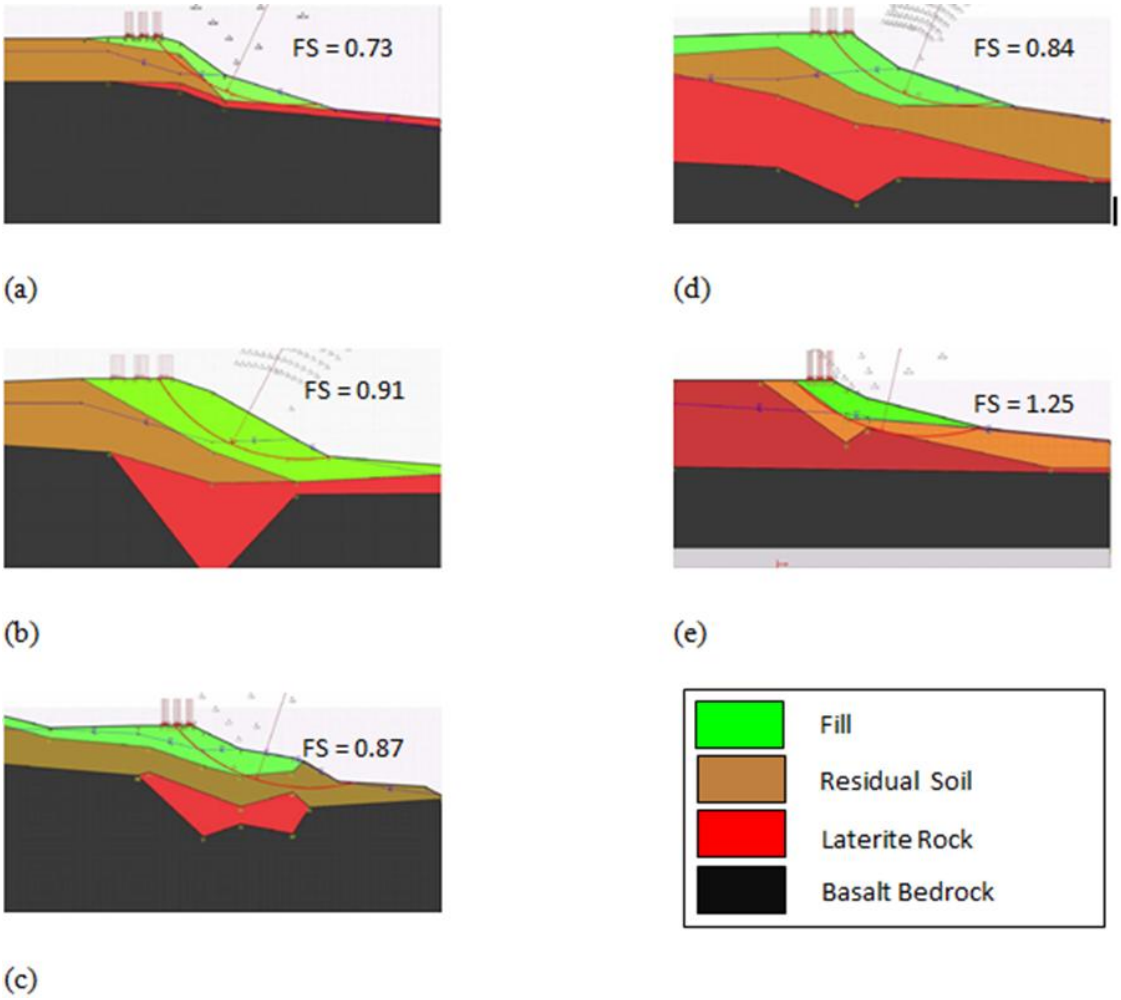
Figures 12a-e. Safety factor during wet season with modified parameters for section: (a) A-A; (b) B-B; (c) C-C; (d) D-D;and (e) E-E.

Figures 12a to 12e show the minimum safety factor and the location of critical circles in sections A-A to E-E for the wet (monsoon) season. In all the figures, the critical slip circle passes through the toe of the embankment, which is similar to the observations made at the site (see Figure 5). Similarly, the top of the circle in Figure 12c intersects the rail tracks and lie close to point X in Figure 2. The safety factor of all the 5 sections for the dry and the wet seasons are compared in Table 8. As can be seen, the safety factor reduced to less than one with the rise in ground water table in all sections, except in section EE. Figure 12e shows that only section E-E was stable during the wet season. This section was far beyond the failure zone shown in Figure 7. Regardless of the above observation, it is plausible that factors such as deep-rooted trees present at the site may have affected the safety factor. All the same, the effect of vegetation on the slope stability cannot readily be incorporated within this simplistic framework (Bernhardt et al. 2011).

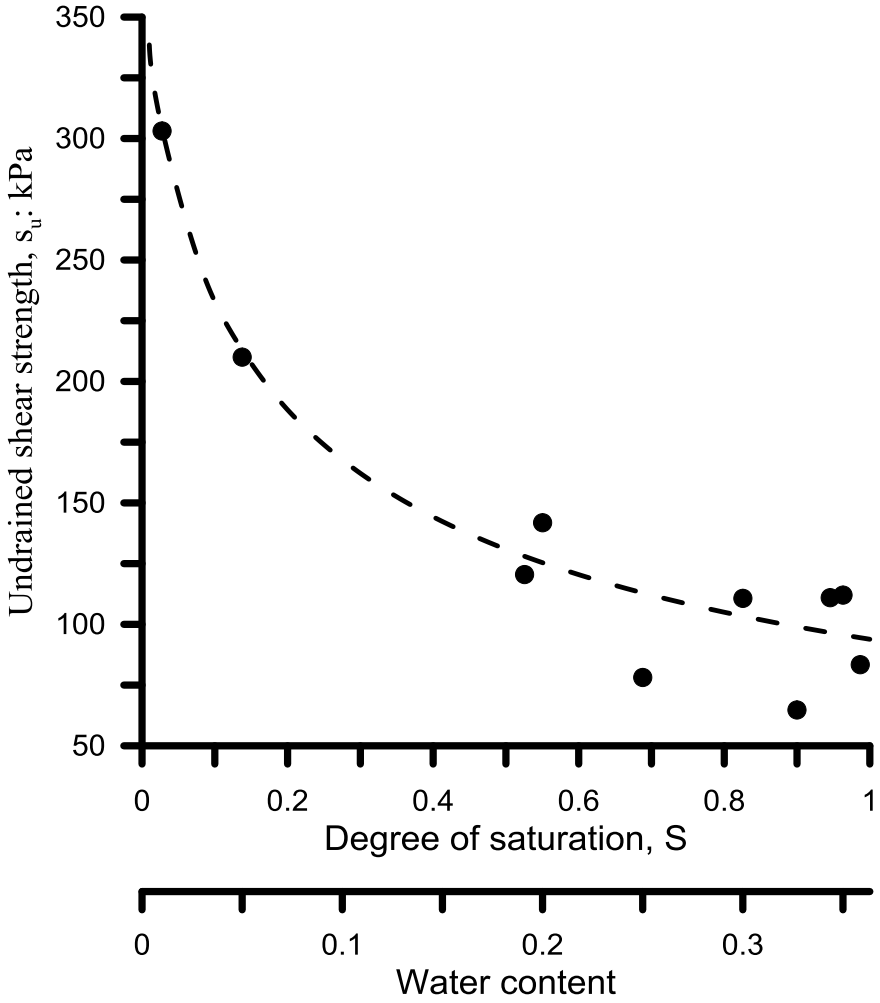
The above slope stability analysis only permits the estimation of the safety factor using the effective (or drained) shear strength parameters. It does not account for the change in strength of the soil due to the change in the degree of saturation as the rainwater percolates. An experimental programme was therefore designed to also study the effect of the change in the degree of saturation on the strength of the residual soils. A series of routine UU-triaxial shear tests were conducted on remoulded and reconstituted samples at 100 to 200 kN/m^2 cell pressure. The samples were compacted at constant void ratios but different degree of saturation. The dry unit weight of all the samples was within the range of 13.5 to 14 kN/m^3. The tests were carefully conducted to avoid any change in water content during the testing procedure. However, it must be noted that since most of the samples were partially saturated, the tests were not truly undrained. There was no arrangement to measure the pore pressure suction because its effect was considered to be insignificant in view of the short duration of the test (Vanapalli et al. 1999). Figure 13 shows the variation of the undrained shear strength, s_u with the degree of saturation, S. Despite the scatter of the data points, the results appear to suggest that the water content has significant influence on the strength of residual soils. For instance, the figure shows that an increase in S from 0.1 to 1 caused s_u to decrease by over 100%. Notwithstanding the above, the results also permit a semi-empirical relationship to be fitted to the data:

Figure 13. *Variation of undrained shear strength, with degree of saturation at constant void ratio/ dry density.*

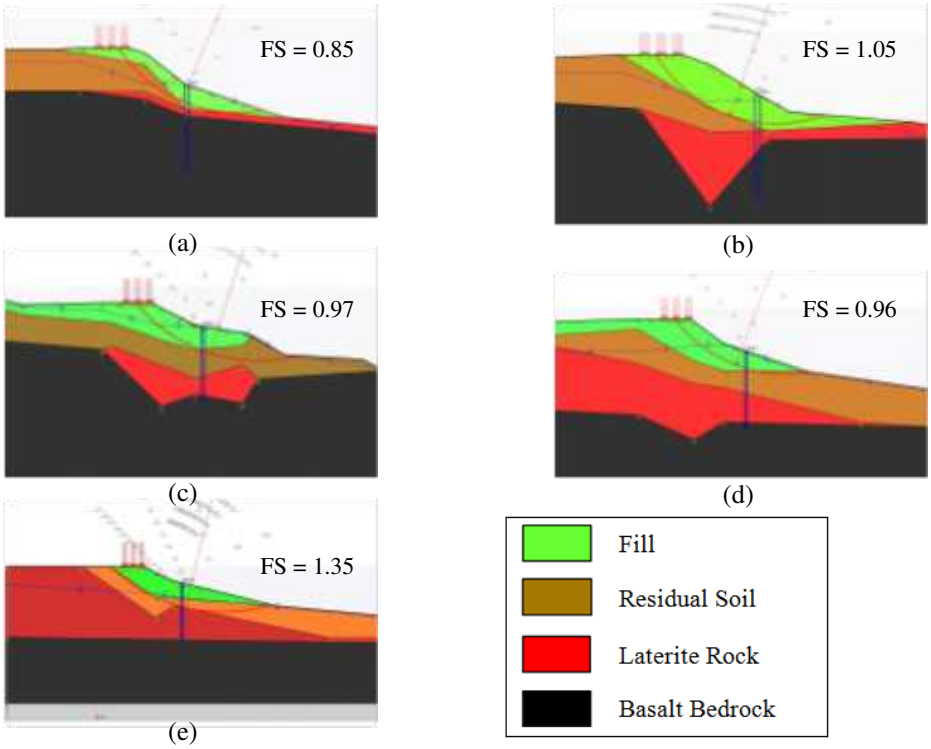
Figures 15a-e. Safety factor and critical slip circle during wet season with January 2007 ground improvement scheme for section: (a) A-A; (b) B-B; (c) C-C; (d) D-D; and (e) E-E.

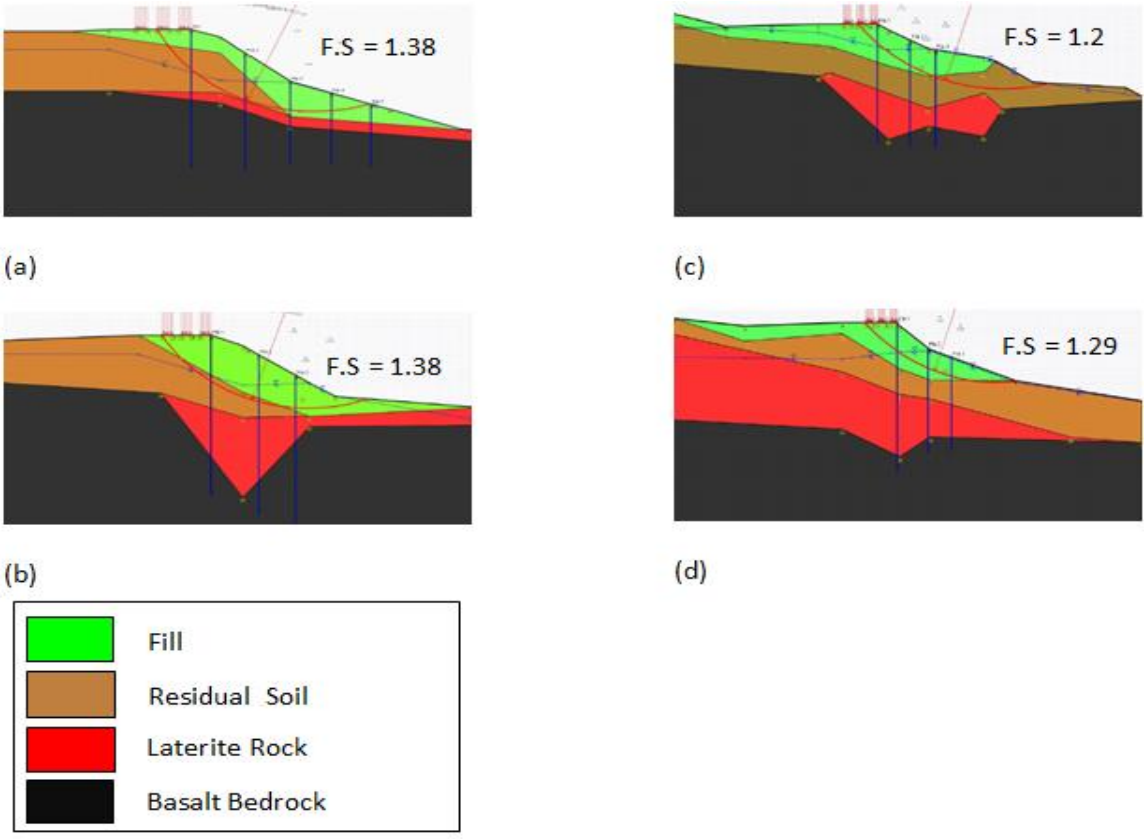
Figures 17a-d. Safety factor during wet season with proposed contiguous bored pile pile for section: (a) A-A; (b) B-B; (c) C-C; and (d) D-D.

One possible solution to enhance the stability of the slope was with the use of large diameter piles to retain the (failed) soil mass. In this case, safety factors of sections A-A to E-E were also deduced by assuming that the slope was reinforced with single or multiple rows of contiguous bored pile wall constructed parallel to the platform. Figure 16 shows the schematic layout of the proposed bored pile wall. The 1.2m diameter piles terminated below the slightly-to-moderately weathered basalt rock because of which sections B-B and C-C had long piles to provide adequate anchorage (Table 3). Table 9 shows the location and length of the piles used in the analysis. Figures 17a-d show the minimum safety factor and the location of critical circles in sections A-A to D-D for the wet season when the slope is reinforced with contiguous bored pile wall. As can be seen, the minimum safety factor increased up to 1.2 and 1.38 with the use of contiguous bored pile wall.

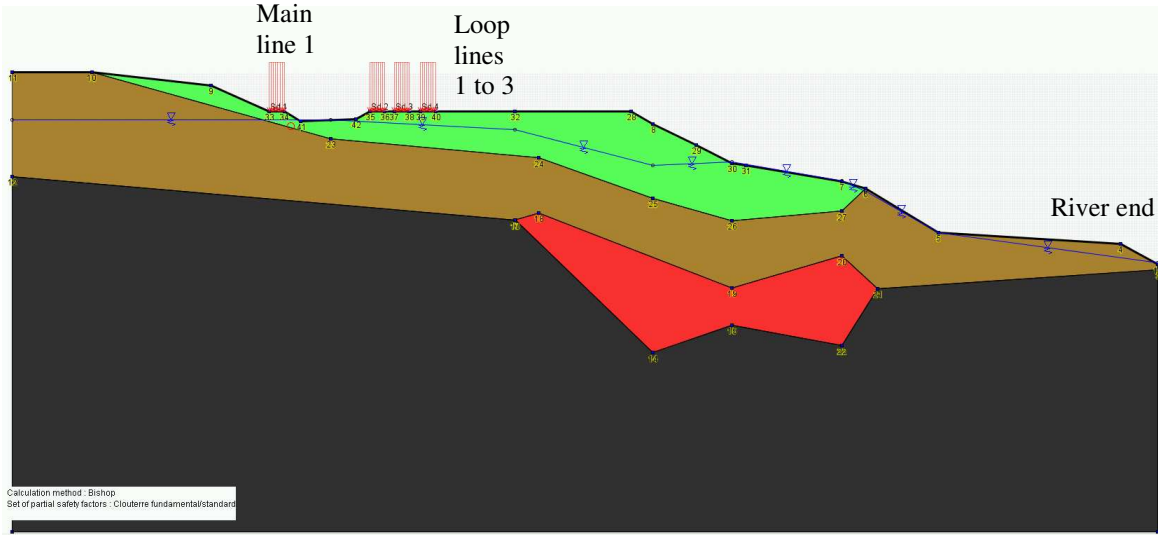
Figure 18. Section C-C with new rail alignment. The main alignment consists of 3 loop lines and 1 main line.

The cost to use the bored pile wall was over 200 million Indian Rupees (US$ 3.6 million) and appeared to be prohibitive. As an alternative to this design, the old rail alignment was removed and replaced by a new alignment. The new alignment consisted of 3 loop-lines and 1 main-line. Figure 18 shows section C-C along with the location of the new alignment. In this section, the top left side of the hill was slightly levelled to accommodate the main line and the loop lines. Section C-C was chosen because the new alignment was closest to the failure surface at this section. The horizontal distance from the vertex of the failure surface and the 4 lines was 16m, 21.3m, 26.2m and 46.4m, respectively. The stability of the slope was then reinvestigated using the computer program Talren-4 (Terrasol 2005). As in the previous case, all the lines were loaded by 125 kN/m^2. This assumption was unduly conservative in absence of strict guidelines (RDSO 2003b). Nonetheless, it permitted trains with more overtaking opportunities on the passing-loops. The ground water level was modeled using the highest RL recorded in Table 5. The failure circles are shown in Figure 19. As can be seen, the minimum safety factor is

more than 1.4. The slope was therefore considered to be safe and unlikely to fail under the new loads. This new alignment has been implemented since 2011. It has been constructed at less than 20 percent of the cost incurred to improve the ground. The railways have also the removed speed restriction at Nivsar which has resulted in additional savings during the monsoon.

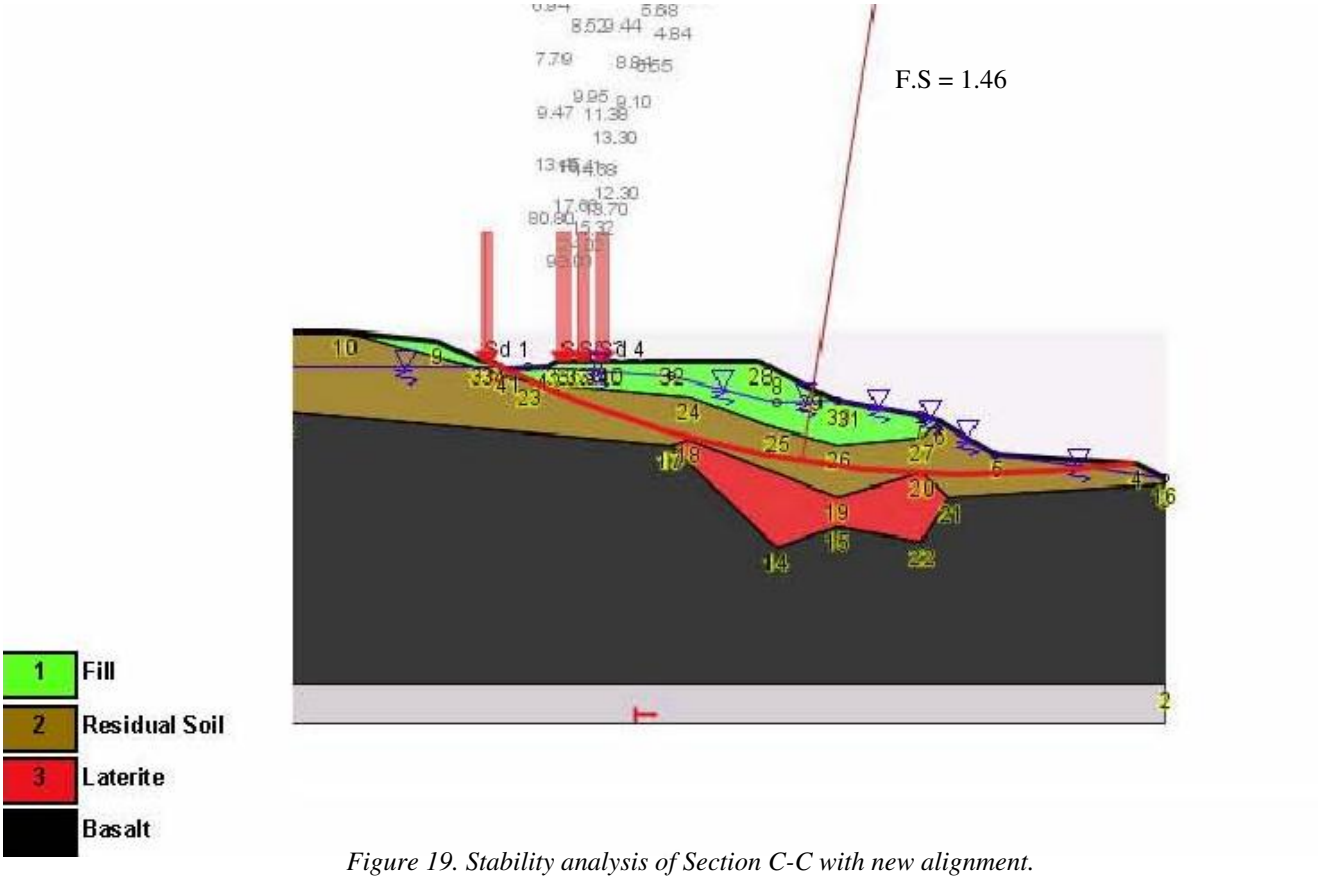
Figure 19. Stability analysis of Section C-C with new alignment.
